Regional District of Central Kootenay (RDCK)

Johnsons Landing Landslide Hazard and Risk Assessment

May 16th 2013

Doug Nicol¹, P.Eng., Peter Jordan², P.Geo., Dwain Boyer², P.Eng., Daryn Yonin³, P.Eng.

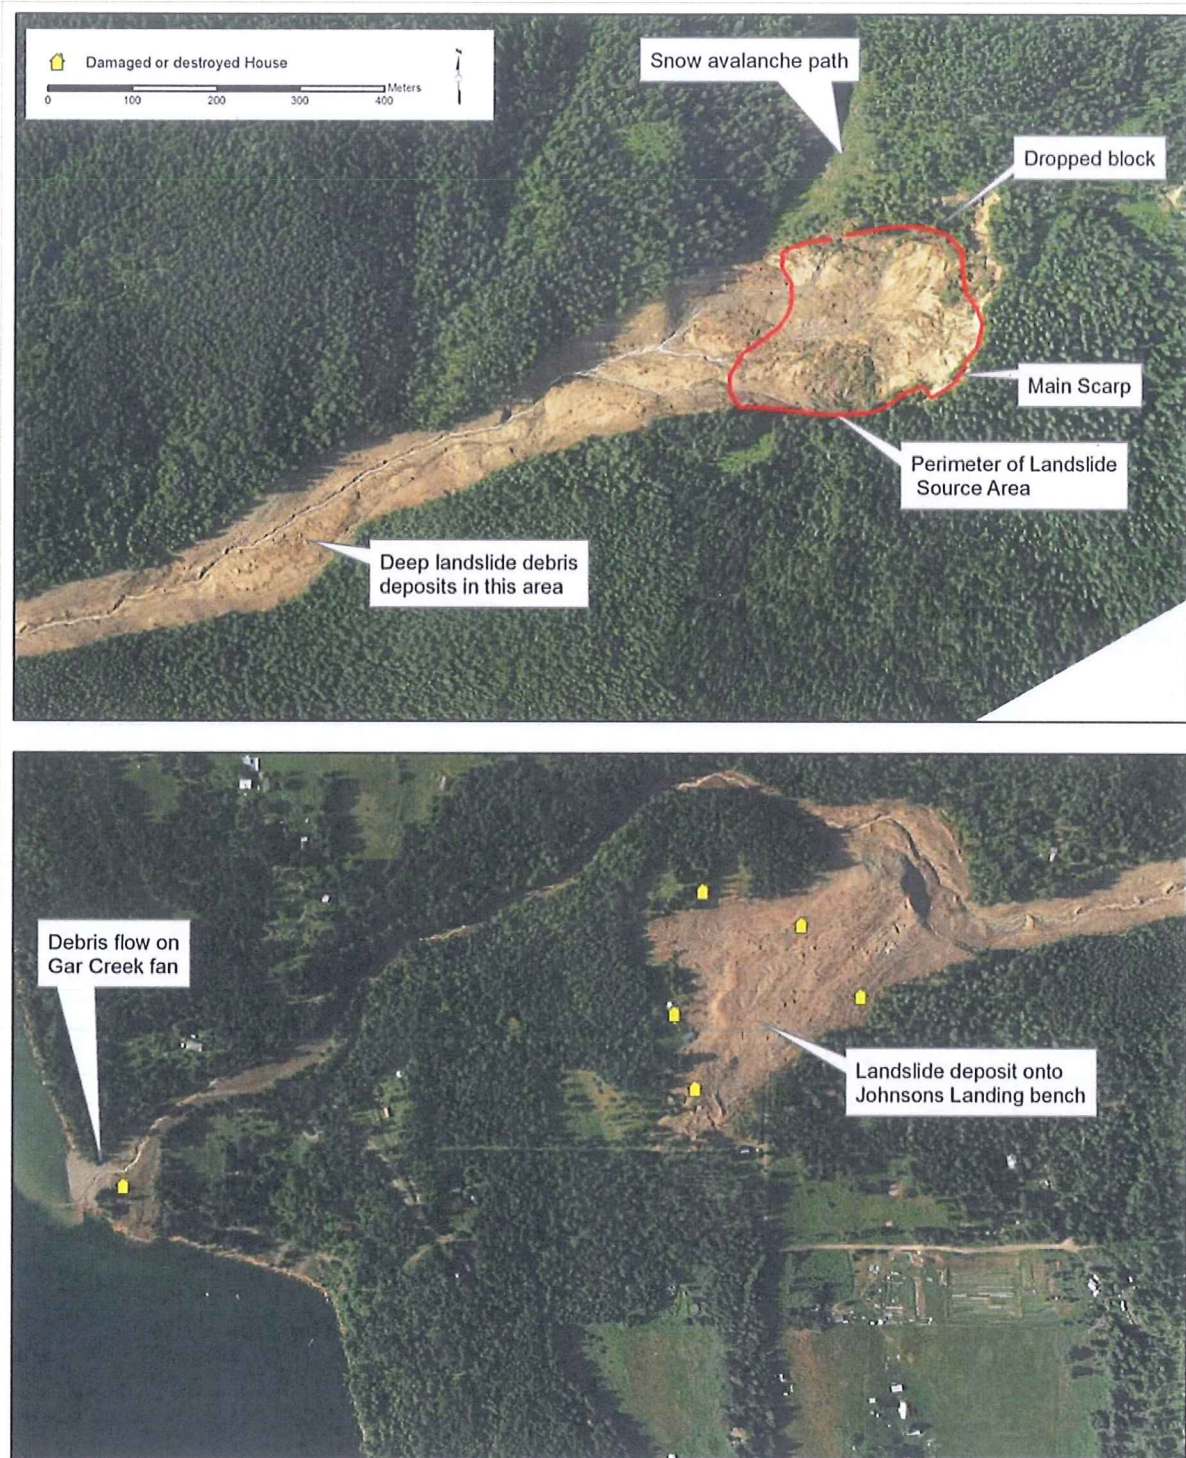
The main Johnsons Landing landslide occurred on the morning of July 12th 2012, at 10:37 a.m. The landslide originated in deep glacial till and colluvium at an elevation of 1050 m to 1250 m (Figure 3 and Figure 4). The estimated landslide volume was approximately 320,000 m³ (see Photos 1 to 6 Appendix A). The initial event comprising most of the volume is classified as a rapid debris avalanche (Hungr et al 2001). It descended the channel of Gar Creek, a steep narrow valley which occasionally carries small debris flows and snow avalanches. Approximately 50% of the debris (169,000 m³) left the creek channel at a 70° bend in the creek 1400 m from the initiation area, travelled up and over a low ridge at 750 m elevation, and spread out approximately 250 m wide by 300 m long with an average thickness of 2.6 m on a gently sloping bench (Johnsons Landing bench) which was occupied by forest, cultivated land, and houses. Three houses were destroyed on the Johnsons Landing bench and two additional houses were severely damaged. Four lives were lost. A portion (less than 5%) of the debris continued flowing down the narrow creek channel as a debris flow, destroying three creek crossings of the Argenta-Johnsons Landing Road, and inundating a portion of the fan area at the lake damaging a house (see Photos 7 and 8 Appendix A). The total area impacted by the landslide is 30.8 hectares (ha), of which the source area is 7.5 ha. The source area is the area from which the landslide material originated. Landslide debris covered an area of 6.5 hectares on the Johnsons Landing bench and affected 16.8 hectares in the channel and fan.

Figure 3: Features of the 2012 landslide source area (upper) and deposits (lower)

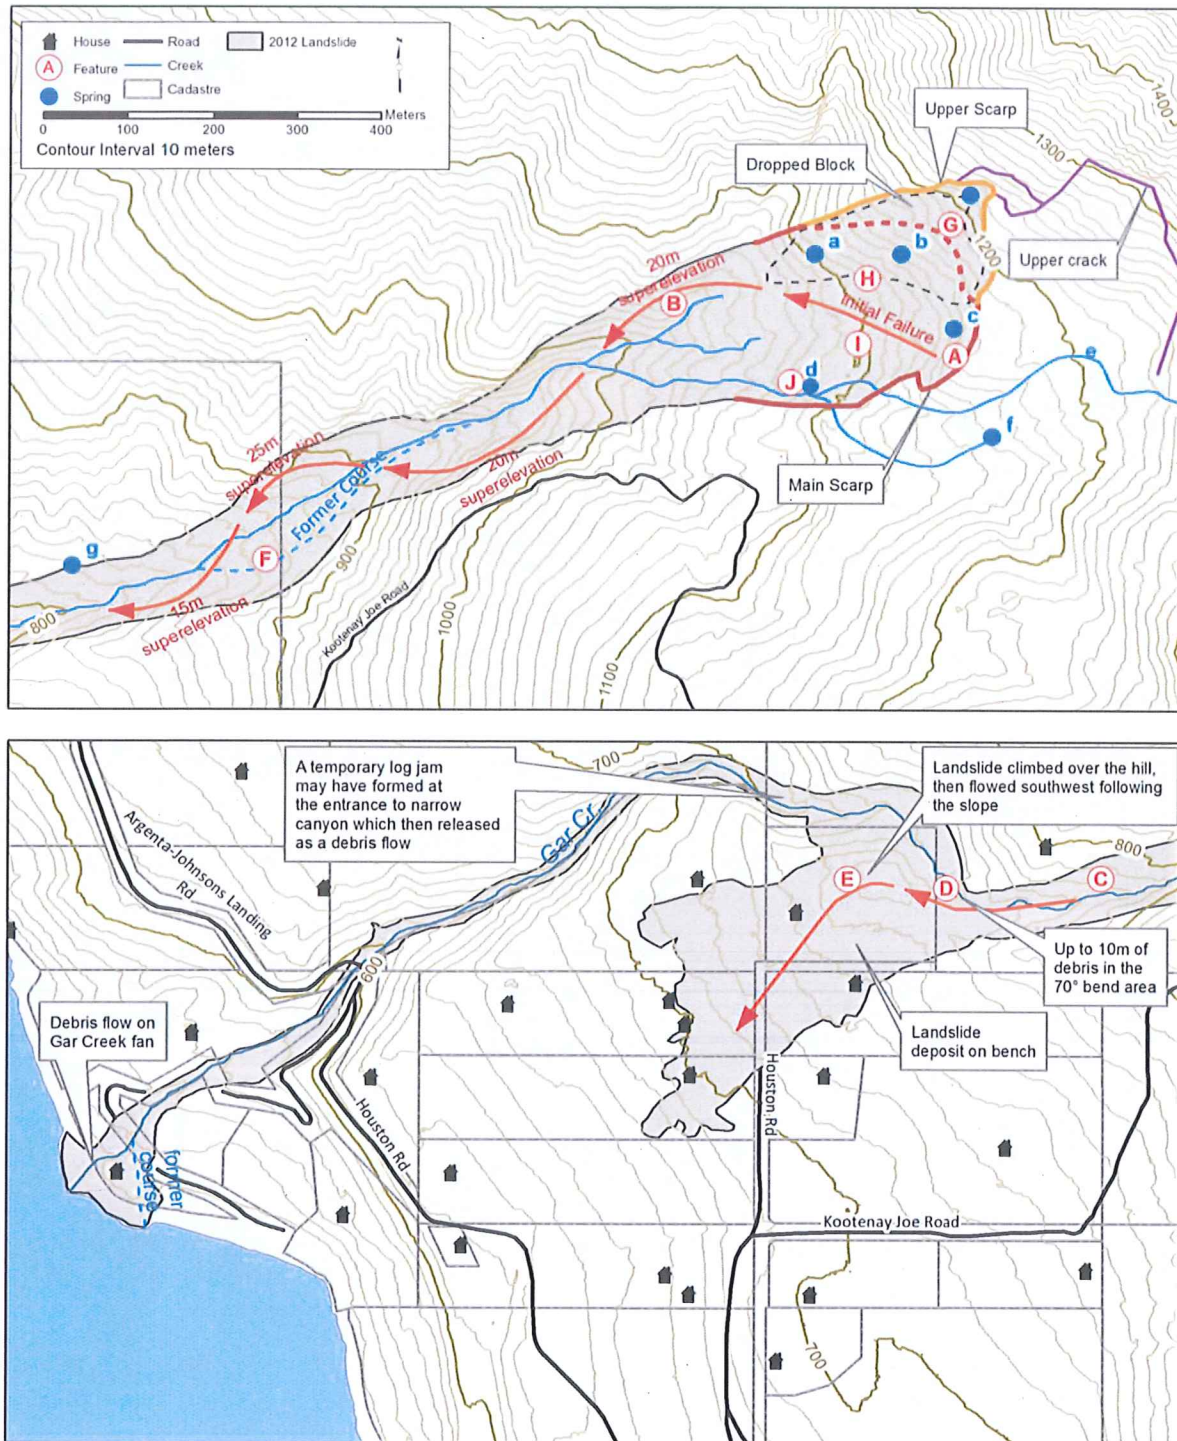
Figure 4: Landslide source area (upper) and deposits (lower) of the 2012 landslide.

Note: The main scarp of the initial landslide source area is shown in red (solid where intact; dashed where disrupted by the dropped block). The dropped block is outlined with a black dashed line, and its upper scarp is shown in orange.

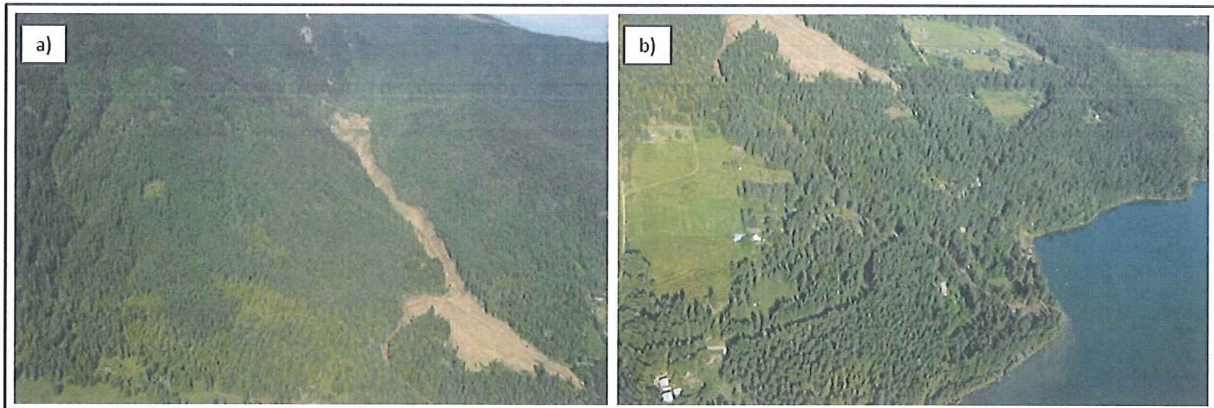
Figure 5: Photos of the landslide on the afternoon of July 12th. a) Initiation zone to Johnsons Landing bench, b) Johnsons Landing bench to Kootenay Lake.

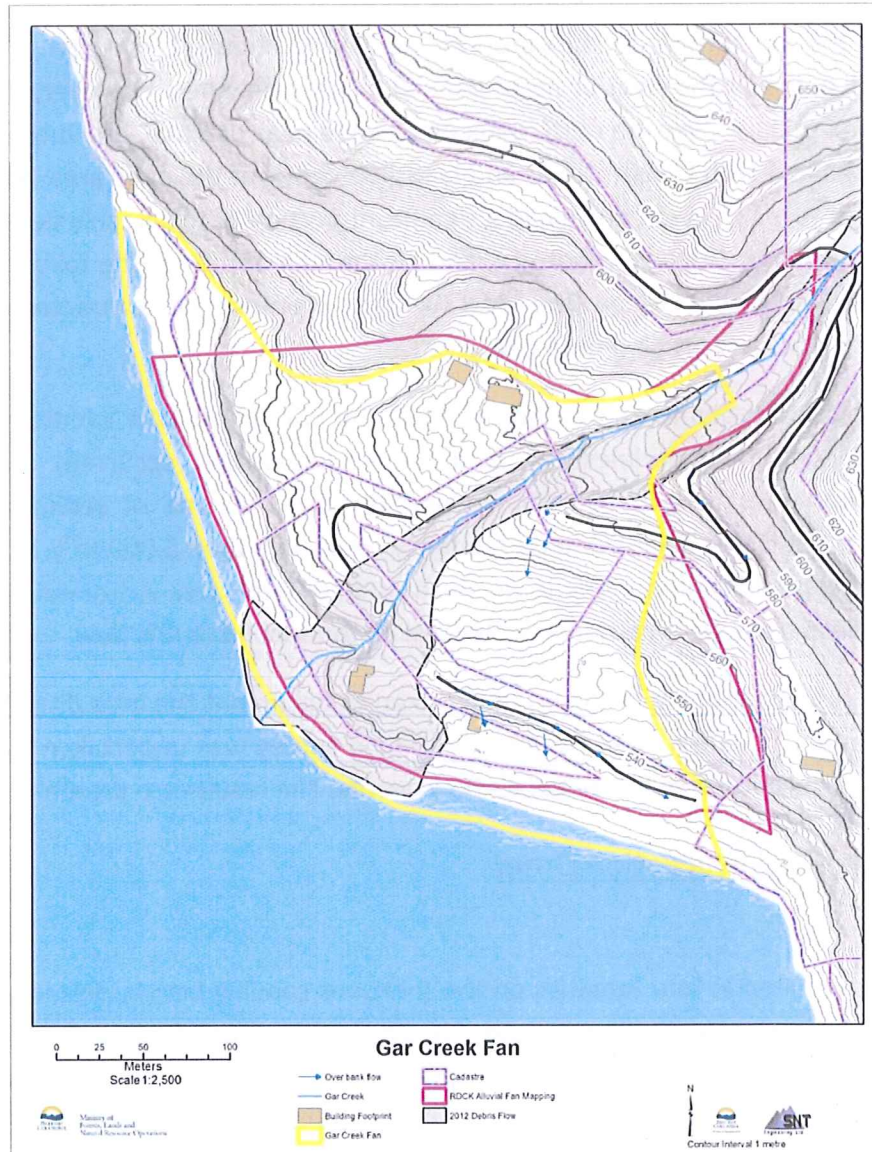
There was no evidence of recent (over the last 100 years) debris flow events onto the Gar Creek fan. However, from the topography and soil materials on the fan, it is evident that the fan was constructed, over the last 12,000 years, by earlier debris flow and flood events. The fan is delineated in Figure 7.

Figure 7: Gar Creek Fan. The 1 m contour map is derived from the post-landslide LIDAR imagery. The outline of the July 12th-13th debris flows is shown.

The fan has two levels. There is a more active smaller fan at the lake associated with the current lake level, which was completely inundated on July 12th/13th, 2012, and a higher larger fan (approximately 9.6 hectares) with the apex as shown on the map that is most likely associated with past debris flow events that occurred at higher lake levels. The area inundated during the July 12th/13th events is shown on Figure 7.

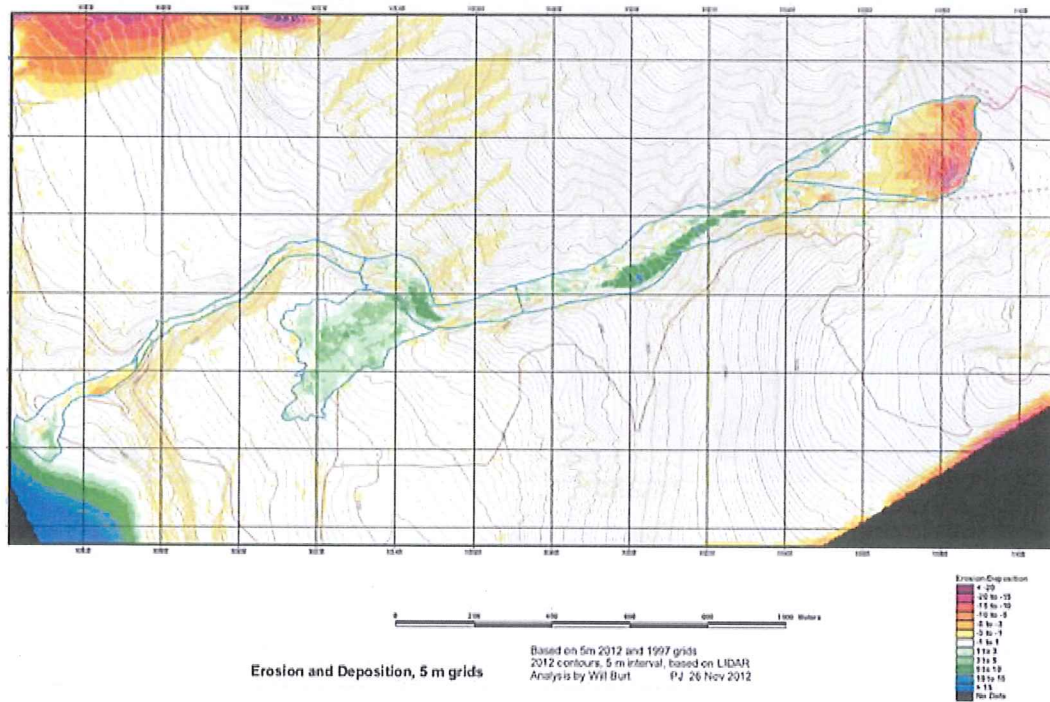
Figure 18 presents a map of estimated landslide erosion and deposition. Table 2 is a summary of the areas and volumes. The deposit volume is 19% greater than the estimated source volume, which is expected due to “bulking” or expansion of the original material upon failure.

Figure 18: Estimated landslide erosion and deposition volumes

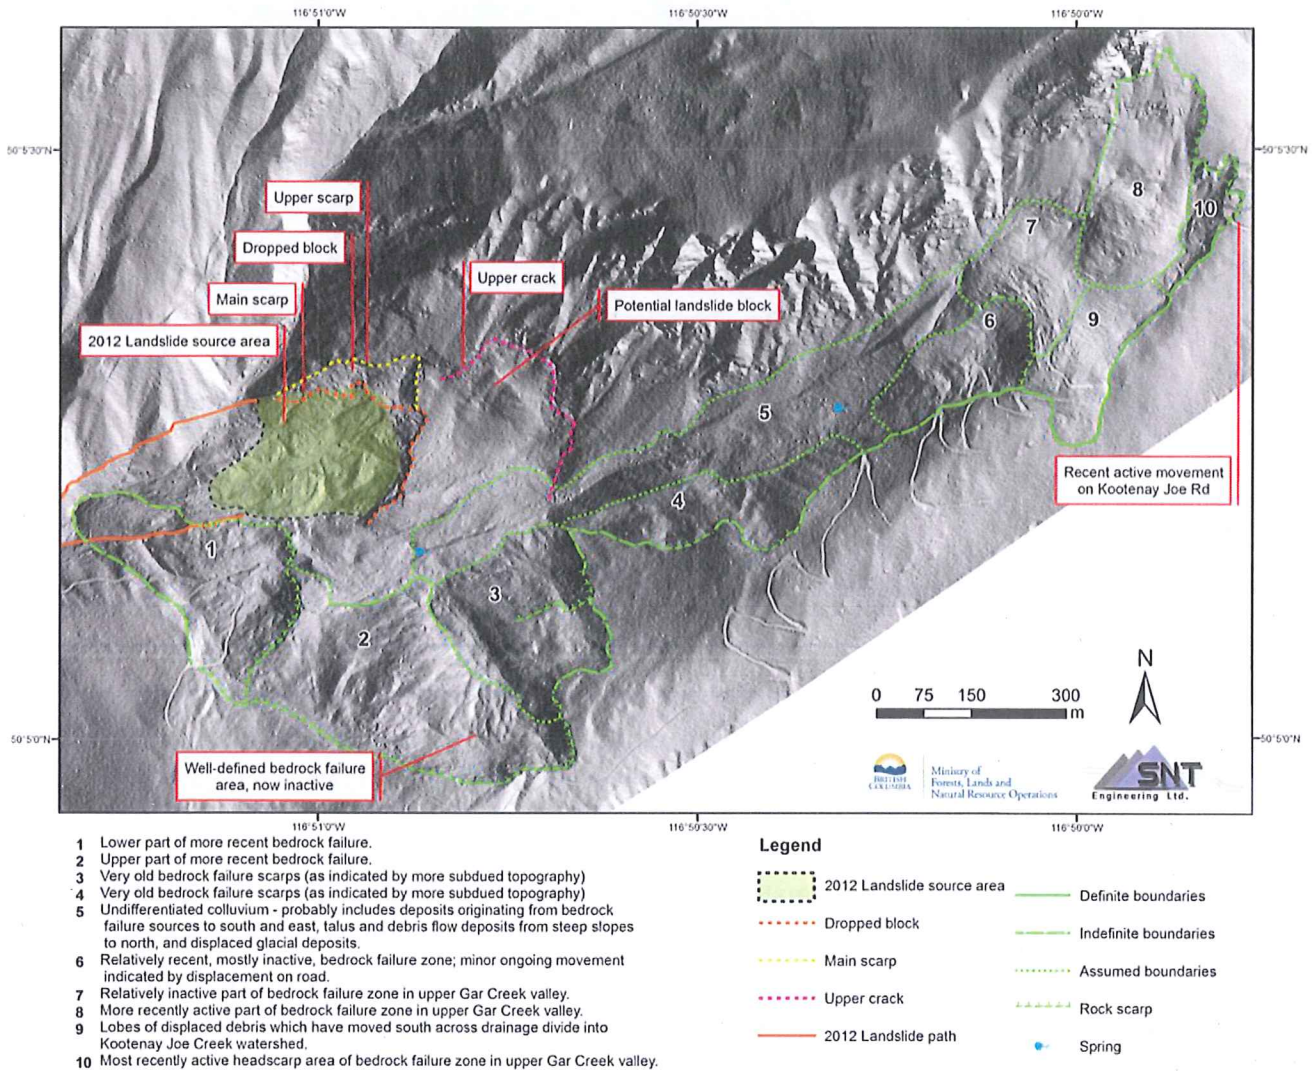
Figure 24: Slope features adjacent and upslope of 2012 Landslide source area

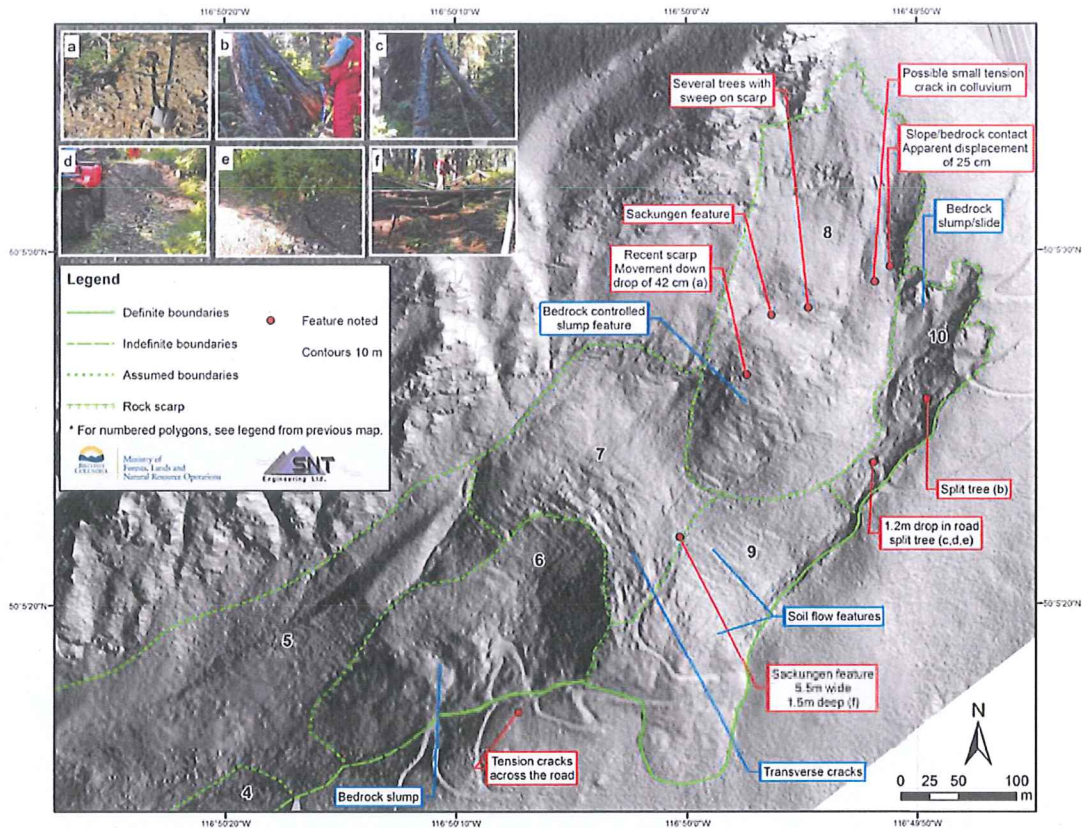
Figure 25: Slope features in upper Gar Creek drainage

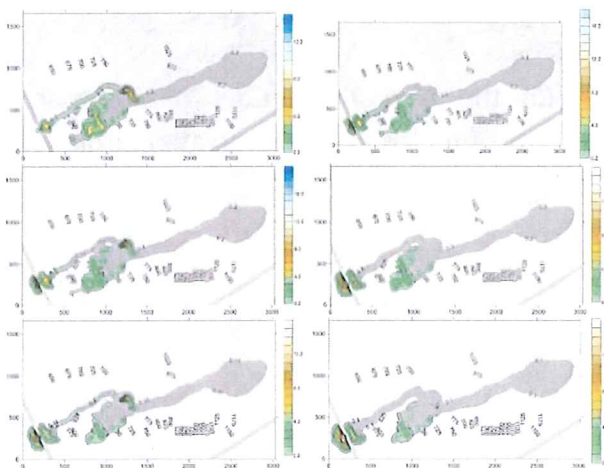
The volume of landslide material that flows onto the Johnsons Landing bench and landslide travel distance could be reduced by the construction of a berm at the location of the 70° bend in the Gar Creek.

Figure 35: Modelled deposits in the left column with channel obstruction and in the right column with no channel obstruction. The top row has no berm, the middle row has a 5 m berm and the bottom row has a 10 m berm. The source volume for all events was 400,000m³

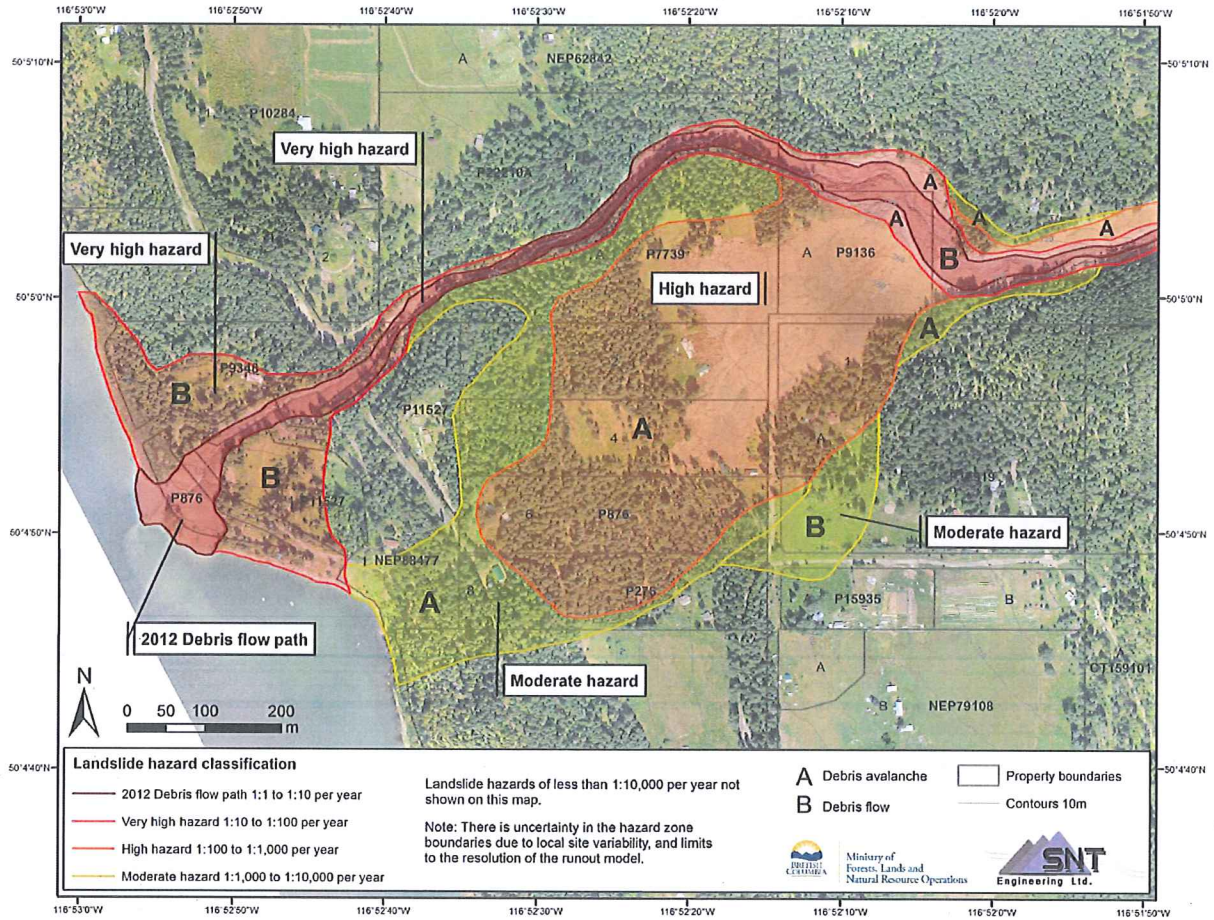
Figure 36: Johnsons Landing landslide hazard zoning maps

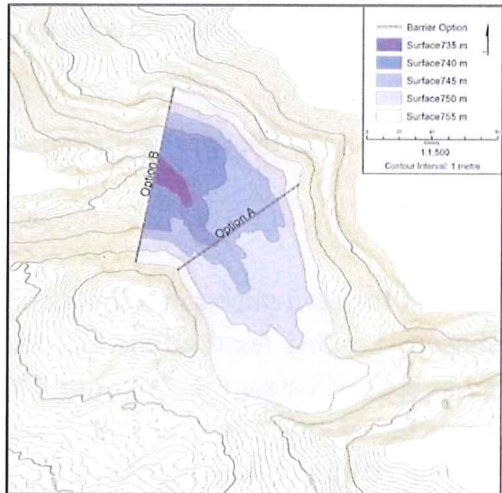
Figure 41: Channel berm construction option A and B
