MINISTRY OF FORESTS, LANDS AND NATURAL RESOURCE OPERATIONS, POST-WILDFIRE RISK ANALYSIS – PRELIMINARY REPORT

| FIRE: 15 N70624 | | FIRE YEAR: 2015 | DATE OF REPORT: Oct. 14, 2015 |

Mt. Midgely Fire 15 N70624 Select Photographs

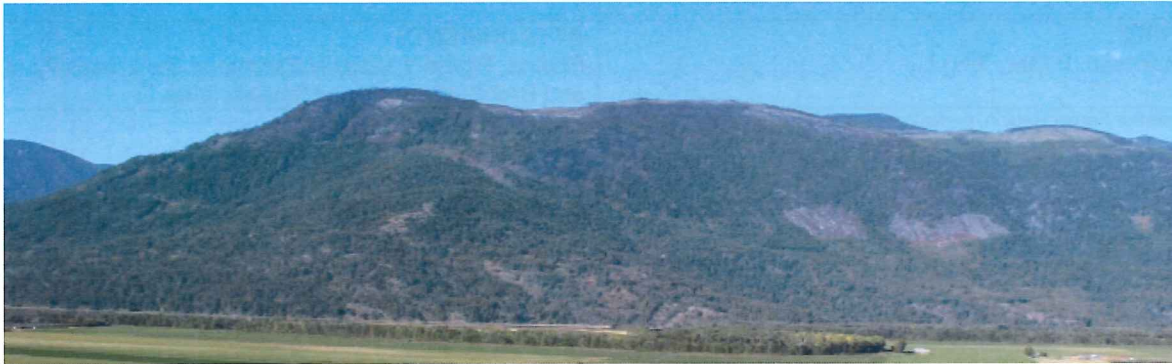
Photo 1: Mt. Midgely Fire 15 N 70624 as viewed from the east side of the valley near Wyndell.

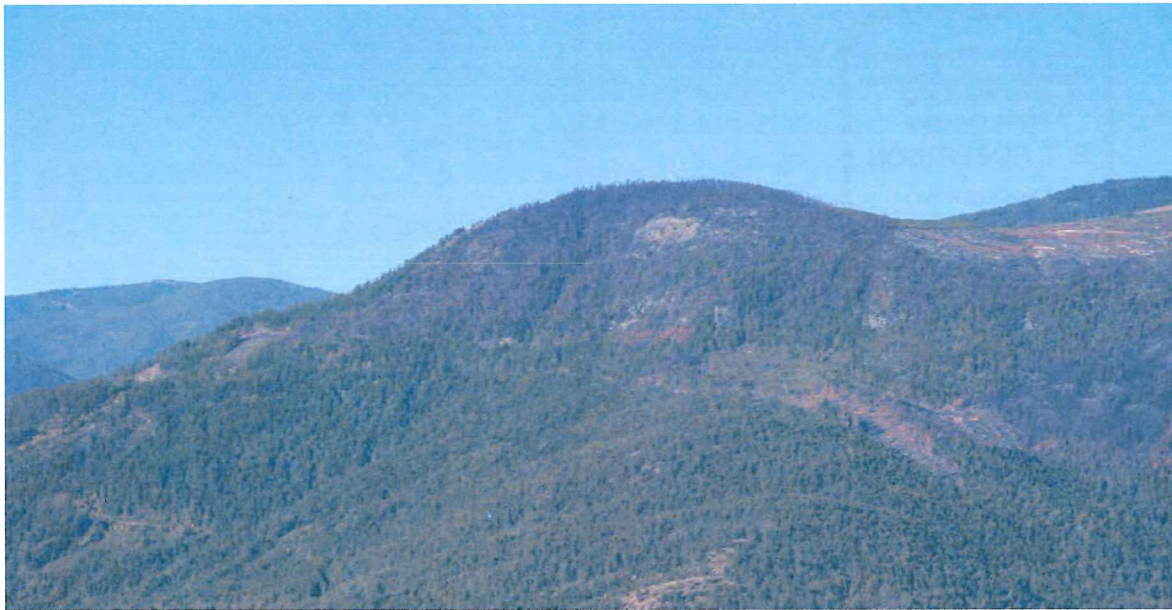
Photo 2: Zoomed in view of charred areas in the upper watershed areas of Brash Creek and Campbell Creek.

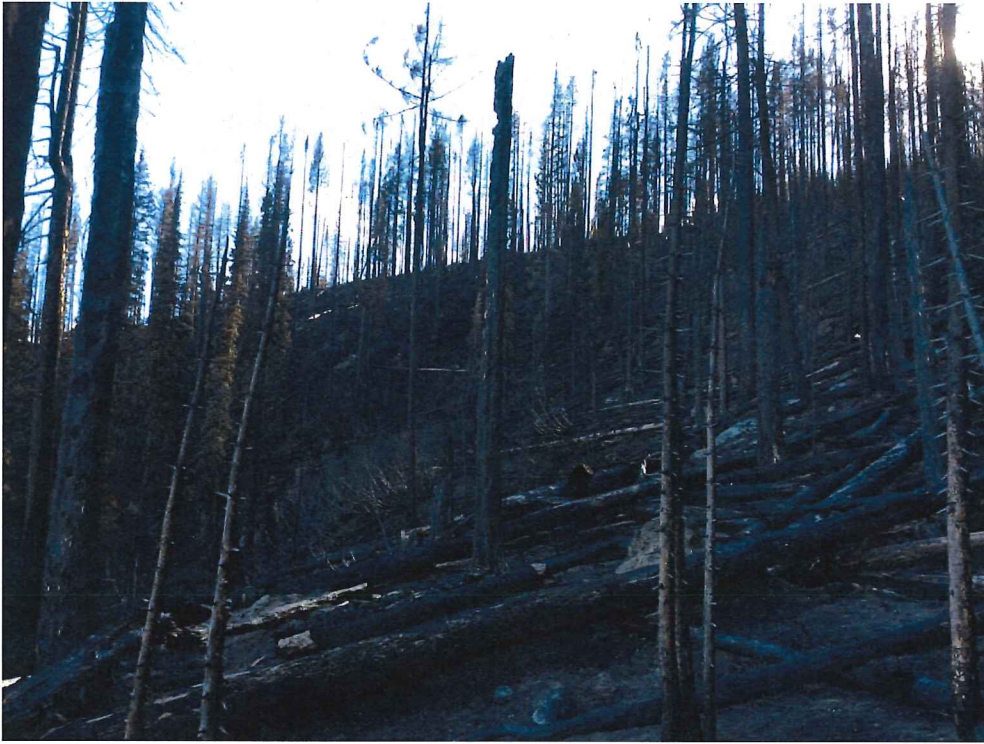
| <i>The Brash Creek gully headwall has areas of high burn severity as well as evidence of past landslide events and snow avalanches (size 2-3). The extent and severity of burn in the upper gully headwall area is expected to increase the likelihood of these natural hazards. The down slope gully is well defined (≥ 10 m deep) and continuous through the private land. In the event of a snow avalanche, it would most likely remain confined in the gully and would unlikely have the runout potential to reach private land given the limit start zone size. In the event of a debris flow, it is unlikely to affect areas outside of</i> | | | |

Photo 3: Area within upper gully headwall of Brash Creek where there is moderate to high vegetation burn severity, and high soil burn severity.

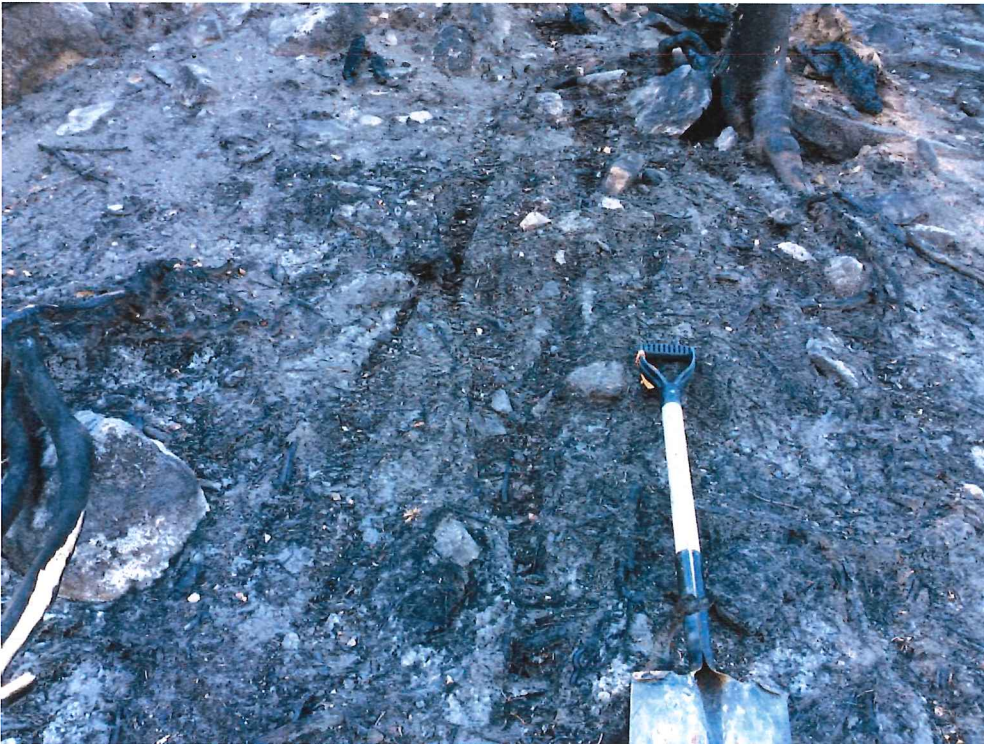
Photo 4: Evidence of overland flow near site of Photo 3.

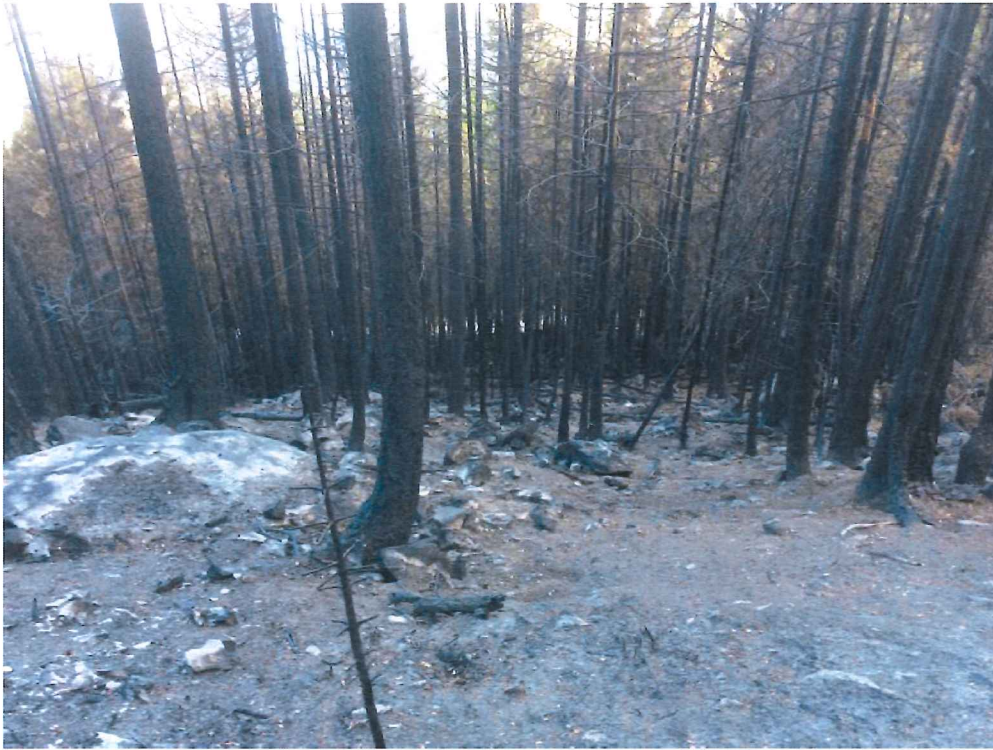
Photo 5: High soil burn severity within area of moderate vegetation burn severity in the upper Campbell Creek drainage.

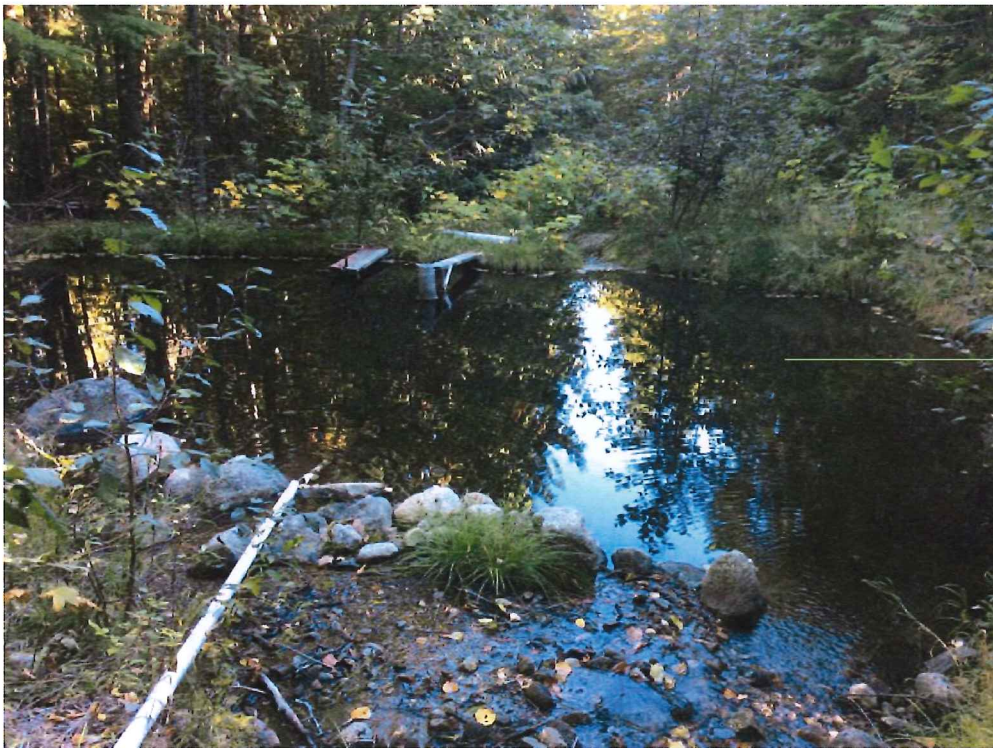
Photo 6: Licensed point of diversion for domestic water supply in Campbell Creek.
