MINISTRY OF FORESTS, LANDS AND NATURAL RESOURCE OPERATIONS, POST-WILDFIRE RISK ANALYSIS – PRELIMINARY REPORT

FIRE: N71691 Morley Creek		FIRE YEAR: 2017	DATE OF REPORT: 28 August 2017
AUTHOR: Sarah Crookshanks			
REPORT PREPARED FOR: Selkirk Resource District (Kootenay Lake FD), and Southeast Fire Centre			
FIRE SIZE, LOCATION, AND LAND STATUS: 76 ha. Fire is located on the face between Sitkum and Kokanee Creeks, 16 km NE of Nelson. Crown land.			
VALUES AT RISK: Houses on Morley Creek fan; water intakes on Morley Creek (35 water licences); Highway 3A			
WATERSHEDS AFFECTED:	TOTAL AREA	AREA BURNED	BURN SEVERITY (% of burned area)
Morley Creek	108 ha	46 ha (43%)	38% H, 62% M
Morley-Sitkum Face	110 ha	8.9 ha (8%)	Moderate
Morley-Kokanee Face	252 ha	6.1 ha (2%)	33% H, 67% M
Kokanee Creek	9500 ha	14.5 ha (<1%)	35% H, 65% M
Sitkum Creek tributary (Bourke Creek)	132 ha	0.4 ha (<1%)	Moderate
<small>**Note: All burn severity calculations are approximate until better data is available</small>			
SUMMARY OF HAZARDS AND RISKS:			HAZARD¹

Post-Wildfire Natural Hazards Risk Analysis, Fire N71691, Morley Creek

Sarah Crookshanks, MFLNRO, 28 August 2017

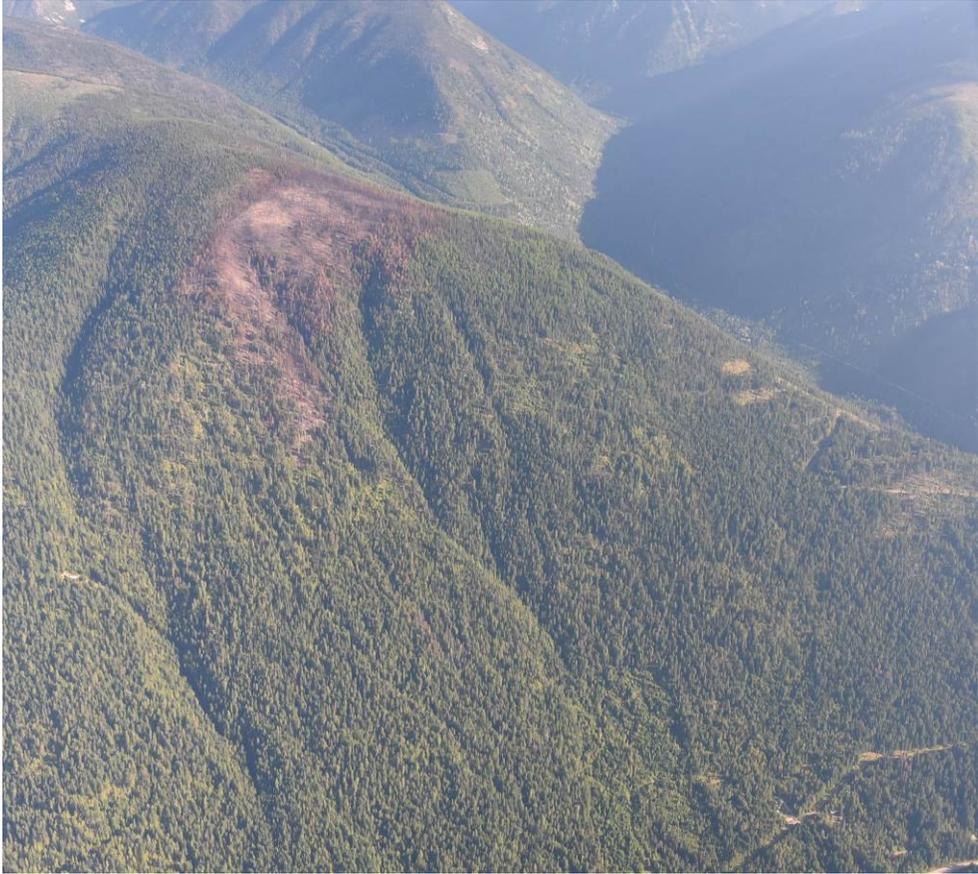
Figure 1 is a map of the Morley Creek watershed and of the fire showing the burn severity mapped from photographs taken from a helicopter (e.g. Figure 2) and ground data. The fire occupies 43% of the watershed area. Of the burned area, 38% is high burn severity. ***The burn severity areas are very approximate and subject to review once satellite imagery is obtained.*** The burn area is located in the headwater area of the watershed. The gullies that form the headwaters of Morley Creek steepen downslope away from the fire. The table below summarizes some of the watershed statistics for Morley Creek.

Figure 2. Overview of fire N71691. Photo taken on August 22, 2017.

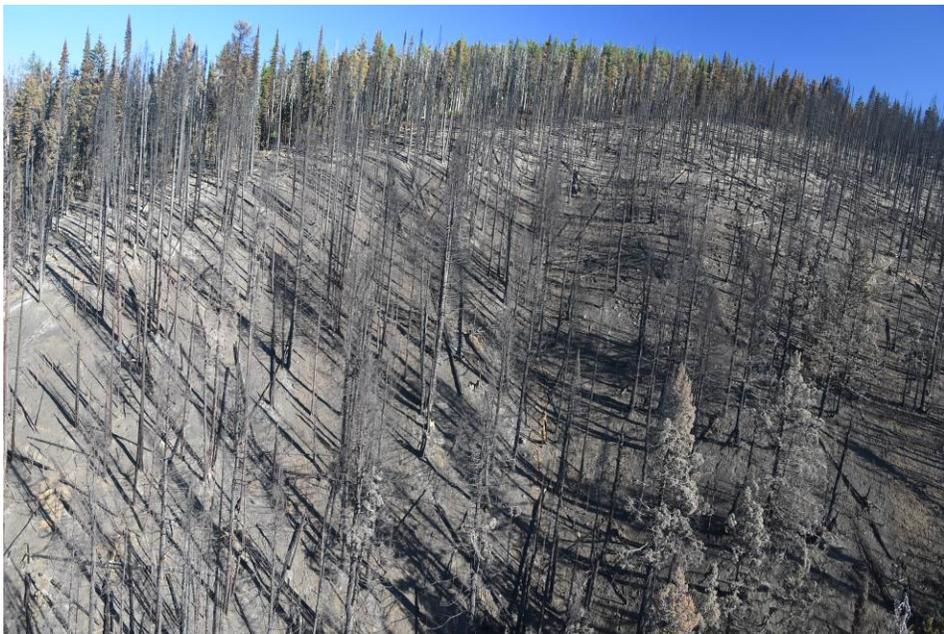
Ground observations of the burn severity showed high soil burn severity at most plots. All duff and organic matter were consumed in high burn severity zones, leaving grey ash and mineral soil exposed (Figure 3). Remnants of charred large woody debris were scattered throughout the burn area. Strongly water repellent soils were widespread and consistent, even where moderate vegetation burn severity was observed. Compared with other fires that have caused post-wildfire debris flows (e.g. the 2007 Springer fire), soil burn severity in this fire is somewhat higher.

Figure 3. Aerial view of high burn severity area. Photo taken on August 22, 2017.

3. Mulch treatments of high burn severity areas in Morley Creek watershed might reduce the hazard of debris flows from high-intensity rainstorms, but would not be effective at reducing hazard during spring snowmelt.

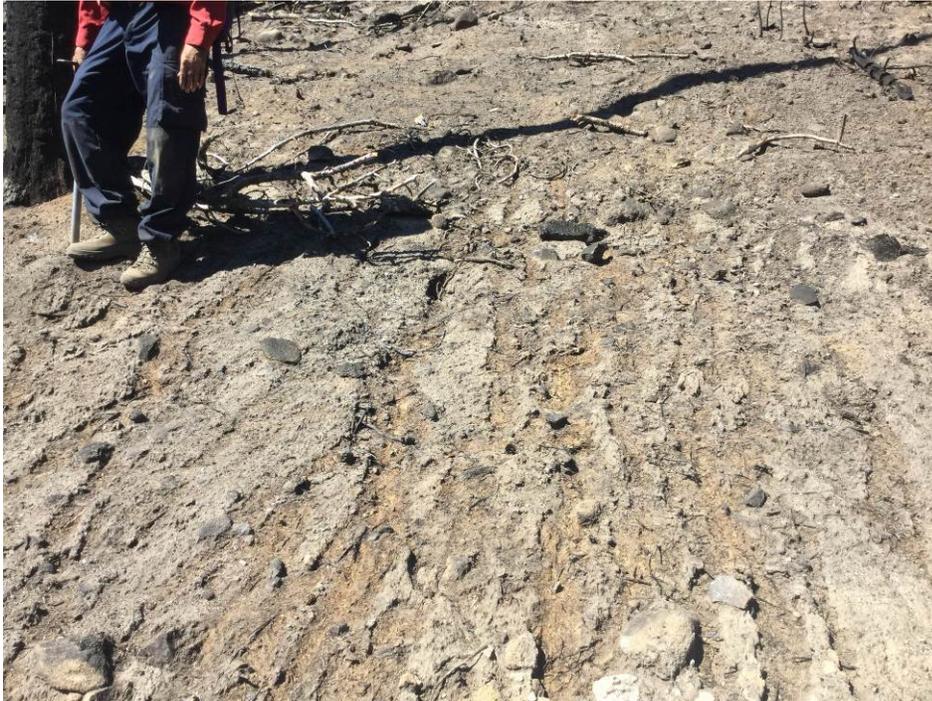
Widespread rilling was observed on steep slopes throughout the burned area (Figure 4). It is assumed that they were produced during a rainfall event that occurred on August 13. A fire weather station installed at Harrop recorded a total of 21.6 mm that day with a max intensity of >14 mm in one hour.

Figure 4. Widespread rilling was observed in the burn area.

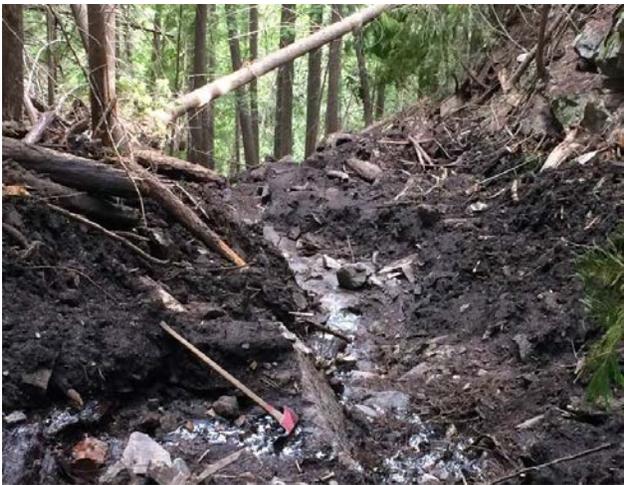
A BC Wildfire Service fire fighter documented a small debris flood event that occurred after a rainfall event that occurred on August 13 (Figure 5). A weather station installed at Harrop recorded a total of 21.6 mm that day with a max intensity of >14 mm per hour. Therefore, if a rainfall event with a similar or higher intensity (and/or duration) occurs within the next few years before vegetation has a chance to re-establish, then a similar or larger debris flood or flow event may be expected to occur.

Figure 5. A view of the western Morley Creek headwater channel after a debris flood event that likely occurred following a rainstorm on August 13 (photo by Nick Davis).

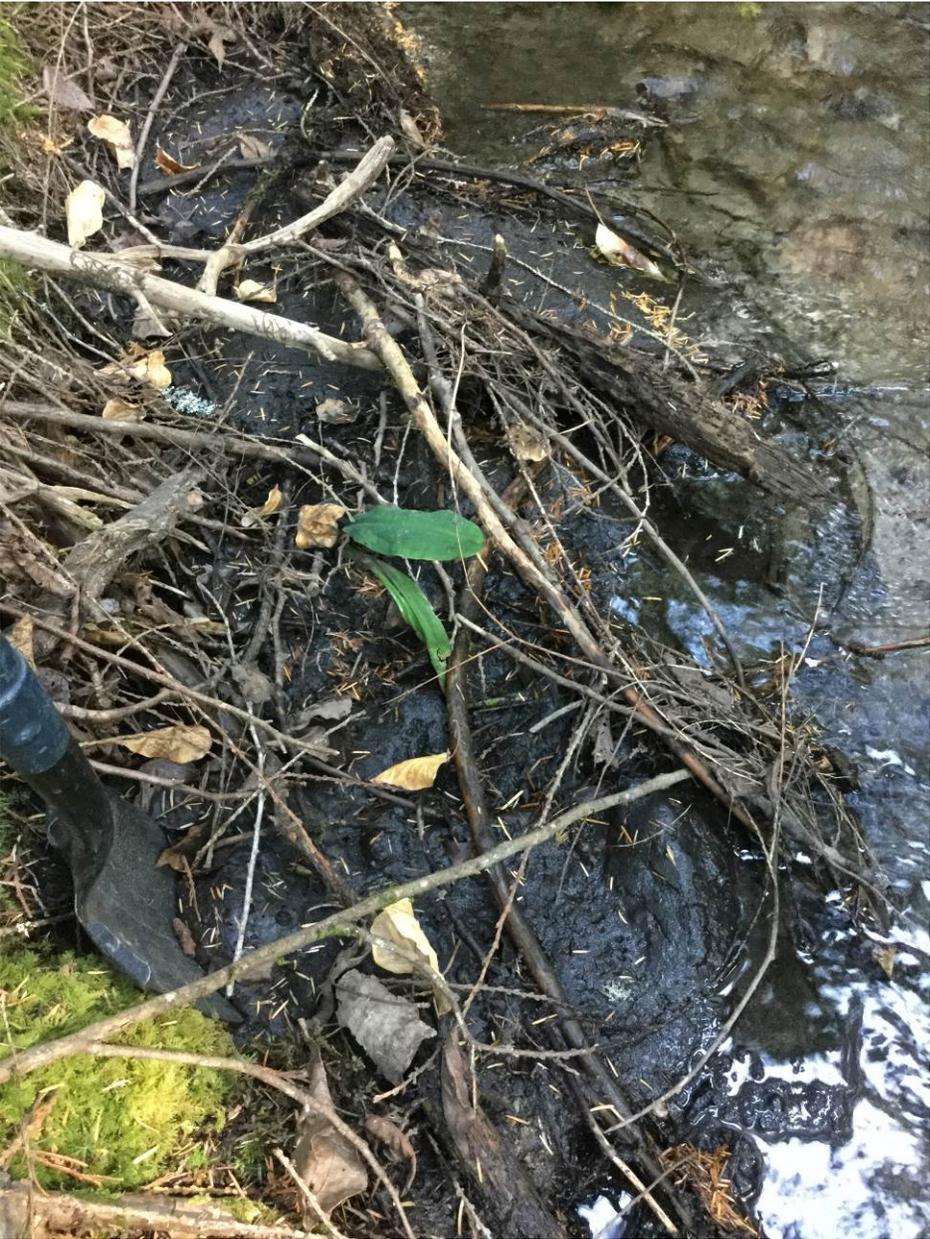
After the rainfall event of August 13, several water users reported fine black sediment that plugged up their intakes and caused water quality issues (Figure 6). This sediment appears to be composed of primarily organics (char/soot from the fire) with some fine particulate matter. This type of sediment has been observed in other watersheds in the West Kootenays following wildfires. This black sediment has been deposited throughout the lower channel of Morley Creek and will likely be remobilized during future high flow events.

Figure 6. Black sediment deposited in the lower reaches of Morley Creek after the August 13 rainstorm.

There is also a high likelihood of ongoing periodic water quality (turbidity) effects due to the large area of exposed mineral soil in the headwaters of Morley Creek and the high connectivity between the burn area and the headwater channels. Past experience from fires in the West Kootenays indicates that these effects are usually minor in nature and of short duration. Water quality impacts could be improved by installing filtration on water systems.
