Report on 2019 monitoring of the Johnsons Landing landslide

Sarah Crookshanks, P.Geo., Research Geomorphologist, MFLNRORD, Nelson
December 16, 2019

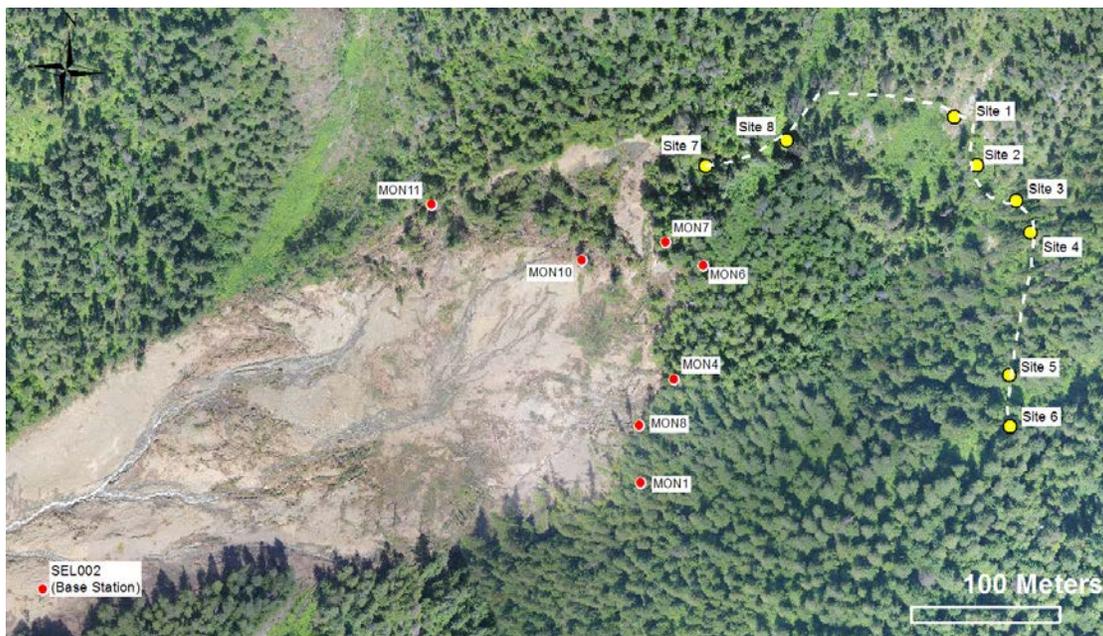
Eight measurement sites are located along the crack that bounds the top edge of the potentially unstable area (see Figure 1 for measurement site locations). One of these (Site 1) is a line of 6 metal pins, with the top pin drilled into bedrock above the crack. This site is the most reliable measurement location. The other sites consist of two or three wooden stakes driven into soil above and below the crack. The distance between the stakes is measured manually with a tape measure. Unfortunately, many of these wooden stakes have become damaged or slanted because of rockfall and snowload; therefore, the wooden stake measurements in the past few years have become less accurate or have been destroyed.

Figure 1. Measurement locations that are measured by hand are identified in yellow, and measurement sites surveyed by SEL from a base station are shown in red. The dashed line shows the approximate location of the upper crack that bounds the top edge of the potentially unstable area.

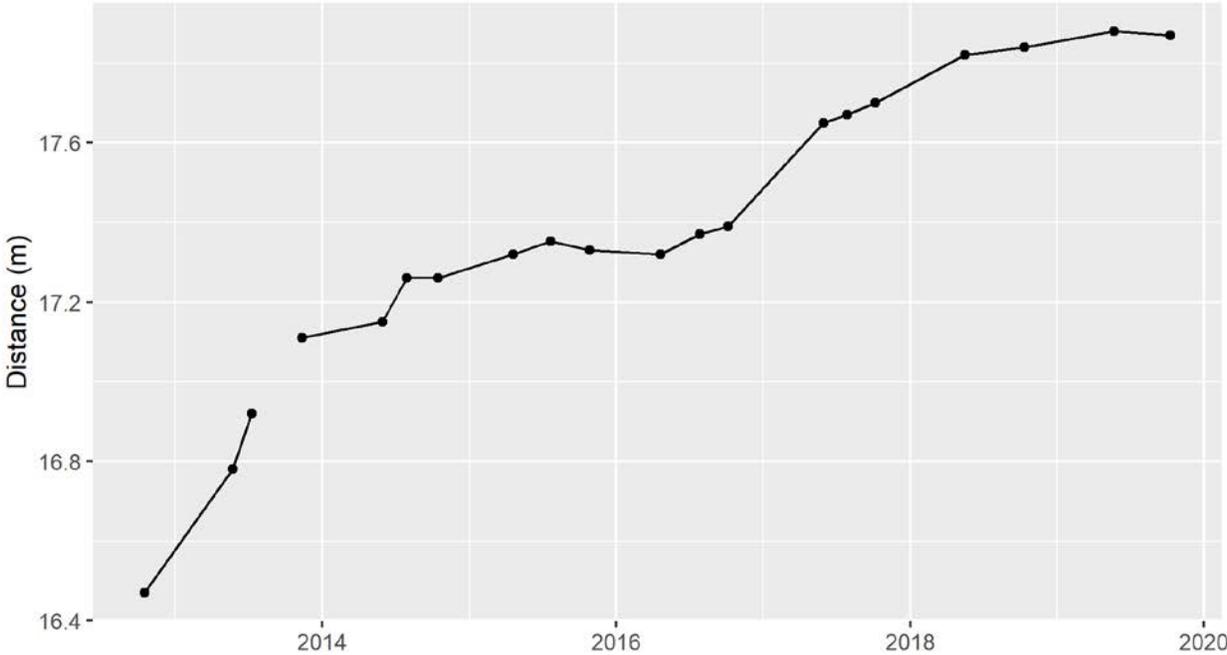
The measurement of the displacement of the upper crack over the past five years shows systematic, progressive movement at the apex of the tension crack (Figure 2) and limited or no movement towards the outer edges. This year limited or no movement was observed at all sites.

Figure 2. Cumulative downslope movement of the upper crack at Site 1 (see Figure 1 for site location). Downslope movement was measured as the distance between stakes spanning the crack.

Given the low spring precipitation and below average snowpack, it is unsurprising that there was little movement observed at Johnsons Landing. I recommend that monitoring continue until a particularly wet spring occurs with no consequent increased displacement or until movement at the headscarp and upper crack slows to near zero for several years despite variable precipitation and snowpack levels.
