# Morley Creek Post-Fire Debris Flood August 2019

October 10, 2019

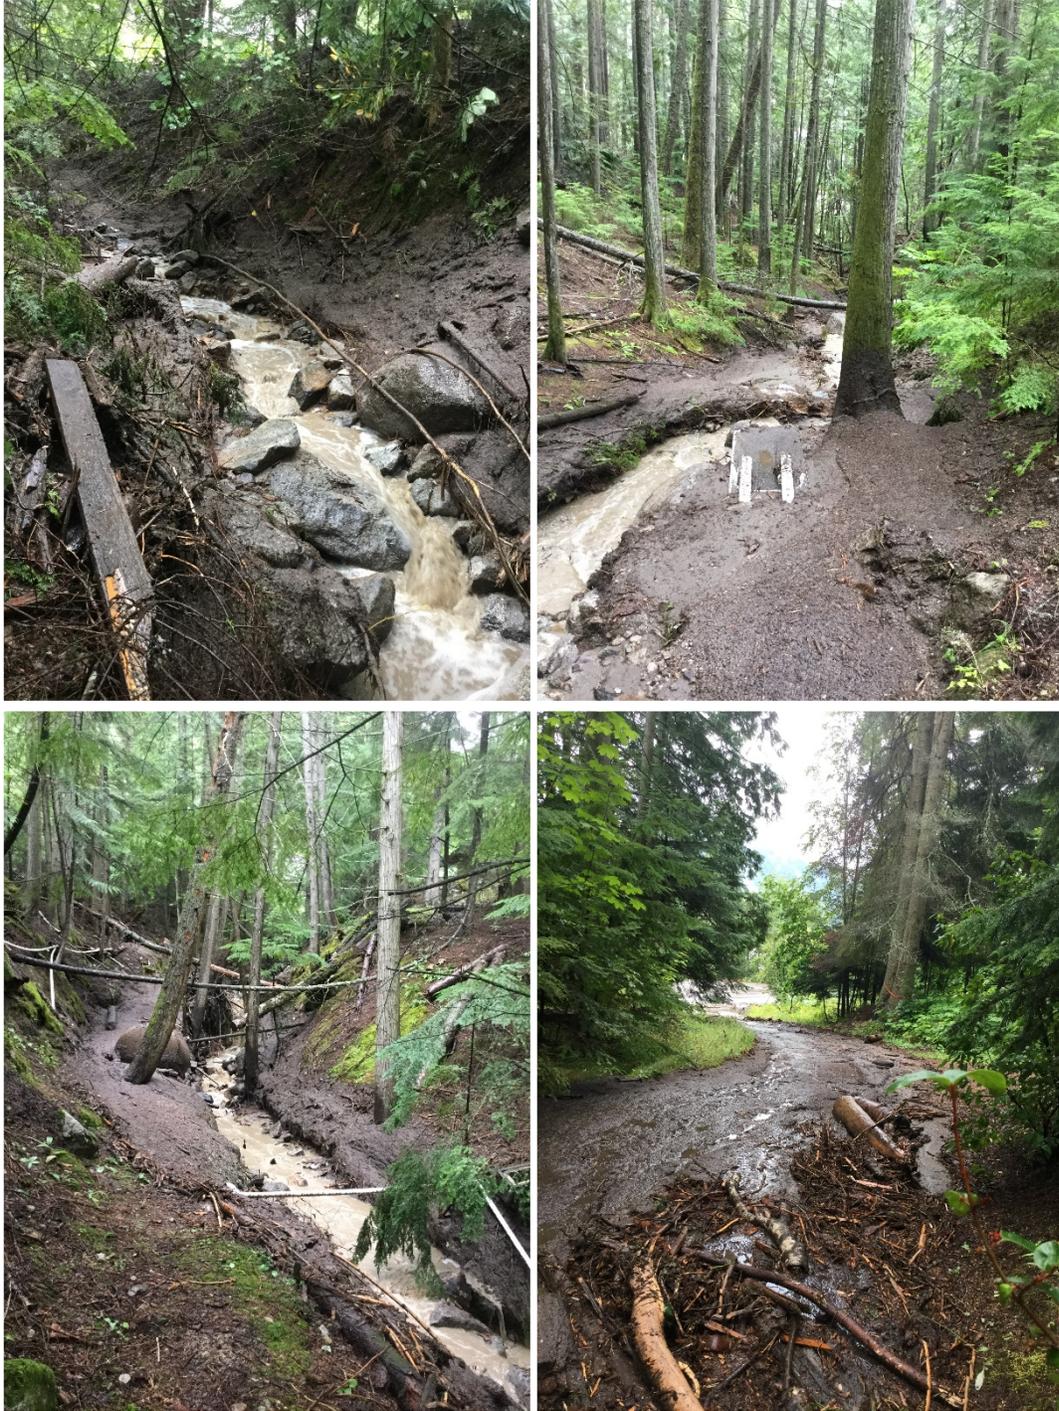
Figure 1. Photos of the Morley Creek Channel upstream of the highway showing debris flood deposits from August 11.

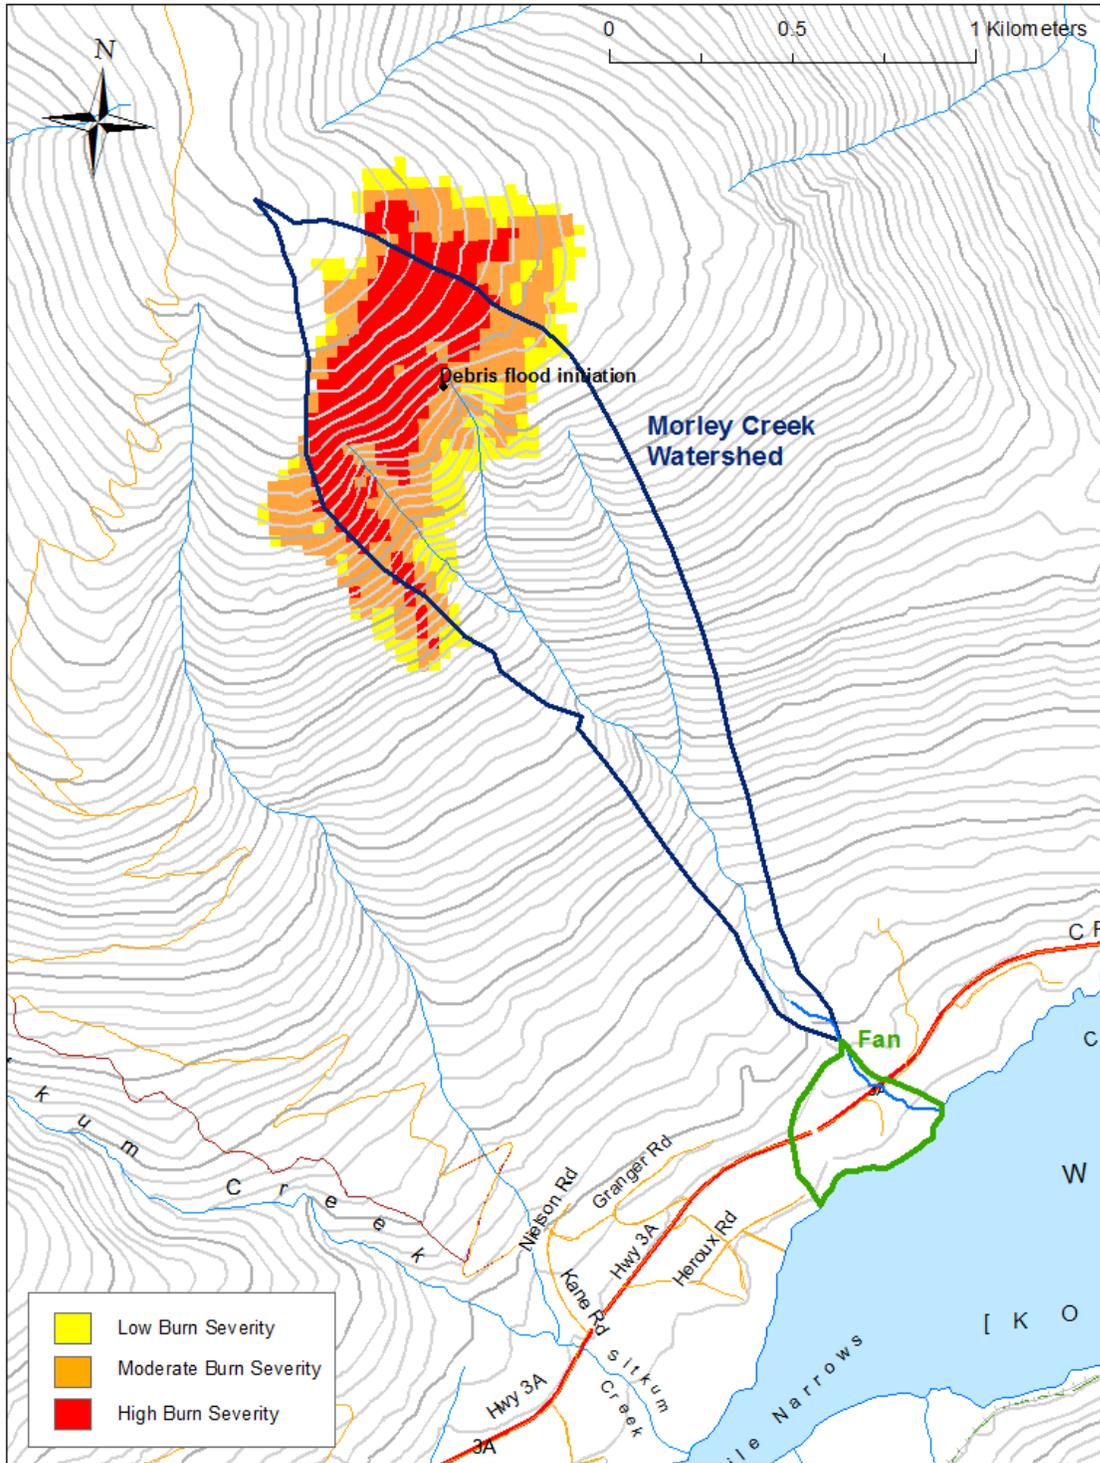
Figure 2. Burned Area Reflectance Classification map of the Morley Creek fire showing the estimated burn severity as derived from Sentinel 2 satellite images taken before and after the fire. The location where the debris flood initiated is also shown.

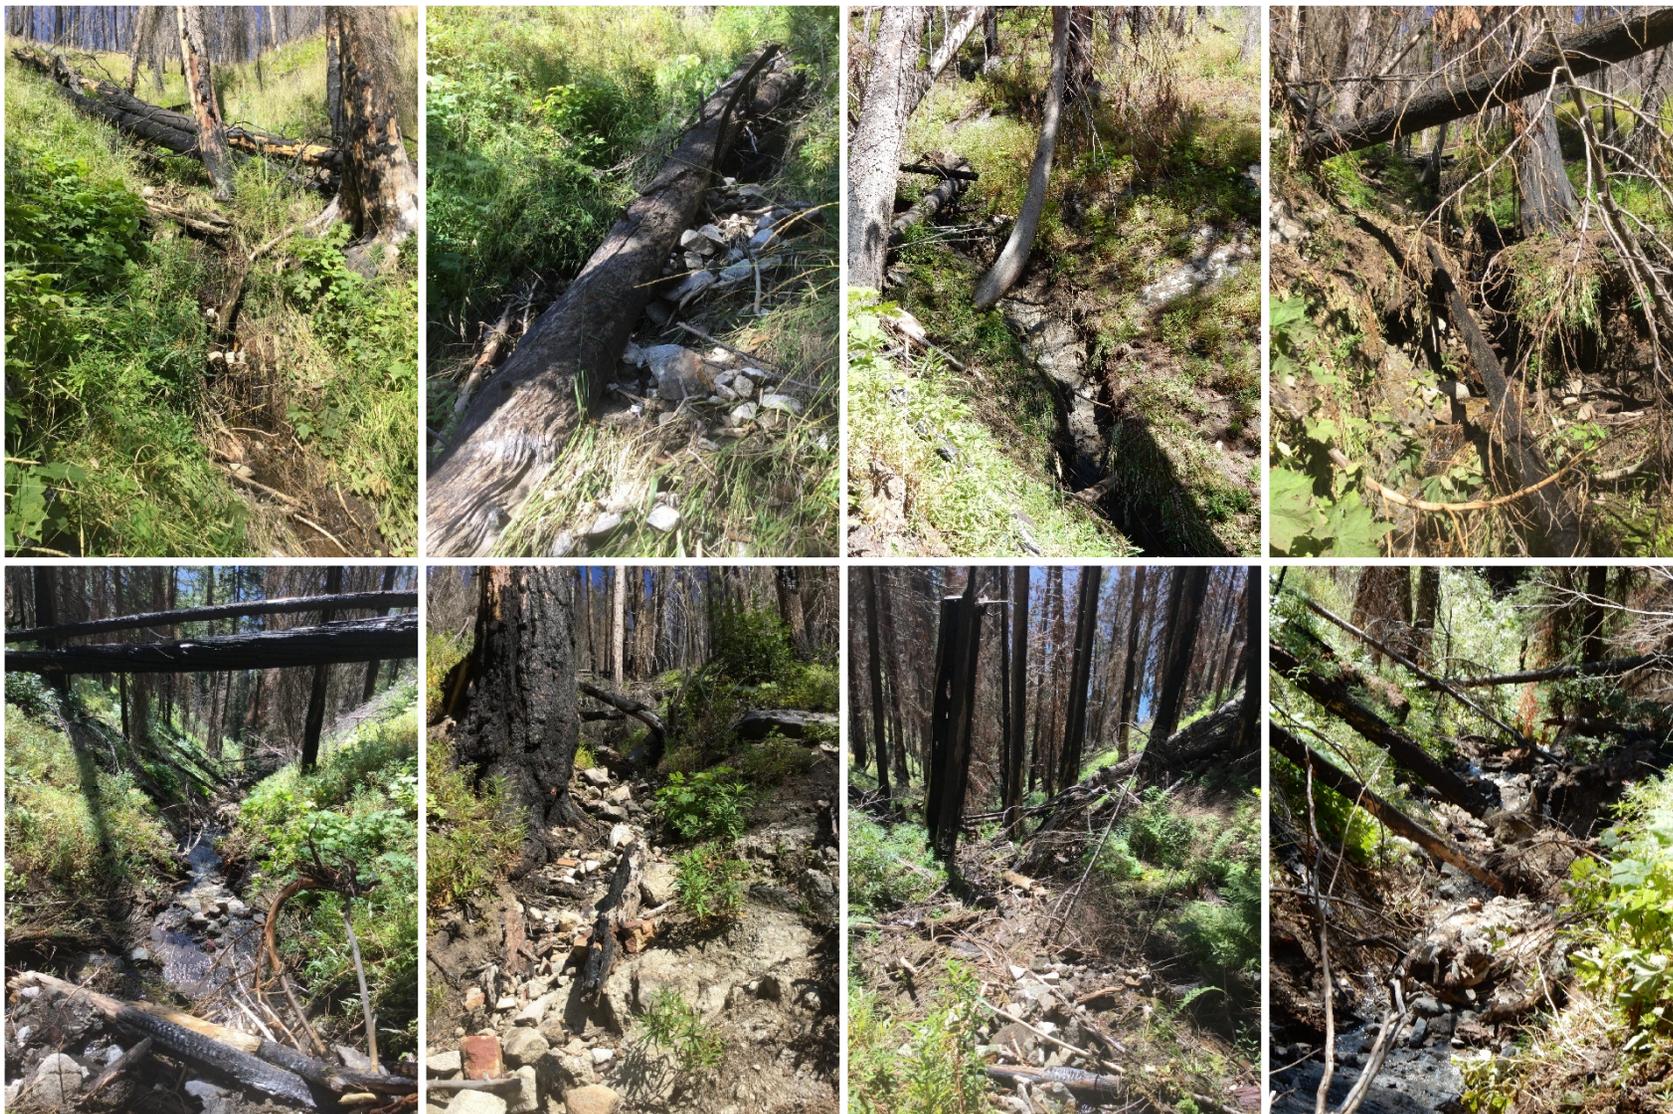
Figure 3. Photographs showing the initiation of the Morley Creek debris flood and its progressive bulking through channel erosion (upstream to downstream locations from top left to bottom right).

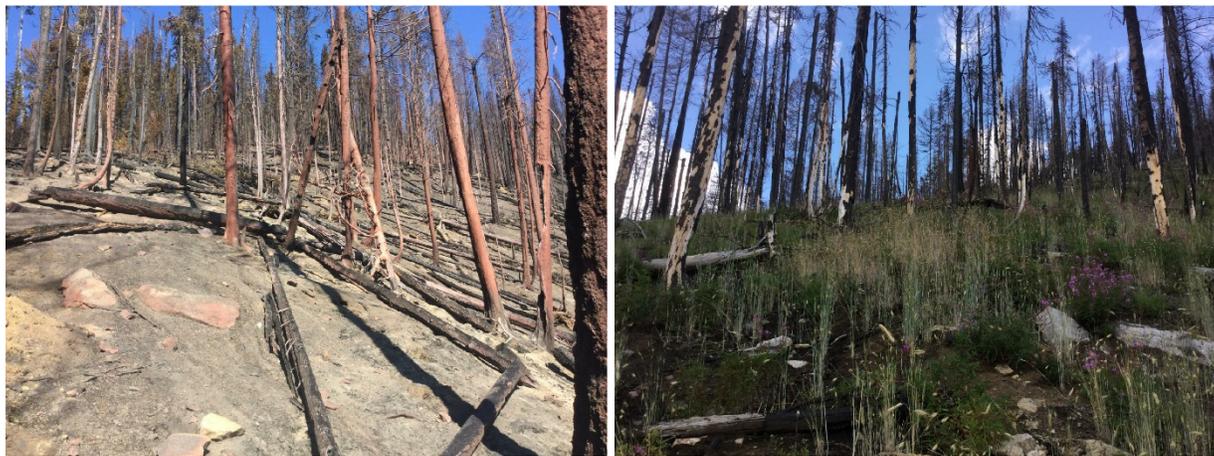
Figure 5. Photographs from August 22, 2017 (upper left and lower left) and photographs at the same locations from August 14, 2019 (upper right and lower right) showing varying rates of vegetation regrowth.

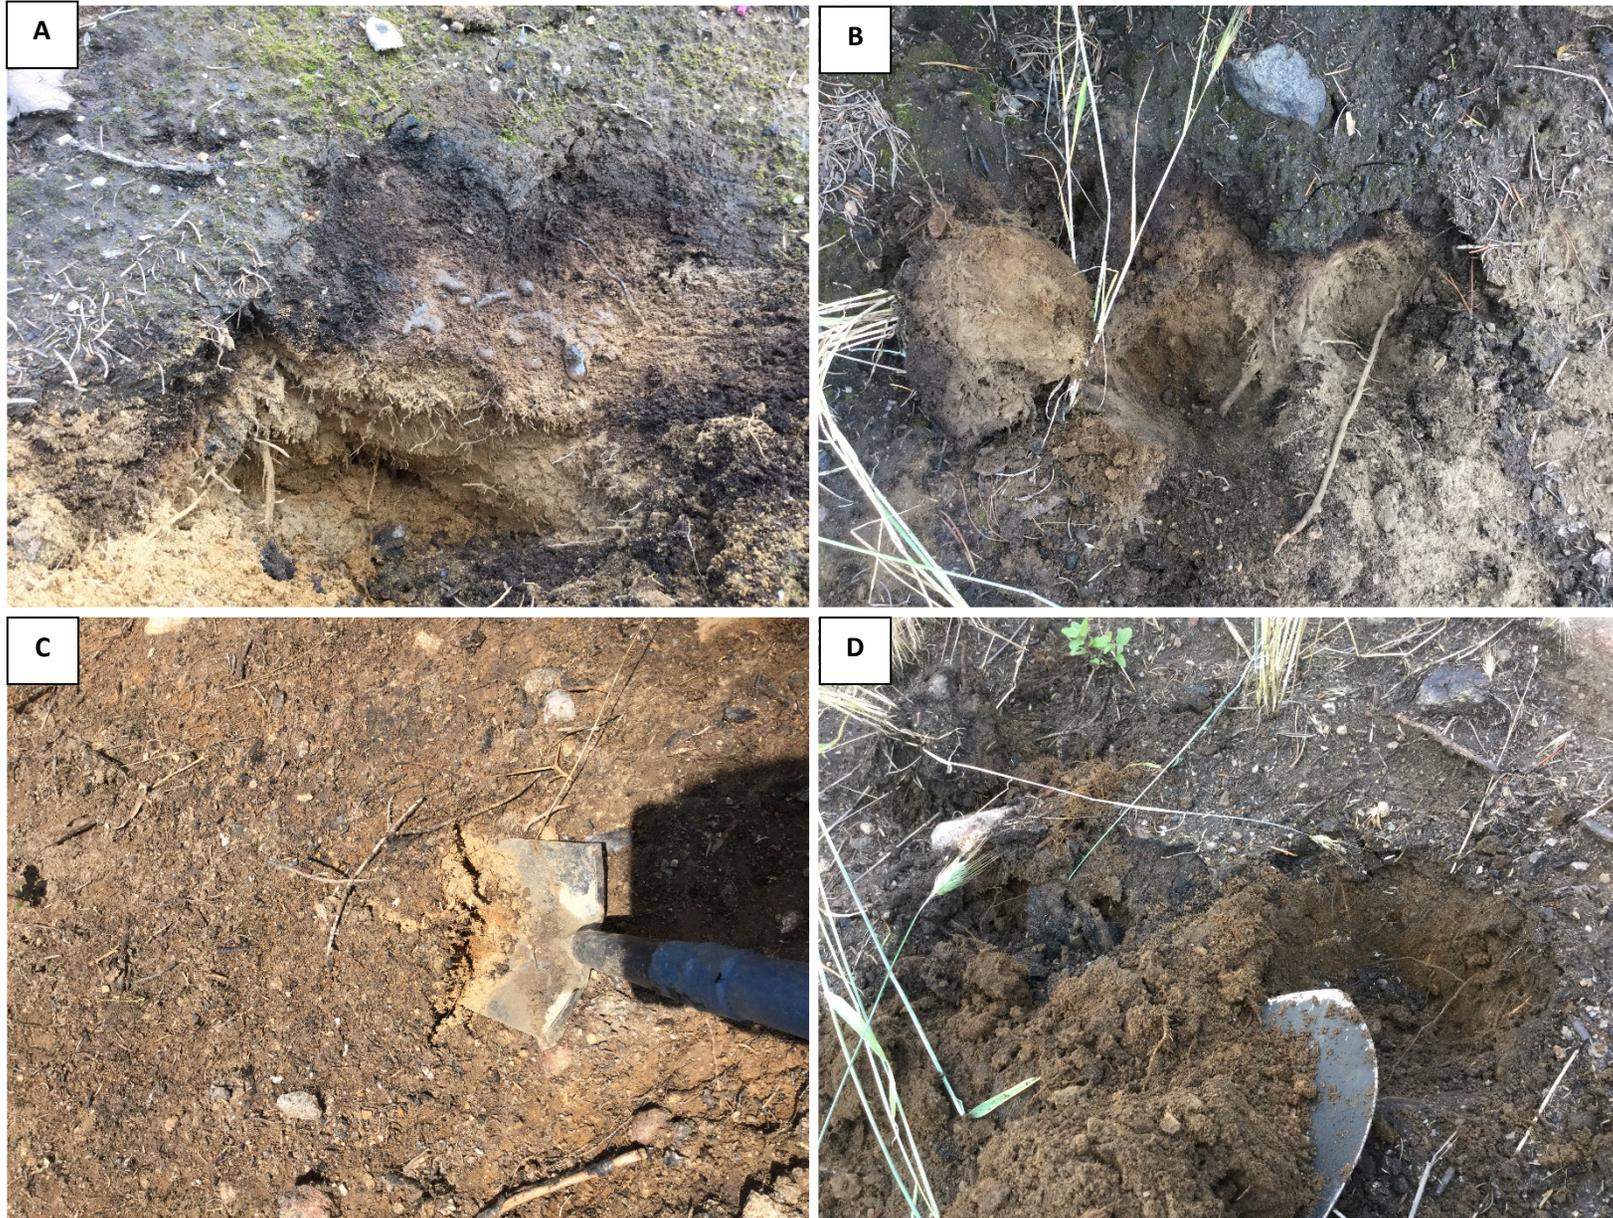
Figure 6. Visual observations of water repellency (or the lack thereof) on August 14, 2019 at four different sites in the Morley Creek fire area: A) At this site, the top two cm of darker material was wet and overlying dry mineral soil. Water drops were not able to infiltrate the dry soil; B) Spatial variability of water repellency is apparent here, where the left hole has damp soil throughout the soil profile and the right hole has dry mineral soil below a wet upper layer; C) At this site, a 0.5 cm layer of wet soil overlies dry mineral soil; and D) No water repellency was observed at this site, and the entire soil column was damp.
