# **RDCK FLOODPLAIN AND STEEP CREEK STUDY**

# **Harrop Creek**

Final March 31, 2020

Prepared by BGC Engineering Inc. for: Regional District of Central Kootenay

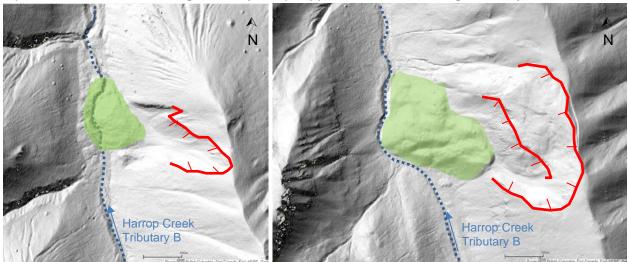
#### A) Lower old landslide along Tributary B B) Upper old landslide along Tributary B

The creek channel throughout the watershed is deeply incised into thick glacial deposits at the valley bottom forming prominent edges of till terrace incision that are visible in the lidar imagery (Drawing 05). Along Tributary B, two large landslides are evident in the lidar (Figure 3-2). BGC estimates the landslide deposit areas are in the order of 70,000 m<sup>2</sup> for the lower landslide and 180,000 m<sup>2</sup> for the upper landslide. The upper landslide has pushed the channel to a new configuration while the lower landslide may have temporarily blocked the channel and was subsequently dissected by the creek. BGC visually assessed both landslides from a helicopter. Photo 4 in Appendix B shows the lower landslide and Photo 5 is looking down, along the upper landslide. The landslides are covered with mature forest suggesting that they are at least hundreds of years old. As these were the only deep-seated landslides identified by BGC in the watershed, the occurrence of two landslides during the Holocene implies an approximate frequency of 5,000 years.

Figure 3-2. Bare-earth lidar image of old landslides along Harrop Creek Tributary B (see Drawing 05 for location). Landslide headscarps are shown in red and the tributary is shown in blue dashed line.

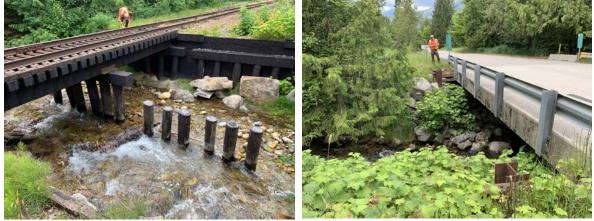
E) Standing on right bank looking west at railway bridge crossing Harrop Creek and log crib structure.

F) Standing on right bank looking at Erindale Rd bridge crossing Harrop Creek.

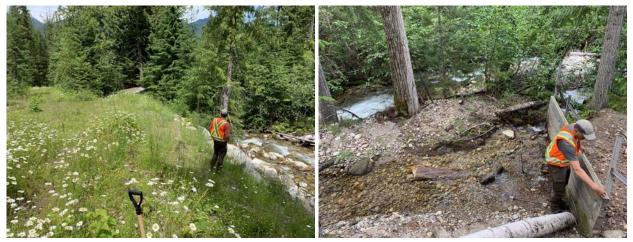
HRP-FP-01 - Rip rap protection on left bankHRP-FP-03 - Water intake with woodenabove water intake house (tin roof is visible at deflection wall (4.10 m x 1.02 m x 0.07 m thick)end of berm).

Figure 3-4. Makeshift flood protection measures encountered on Harrop Creek fan-delta during BGC's field work in July 2019. Refer to Drawings 02A, 02B for locations. No photo taken for HRP02 – 1m high sandbag dike on left bank at potential avulsion point just next to water intake house on left bank.

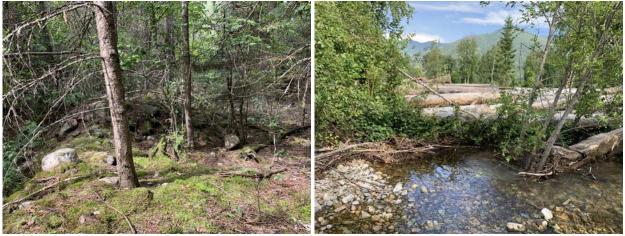
HRP-FP-05 – Non-engineered dike on right bank HRP-FP-06 – Logs piled up on right bank to made from rounded river rock. avoid avulsion.

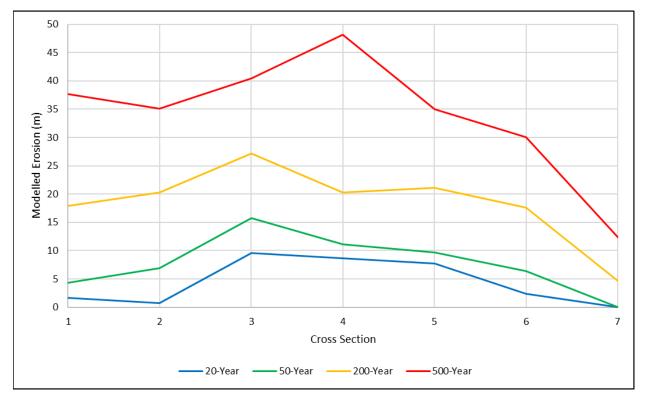
Figure 6-2 shows the 50% percentile modelled bank erosion at each cross-section. The predicted erosion differs between cross-sections based on the cross-section characteristics (e.g., channel geometry, channel slope,  $D_{84}$  grain size). Erosion peaks at cross-section 3 for the 20-year to 200-year return periods, and at cross-section 4 for the 500-year return period.

Figure 6-2. Harrop Creek 50<sup>th</sup> percentile bank erosion model results at each cross-section.

Buildings located on the property off of Mill Creek Road, adjacent to cross-section 2, fall within the improbable corridor for the 200-year return period event. Buildings close to the creek, north of Harrop Procter Road and south of Erindale Road, fall within the improbable corridor of the 500-year return period. Longer-term progressive erosion could impact buildings along the creek in these areas.

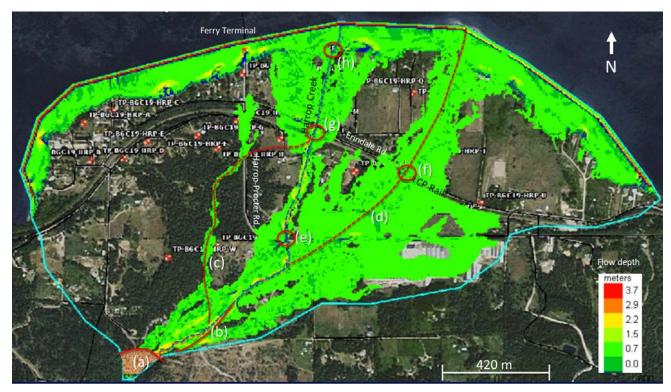
Figure 7-1. Debris-flood inundation map showing flow depths for a 200-year return period debris flood on Harrop Creek from FLO 2D modeling. The figure shows conceptual-level mitigation options for Harrop Creek fan-delta. Note that these mitigation options have not been tested by numerical modelling and only serve as an impetus for further discussion. Other options will likely be developed at the conceptual design level.

With reference to Figure 7-1, the following specific mitigation measures could be considered to reduce hazards and risks on Harrop Creek:

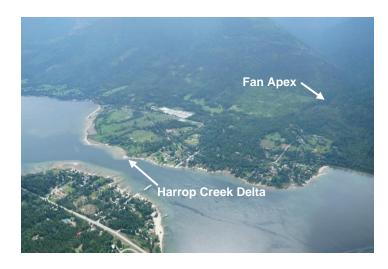
#### Photo 1.

Overview photo taken during helicopter overflight looking south at the community of Harrop, the Harrop Creek delta, and Harrop Creek outlet into Kootenay Lake. The fan apex is indicated. Photo: BGC, July 6, 2019.

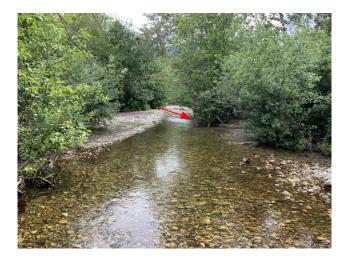
#### Photo 11.

Looking upstream at aggraded Harrop Creek channel and remnants of recently washed out bridge (red arrow), approximately 50 m upstream of Kootenay Lake. Photo: BGC, July 2019.
