## MINISTRY OF FORESTS, LANDS AND NATURAL RESOURCE OPERATIONS, POST-WILDFIRE RISK ANALYSIS – PRELIMINARY REPORT

<b>FIRE: N71382 Harrop Creek</b>		<b>FIRE YEAR: 2017</b>	<b>DATE OF REPORT: 2 Oct 2017</b>
<b>AUTHOR:</b> Sarah Crookshanks			
<b>REPORT PREPARED FOR:</b> Selkirk Resource District and Southeast Fire Centre			
<b>FIRE SIZE, LOCATION, AND LAND STATUS:</b> 3117 ha. Fire is located in the headwaters of Harrop, Narrows and Midge Creeks, 18 km NE from Nelson. Crown land.			
<b>VALUES AT RISK:</b> Houses on Harrop and Narrow Creek fans; water intakes on Harrop Creek (50 water licences) and Narrows Creek (50 water licences); Harrop-Procter Rd			
<b>WATERSHEDS AFFECTED:</b>	<b>TOTAL AREA</b>	<b>AREA BURNED</b>	<b>BURN SEVERITY (% of burned area)</b>
Harrop Creek	4240 ha	1172 ha (28%)	26% H, 48% M, 26%L
Midge Creek	26370 ha	868 ha (3%)	40% H, 47% M, 13% L
Narrows Creek	2210 ha	232 ha (10%)	18% H, 44% M, 38% L
Slater Creek Face	1780 ha	35 ha (2%)	9% H, 43% M, 49% L
<b>SUMMARY OF HAZARDS AND RISKS:</b>			<b>HAZARD<sup>1</sup></b>

# Post-Wildfire Natural Hazards Risk Analysis, Fire N71382, Harrop Creek

Sarah Crookshanks, MFLNRO, 2 October 2017

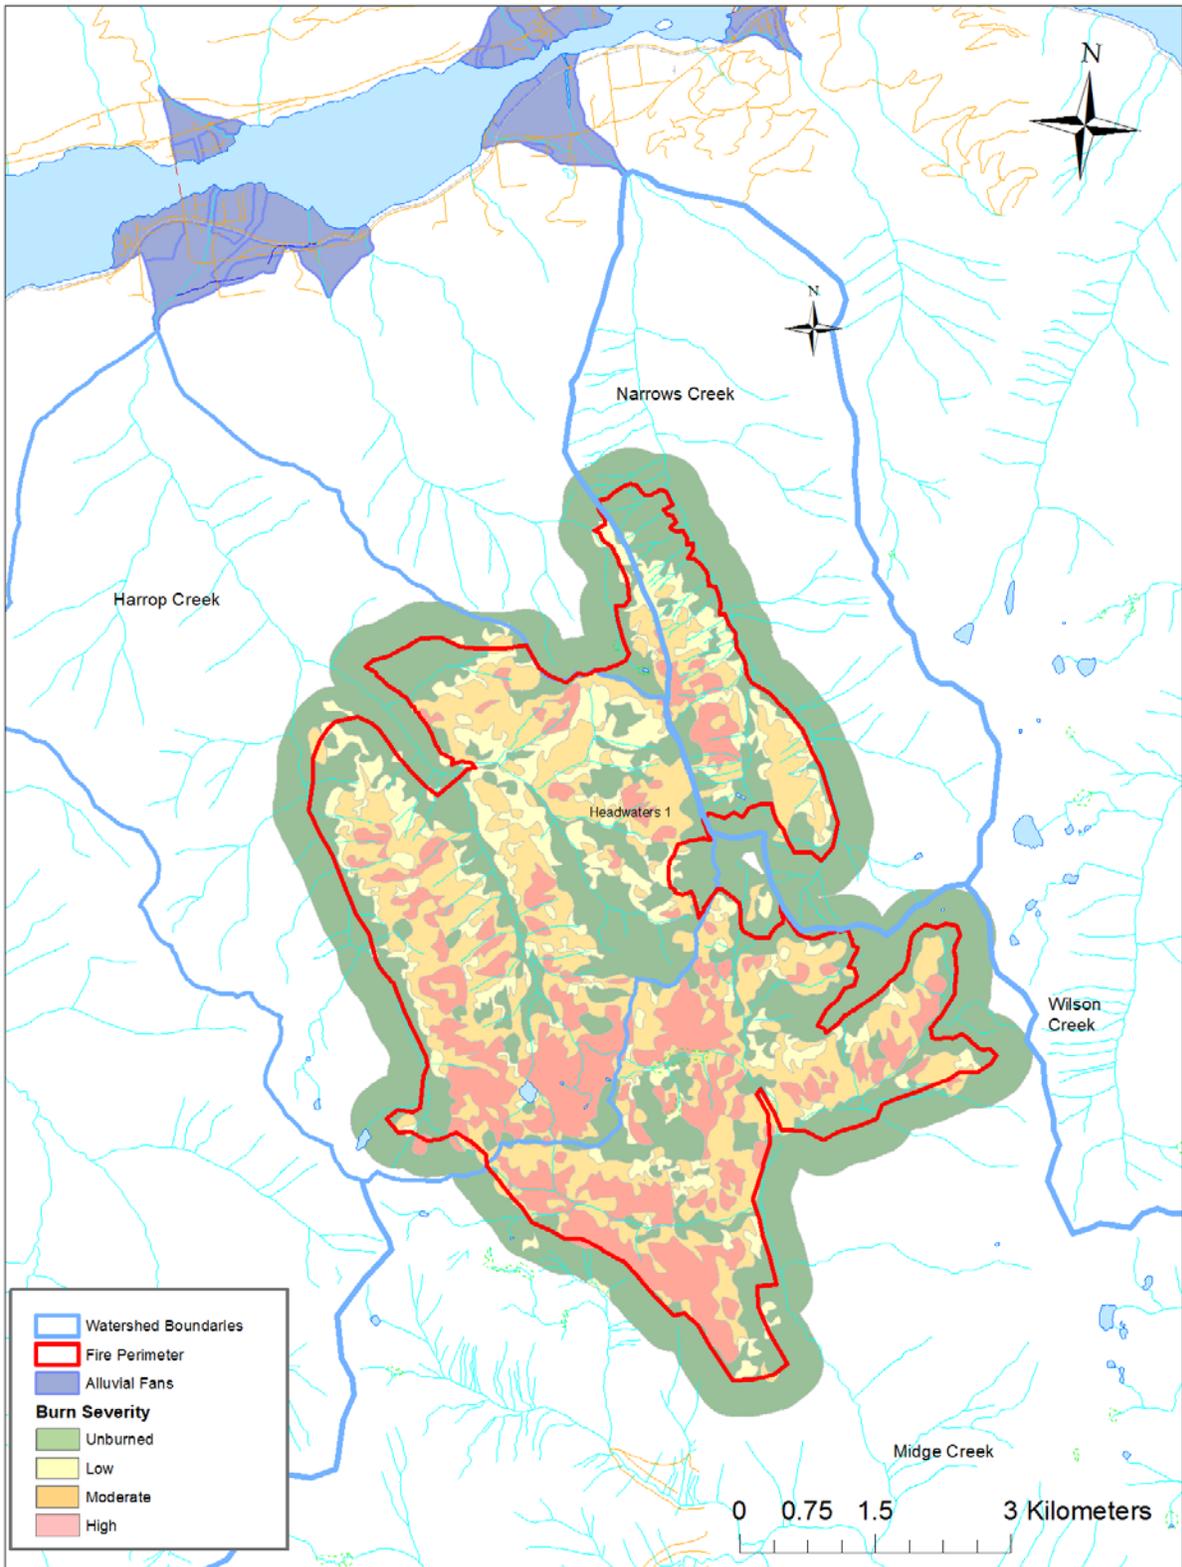
Figure 1 is a map of the fire area spanning the Harrop Creek, Narrows Creek and Midge Creek watersheds. This map also shows the Burned Area Reflectance Classification (BARC) map produced by comparing Landsat-8 imagery from before and after the fire. The BARC post-fire imagery dates from September 2, 2017. This was the latest imagery available at the time of writing this report, and while the fire continued to be active for several more weeks, the effects on the BARC map are likely quite minimal given the fire characteristics (Will Burt, MFLNRO, personal communication). The field sampling and observations of burn severity along the Mill Lake trail and from the air indicate that the BARC map appears to be a fairly accurate representation of burn severity and no calibration was needed.

The BARC mapping in Figure 1 and aerial photos of the fire (Figure 2 through 6) indicate that the vegetation burn severity is quite patchy throughout the fire area. The riparian zones along the bottom of the valleys were generally left unburnt or have low burn severity. Five burn severity plots were completed along the Mill Lake trail on September 21. The soil burn severity was generally equivalent to the vegetation burn severity. Water repellency was observed at most plots, but it was quite patchy with areas of no repellency observed at each plot.

Figure 1. Burned Area Reflectance Classification map of the Harrop Creek fire showing estimated burn severity derived Landsat 8 satellite images taken before and after the majority of the fire had stopped burning. The post-fire imagery is from September 2, 2017.

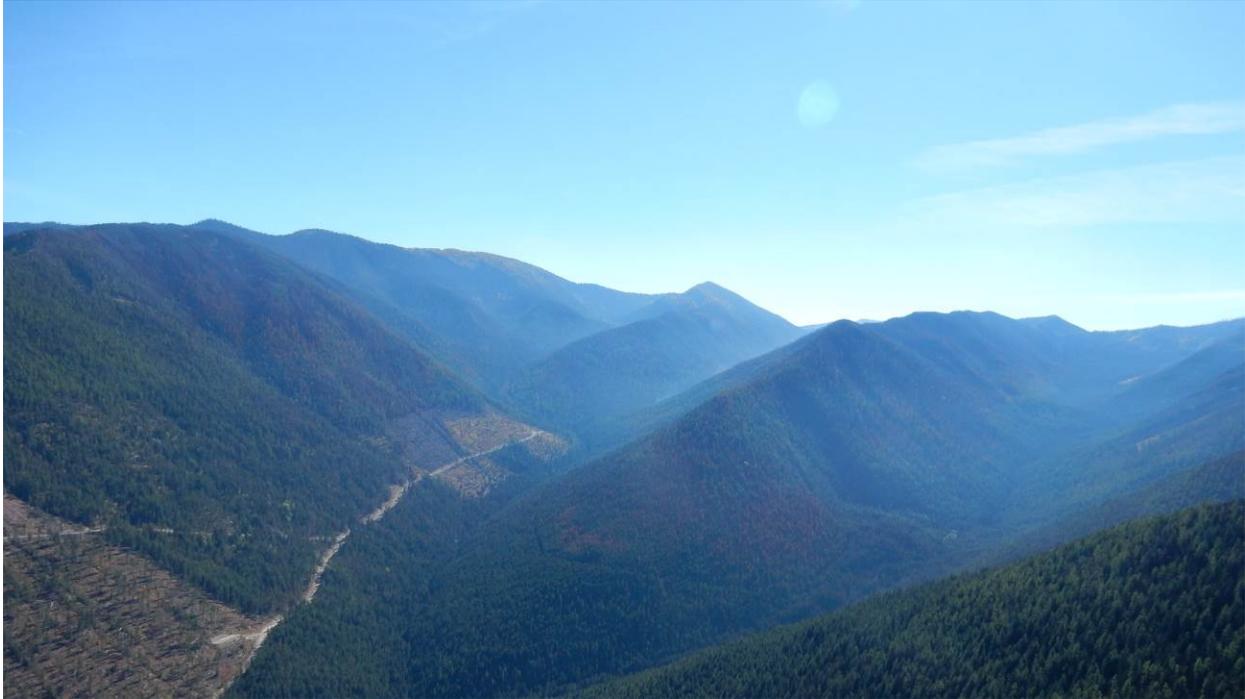
Figure 2. Overview photo of fire N71382 looking up Harrop Creek towards the south. This photo (and all subsequent photos) taken on September 27, 2017.

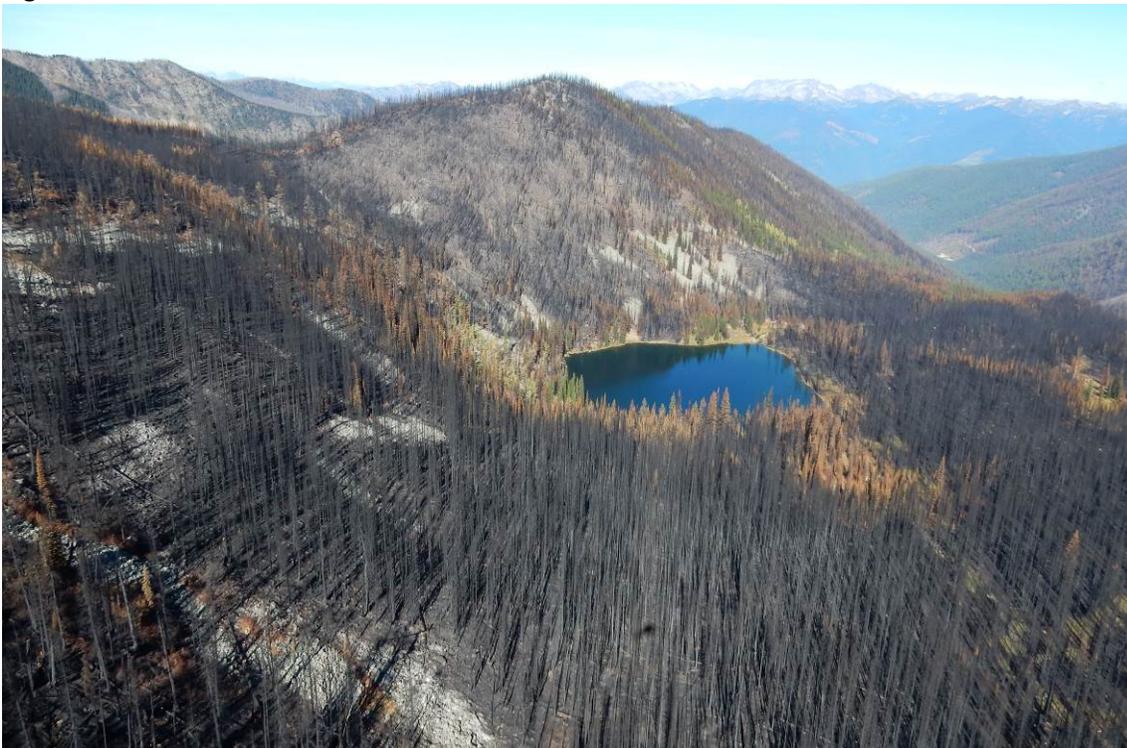
Figure 3. View downstream from Mill Lake.

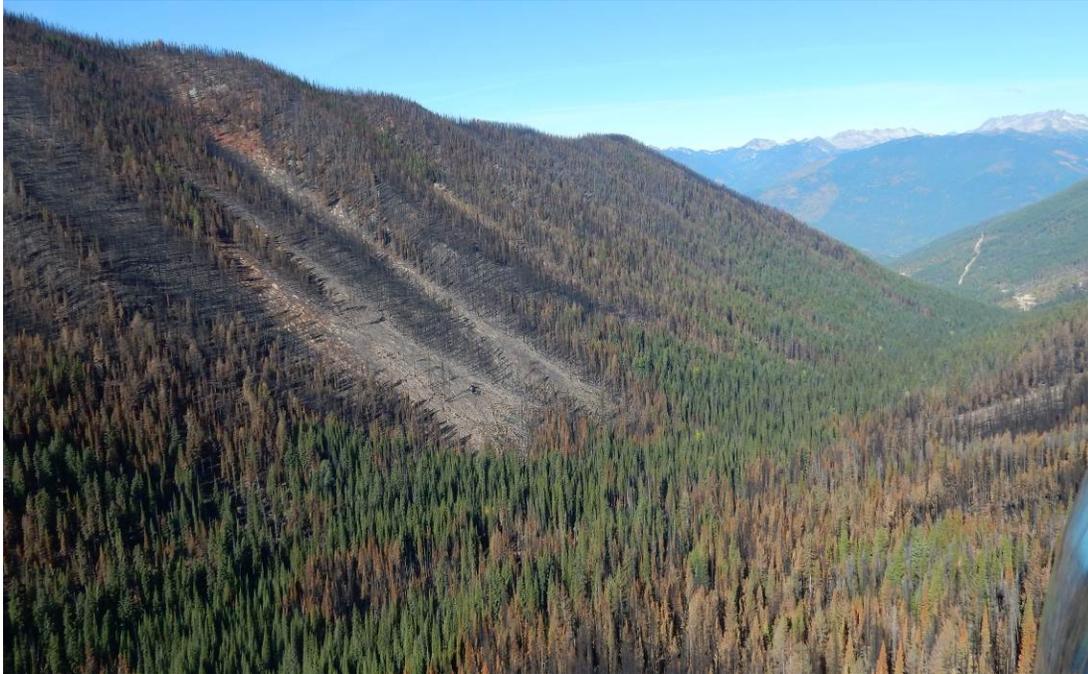
Figure 4. Northwest view down the east fork of Harrop Creek. Note the avalanche paths from last winter.

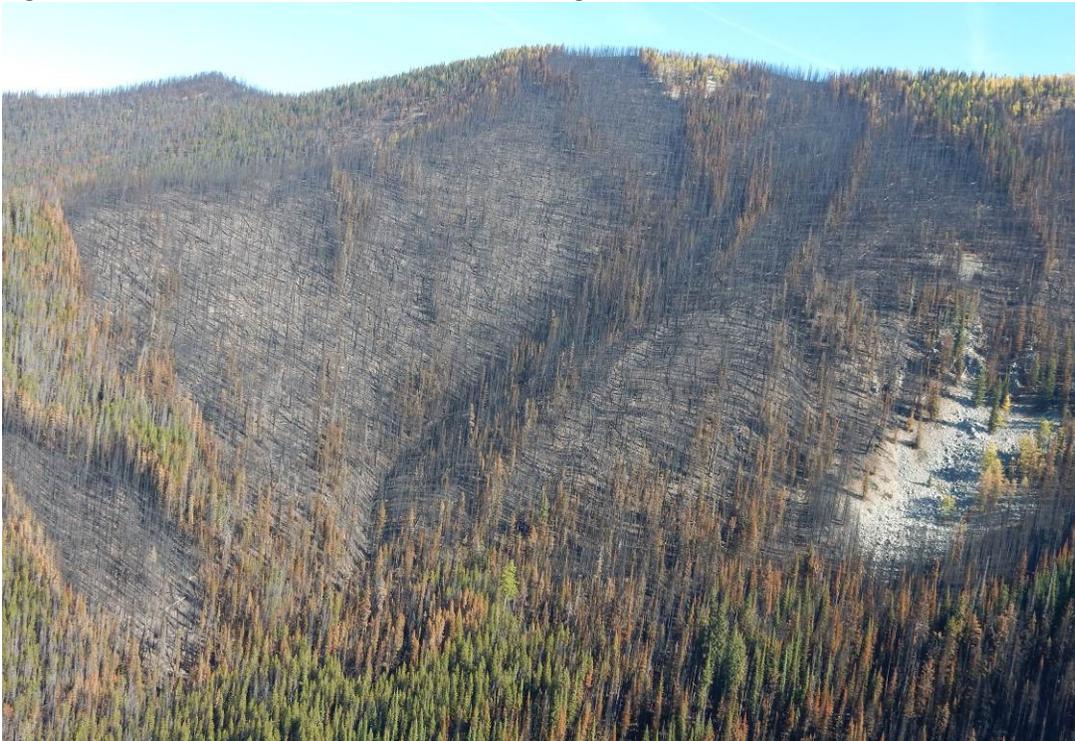
The fire has increased the debris flow hazard particularly in the Headwaters 1 sub-basin of Harrop Creek (see Figure 1 for location and photo in Figure 5). The burn severity on the upper slopes of this drainage is not uniform, but patches of moderate to high burn severity are located in the headwaters of what appear to be several debris-flow prone channels. Aerial photos from a helicopter and the high-resolution satellite imagery confirm that there are patches of high burn severity and high connectivity to the channel. The LiDAR hillshade imagery for this area reveals several features that provide evidence for historical slope instability within this drainage. A debris flow event in this sub-basin would most likely have water quality impacts downstream, but is unlikely to continue to be transported to the fan given the channel gradients (as discussed in the previous paragraph).

Figure 5. View of Headwaters 1 sub-basin looking east.

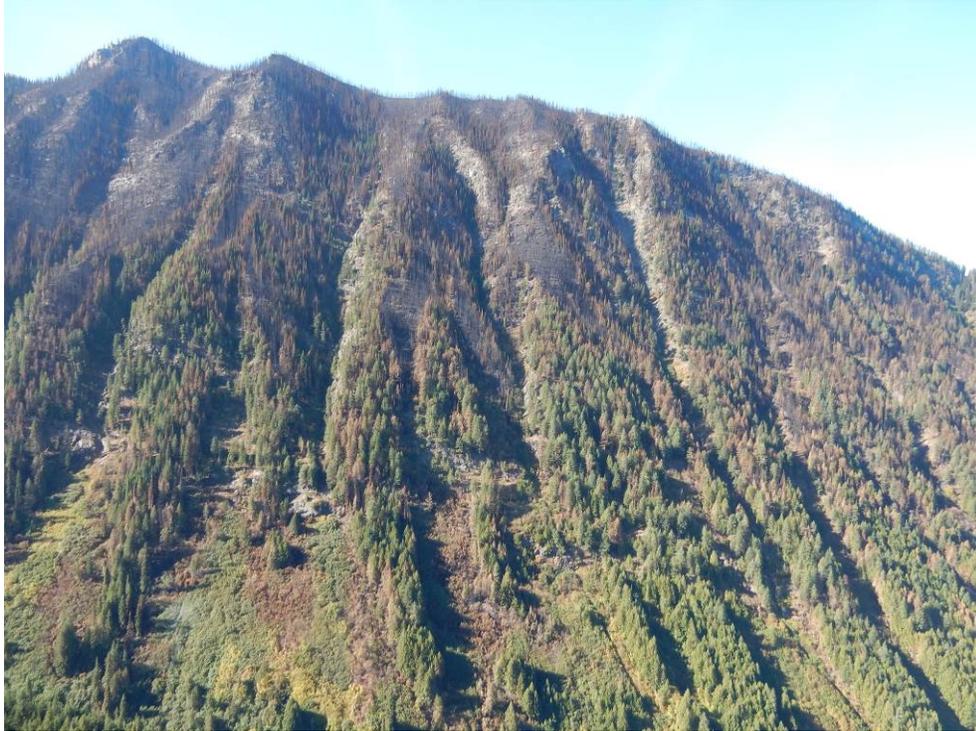
Figure 6. View of the burned avalanche chutes along the east side of Narrows Creek.

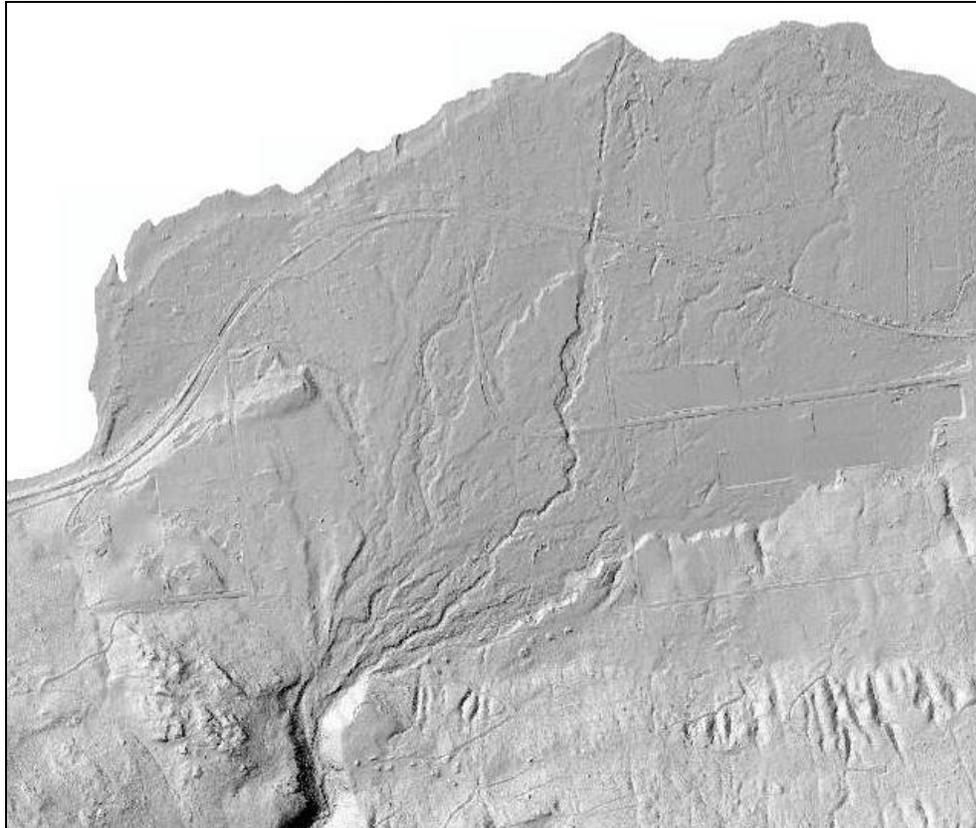
Figure 7. LiDAR hillshade imagery of the Harrop Creek fan (LiDAR provided courtesy of RDCK).
