Report on 2017 monitoring of the Johnsons Landing landslide

Sarah Crookshanks, P.Geo., Research Geomorphologist, MFLNRO, Nelson
December 1, 2017

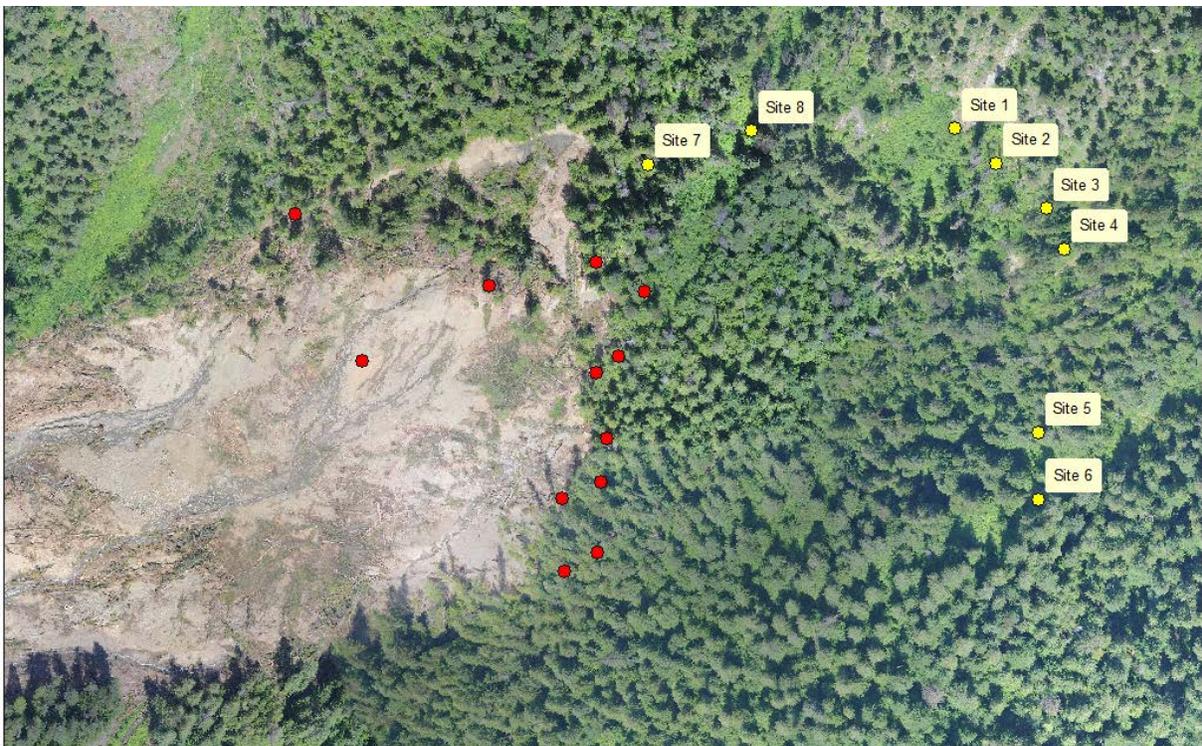
The crack at Site 4 widened by 17 cm and the crack at Site 7 widened by 8 cm. All other sites show no movement or very minor movement within measurement error as some stakes have become loose over the years. Sites 1 and 4 are the two sites that have shown small, but progressive, movement over the past 5 years.

Figure 1. Measurement locations that are measured by hand are identified in yellow (with labels), and measurement sites surveyed by SEL from a base station are shown in red.

Even though this spring was not particularly wet, increased movement at the upper tension crack was measured. Therefore, I recommend continuing to both manually measure the upper tension crack and survey the headscarp in 2018.
