## Report on 2018 monitoring of the Johnsons Landing landslide

Sarah Crookshanks, P.Geo., Research Geomorphologist, MFLNRORD, Nelson  
December 13, 2018

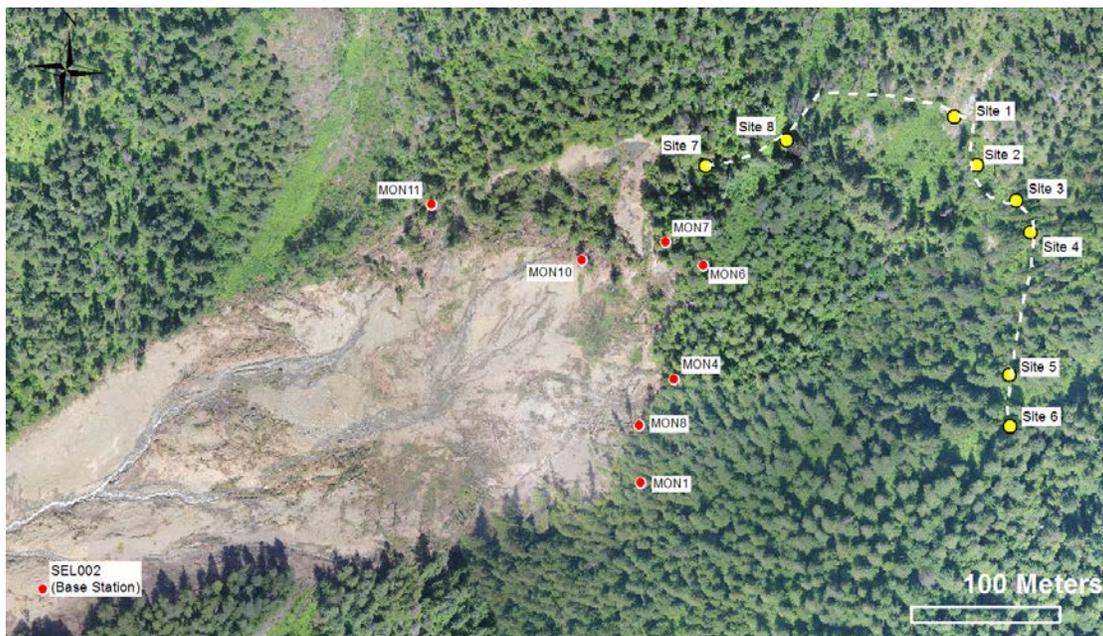
Eight measurement sites are located along the crack that bounds the top edge of the potentially unstable area (see Figure 1 for measurement site locations). One of these (Site 1) is a line of 6 metal pins, with the top pin drilled into bedrock above the crack; therefore, this site is the most reliable measurement location. The other sites consist of two or three wooden stakes driven into soil above and below the crack. The distance between the stakes is measured manually with a tape measure. Unfortunately, many of these wooden stakes have become damaged or slanted because of rockfall and snowload; therefore, the wooden stake measurements in the past few years have become less accurate or have been destroyed.

Figure 1. Measurement locations that are measured by hand are identified in yellow, and measurement sites surveyed by SEL from a base station are shown in red. The dashed line shows the approximate location of the upper crack that bounds the top edge of the potentially unstable area.

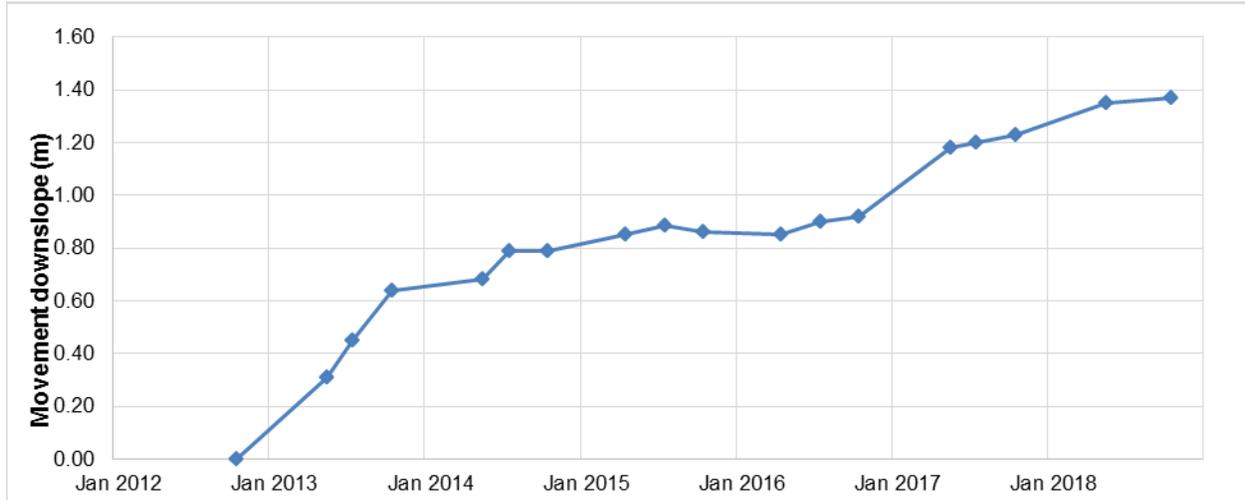
The measurement of the displacement of the upper crack over the past five years shows systematic, progressive movement at the apex of the tension crack (e.g. Figure 2), but limited or no movement towards the outer edges. Table 1 summarizes the measurement data.

Figure 2. Cumulative downslope movement along the upper crack at Site 1 (see Figure 1 for site location). Downslope movement was measured as the distance between stakes spanning the crack.

- The cumulative downslope movement at the apex of the upper crack has been 130 cm over the past 6 years
- The LiDAR differencing data shows approximately 100 cm of subsidence at this location.
- The survey data indicates 10-17 cm of westerly horizontal movement along the headscarp since 2014. Over the equivalent time period, the cumulative downslope movement at the upper crack has been 58 cm.

The greater displacement at the upper crack relative to the headscarp may indicate that the unstable area is settling and will eventually reach a new static equilibrium. In this case the movement would be expected to diminish with time. Significant displacement was observed in

In view of the increased displacement over the past two years and the progressive movement at the headscarp, ongoing monitoring of the site is planned for at least the next few years. Ideally monitoring will continue until a particularly wet spring occurs with no consequent increased displacement or until movement at the headscarp and upper crack slows to zero.

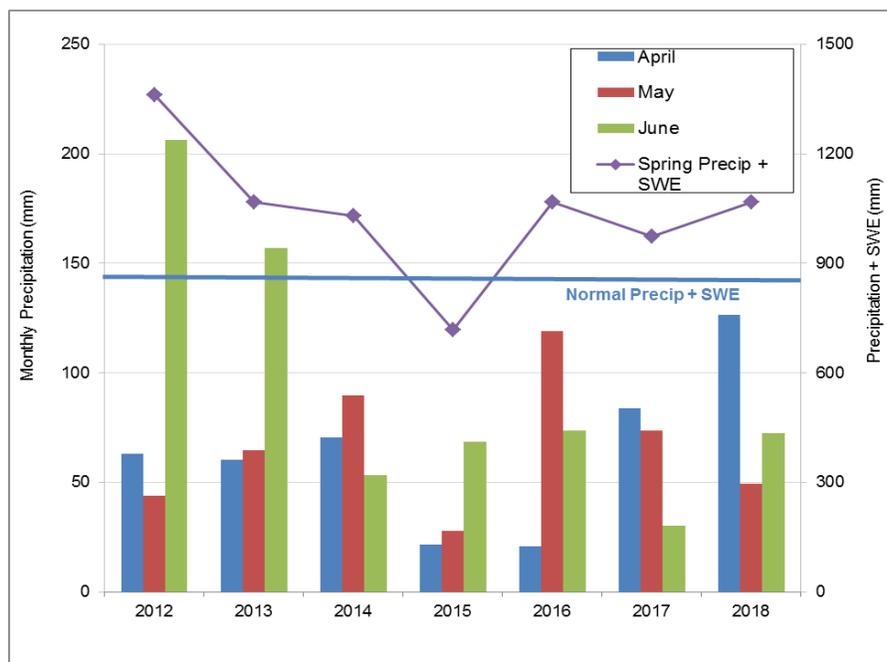
Figure 6. Record of monthly spring precipitation at the Kaslo Environment Canada station 20 km SSW of Johnsons Landing and the spring (April to June) precipitation from the Kaslo station plus the snow water equivalent (SWE) on April 1 at the Upper Gray Creek snow survey site 55 km south of Johnsons Landing.

Given that one of the main triggering factors of the landslide was elevated groundwater levels after a particularly wet spring, the spring precipitation and snowpack are assumed to also be a factor in any ongoing instability. Since 2012 the spring precipitation and snowpack have been remarkably consistent, with the exception of 2015 which was drier. However, there does not seem to be an obvious association between the annual displacement at the upper crack and the precipitation and snowpack records. The movement that has been observed at the upper crack and headscarp could simply be progressive settling of the disturbed area rather than year-to-year variation in groundwater or pore water pressure levels. Alternatively, the interannual variations in precipitation may not have been sufficient to have a detectable impact on the movement. The spring snowpack and precipitation was almost 150% of normal in 2012, whereas in the years since the snowpack and precipitation has been within 15% of normal.
