BC Ministry of Forests, Lands, and Natural Resource Operations
and Rural Development

POST-WILDFIRE NATURAL HAZARDS RISK ANALYSIS
SYRINGA COMPLEX FIRES
(N52497, N52489, N52548 – 2018)

December 13, 2018

Report Number: 511.18.26

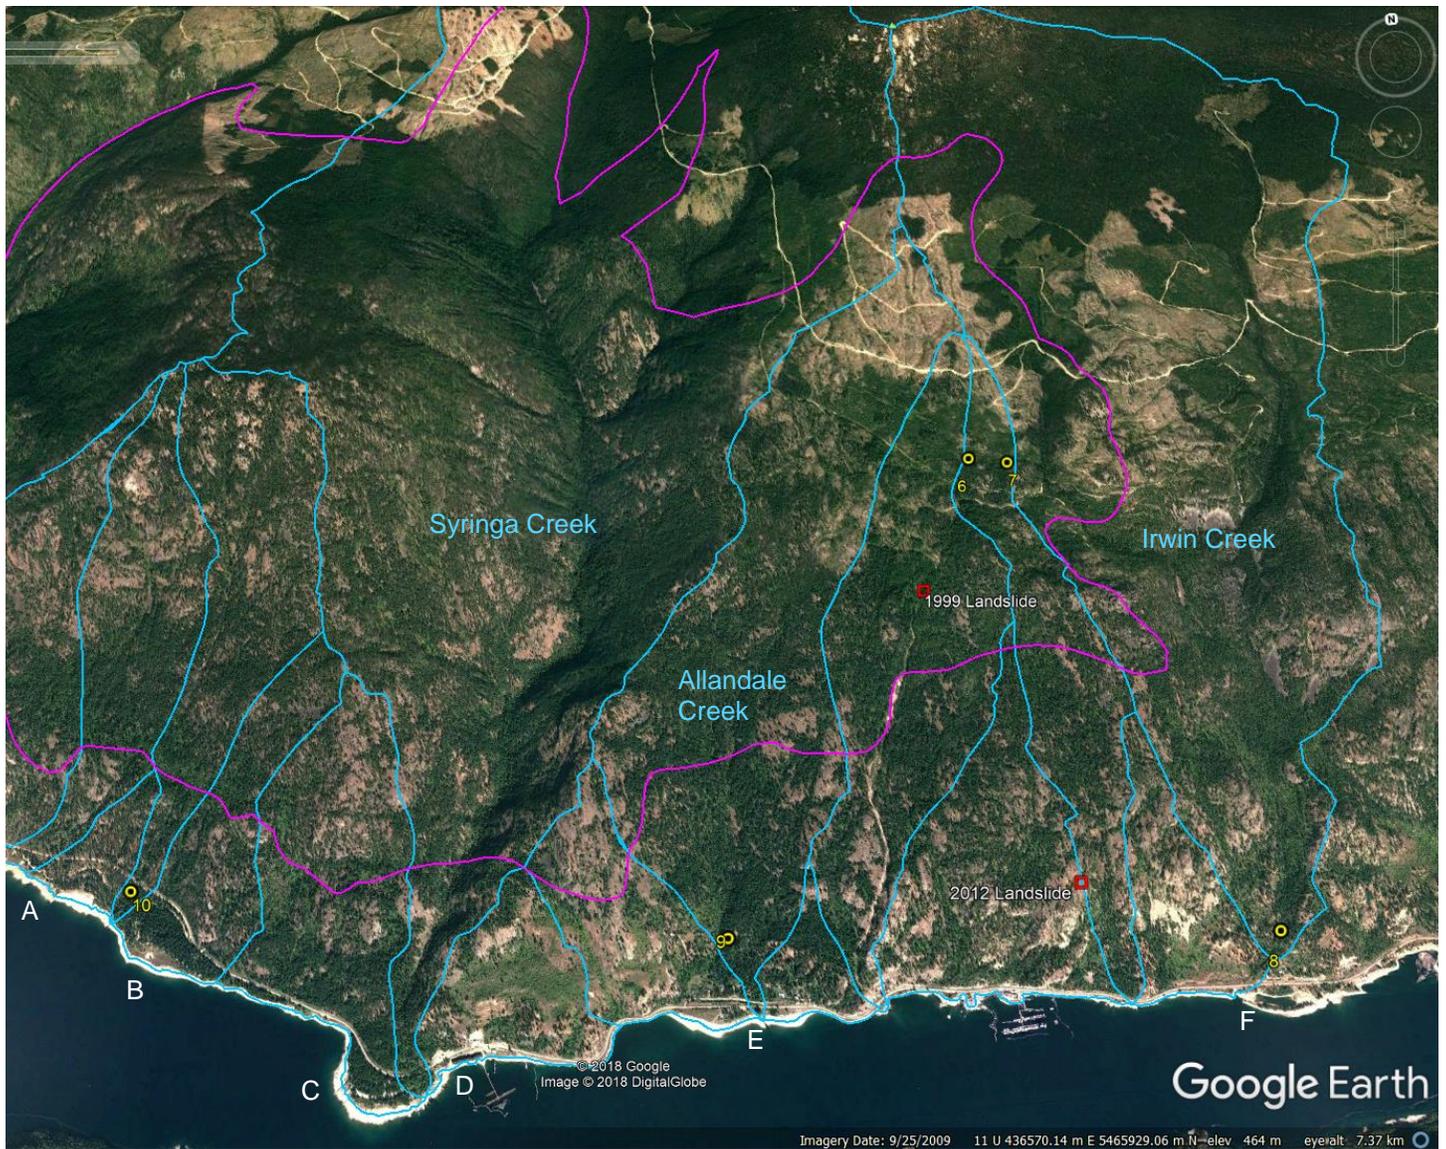
4.1.6 Broadwater Road between Irwin Creek and Allandale Creek: Two landslides are known to have impacted the road in the past, in 1999 and 2012 (Figure 3). One of these was caused by a road drainage diversion. Two steep drainages, “Landslide Creek” (site of the 1999 event) and “Unnamed East Creek” intersect Broadwater Road. Most of the upper plateau which has not been recently logged has been burned, at moderate severity with some patches of high severity. Debris flow hazard is moderate (pre-existing, somewhat increased by the fire), and partial risk to the road is high. The intervening steep faces were not affected by the fire.

Figure 3. Google Earth oblique view of the Syringa Creek fire, showing watersheds (blue lines) and fire perimeter (purple). Elements potentially at risk include: Provincial Park campground (A and B), park group campsite, day use facilities and boat launch (C), marina and condominium development (D), houses on Allandale Creek fan (E), and houses on Irwin Creek fan (F).

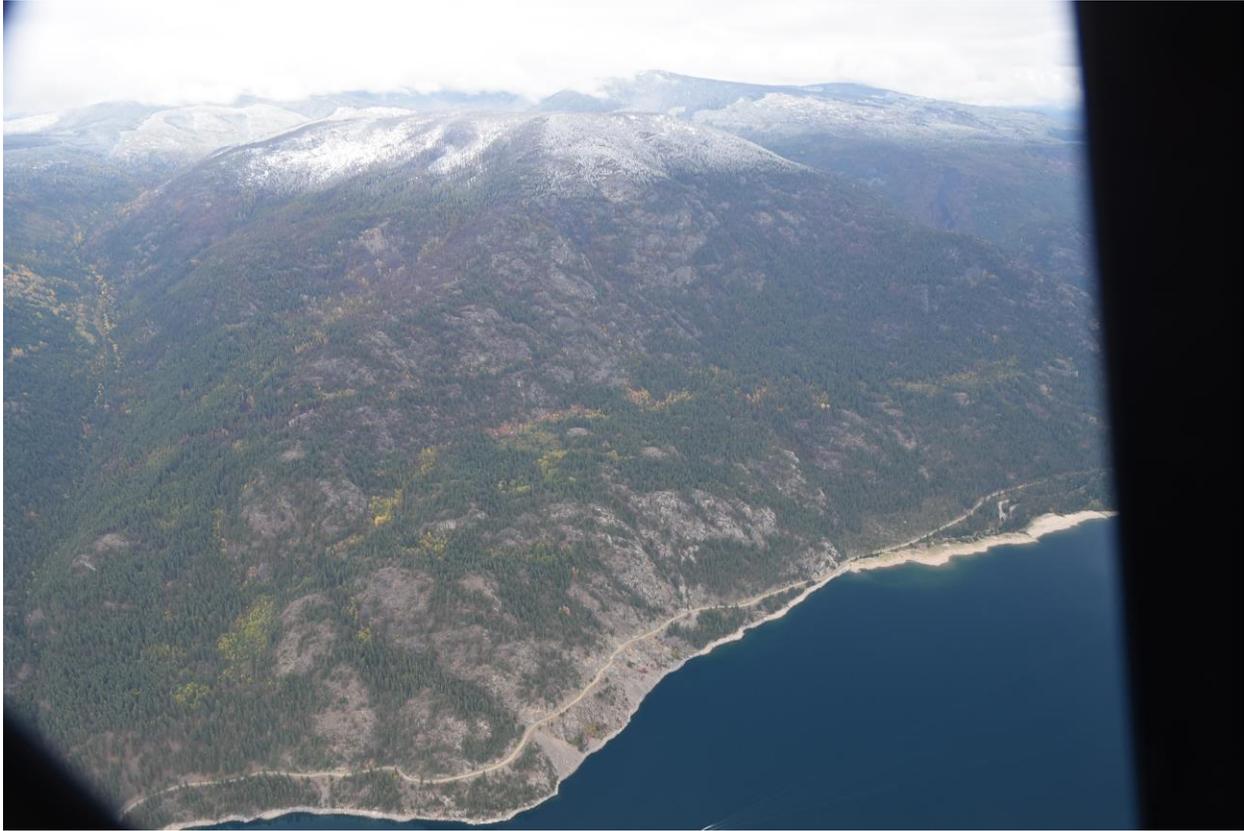
“Campground Creek 1” is smaller and does not have an obvious fan. Its watershed and the adjacent faces to the east and west have only small patches of low and moderate burn severity. Hazards due to the fire are very low. The lower part of the face is shown as “missing” on the burn severity map, as this area was concealed by cloud when the satellite imagery was obtained. As seen from the air, it is mostly unburned with a few small patches of low severity burn (Photo 1)

Photo 1. Syringa Creek fire. Tulip Creek on left, campground on right.

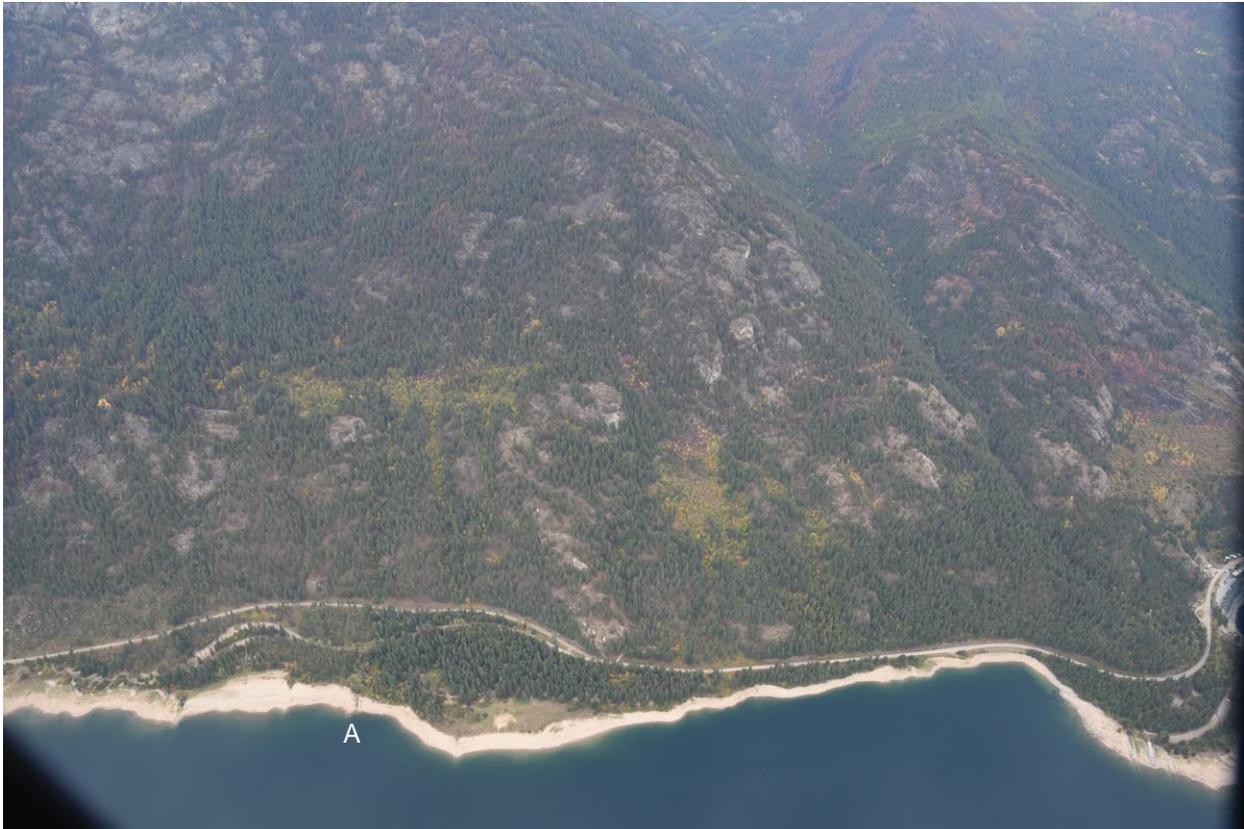
4.1.2 Campground watersheds and adjacent faces: The headwaters of “Campground Creek 2” has been partly burned (59% total) at low and moderate severity (Photo 2). It has a forested alluvial fan which was probably formed by debris flows, but has no evidence of recent activity. The creek is incised about 3.5 m in a stable channel, and crosses both the campground access road (old highway) and the Deer Creek FSR in 900 mm culverts. Campground facilities are located east and west of the fan. Debris flow and flood hazards due to the fire are considered to be low and partial risk to the campground is low.

Photo 2. Syringa Creek fire. Campground area at left and centre; "Campground 2" creek enters at A. Syringa Creek fan at far right.

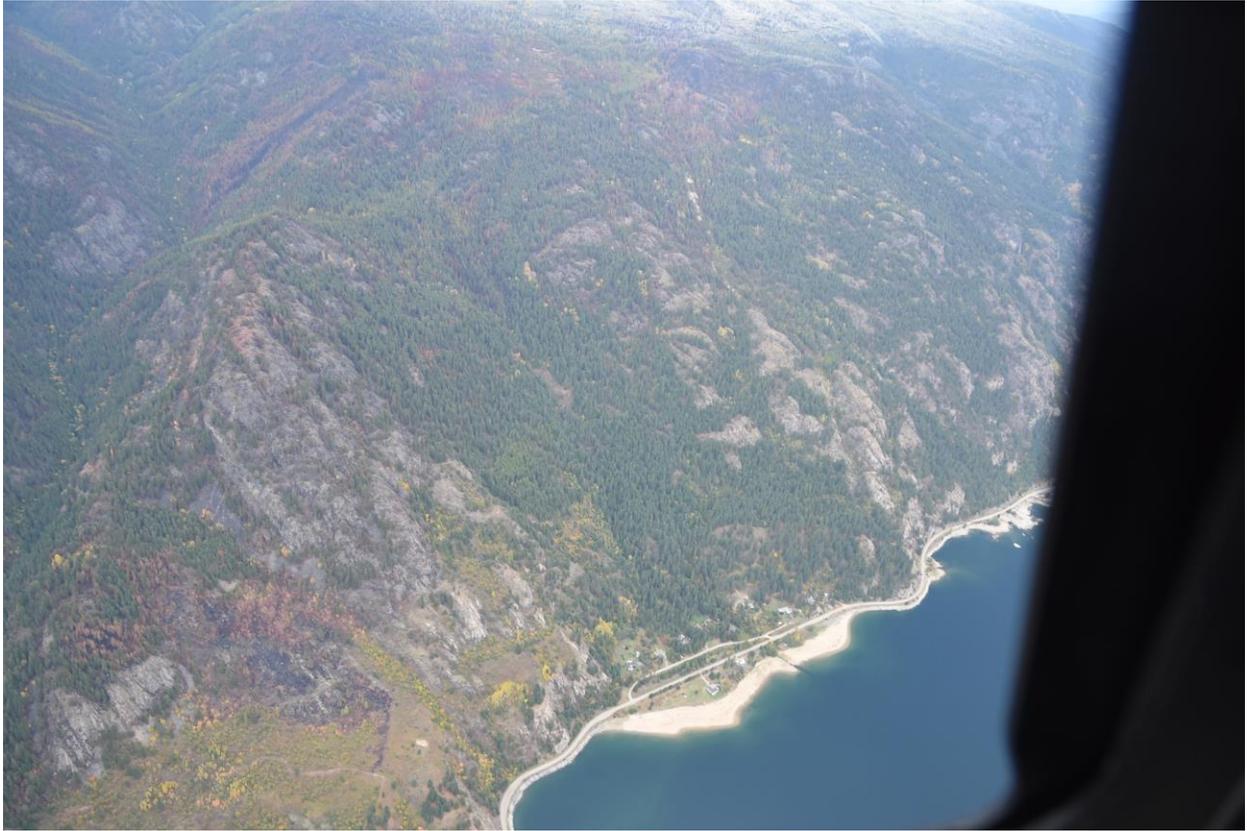
Photo 3. Syringa Creek fire, looking northeast over Allandale Creek. The terrace above the marina-condominium complex is at lower left.

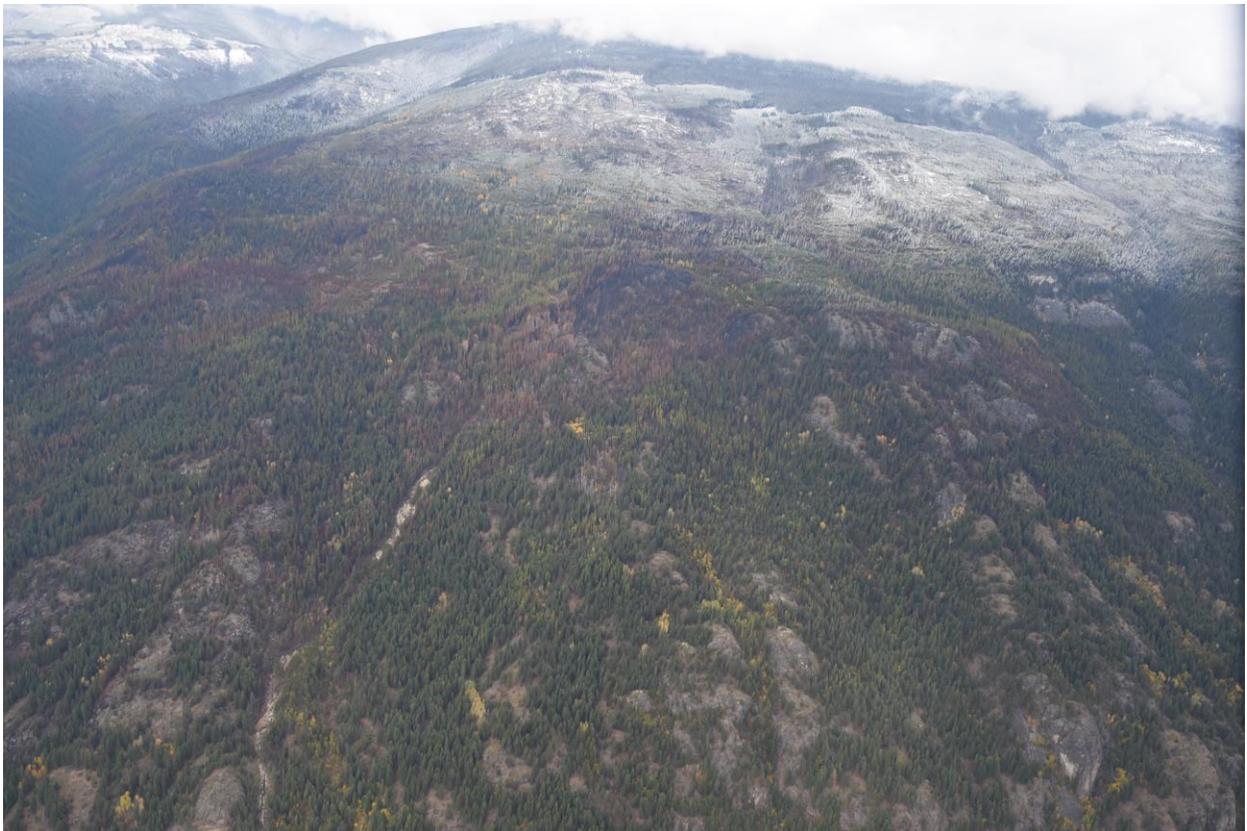
Photo 4. Syringa Creek fire, looking north over eastern part of the fire. 1999 landslide is at centre left; upper Syringa Creek is on top left.

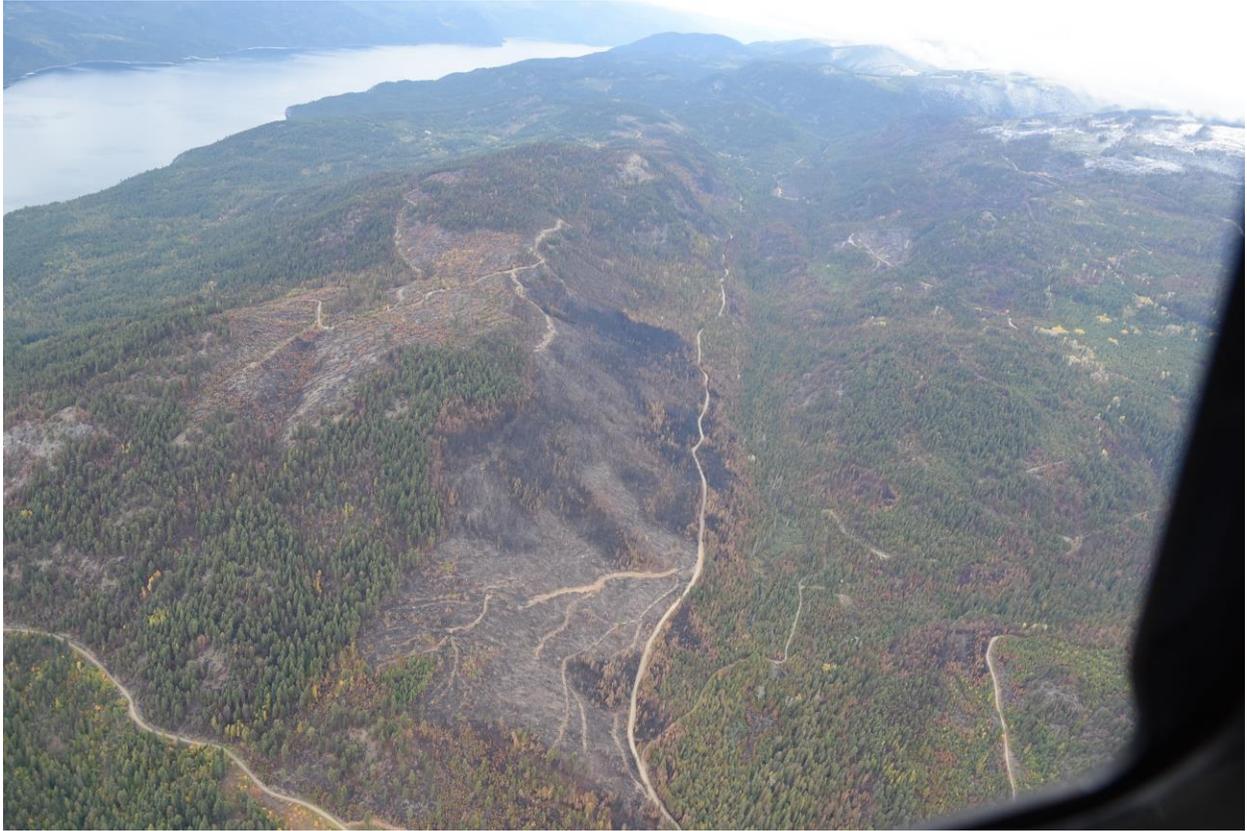
4.2.1 Deer Creek flooding and water quality: The west fork of Deer Creek has been extensively burned (34% moderate and high severity). Some increase in peak flow is likely. Sediment and ash could enter the creek from an area of high severity burn above its right (west) bank (Photos 5 and 13). The west fork is only about 16% of the total watershed area of Deer Creek, so its contribution to peak flows is minor. The larger east fork has some small areas of high severity burn on steep slopes (Photo 6) which also could contribute some sediment locally. The riparian zone of both the east and west forks is unburned.

Photo 5. Deer Creek fire, looking north up west fork. Note unburned riparian zone, and high severity burn on slope above (centre).

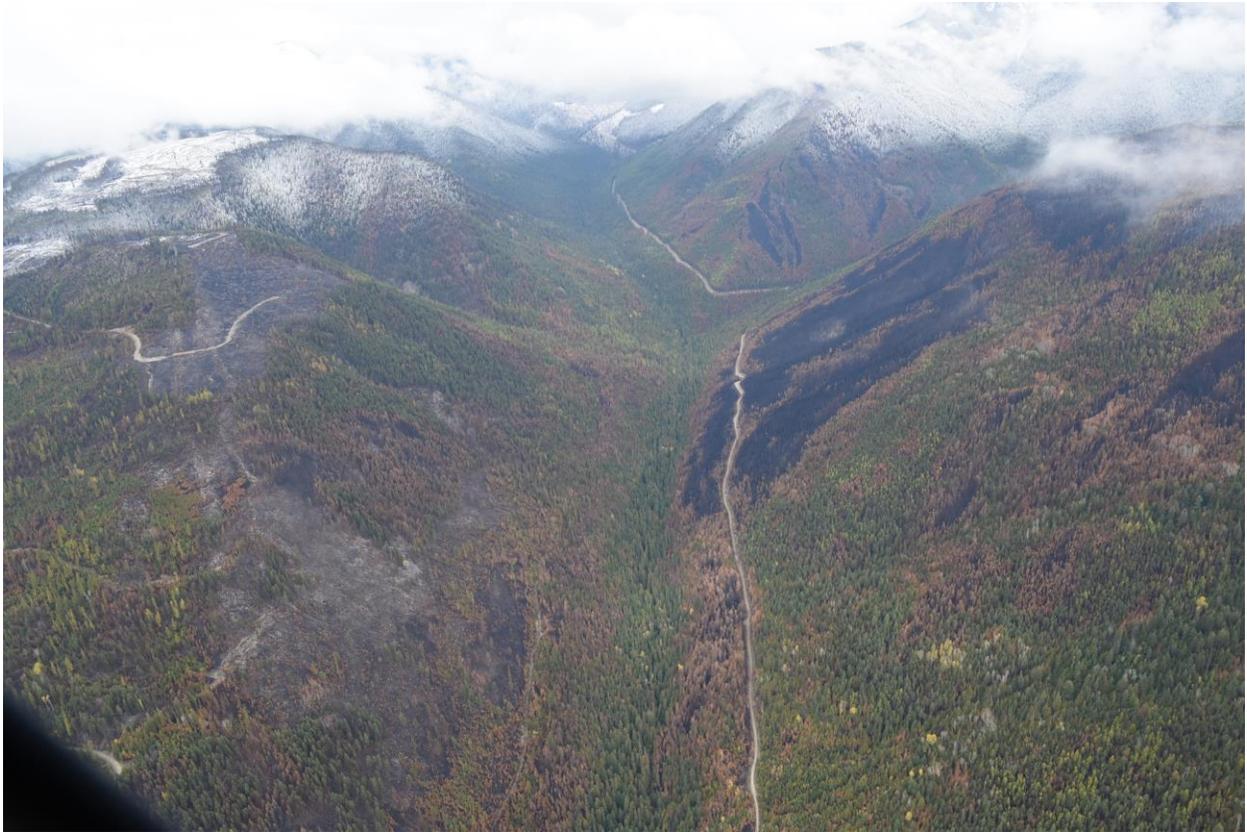
Photo 6. Deer Creek fire, looking northeast up east fork. Note unburned riparian zone, and high severity burn on steep northwest facing slope above.

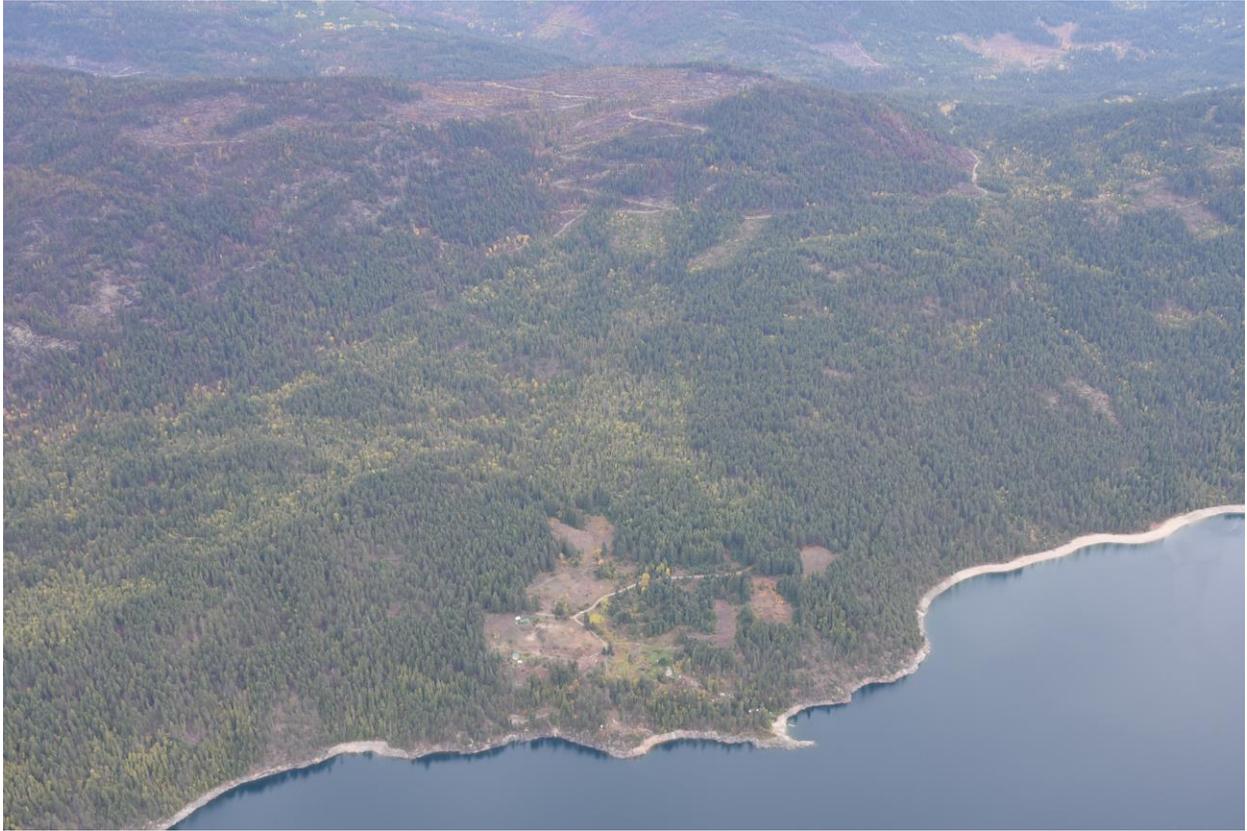
4.2.2 Broadwater Creek: There are several houses near the mouth of Broadwater Creek (Photo 7). The upper part of Broadwater Creek has been burned at low and moderate severity. Most of the burned area is in immature plantations. The incremental effect of the fire on peak flows is likely to be small.

Photo 7. Deer Creek fire. Broadwater settlement at lower centre; patchy low and moderate severity burn and logged areas in upper part of Broadwater Creek watershed, centre distance.

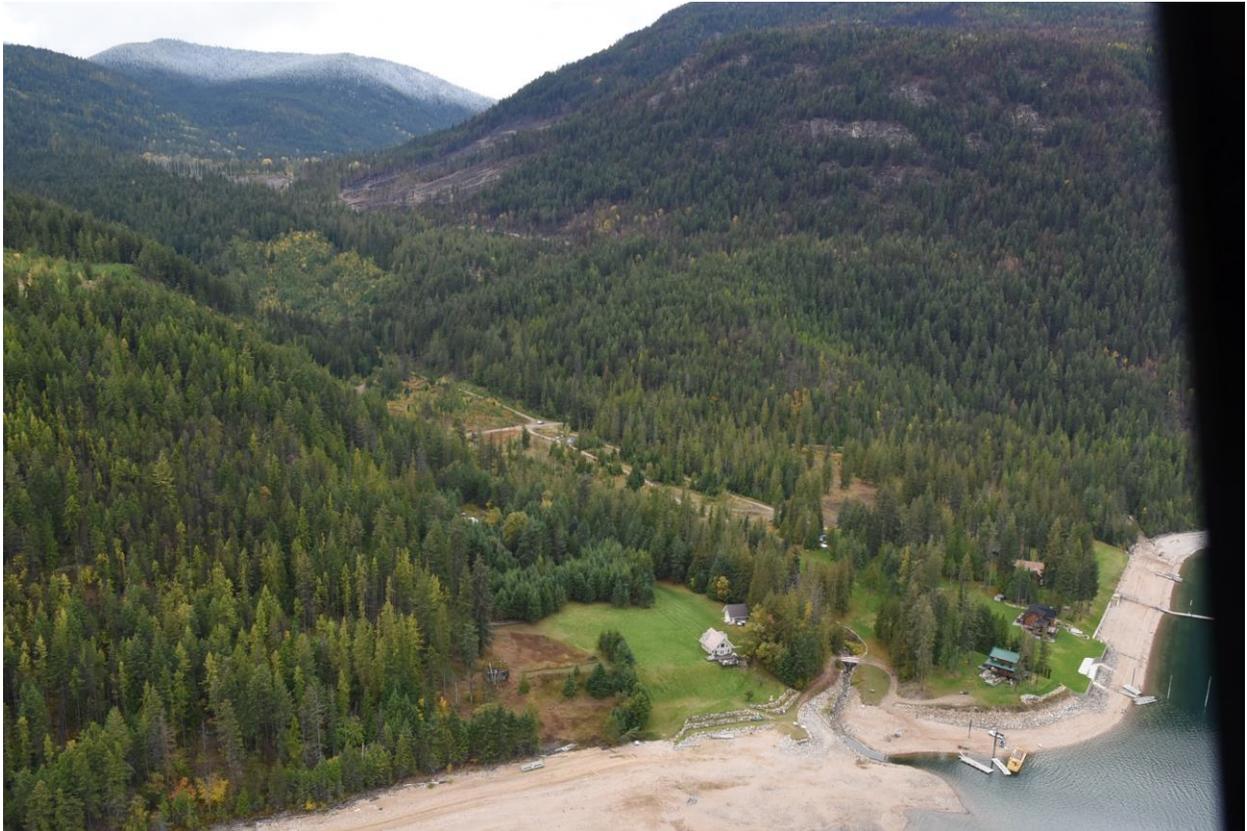
4.3.1 Churchill Creek and lower Pup Creek face: Churchill Creek is a small tributary of Pup Creek, entering just above the community of Brooklyn (Photo 8). It has 23% moderate and high severity burn, in the upper part of the watershed. There is a cutblock planned in this area, which would include most of the moderate and high severity burn. There is some potential for debris flows in the steep creek channel, although from the LiDAR imagery, it appears that past events have stopped on a bench in the valley below, and not reached Pup Creek. The hazard of a debris flow which could reach Pup Creek is considered low. Houses at Brooklyn are separated from the steep slopes to the southwest by a dissected terrace and by a broad area of flat land at the mouth of Pup Creek and so the partial risk is very low.

Photo 8. Bulldog Mountain fire. Settlement of Brooklyn and mouth of Pup Creek.

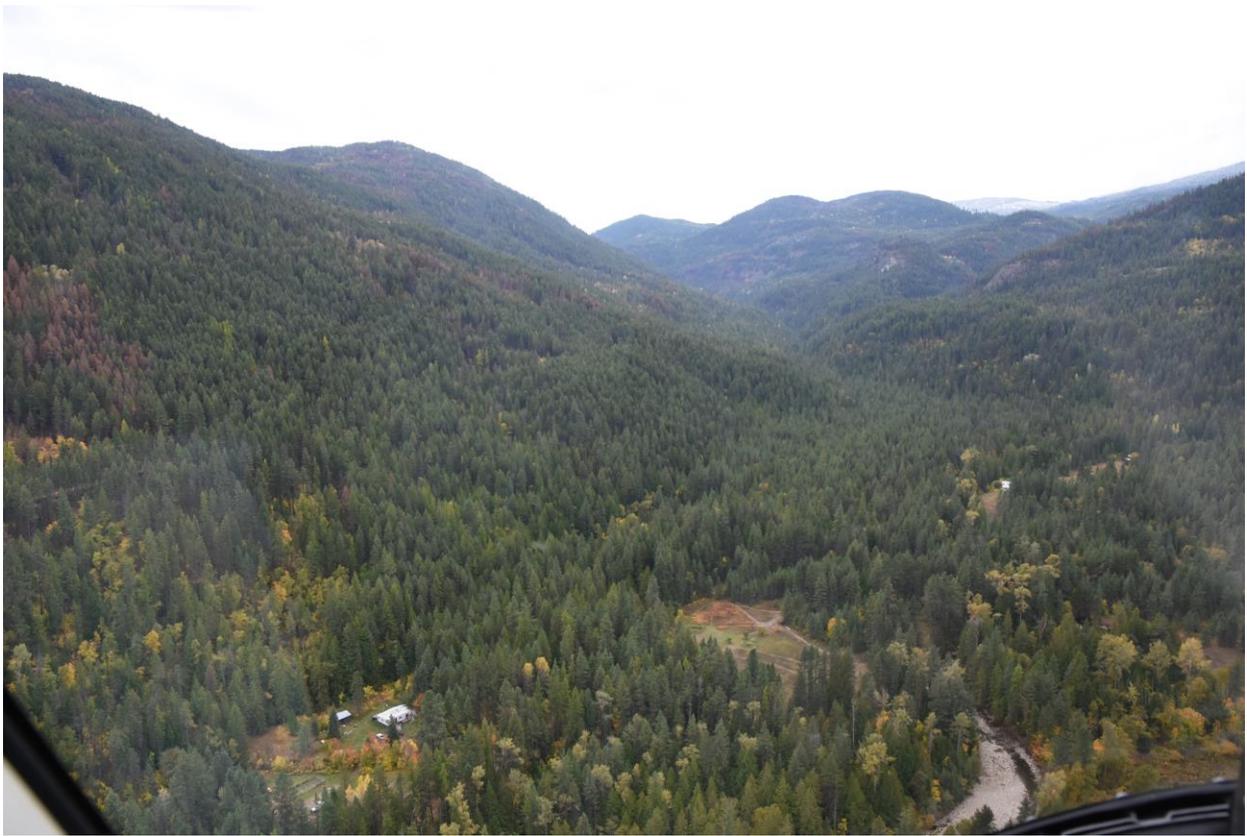
4.3.3 Water quality in Dog Creek, and hazards at Renata: There are several houses on the east side of lower Dog Creek, below the northwest part of the fire (Photo 9). The burn on the slope consist only of small patches, and hazards due to the fire are very low. As Dog Creek is a large watershed and only a very small part of it has been burned, effects on peak flow and water quality are likely to be negligible. The partial risk to houses is low.

Photo 9. Bulldog Mountain fire. Houses on right bank of Dog Creek at lower left; slopes above have isolated small patches of burn.

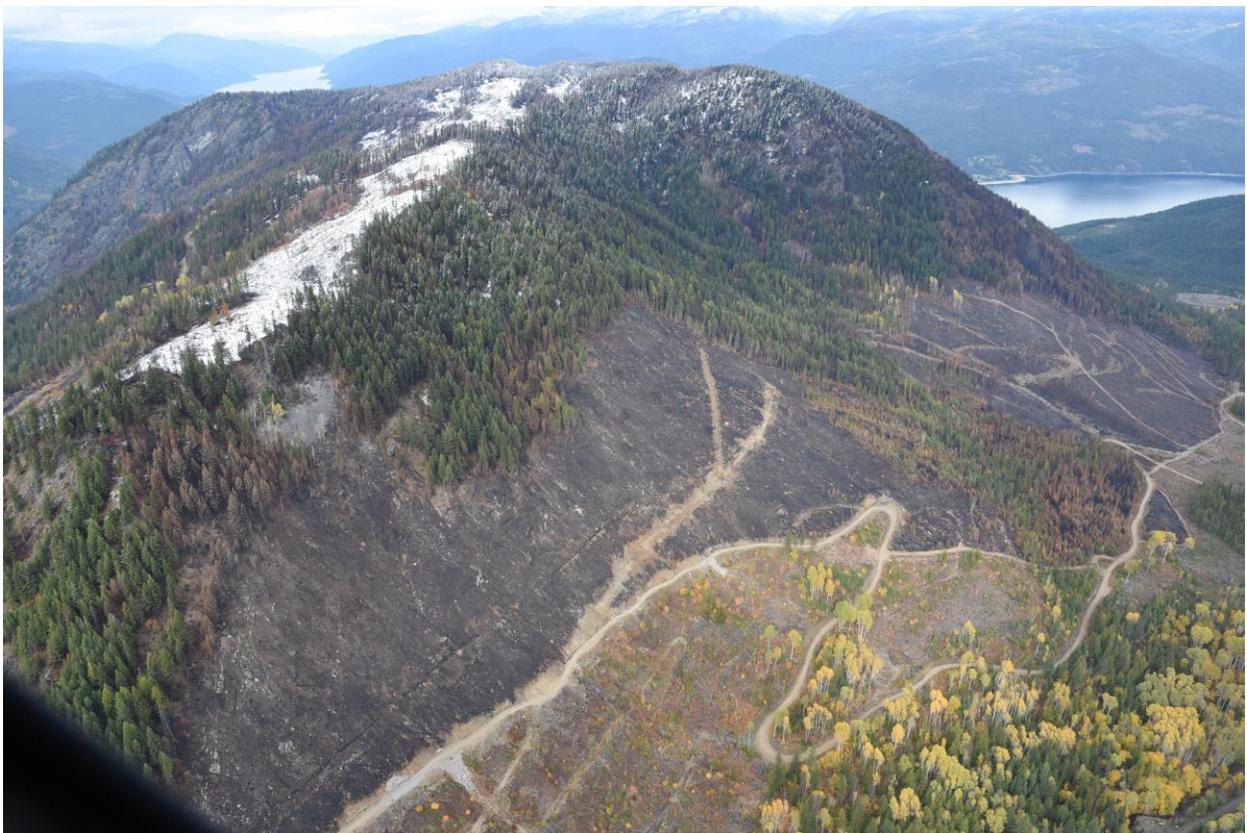
4.3.2 Water quality in Pup Creek: There is an extensive area of mostly moderate burn severity in Brooklyn Creek, on the southeast side of Bulldog Mountain. Much of the burned area is in recent cutblocks (Photos 10 and 11). There is some potential for sediment to be introduced to Brooklyn Creek by erosion from the burned area or the logging road below. The incremental hazard due to the fire is considered low; previous erosion and a landslide from the road, and a failure several years ago on the old rail grade, are probably responsible for most sediment in Brooklyn Creek.

Photo 10. Bulldog Mountain fire. View north over Bulldog Mountain with recent logging along ridge. Burned cutblocks and forest to right are in Brooklyn Creek watershed.

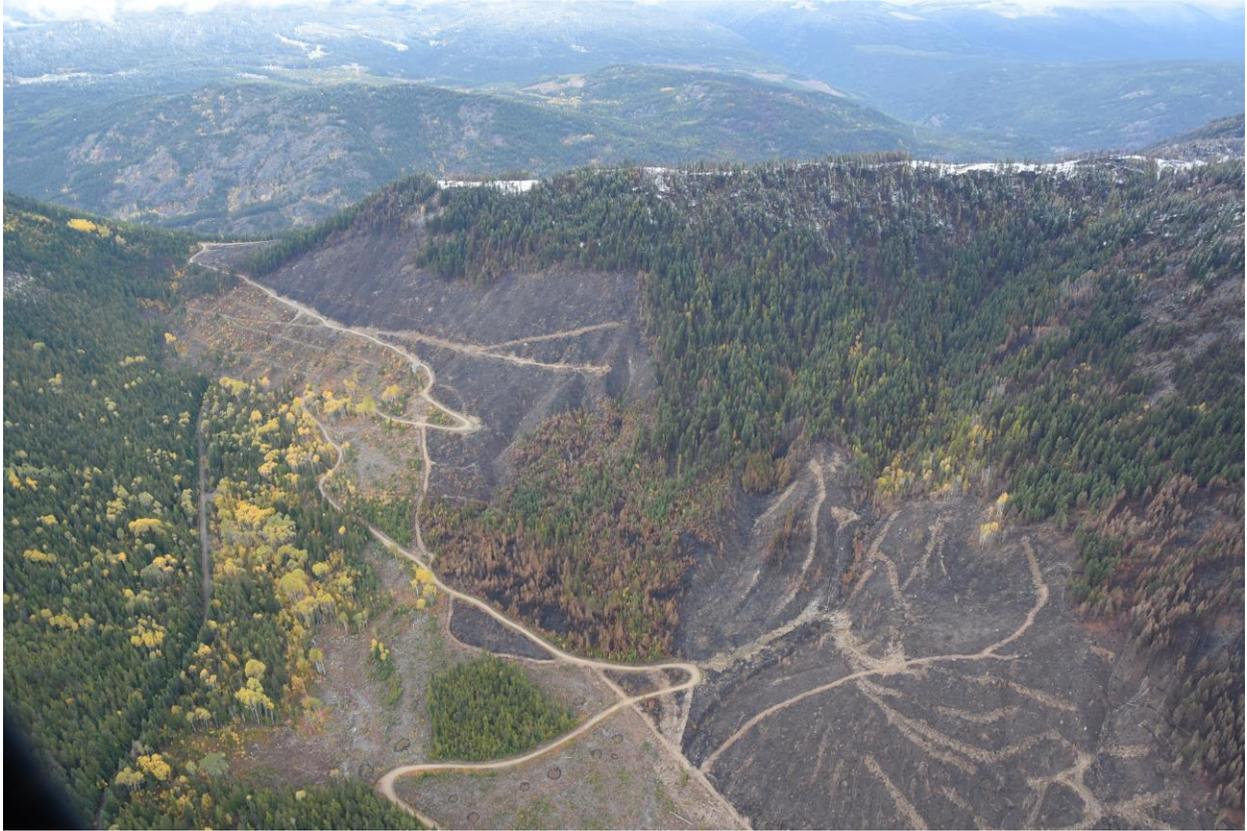
4.3.4 Recreation sites and trails: The Bulldog Tunnel is a significant historical feature on the Columbia & Western rail trail. Small areas of mostly moderate burn severity are above the tunnel entrances on both sides, but the incremental hazard of landslides that could affect the rail grade are considered low. A landslide several years ago from the logging road on the slope above came close to the tunnel entrance (Photo 11).

Photo 11. Bulldog Mountain fire. Looking west up Brooklyn Creek. Rail grade and entrance to Bulldog Tunnel are visible at left. Note landslide from road just above tunnel entrance. Cutblocks were logged in 2015 to 2016, and have unusually severe burn (mapped as “moderate” on BARC map).

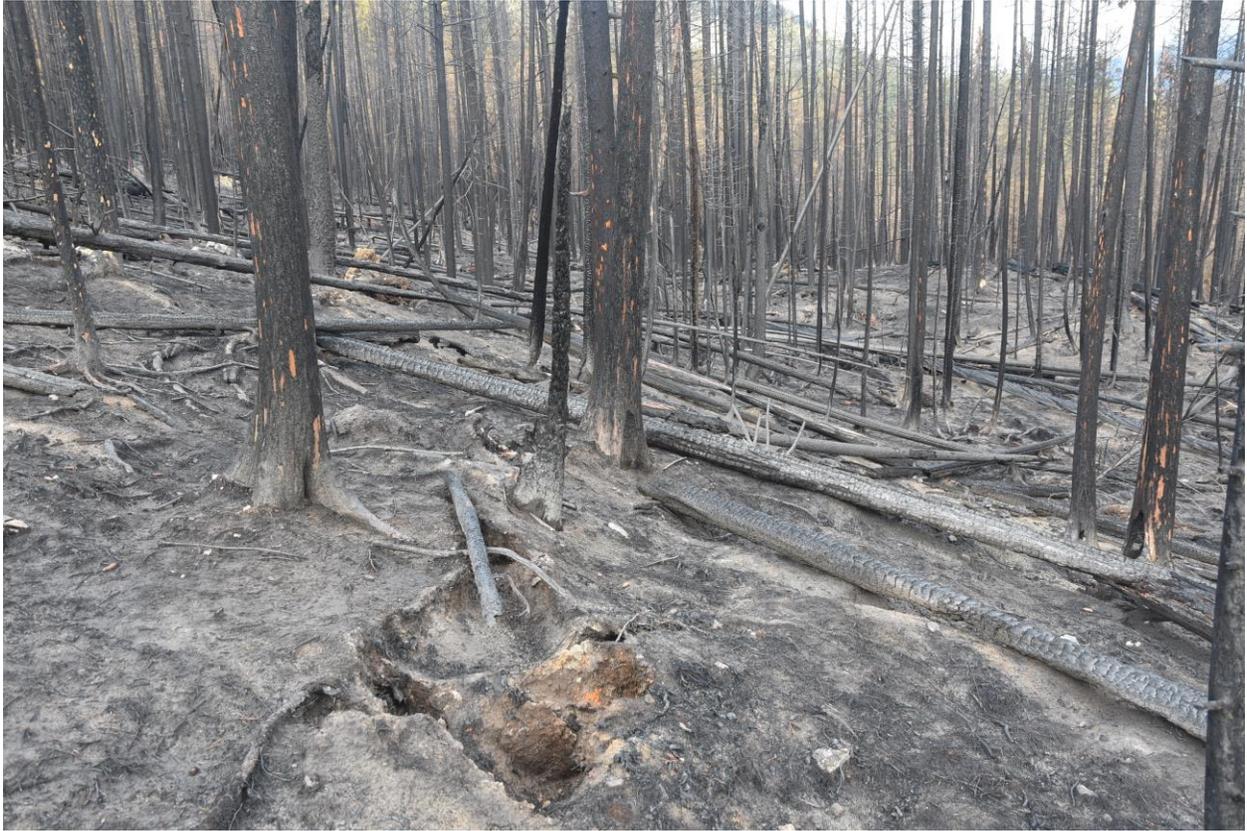
Photo 13. High severity burn in west fork of Deer Creek. Strong water repellency was observed at this site.

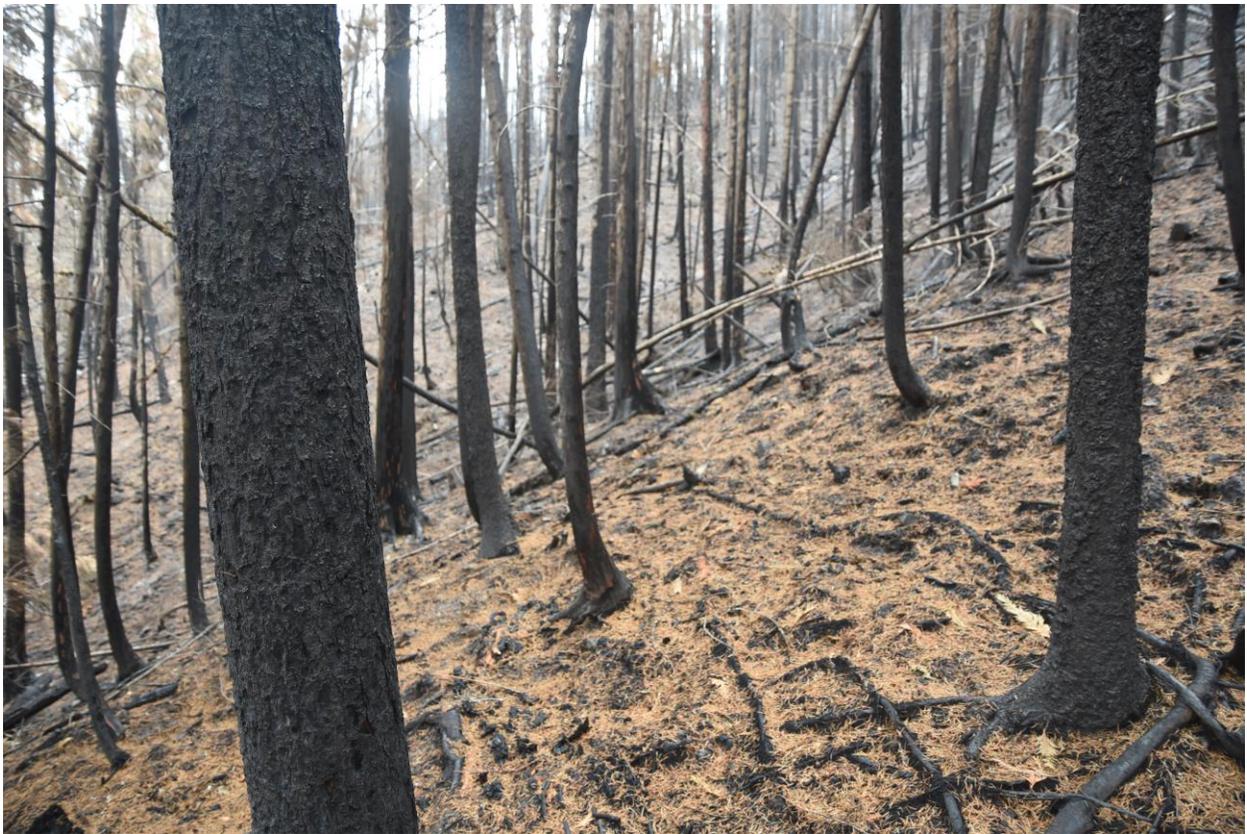
Photo 14. Moderate vegetation burn severity site, with high soil burn severity; east fork of Deer Creek. Note fallen needles which provide a mulch.

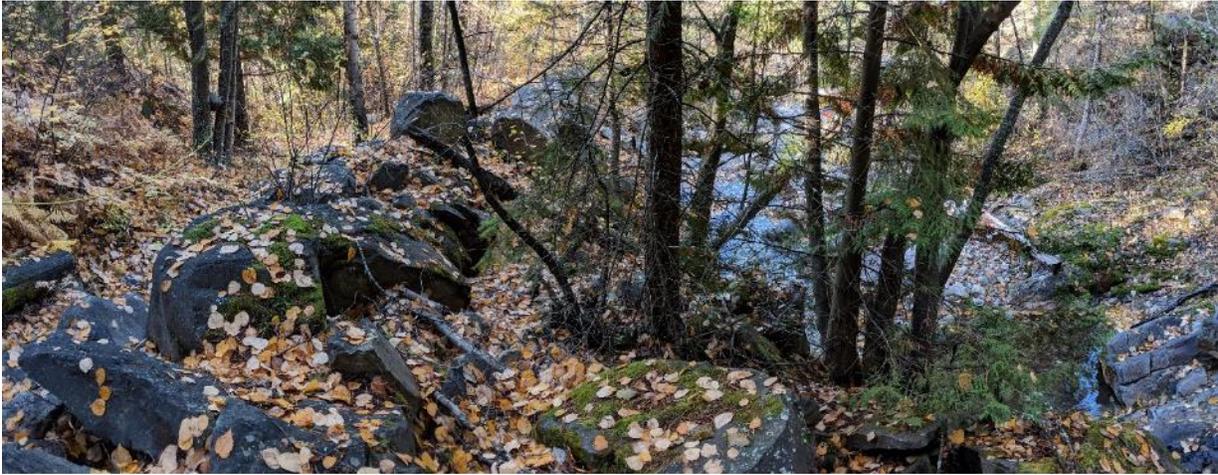
Photo 6. Machine constructed berm along left bank for a distance of 50m

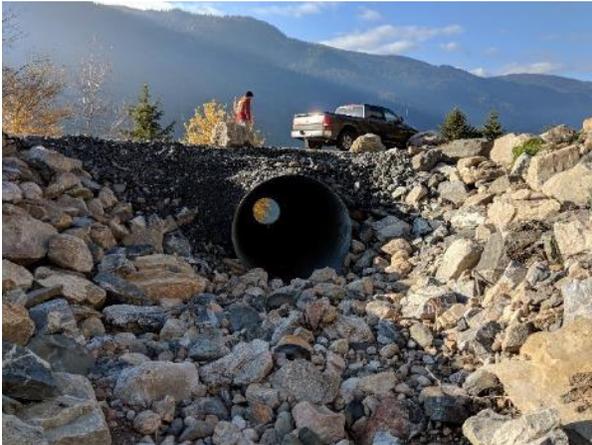
A large (2500mm) culvert is located across Broadwater Road (Photo 7). The Q_{100} is estimated (via the formula below) at $6\text{m}^3/\text{sec}$ while the 2500mm culvert capacity is in the order of $12\text{m}^3/\text{sec}$ so the small increase in creek flows will have a small incremental hazard at the crossing location.

Photo 7. 2500mm diameter culvert at Broadwater Road

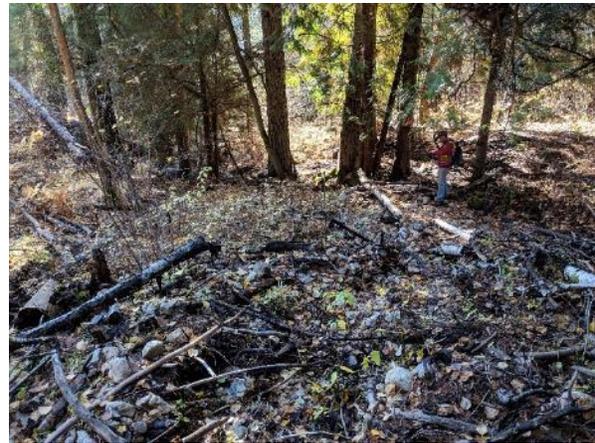
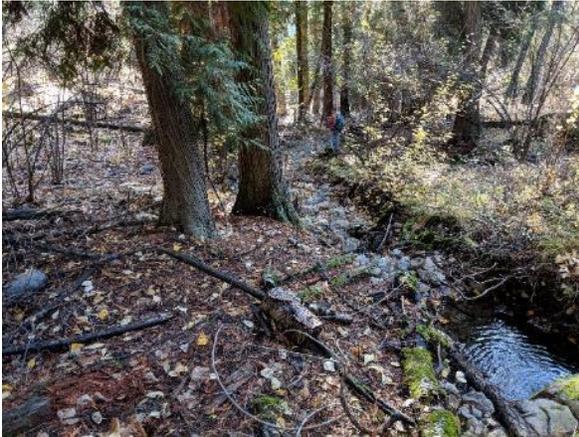
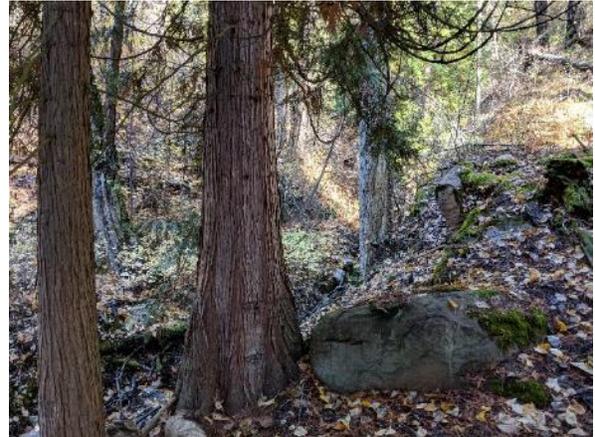
Near the apex of the fan, the creek banks are low, and there is a hazard of an avulsion of the creek, if high flow occurs or if additional gravel is deposited in the channel (Photos 1 through 4). This hazard existed before the fire, and the fire has increased the hazard slightly. The post wildfire hazard P(H) is considered L-M for debris flow and M for flood/channel avulsion. The spatial and temporal probabilities P(S:H) and P(T:S) for the houses are considered moderate (M) for debris flows and high (H) for flooding/channel avulsion. The post wildfire partial risk is considered low to moderate (L-M) for debris flows affecting houses and high (H) for flooding/channel avulsion affecting houses. It is noted the hazard was present pre-fire and is now elevated.

Photo 2. Allandale Creek fan

Photo 3. Allandale Creek – note low banks

Photo 4. Allandale Creek fan apex (looking up)

Regardless of the effects of the fire, risk reduction can be achieved by providing increased channel conveyance area which will reduce the likelihood of flood flows and channel aggradation which could cause the creek to be directed towards houses below. Increased channel conveyance will also reduce the likelihood that a debris flow will cause an avulsion (although it will not eliminate the potential for an avulsion).

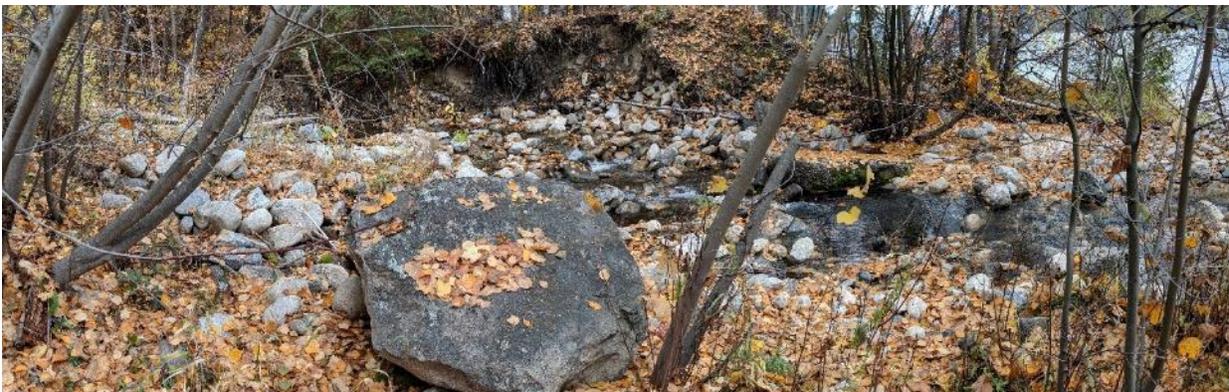
The hazard (flooding) due to the burned area is considered low and the partial risk (Broadwater Road and fan infrastructure) is also low. The culvert appears to have excess capacity to convey some increase in flow volumes.

Photo 1. Syringa Creek near the mouth – well incised

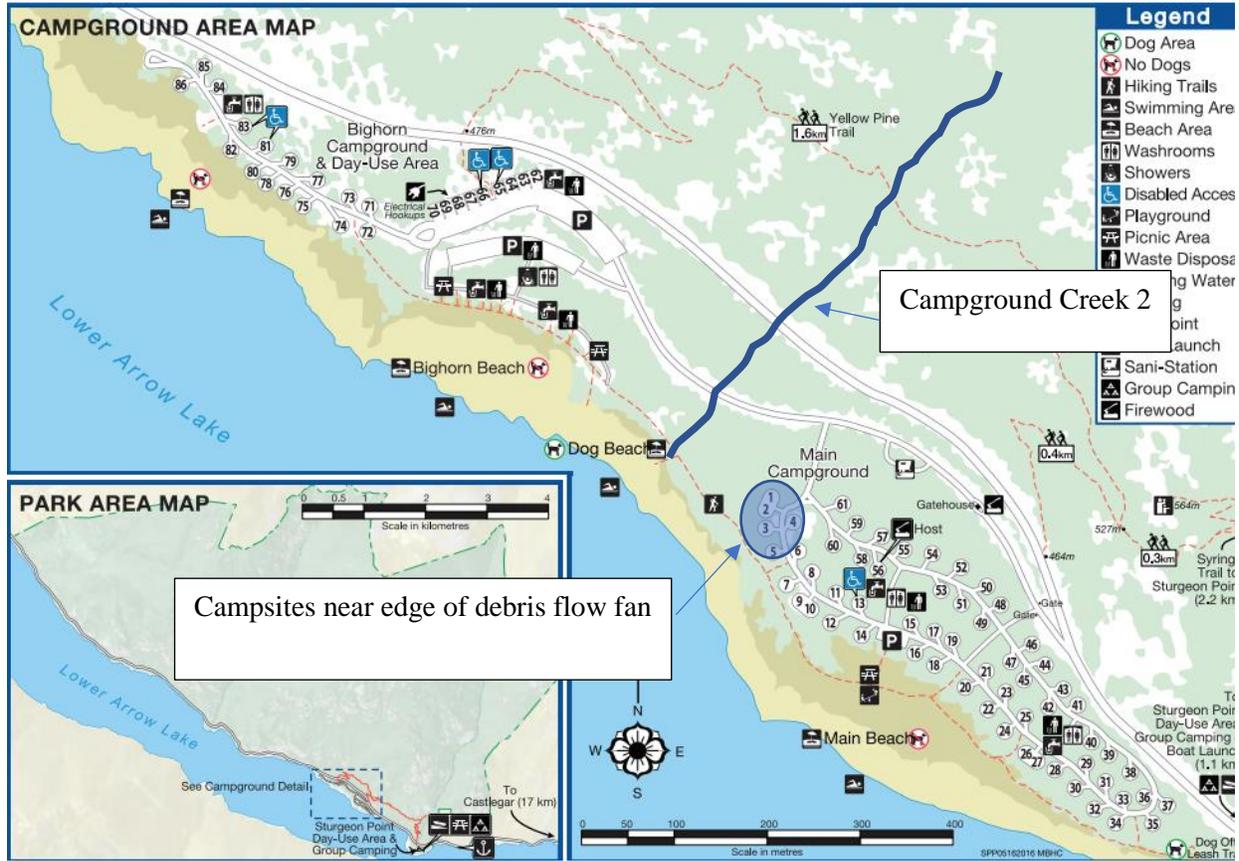
The post wildfire hazard of debris flow and flooding is considered low (L). The culverts may be undersized for a Q_{100} flood event; however, they are located 3.5m below local ground grade and so there is potential for increased culvert capacity with the excess head. A debris flow would likely block the culvert at the upper FSR crossing location - potentially redirecting stream flows; however, the nearest campsites are located 200m away at the left distal edge of the fan. The temporal and spatial hazard is considered moderate (M) and partial risk is low (L).

Figure 2. Approximate location of Campground Creek 2 relative to campsite locations

Even though the partial risk is considered low, the cost/effort to reduce the risk further is minimal and involves not having the campsites at the distal edge of the fan occupied until the hazard is reduced (2 to 3 years). If BC Parks requires a reduction in the risk, then the limits of potential debris flow runout should be mapped in the field so that the campsites at risk can be identified and use restricted.
