Burton Legacy Landfill Closure Plan

Regional District of Central Kootenay

ISSUED FOR USE

Sperling Hansen Associates Inc.

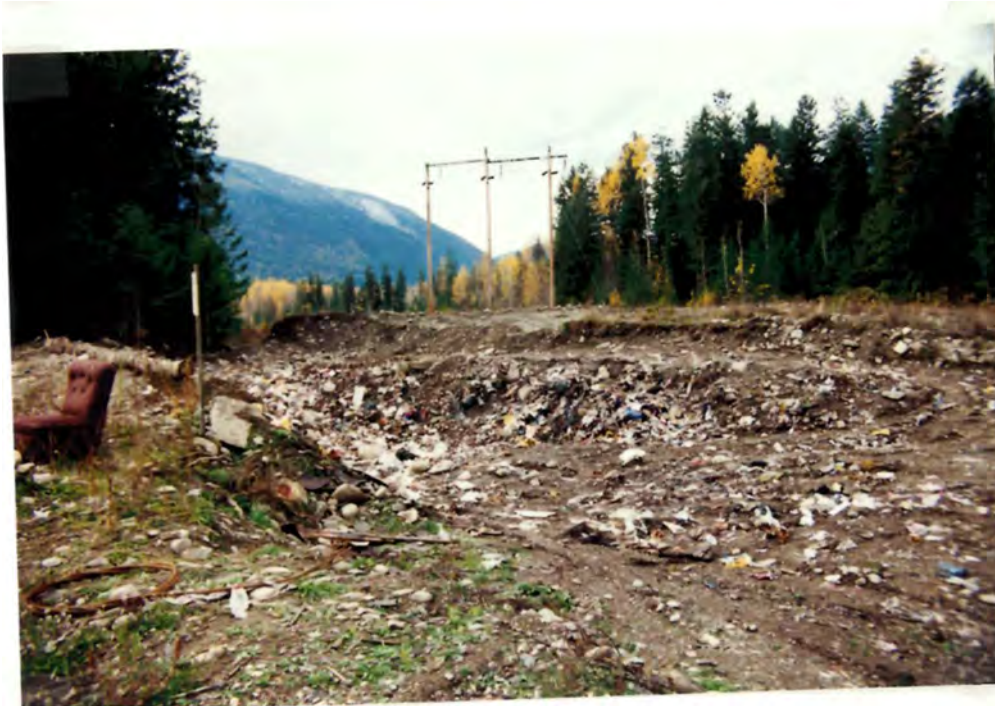
It should be noted that there is likely waste within the BC Hydro Right-of-Way, given the contours of the site and the photos found showing waste trenches close to the power lines (Figure 3). At this time, SHA believes that it is not necessary to remove the waste within the right of way as this will likely cause more exposure of waste and potential for litter to be spread around the site.

Figure 3: Photo showing trench and fill operation within power line area at the Burton Landfill site. ENV records show photo was taken in November of 1994.

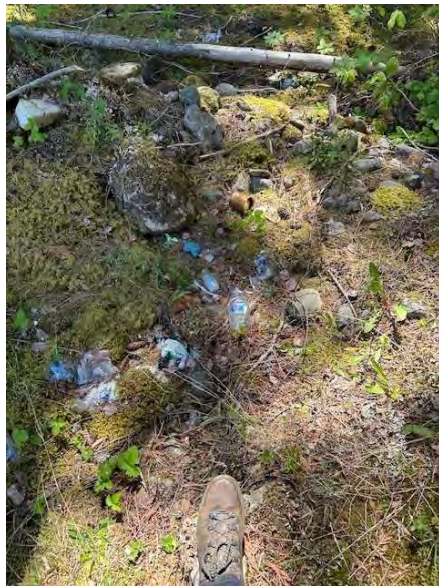
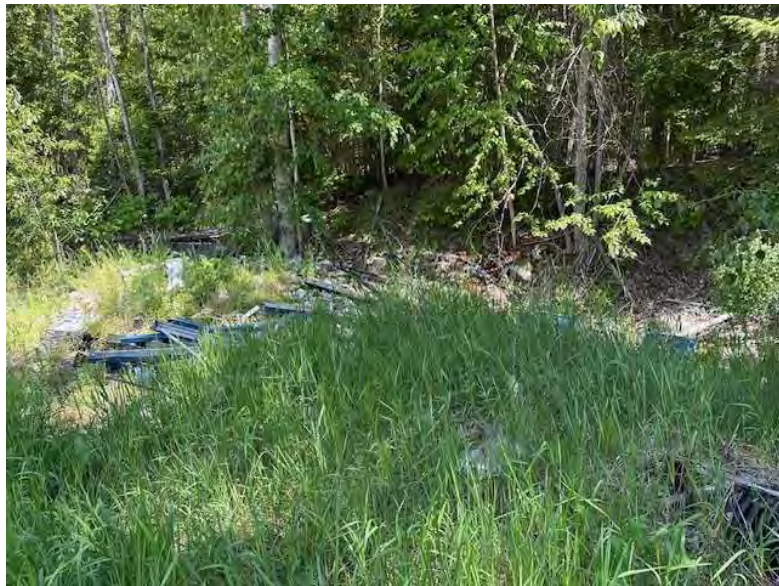
The Burton Transfer Station site is well maintained, with minimal litter from transfer station operations observed in the area. There was however some litter observed along the Southwest side of the site, along with some minor debris and waste observed around the metal pile, leftover from 'push-up' during operations. (Figures 5 and 6) This litter and debris should be removed from the site and disposed of properly, and the metal pile edges cleaned up to ensure that no waste is left over from previous landfilling operations.

Figures 5 and 6: Litter and debris observed in SW corner of site.

1. Apply material well suited for vegetation growth to obtain positive drainage away from historic waste filled trenches.
 - a. Low permeability soil is recommended, but if the monitoring carried out as per Recommendation 3 shows no adverse groundwater impacts, material can simply be suited to rapid vegetation growth.
2. Clean up litter and debris from areas surrounding the site and dispose of accordingly.

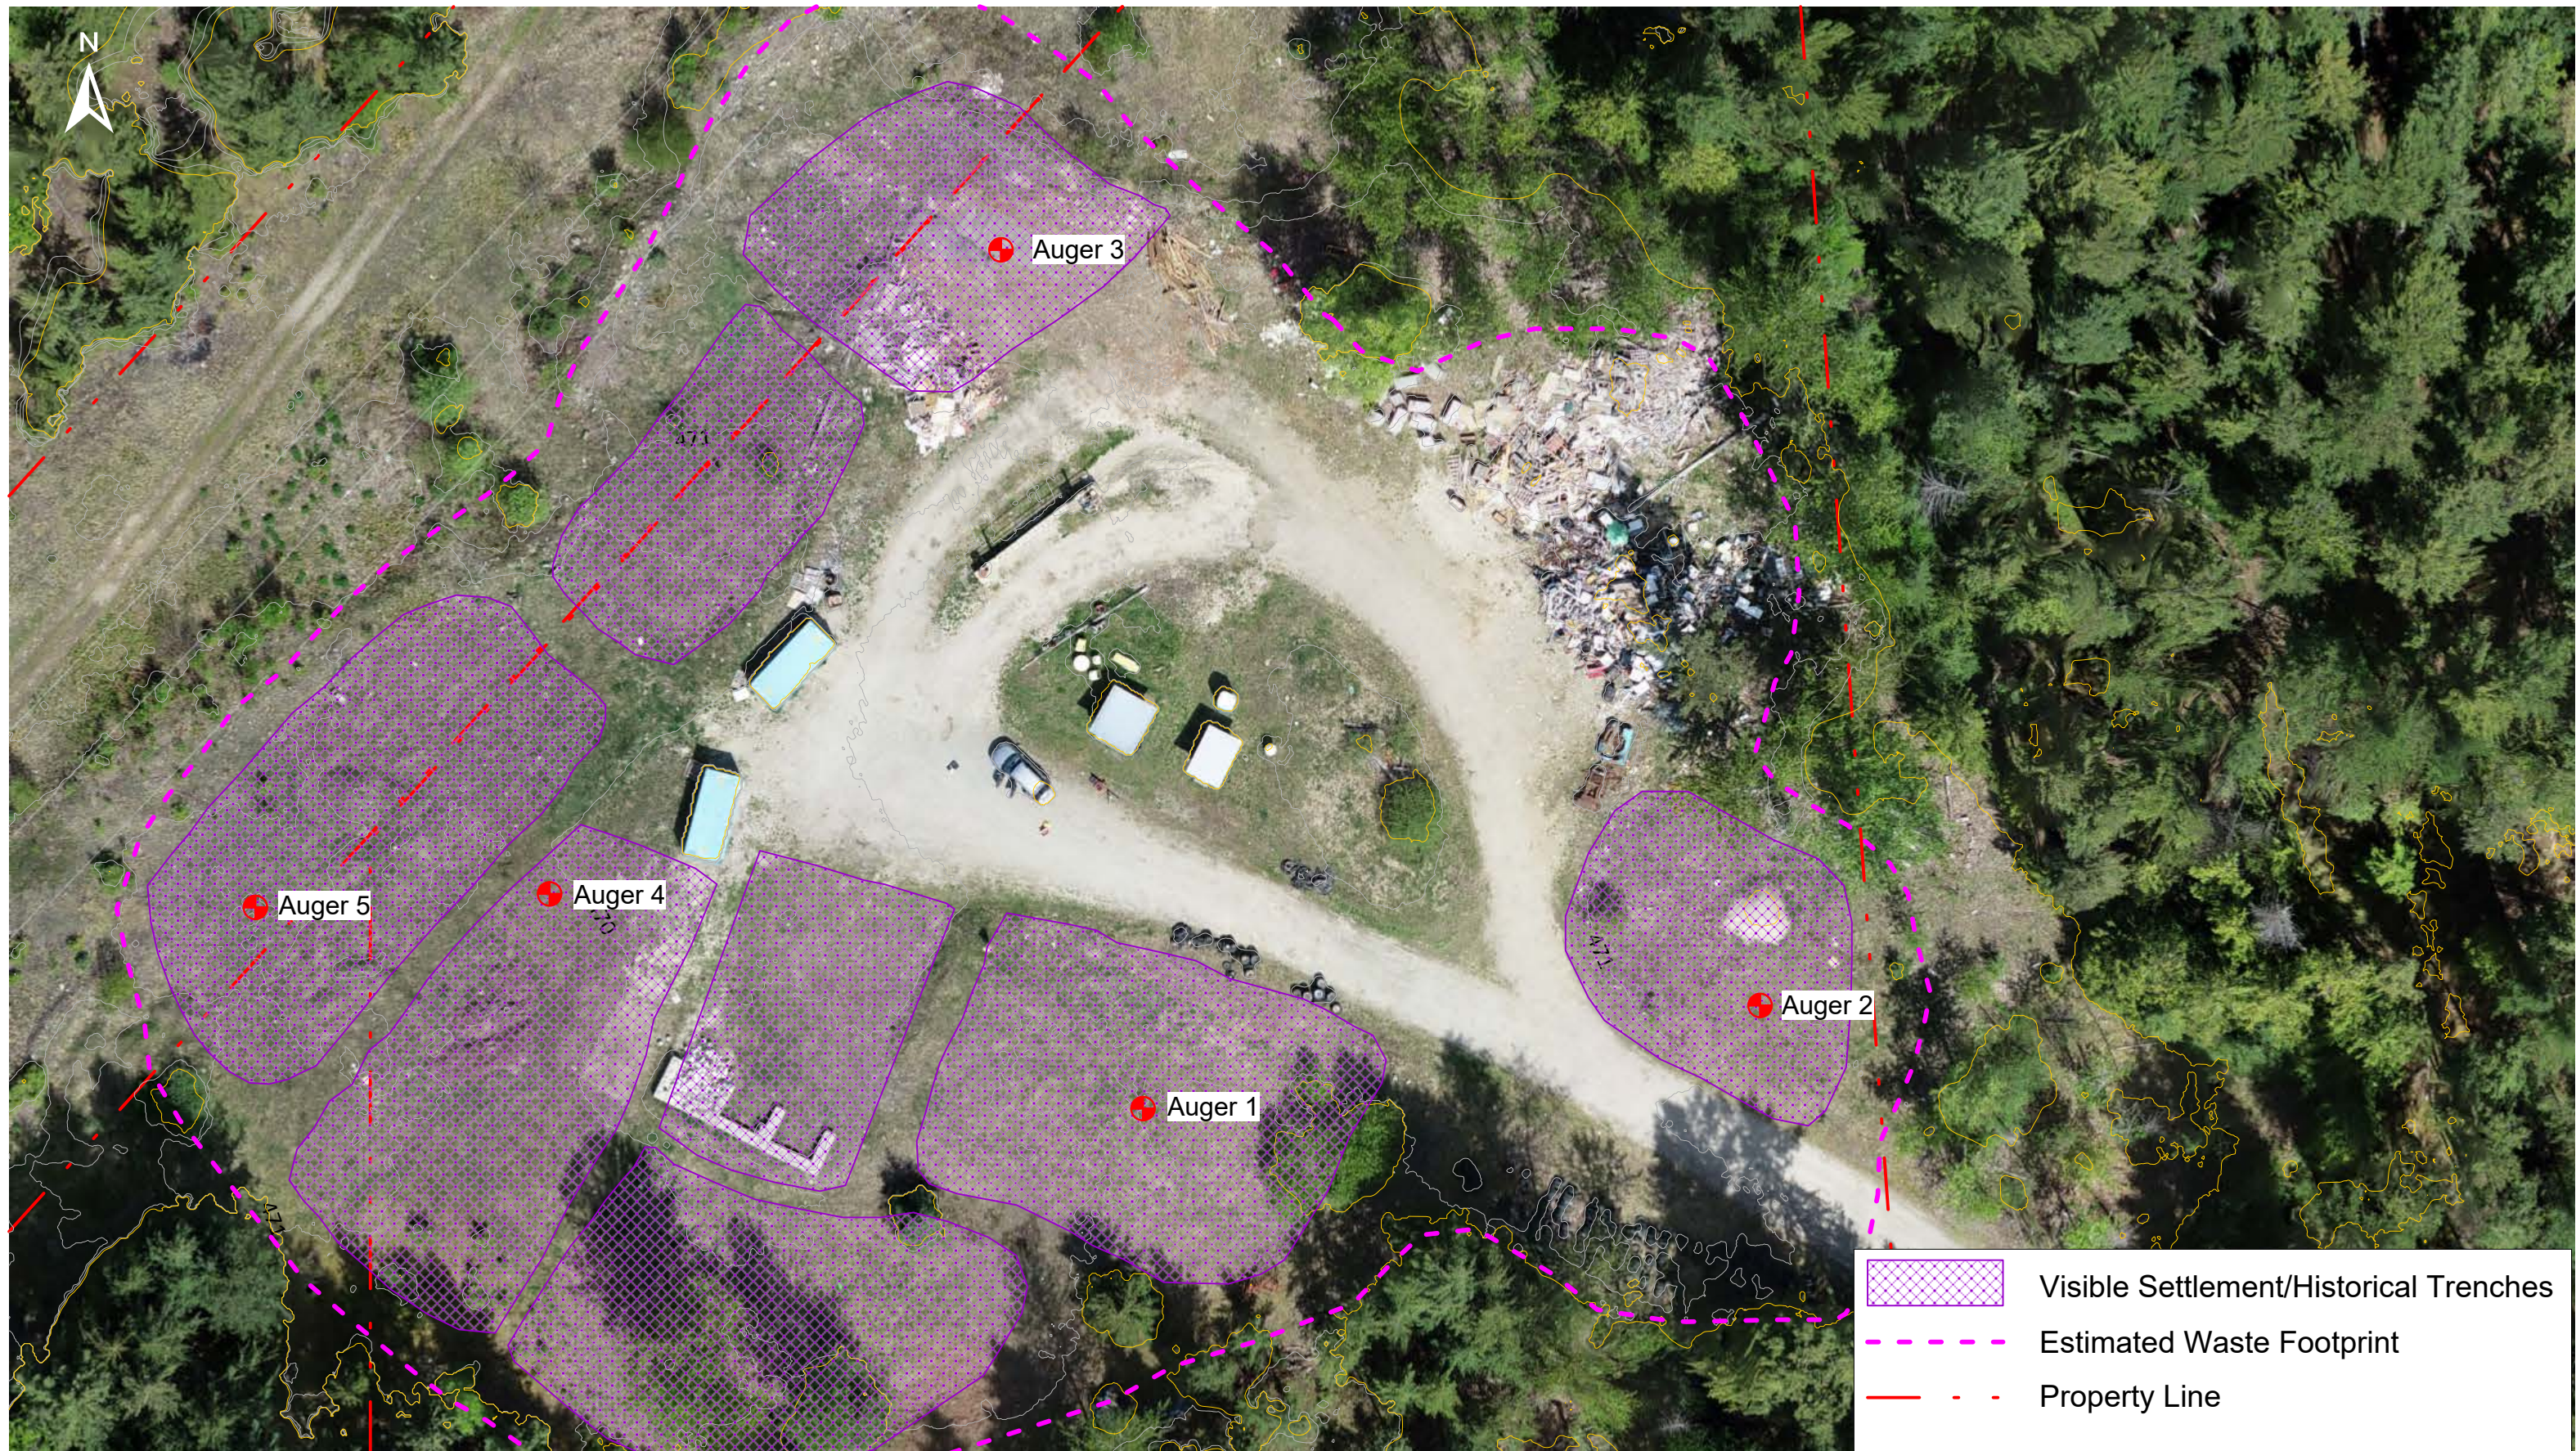
RDCK LEGACY LANDFILL CLOSURE PLANS		
BURTON LANDFILL		
DRAWING NO.	REV	SHEET
PRJ25043-BURTON-2	1	1

Table 1, and locations presented in dwg. PRJ25043-BURTON-2. It was found that the cover consisted of an initial layer of established mosses and grass, with the remaining layers consisting of sandy pit run gravels and some silt, with a minimum thickness of 300mm in all areas. No auger holes were advanced within the operational area, as SHA deemed that this area had aggregates placed to support regular vehicle traffic and general transfer station operations.

However, during SHA's site visit it was clear throughout the areas not used for current operations that waste trenches were previously present. This was seen through depressions on the landfill surface caused by settlement of the waste, which is difficult to capture in photos but presented in dwg. PRJ25043-BURTON-2.

These depressions likely promote infiltration especially during the spring months when snowmelt may accumulate in these areas. Due to the relatively flat nature of the site, SHA believes that it will not be possible to meet the minimum grade requirements of the Landfill Criteria without significant efforts, and SHA also believes that it will be sufficient to add materials to these areas to obtain positive drainage and direct surface water away from the landfill area. The material to

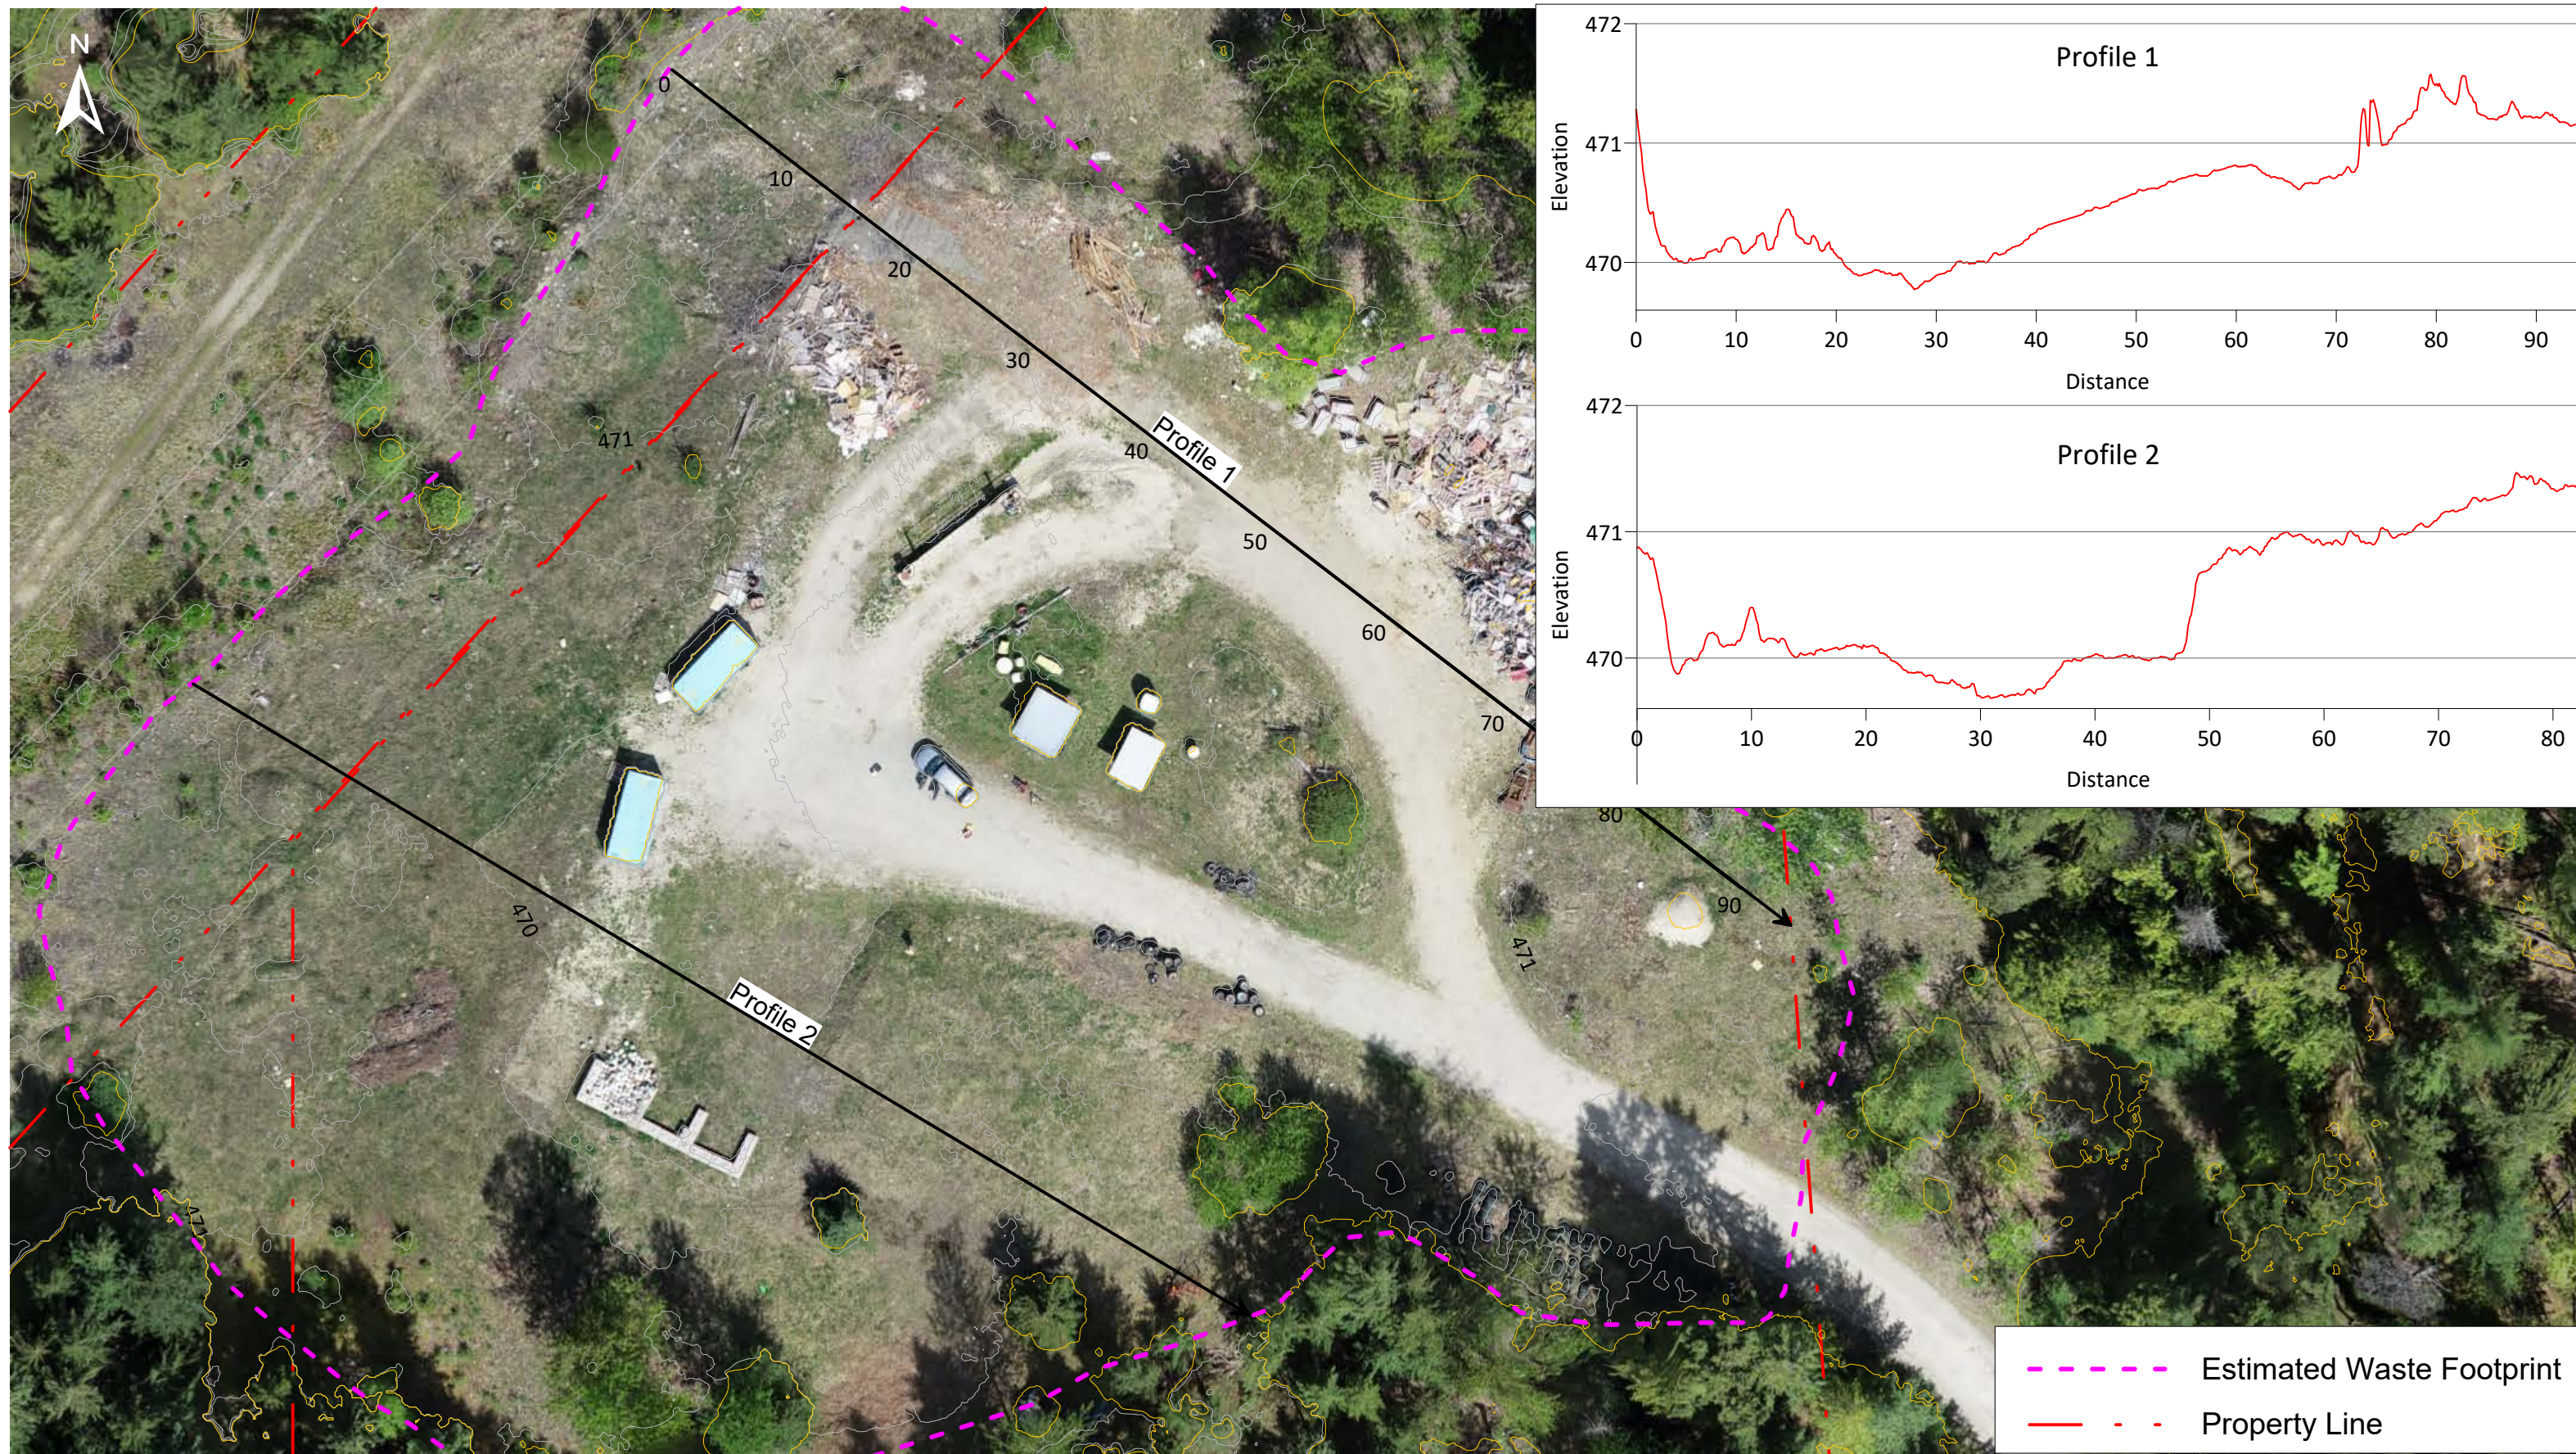
RDCK LEGACY LANDFILL CLOSURE PLANS		
BURTON LANDFILL		
DRAWING NO.	REV	SHEET
PRJ25043-BURTON-3	1	1

The Burton landfill site is very flat as indicated in drawing PRJ25043-BURTON-3, and SHA believes that it will take significant effort to meet the grades within the landfill criteria. As the intent of the grades is to promote runoff of surface water, SHA believes that the recommendations made surrounding additional landfill cover material will be sufficient to meet the runoff requirements of the Criteria.

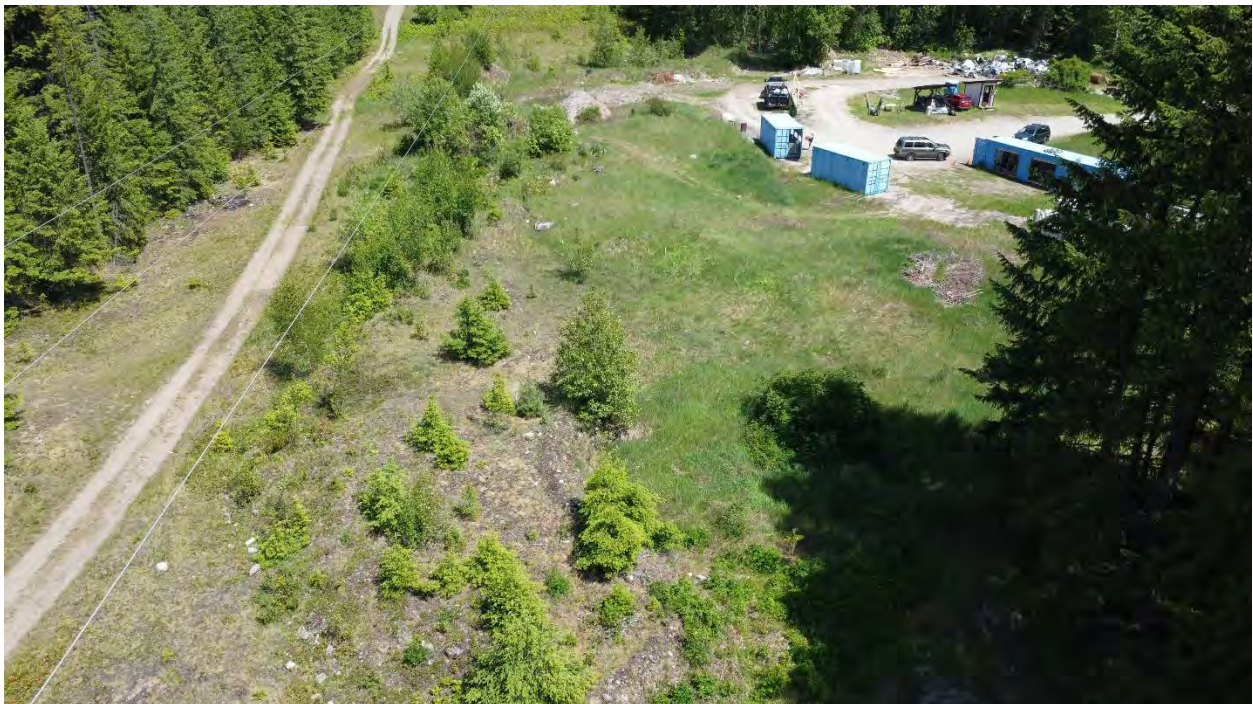
Photo 4: Landfill area with signs of settlement noted while on site.

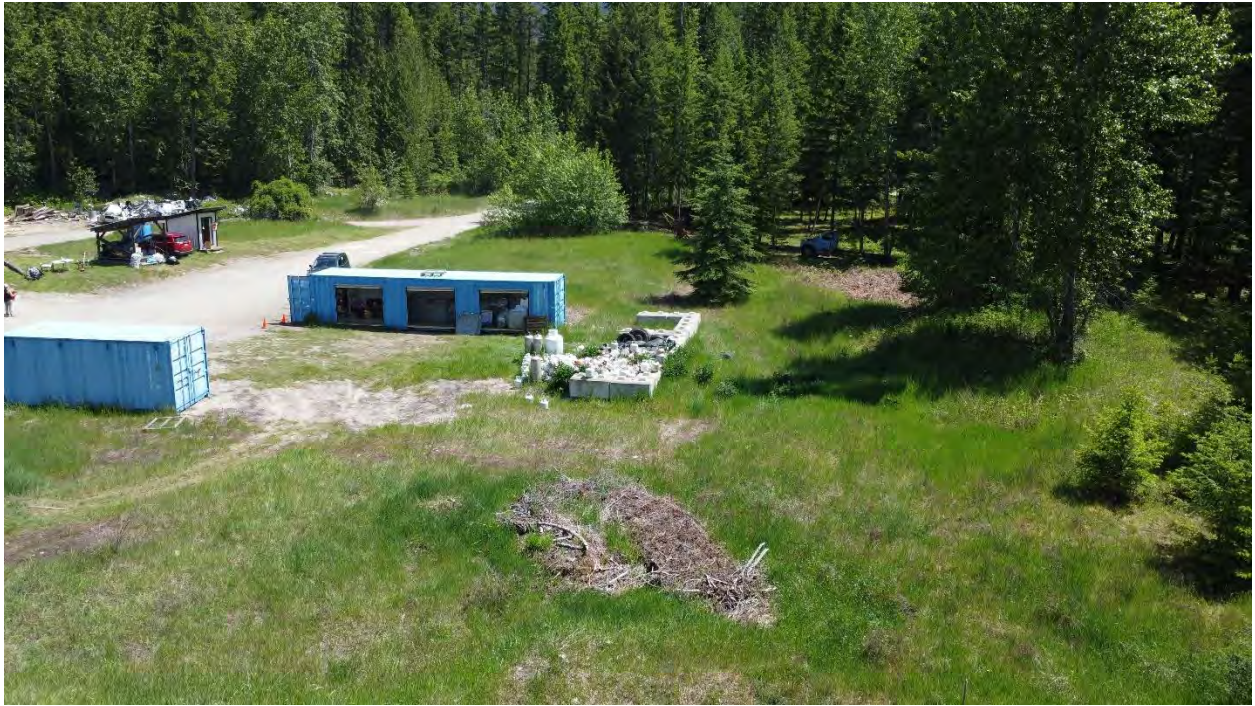
Photo 5: West side of site with debris and pieces of farm equipment visible in treeline.

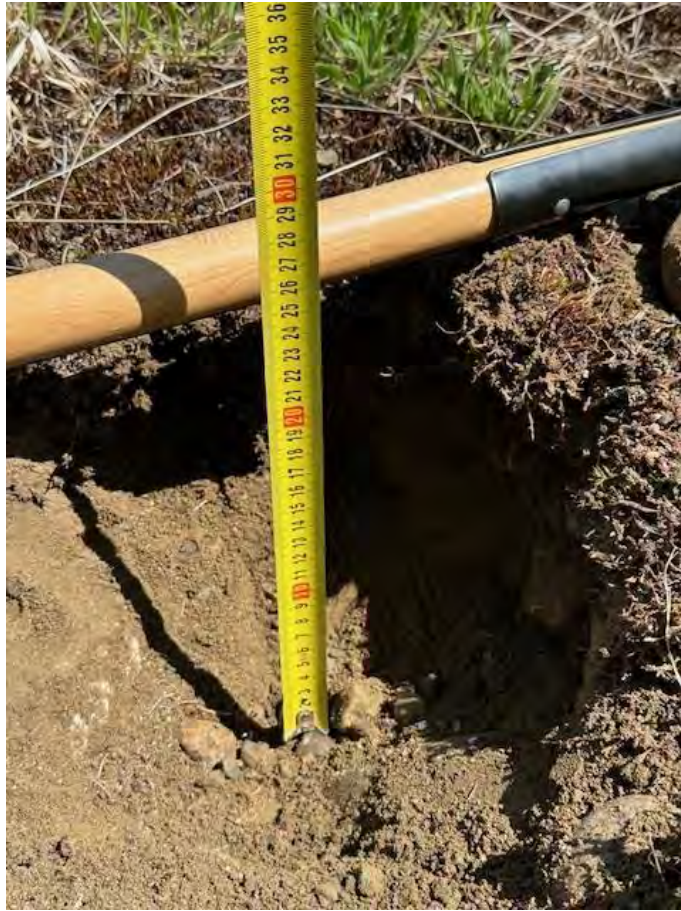
Photo 7: Typical cover found on site.

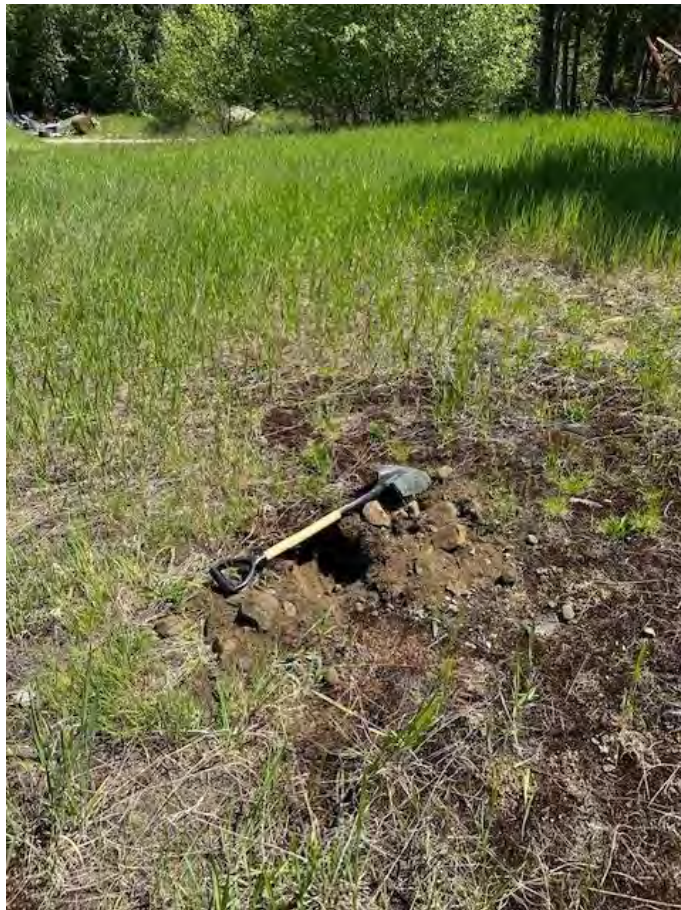
Photo 8: Cover investigation location 1 in Southern portion of site.

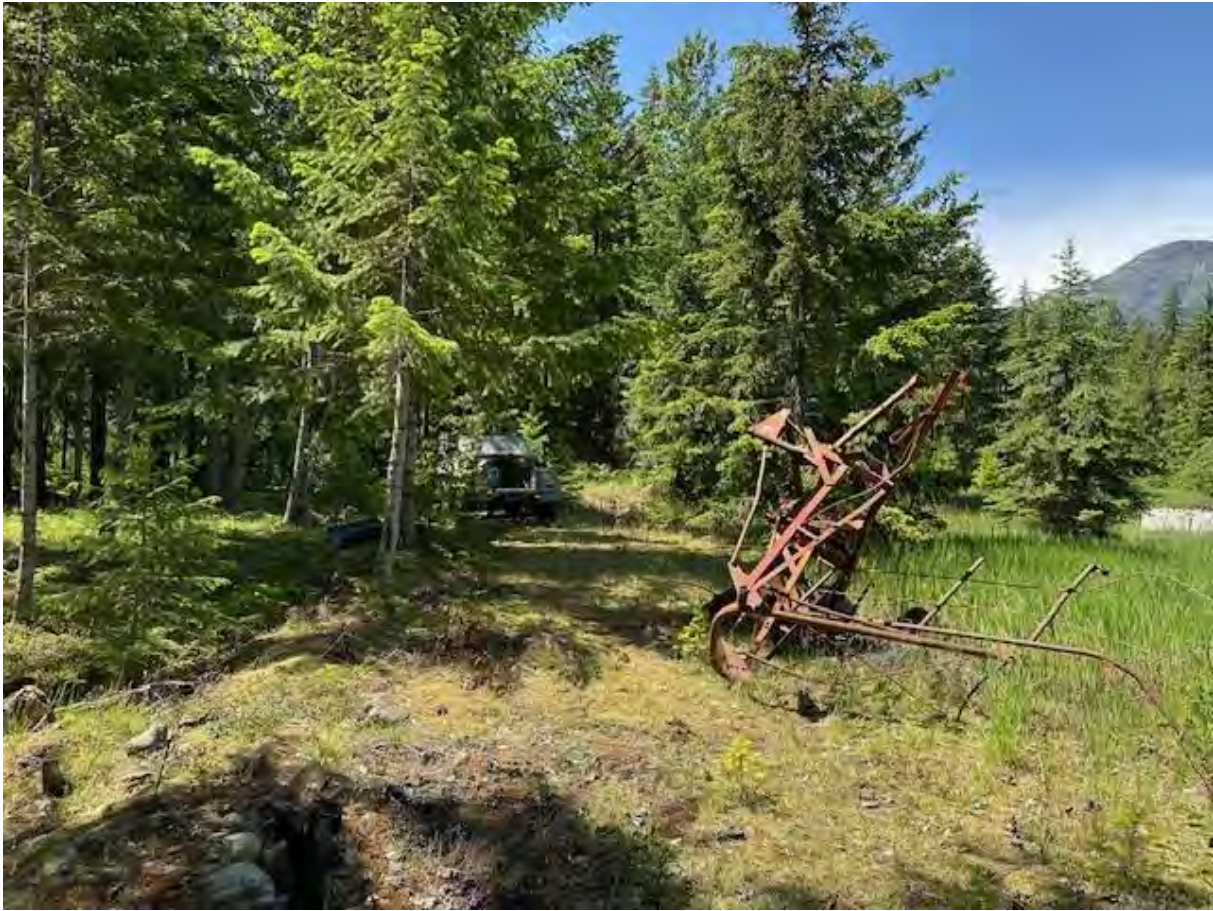
Photo 9: Equipment left on site.

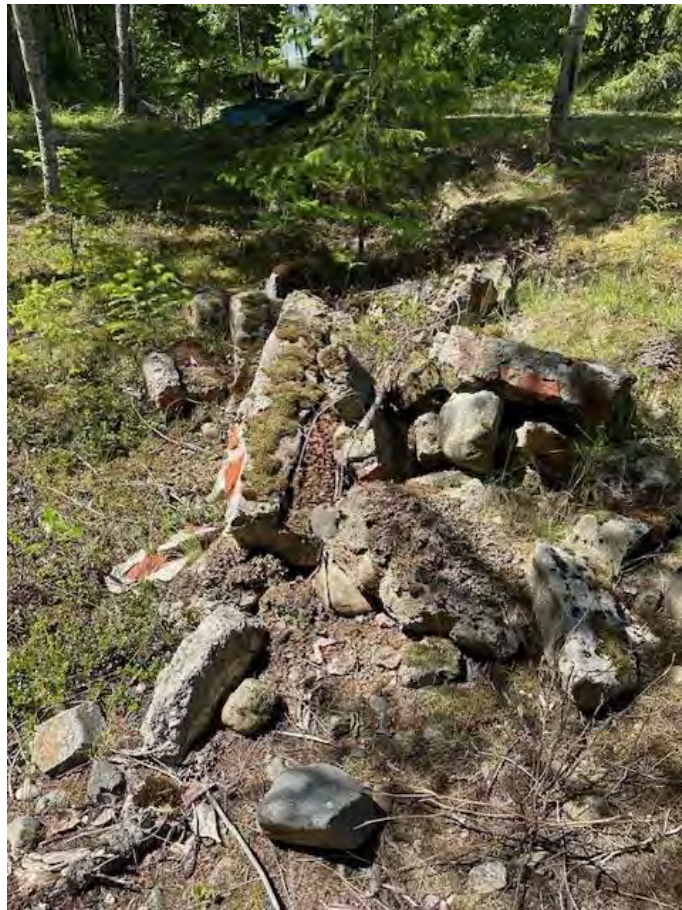
Photo 10: Debris found in Southwestern area of site.

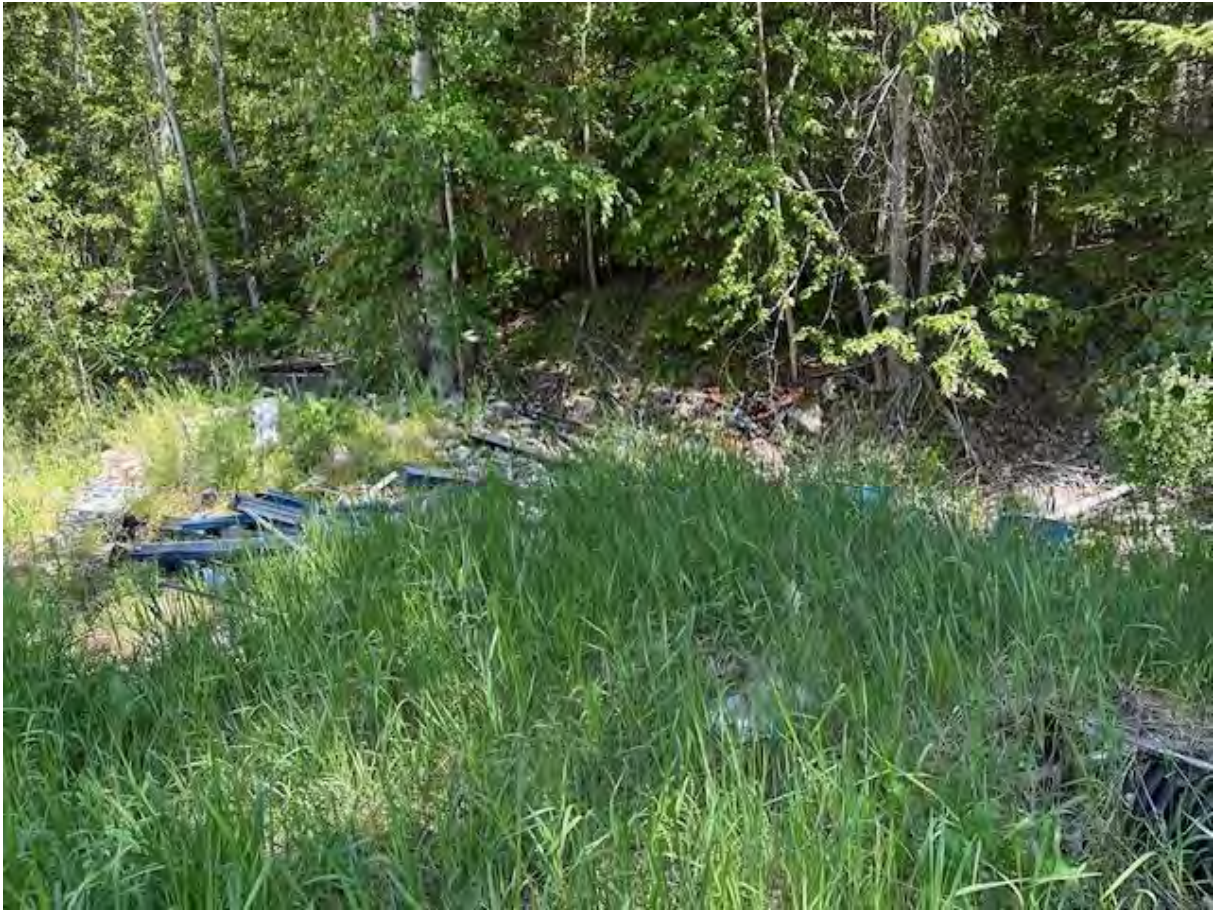
Photo 13: Litter and debris found in Southeast area of site.

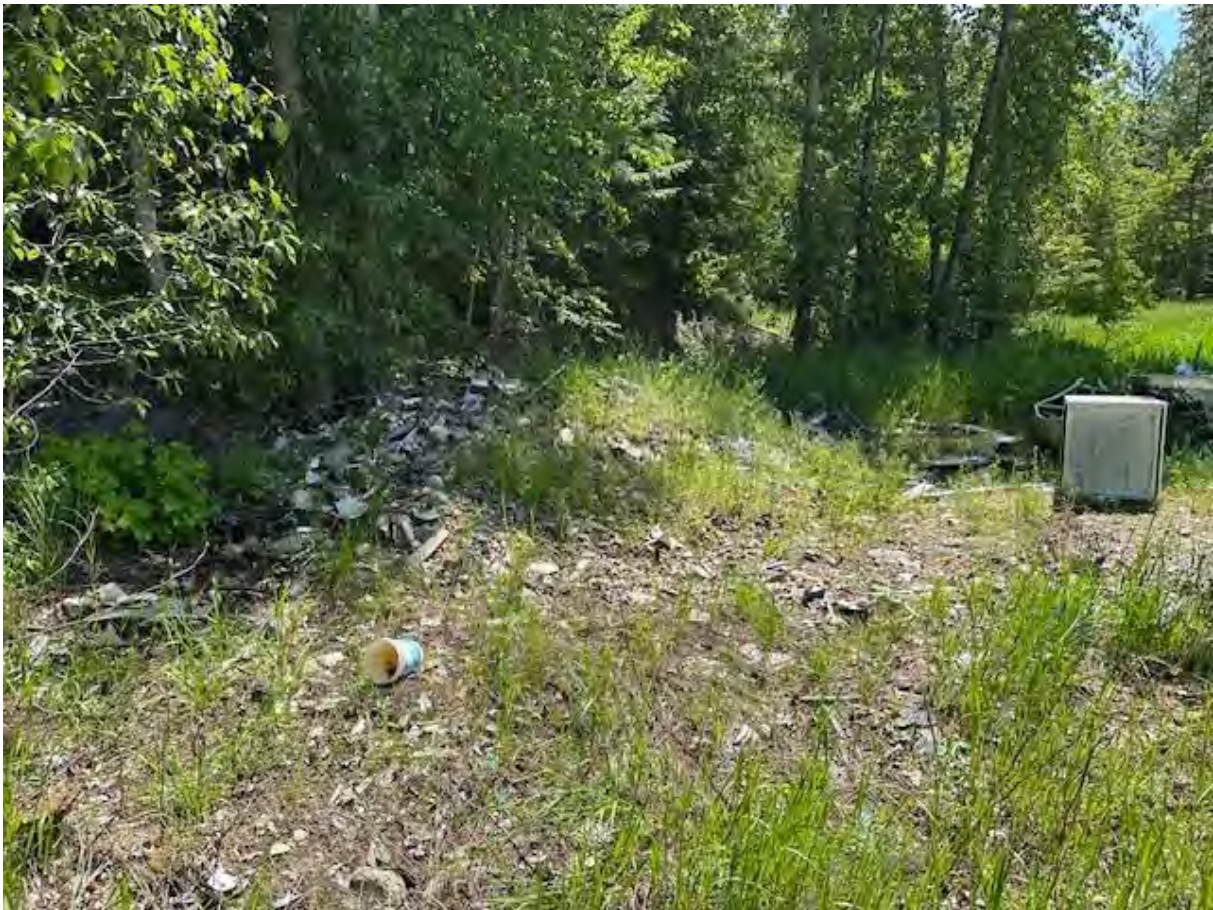
Photo 14: Litter and debris in white goods storage/metal pile area.

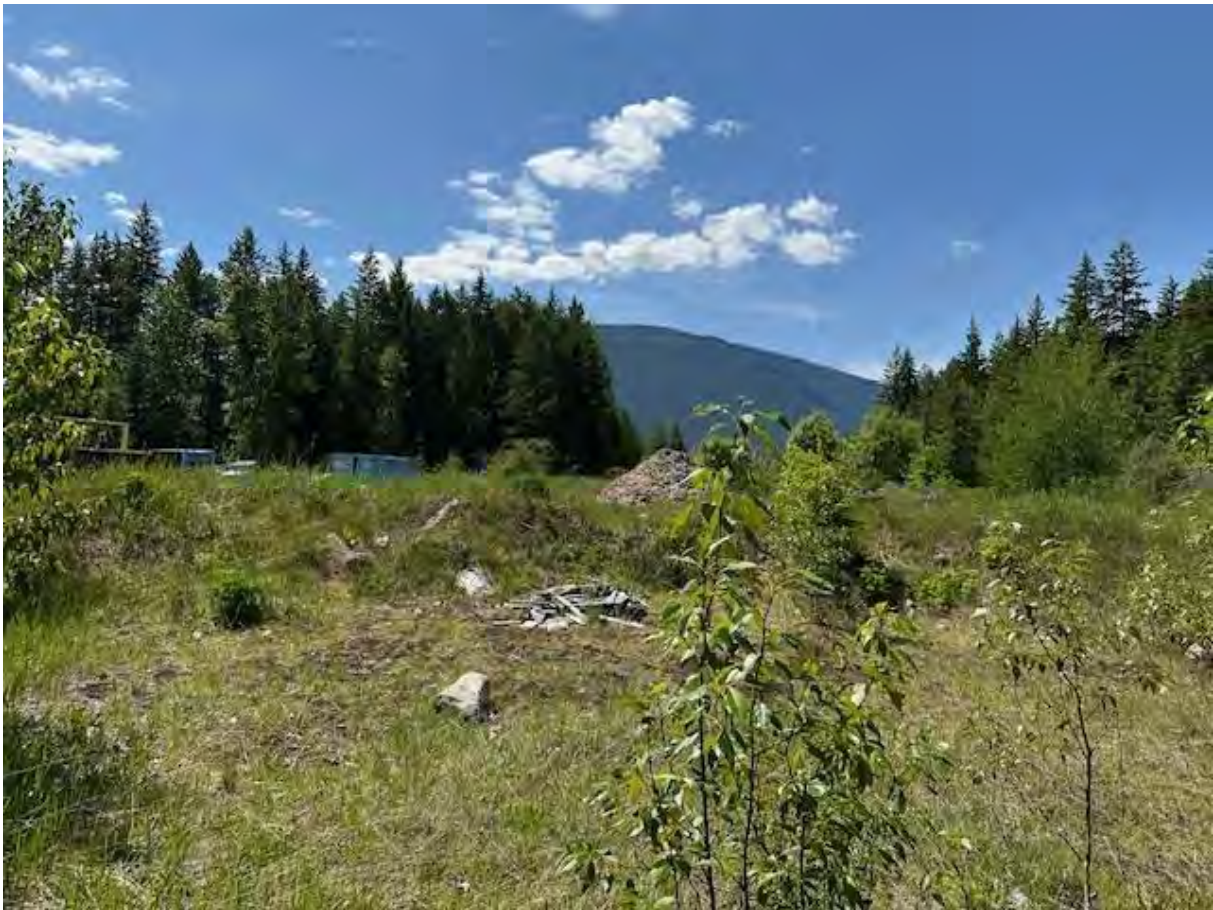
Photo 16: Berm/short slope within power line area, likely part of historical trench and fill.

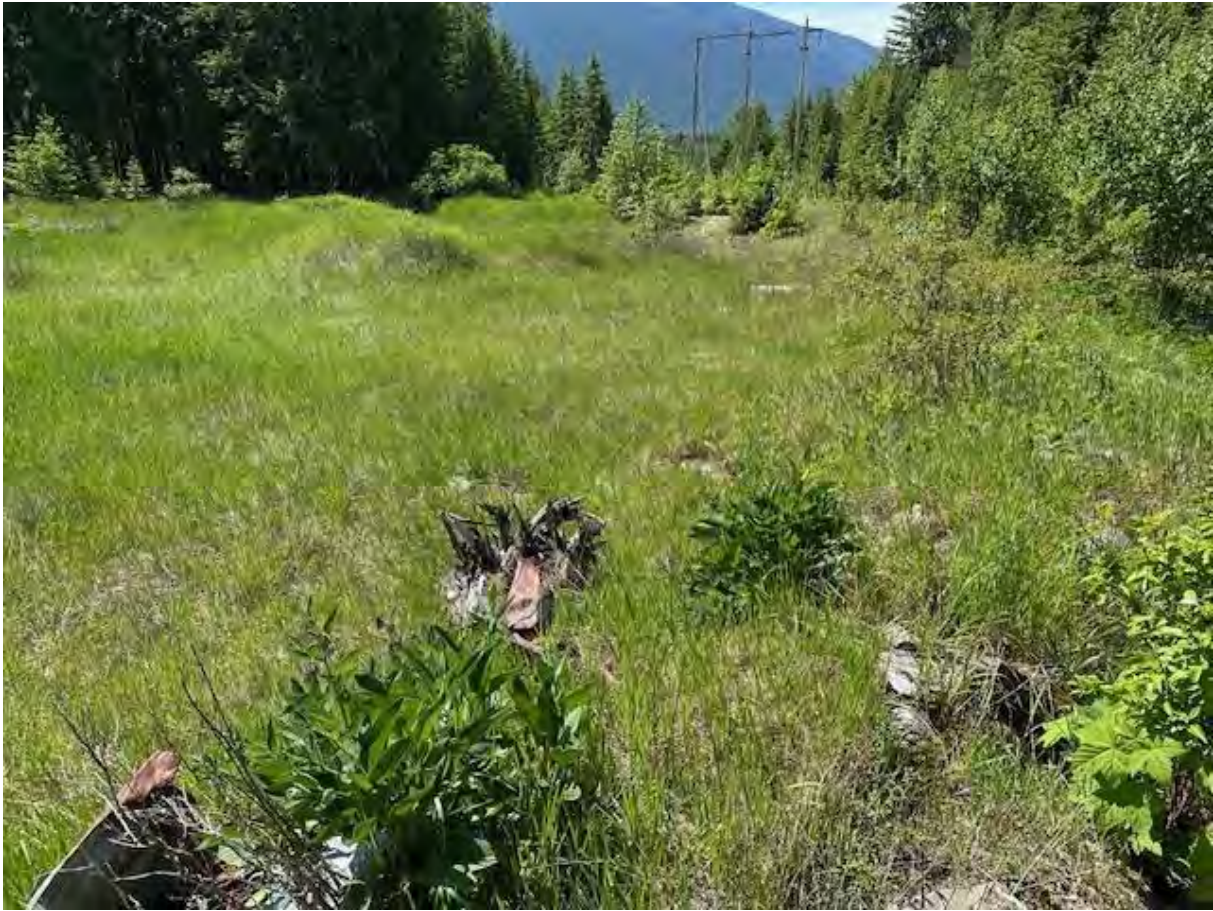
Photo 17. Berm/short slope within power line area, likely part of historical trench and fill.

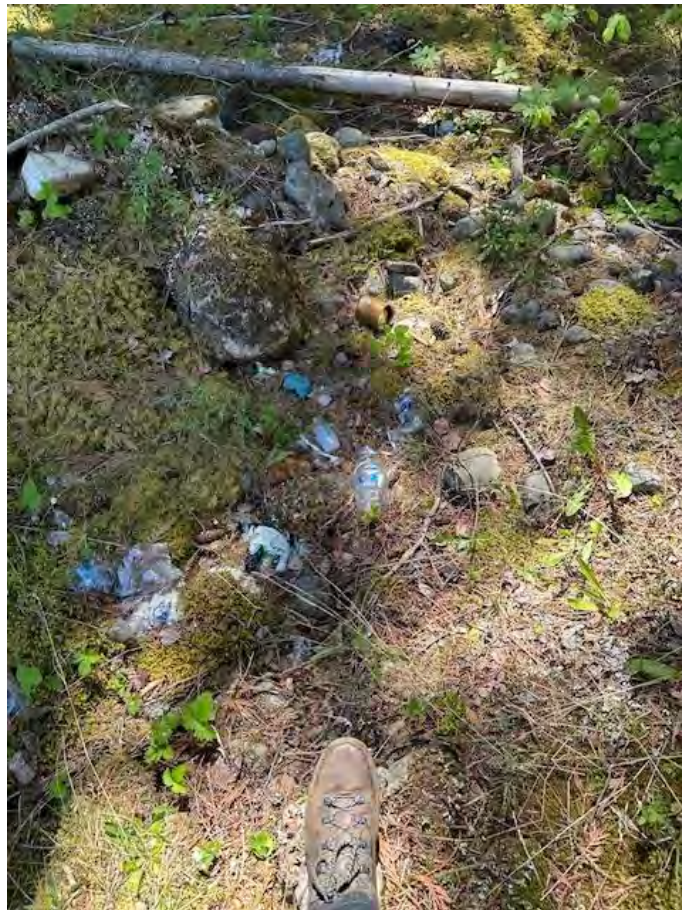
Photo 18: Litter found in Western area of site.
