Edgewood Legacy Landfill Closure Plan

Prepared for:
Regional District of Central Kootenay
ISSUED FOR USE

Prepared by:
Sperling Hansen Associates Inc.
T: 604-986-7723
E: sgarthwaite@sperlinghansen.com

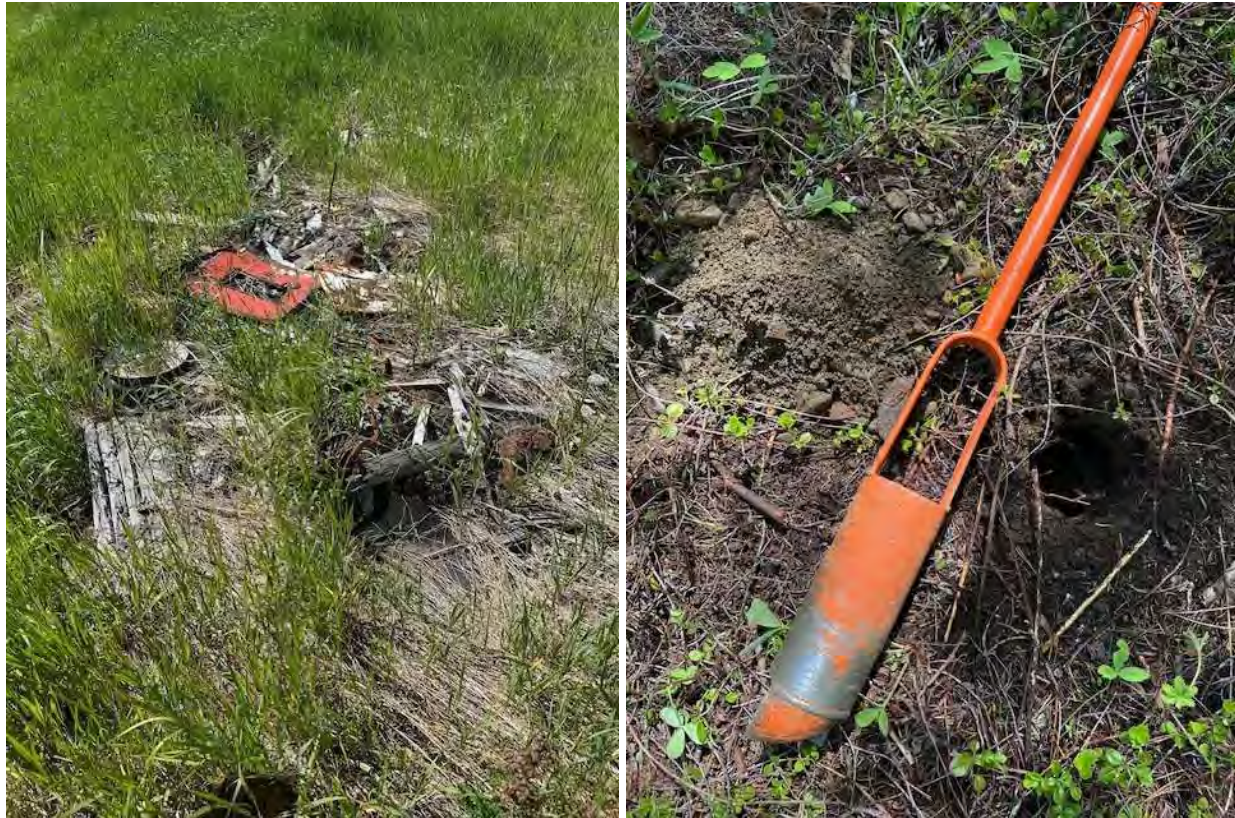
There are no records for the final cover that might have been placed on the landfill site, but SHA's site investigation revealed that there is between 150mm to 300mm of sandy soil and vegetative

layer covering 50% of the landfill surface, with the other 50% being exposed waste or consists of minimal cover (Photos 1 and 2). While on site, SHA used a hand auger to investigate 5 locations (dwg. PRJ25043-EDGEWOOD-2) to gain an understanding of the cover soil, the results of which are presented in Table 1.

Photos 1 and 2: Exposed Waste on Landfill Area and Typical Cover Soil Found on Site

Portions of the historical landfill site that are not currently utilized for the Transfer Station do not have sufficient cover, and in some areas have inert waste exposed. These areas should be covered with 0.5m of material to prevent exposure of humans or wildlife to MSW. As there is no readily available cover material on site, SHA recommends that cover material be sourced from the adjacent gravel pit, or the RDCK could use the excess of woodchips at their other solid waste sites, to cover the area. While this material will not prevent the infiltration of surface water, it is SHA's professional opinion that the waste placed at the site is sufficiently old enough that leachate generation is not a concern at this time.

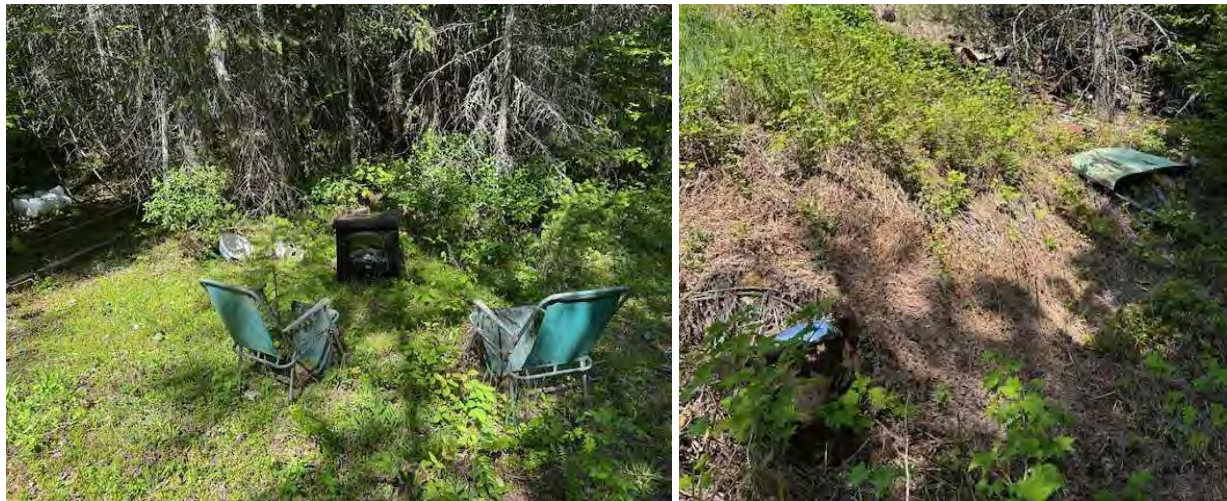
While on site, SHA observed that there is litter scattered throughout the site boundary. While the site currently consists of a transfer station and this may contribute to the litter, these areas should be cleaned up and litter removed. Some exposed waste will be covered through the application of cover material, but larger pieces of waste such as the 'camping setup' and parts of auto hulks shown in the photos below will need to be removed.

Photos 3 and 4: Litter and Pieces of Exposed Waste Observed by SHA While on Site

1. Clean up litter on site and in surrounding areas and dispose of accordingly.
 - a. This includes clean up of the rubber tires, metal scatter and debris in the Northwest area of the site.

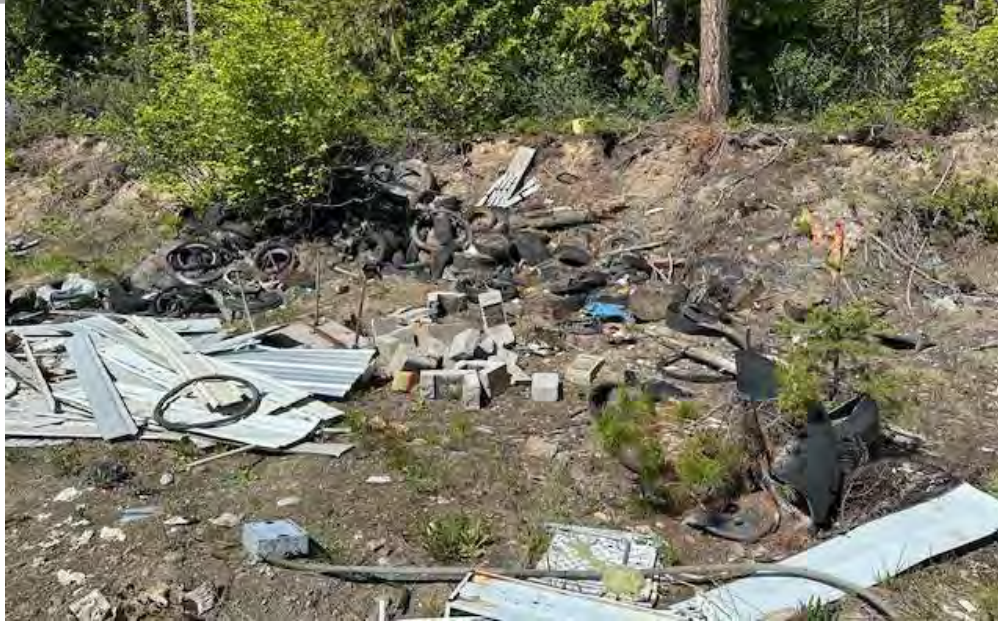
In addition to the litter and larger pieces of waste present surrounding the landfill, the metal and tire piles at the transfer station do not seem to be well consolidated, leading to the potential for confusion or mixing with the historical waste at the site. The tires semi-buried in the slope adjacent to the transfer station should be removed (Photo 5), and the metal and wood piles should be delineated in a fashion that waste is not pushed over the edge and is stored in a tidy fashion. SHA believes that this can be achieved with a simple lock-block wall or lock-blocks placed along the edge of the slope.

Photo 5: Tires and Metal Waste Scattered in Northwest Area of Site

2. Implement measures such as lock-block delineation of edge of slope to prevent metal waste from being pushed over edge and potentially impacting the closure system.
3. Place a minimum of 500mm of cover material over the landfill slope to prevent human or wildlife exposure to waste.
 - a. Material does not need to be low permeability material, as there are no concerns about leachate at the site.
4. The area with steep slopes should have a minimum of 500mm of cover material placed over top, with material well-suited for vegetation growth to prevent erosion and improve slope stability.
 - a. This area should be seeded following cover placement

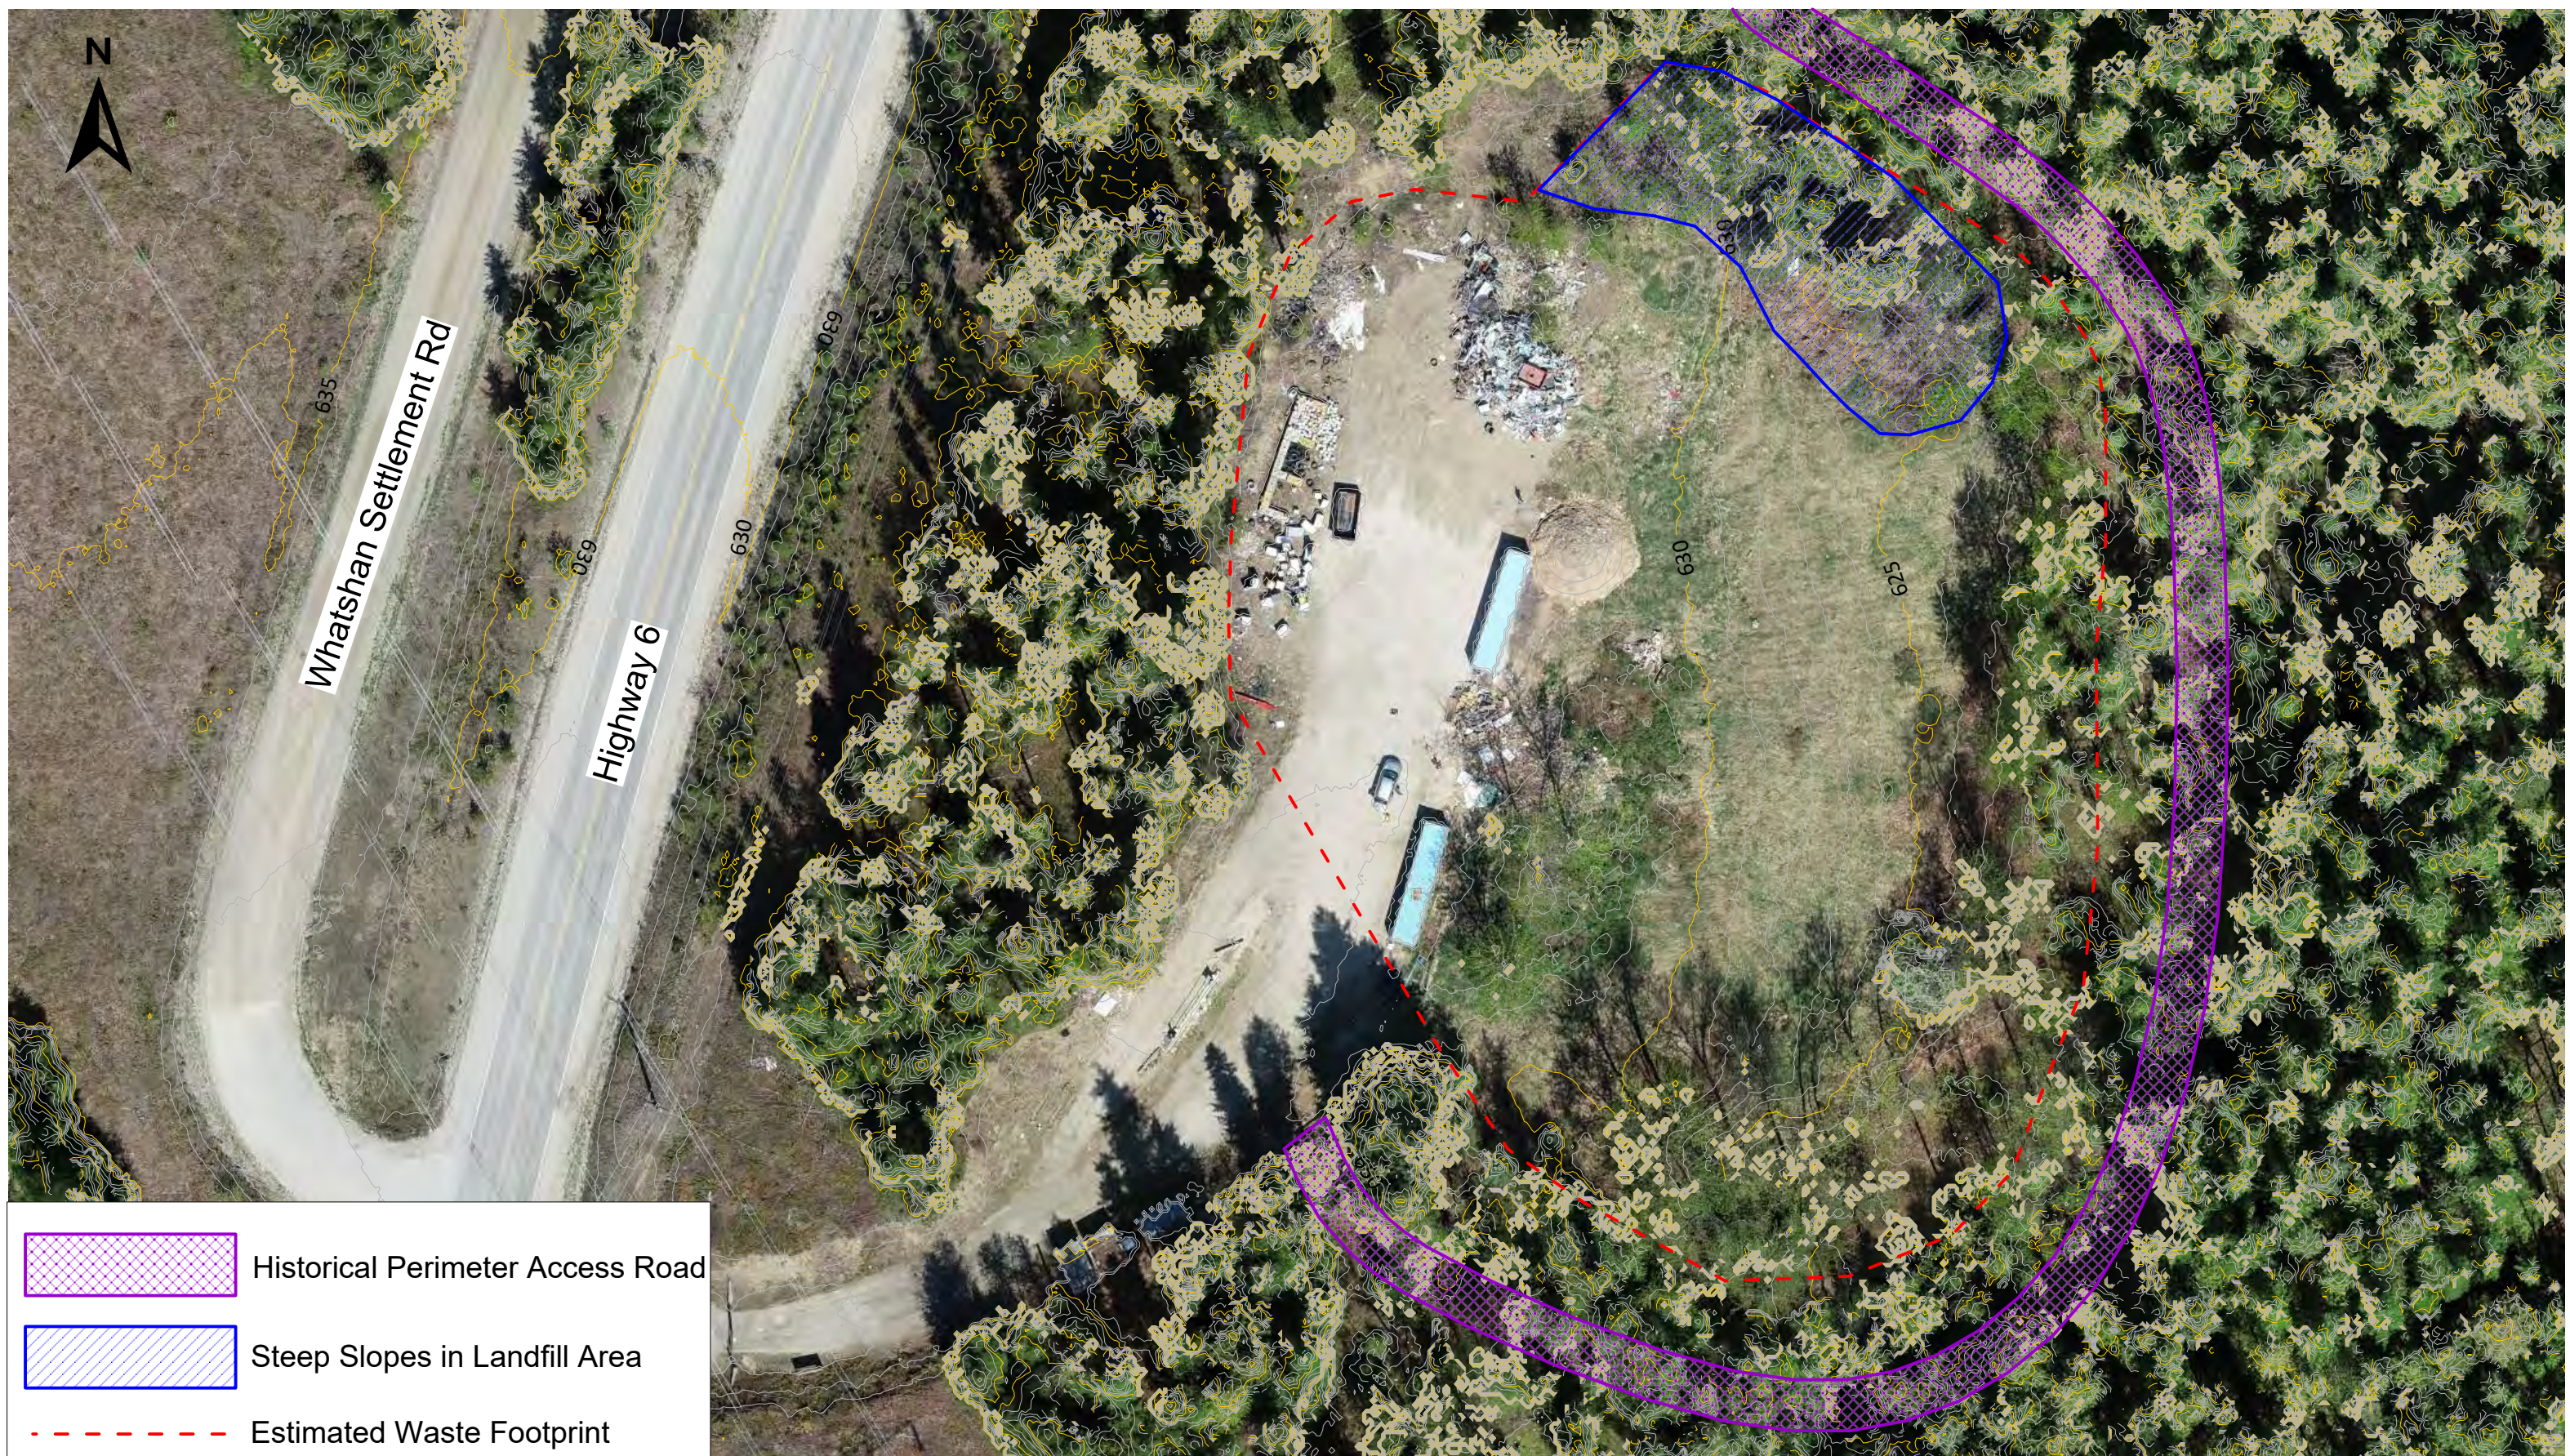
RDCK LEGACY LANDFILL CLOSURE PLANS		
EDGEWOOD LANDFILL		
DRAWING NO.	REV	SHEET
PRJ25043-EDGEWOOD-1	1	1

Based on SHA's assessment of the Edgewood Landfill and as discussed in Section 3, the existing contours meet the requirements for closure, except for the northern area as indicated on dwg. PRJ25043-EDGEWOOD-1. This steep slope area should be covered with material well suited for quick vegetation growth so that vegetative cover can be quickly established and prevent erosion.

Steep Slopes in Landfill Area

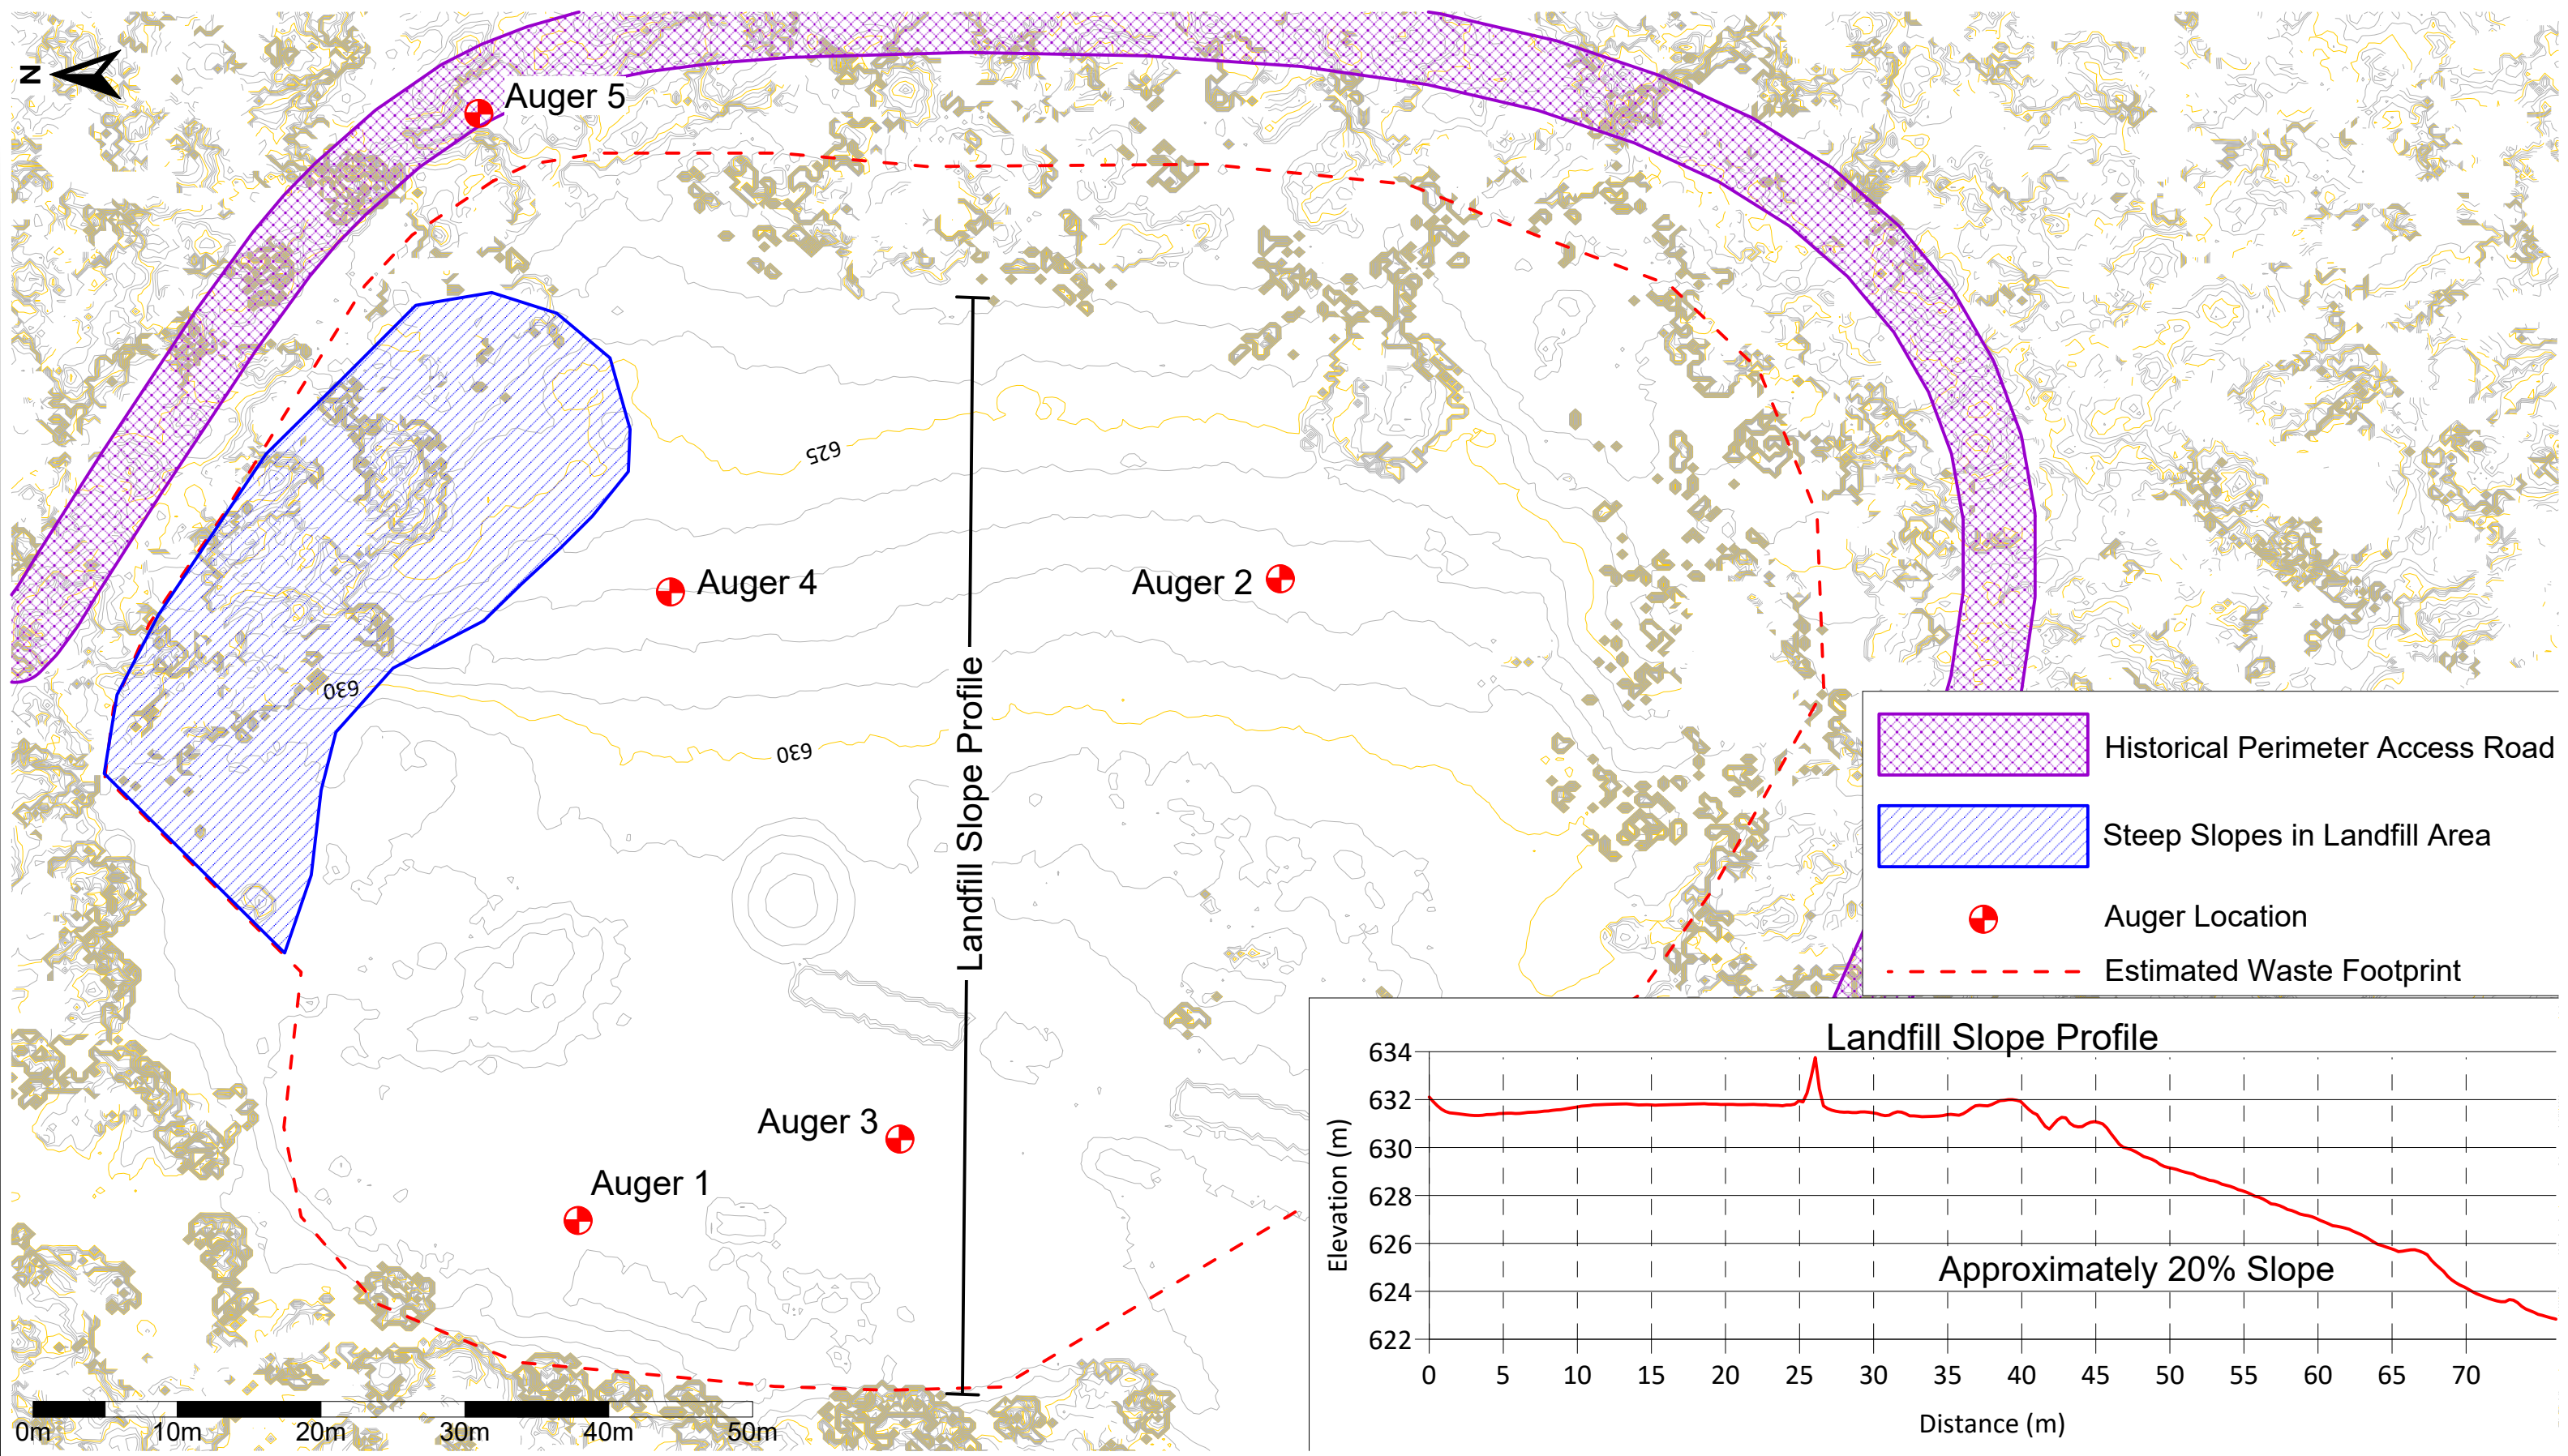
RDCK LEGACY LANDFILL CLOSURE PLANS		
EDGEWOOD LANDFILL		
DRAWING NO.	REV	SHEET
PRJ25043-EDGEWOOD-2	1	1

#	Location	Depth	Results
1	Transfer Station Area	0.35m	0 to 0.1m – Wood waste 0.1 to 0.35 m – Native sand
2	Closed Landfill Slope	0.4m	0 to 0.1m – Vegetative cover 0.1 to 0.3m – Sandy soil 0.3m – Waste encountered
3	Transfer Station Area	0.15m	0 to 0.15m – Gravel
4	Closed Landfill Surface	0.3m	0 to 0.1m – Vegetative Cover 0.1 to 0.25m – Sandy soil 0.3m – Waste encountered
5	Old Site Access Road		Native soils/sand

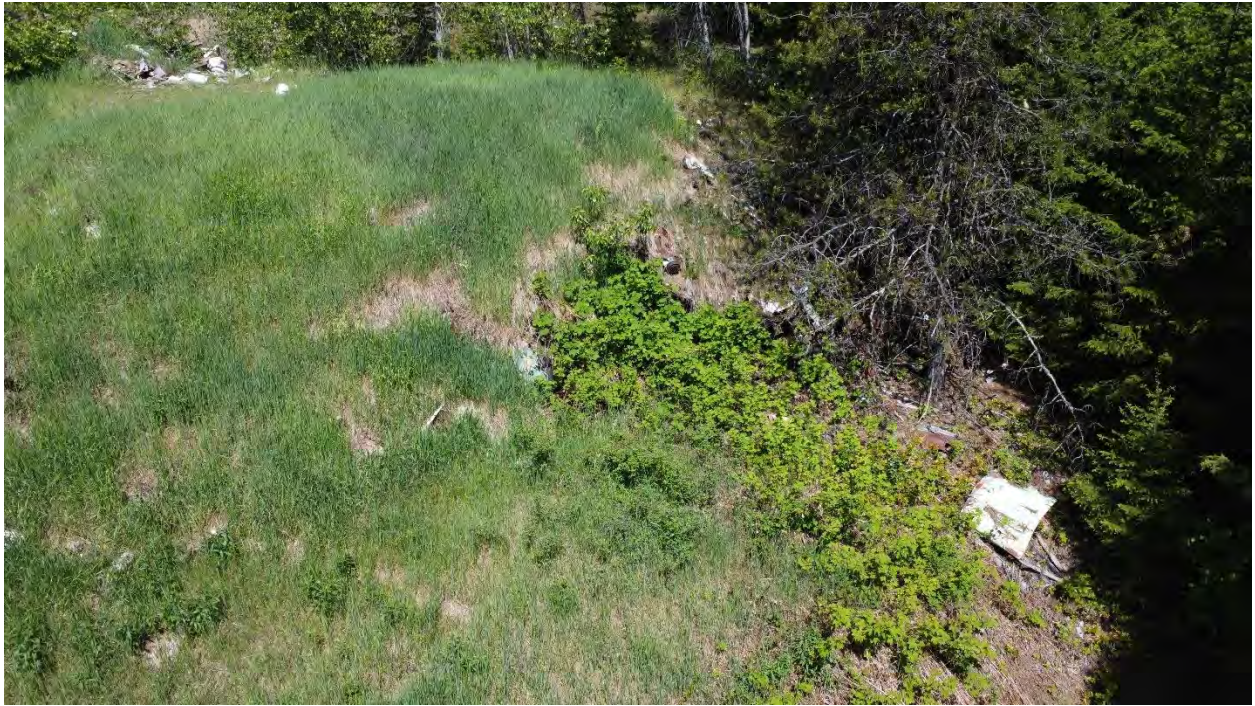
Photo 5: North edge of landfill slope area. Note exposed waste in treeline.

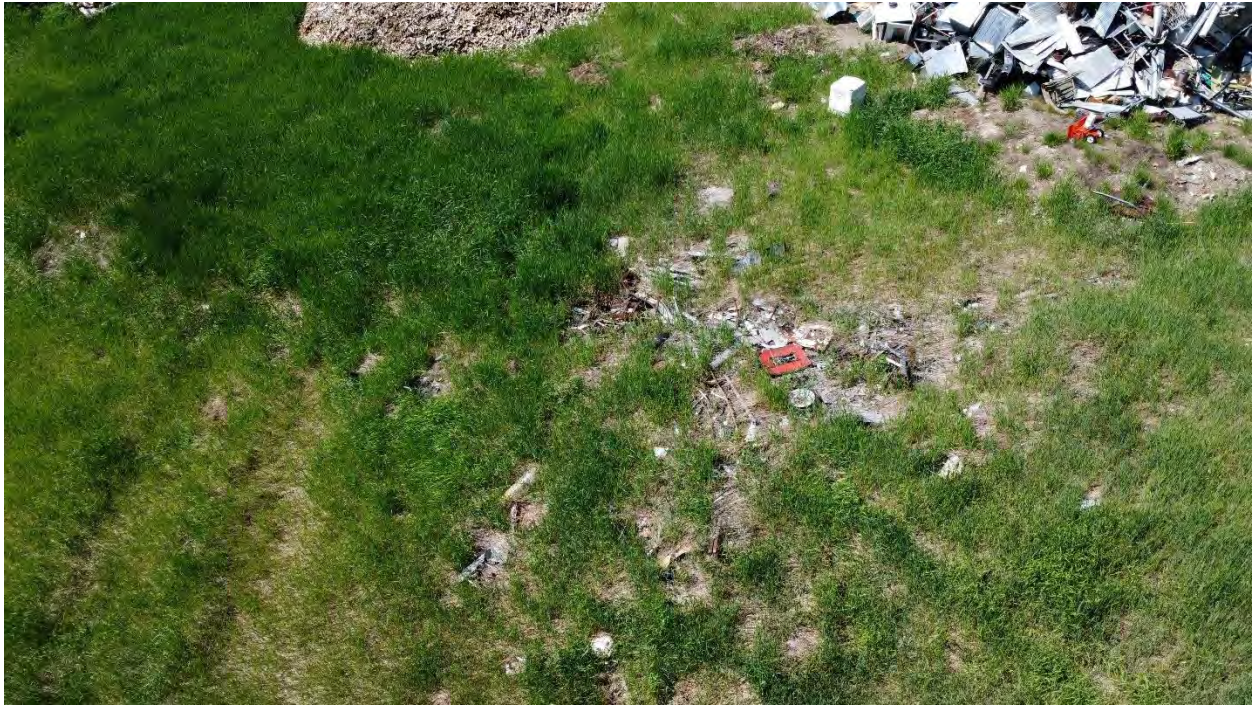
Photo 7: Exposed waste on landfill slope area.

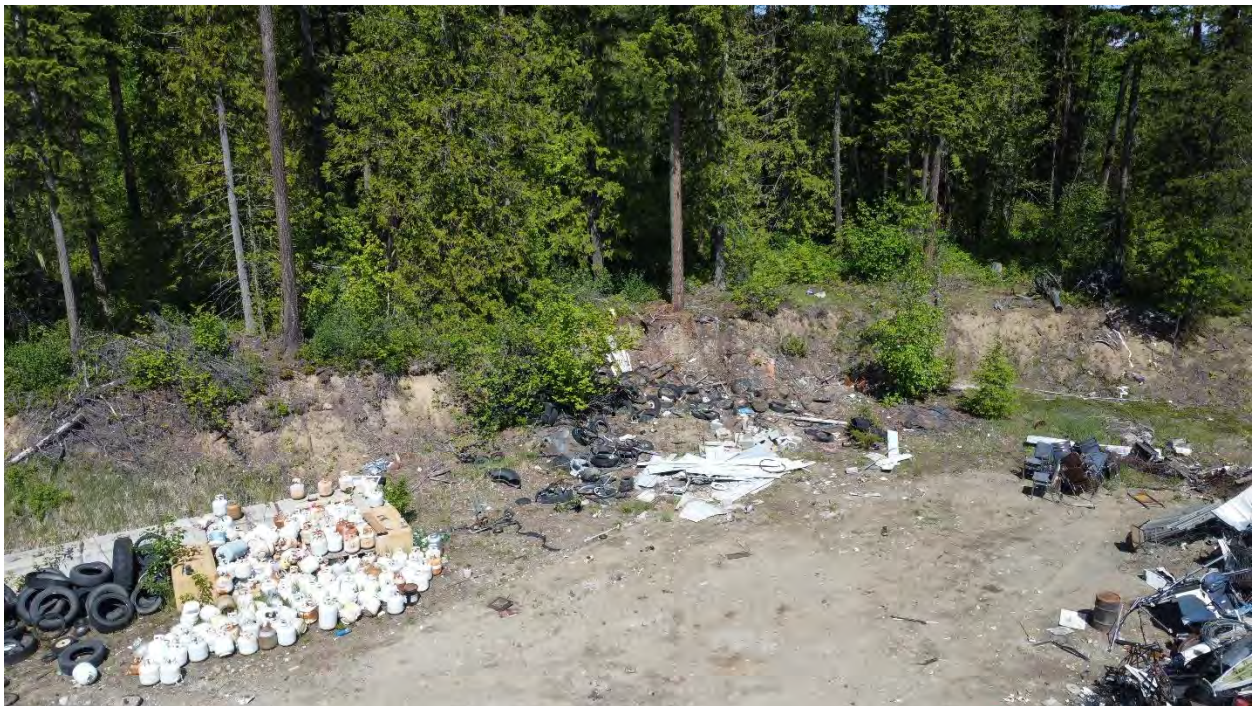
Photo 8: Metal waste and tires embedded in upslope area.

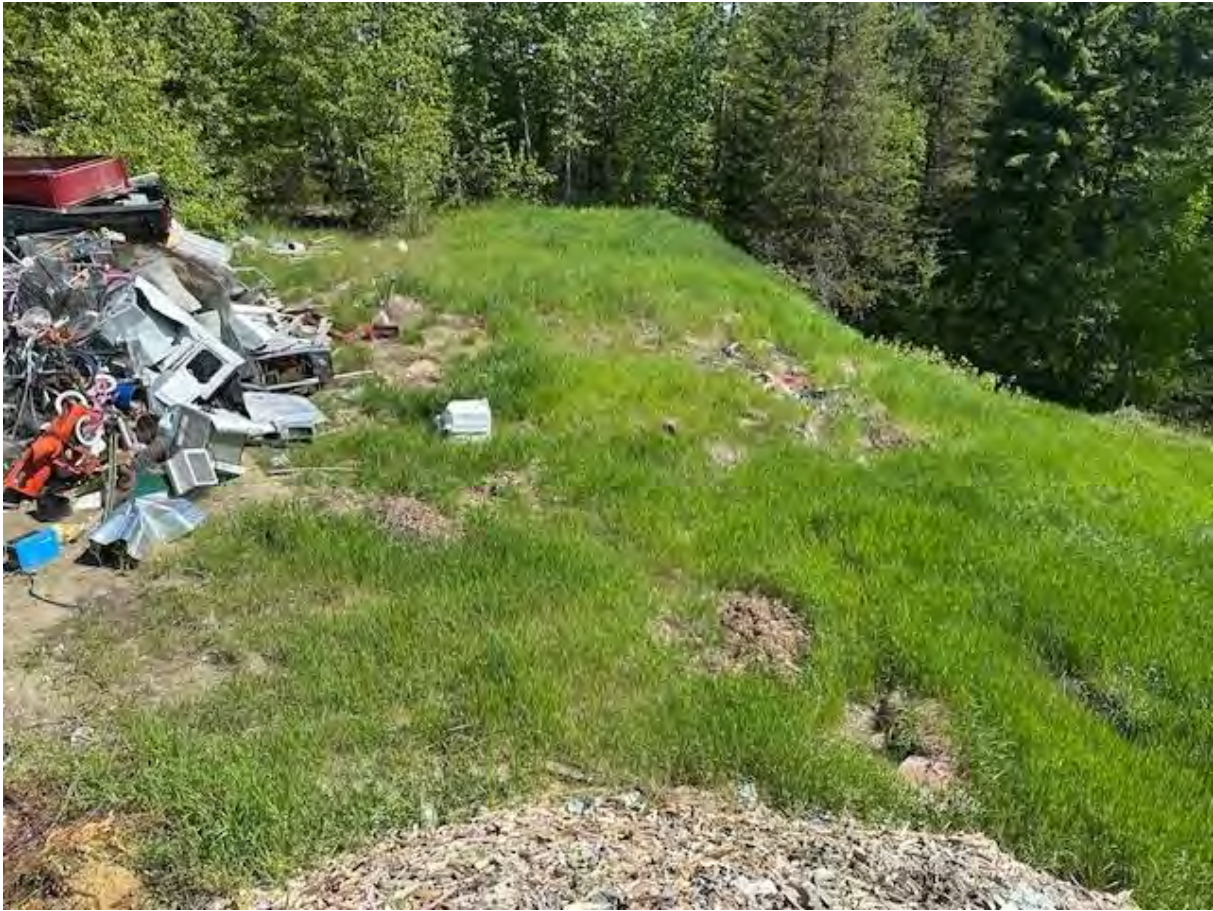
Photo 15: Metal pile placed just upslope of exposed waste on landfill surface.

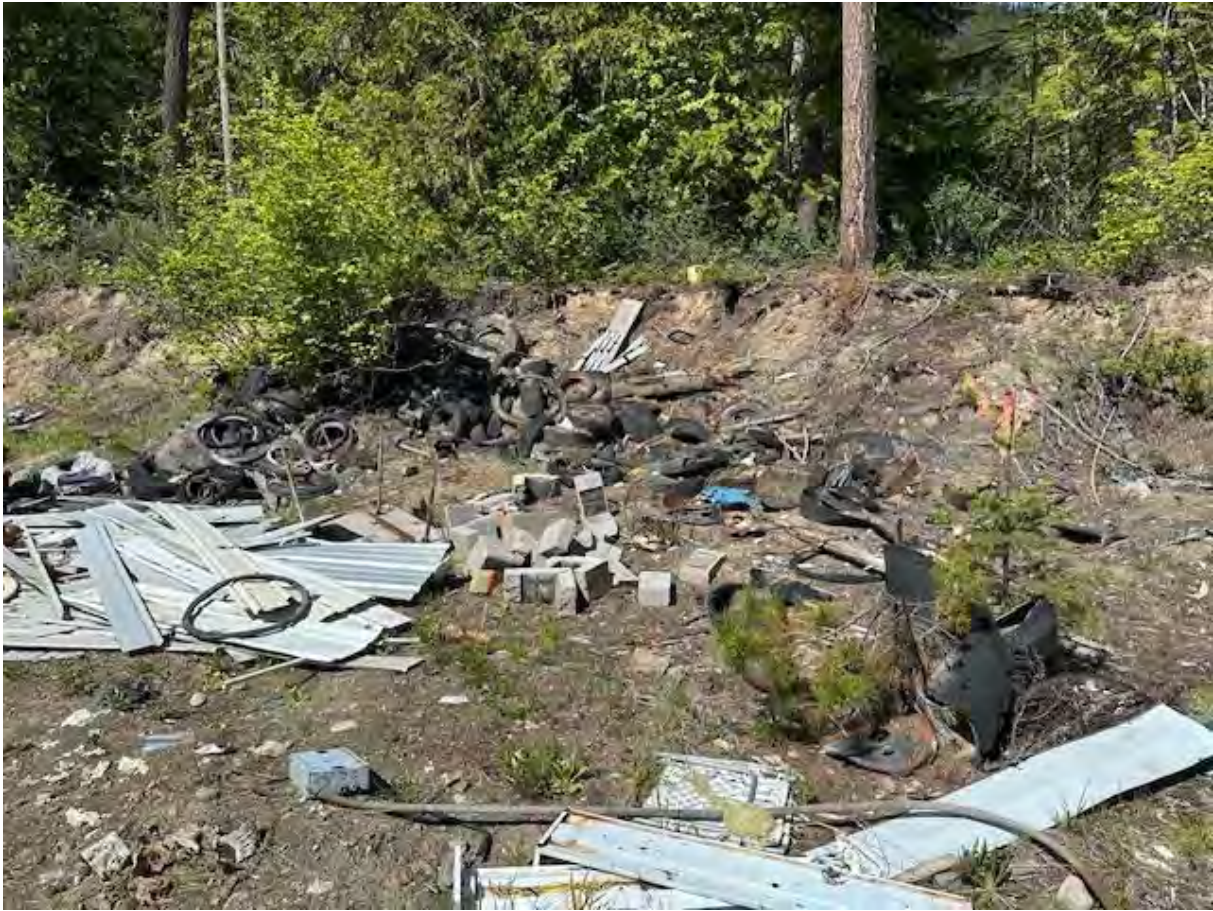
Photo 17: Metal and tires embedded on upslope side of site.

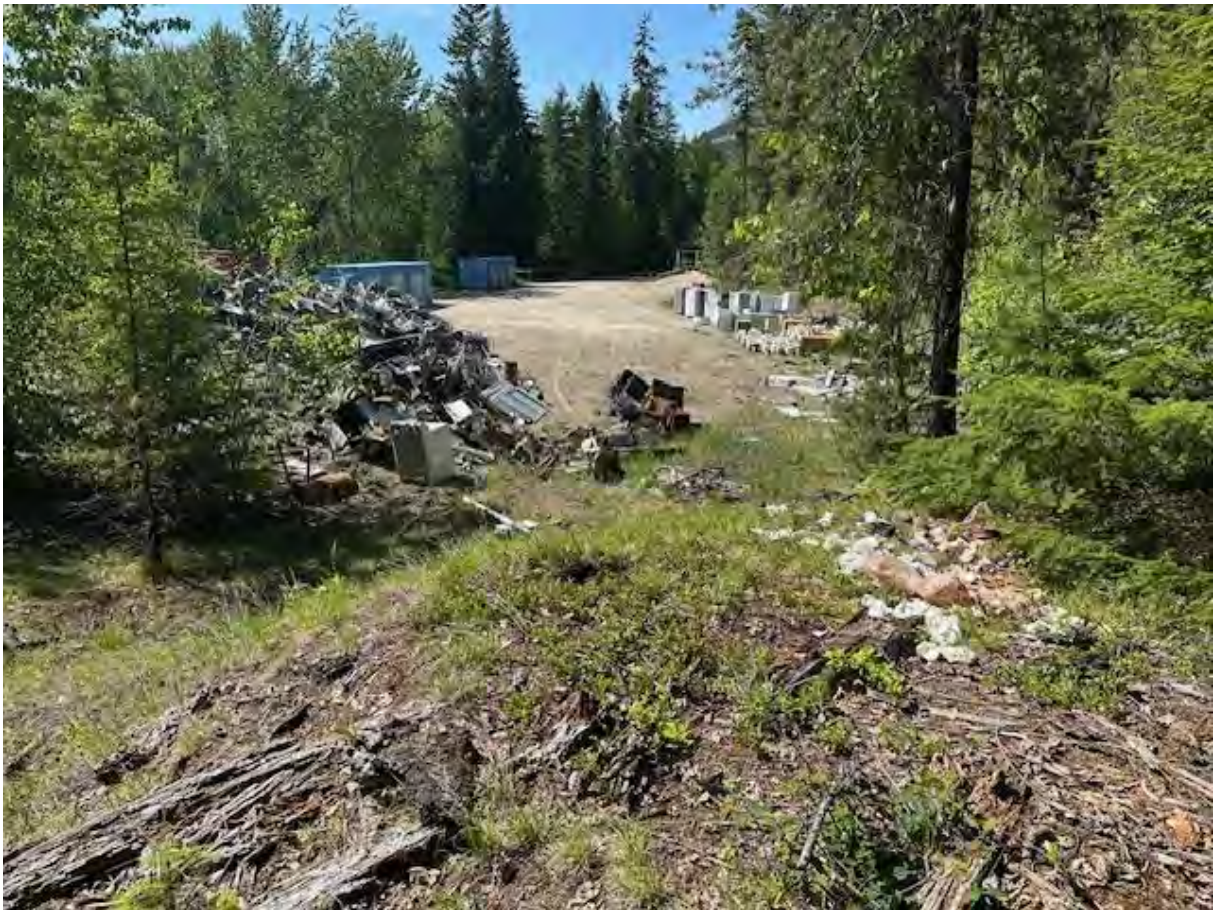
Photo 18: Litter on site just North of recycling area.

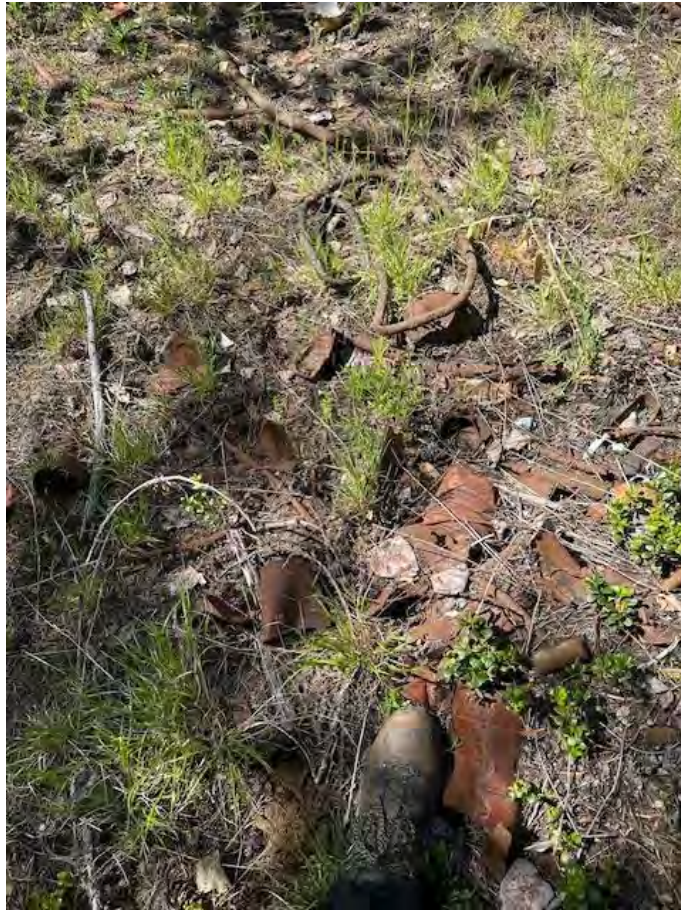
Photo 19: Metal waste on surface North of recycling area.

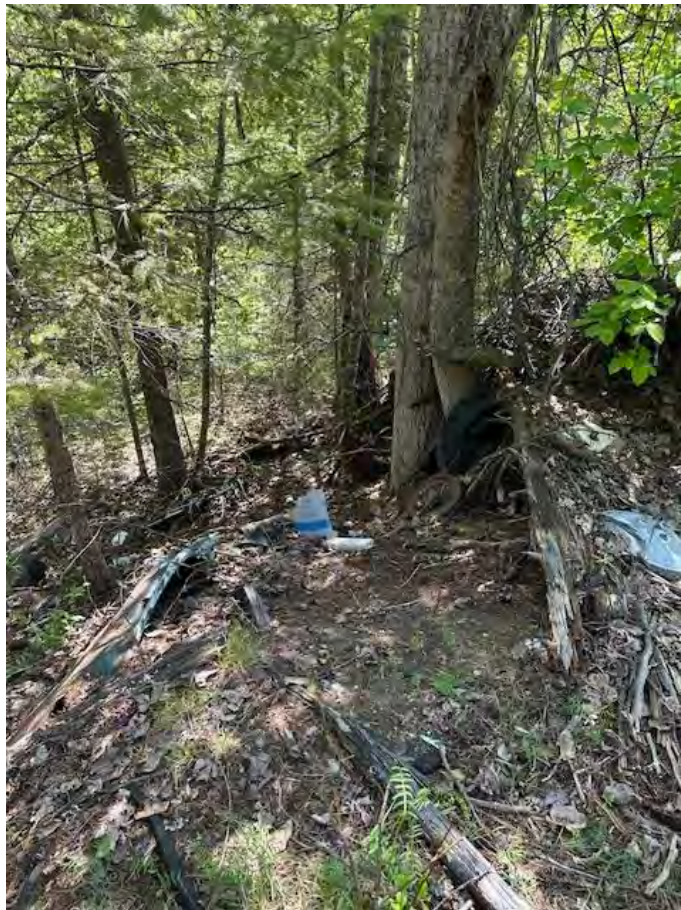
Photo 20: Steep slopes with exposed waste on North side of site.

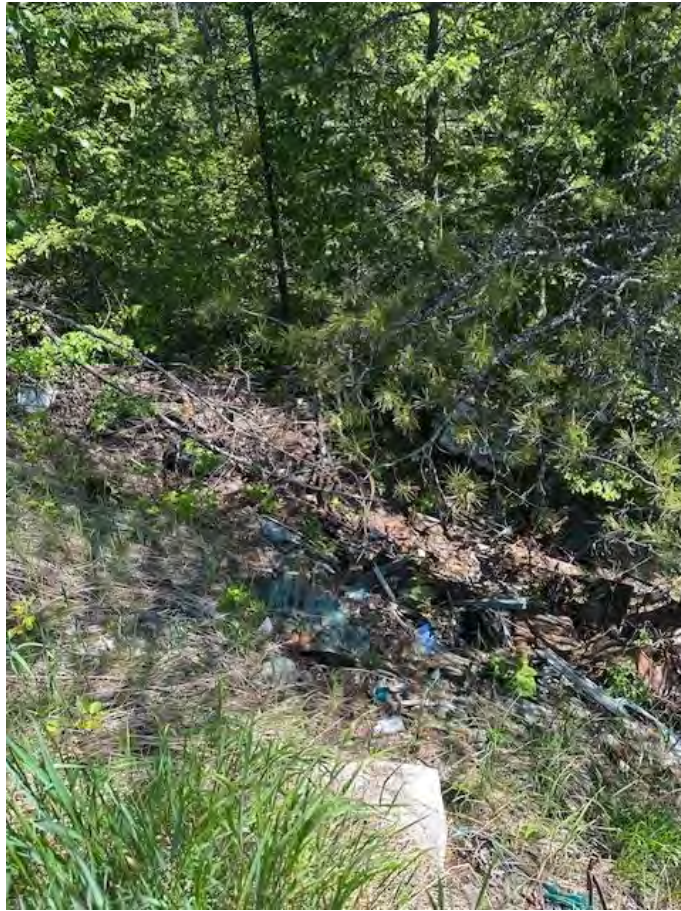
Photo 21: Steep slopes and exposed waste on North side of site, viewed from above.

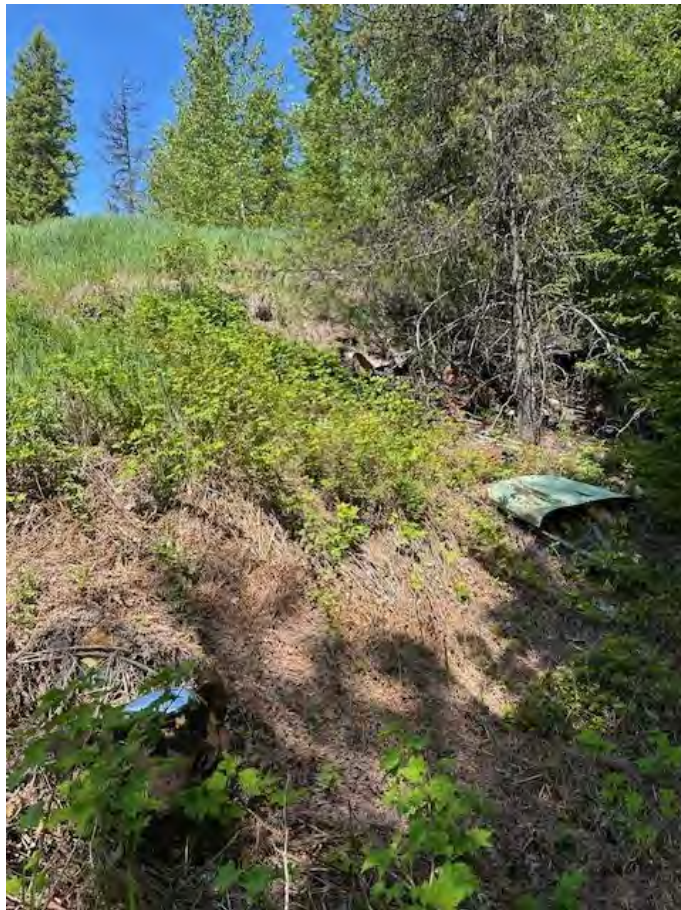
Photo 22: Steep slopes and exposed waste on North side of site, viewed from below.

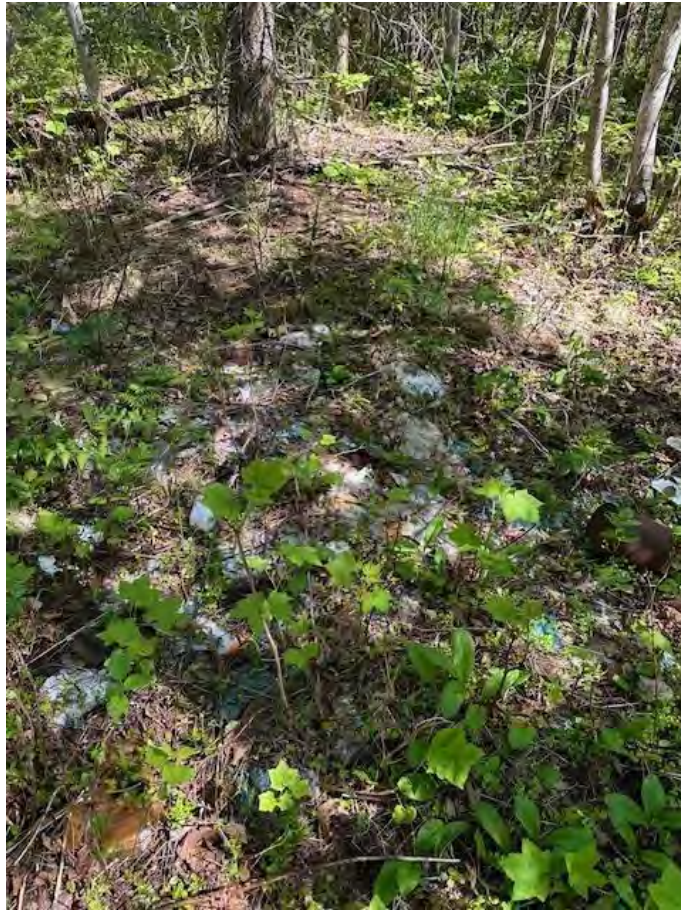
Photo 22: Litter scattered in treeline adjacent to site.

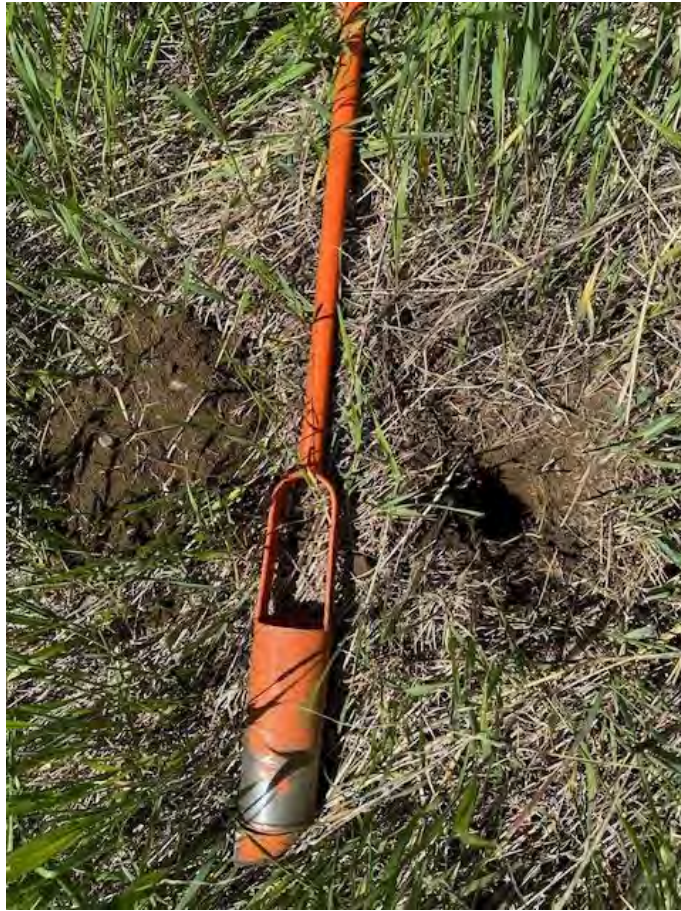
Photo 24: Typical cover material on landfill slope.

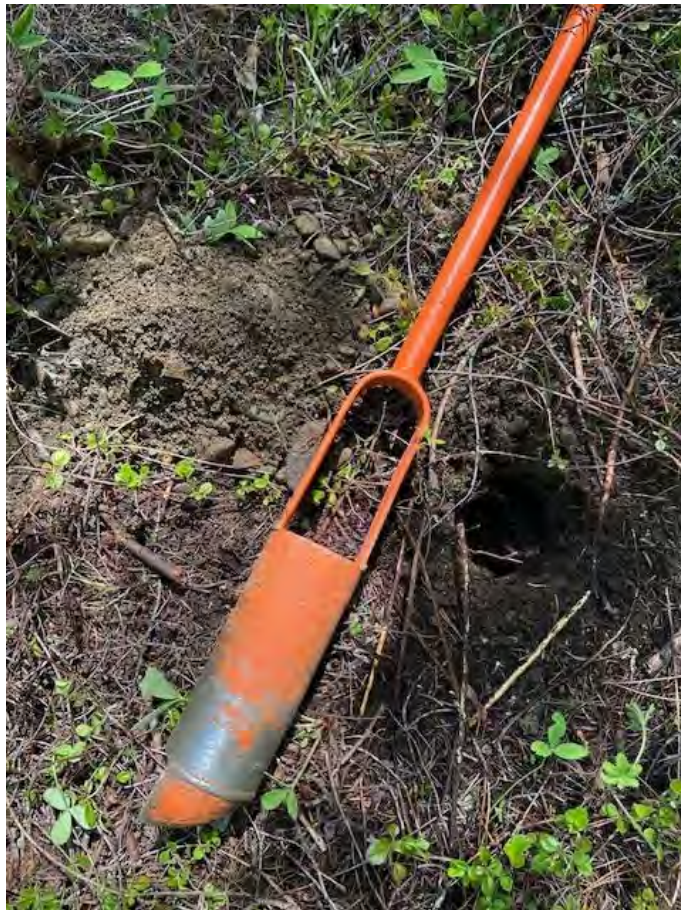
Photo 25: Typical cover material on landfill slope.
