# Rosebery Legacy Landfill Closure Plan

Prepared for:  
**Regional District of Central Kootenay**  
ISSUED FOR USE

Prepared by:  
**Sperling Hansen Associates Inc.**  
T: 604-986-7723  
E: sgarthwaite@sperlinghansen.com

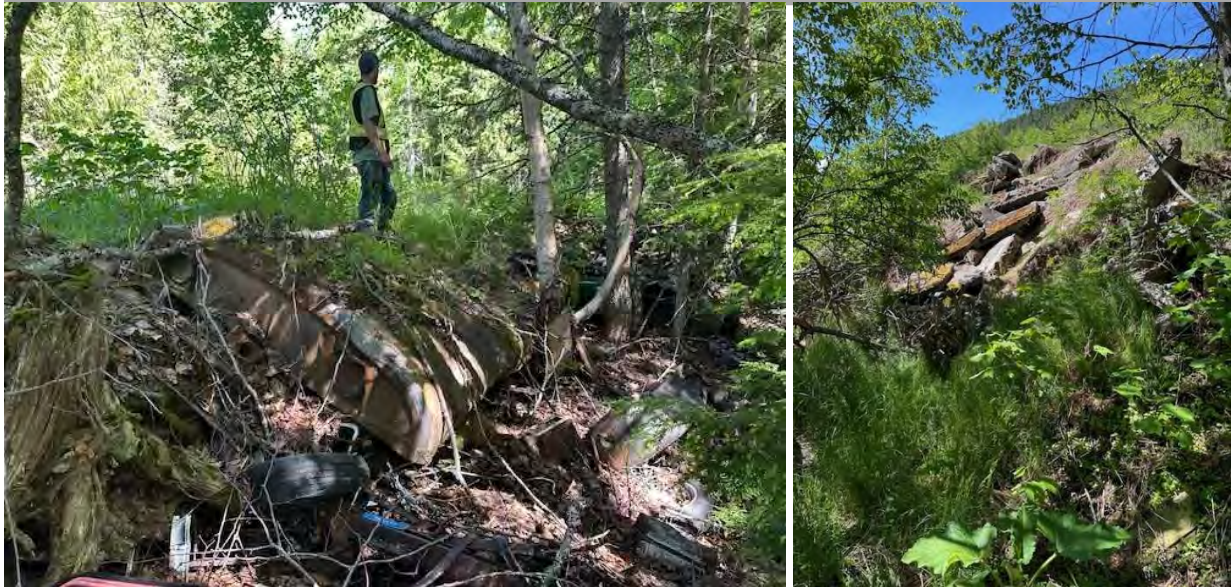
Although the cover is sufficient over the crest, the edges of the landfill consist of a steep drop-off 2 to 3 metres in height much of which consists of concrete and metal (Photos 1 and 2). As the landfill is often used by bikers and hikers, SHA believes that efforts should be made to remove much of the metal waste from the area using an excavator to pull these metal pieces and some auto hulks out of the slope and adjacent area. This metal can then be placed in roll-off bins and transported to active landfills under RDCK control.

**Photo 1 and 2: Debris near edge of landfill site and on steep slopes.**

While the metal is being removed, some effort should be made to knock down the steep slopes to a grade of 2.5H:1V and ensure a more gradual transition from landfill surface to native ground. This will provide greater slope stability and allow for easier covering of exposed waste. Although the grade is steeper than the 3H:1V recommended in the criteria, the recommended slope grades will ensure stability while minimizing the zone of disturbance.

Following removal of the metal, the remaining exposed waste should be covered with a minimum of 500mm of material as required in the Landfill Criteria. This material is not required to be low-permeability material as there is little concern around surface water management and leachate production, given that there are no concerns around surface water (Section 4) and the age of the waste means any leachate produced will be relatively weak.

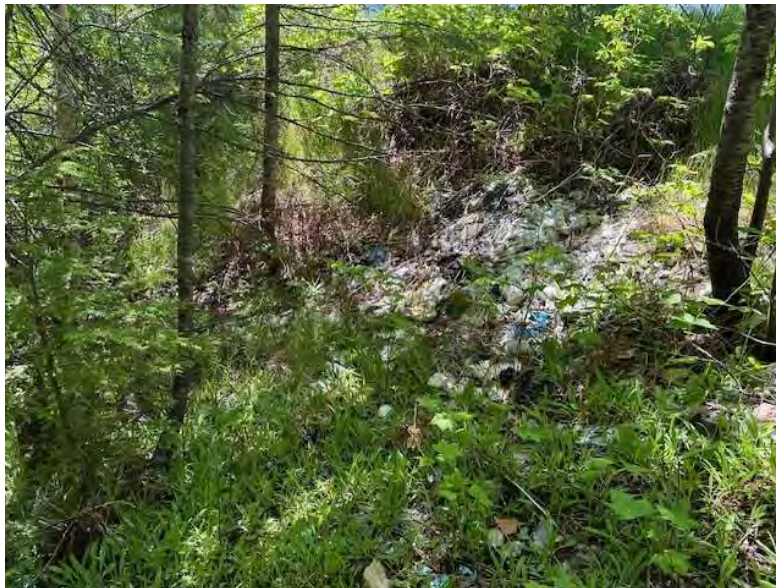
During SHA's site visit, several areas of litter were observed on the landfill surface (Photo 3). SHA believes that these are areas where waste was deposited post landfill closure in 2003, and that these are not areas where cover is insufficient. These areas are delineated on dwg. PRJ25043-

Photo 3: Litter spread adjacent to landfill surface, likely placed post-closure.

ROSEBERY-1, and while any litter on the landfill surface or in surrounding areas should be cleaned up the areas noted on the drawing should be given specific attention.

1. Clean up litter present on landfill surface, with specific attention to the areas identified on dwg. PRJ25043-ROSEBERY-1.

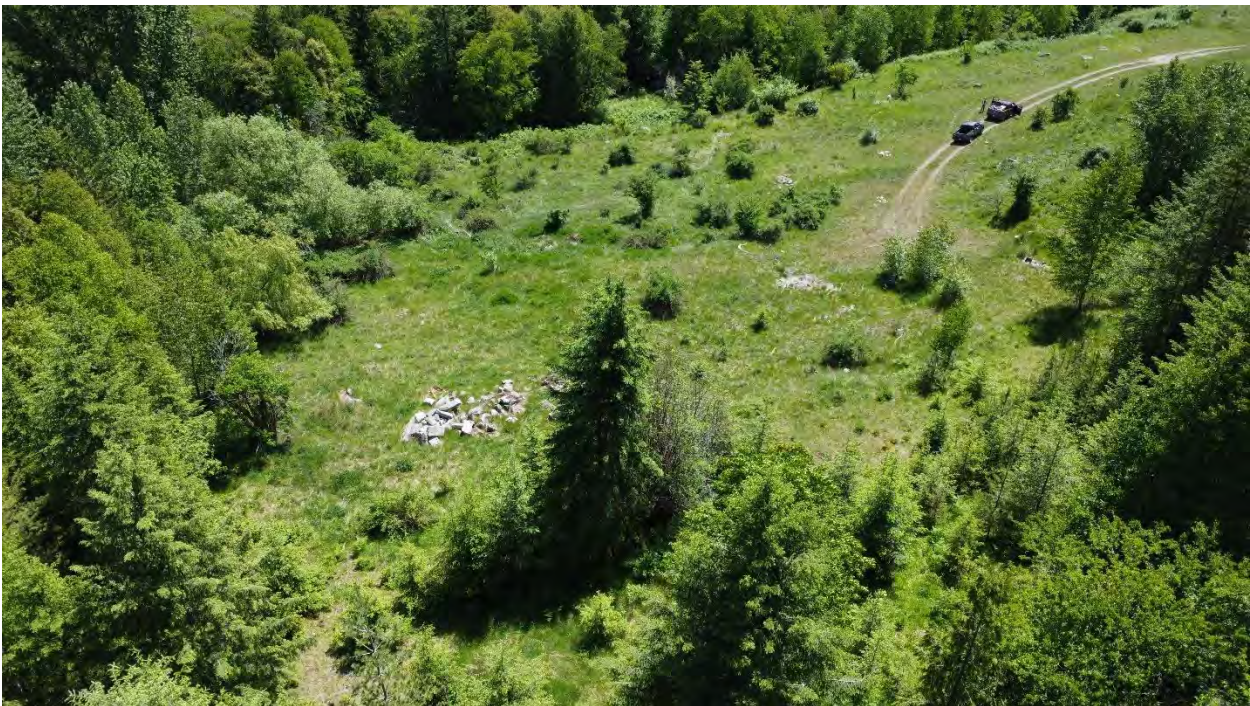
**Photo 4: Eastern portion of site, debris placed in foreground**

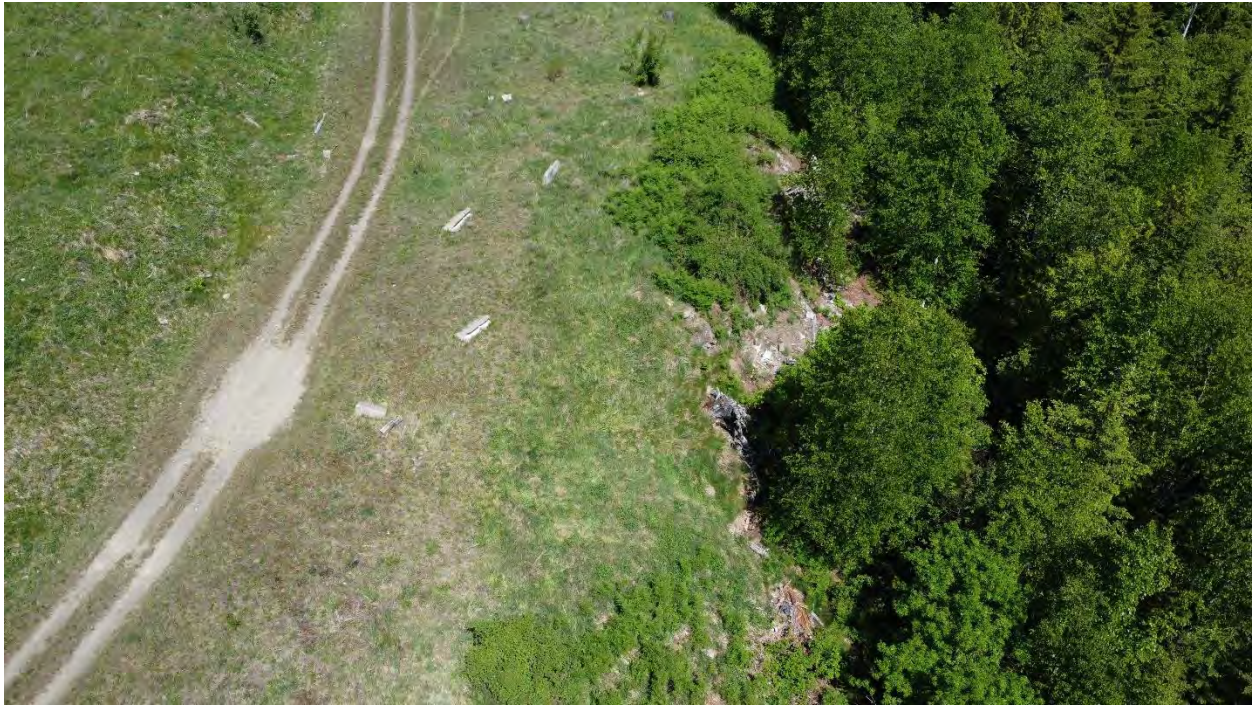
**Photo 5: Debris and steep slopes visible on treeline on East side of site.**

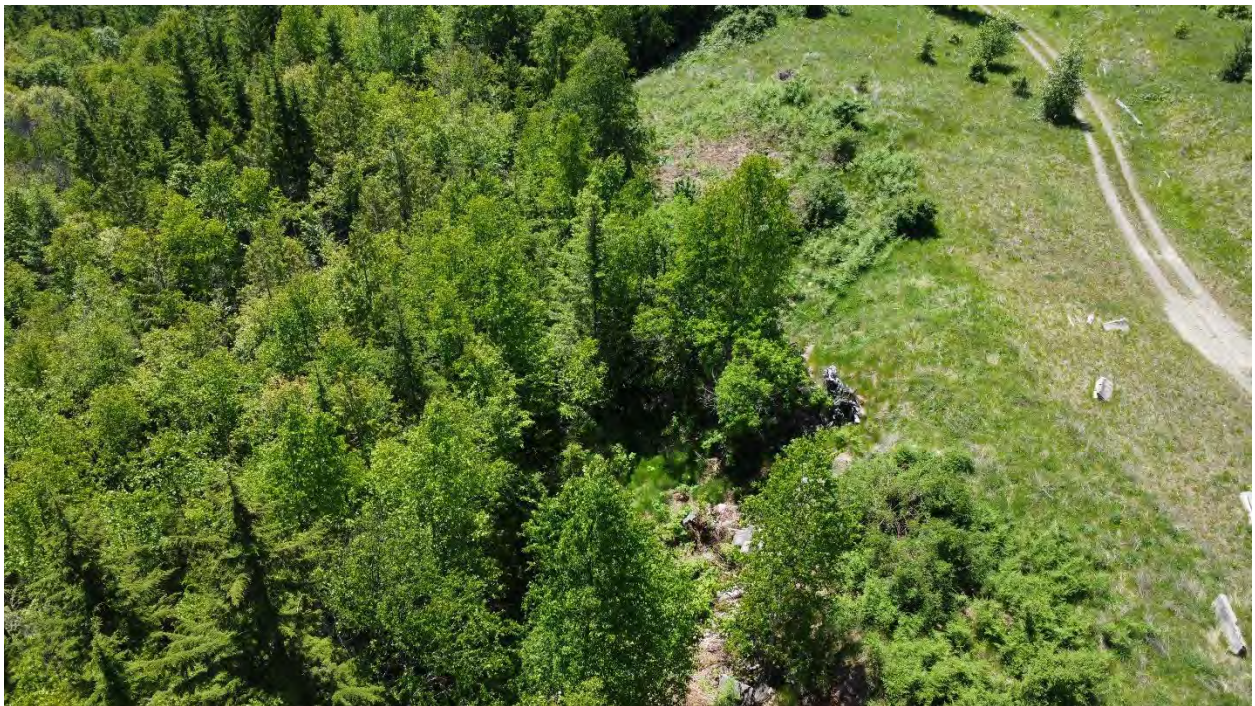
**Photo 6: Debris and steep slopes visible on treeline on East side of site.**

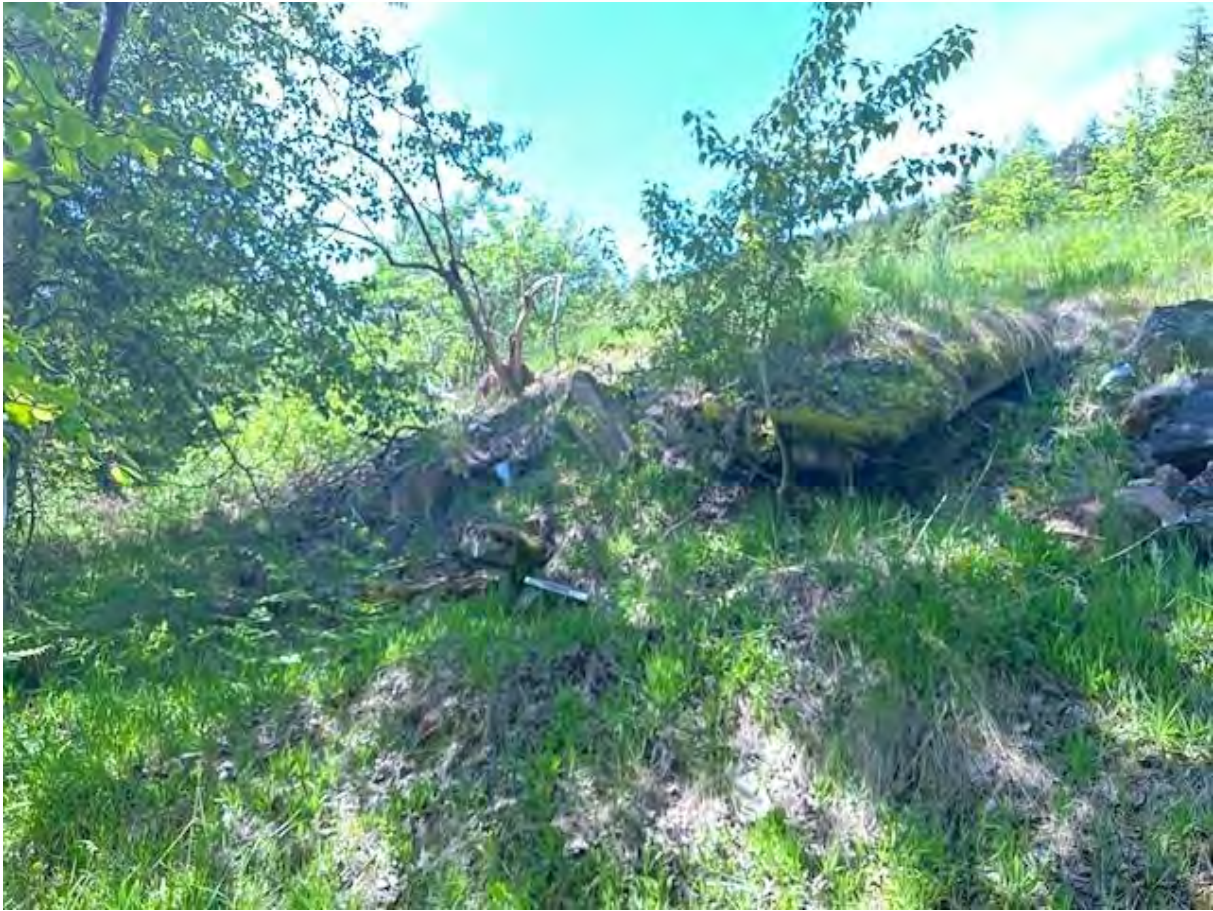
**Photo 7: Debris deposited in East treeline.**

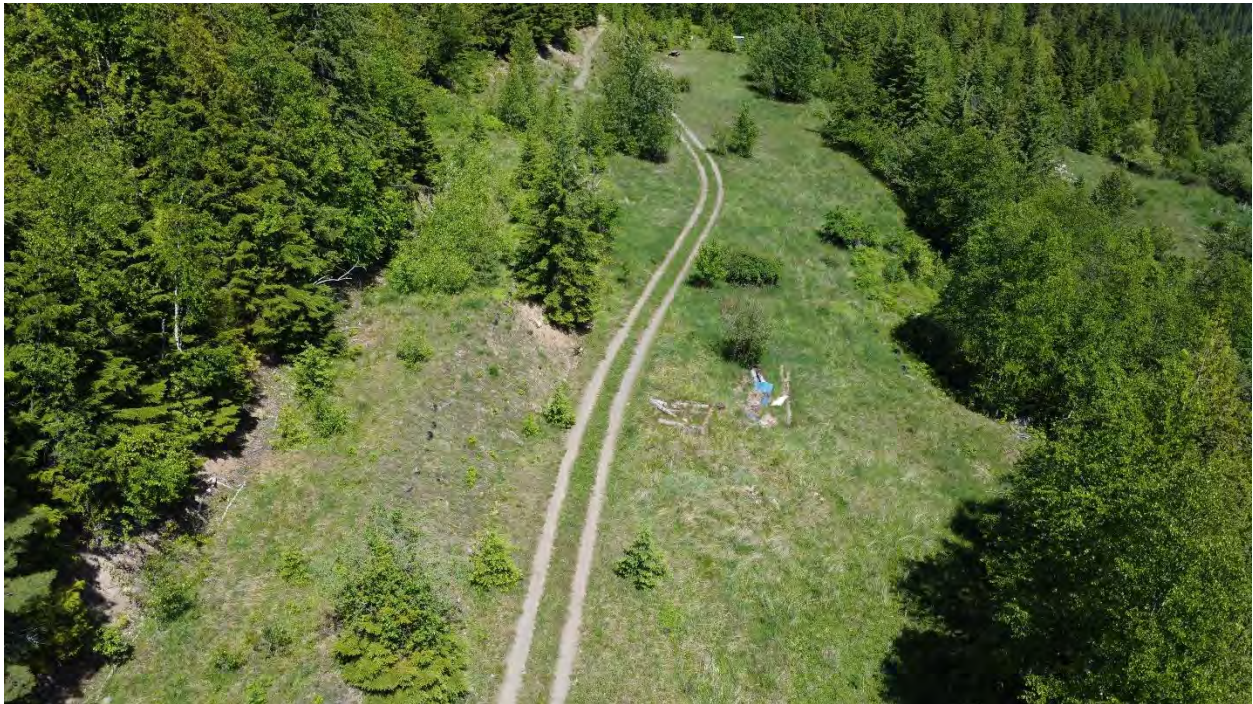
**Photo 8: Western portion of site, debris in center of photo and pit toilet at top of photo.**

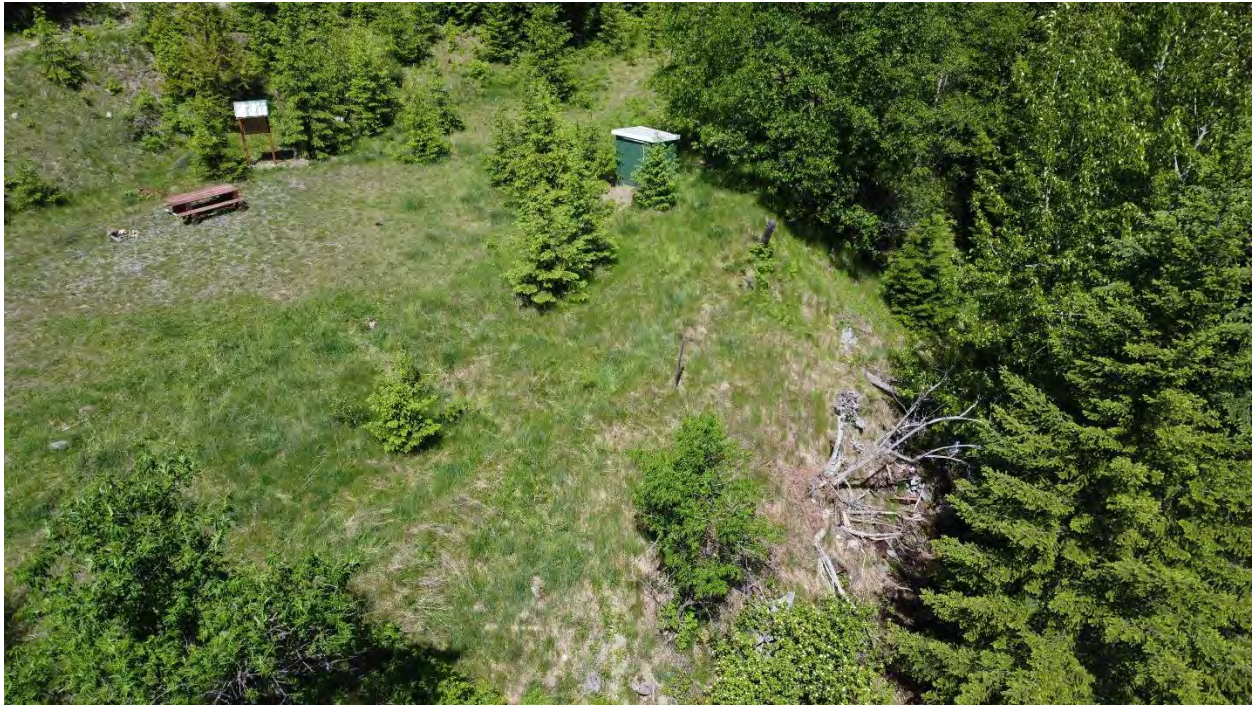
**Photo 9: Pit Toilet with exposed waste and steep slopes noted at bottom right of photo.**

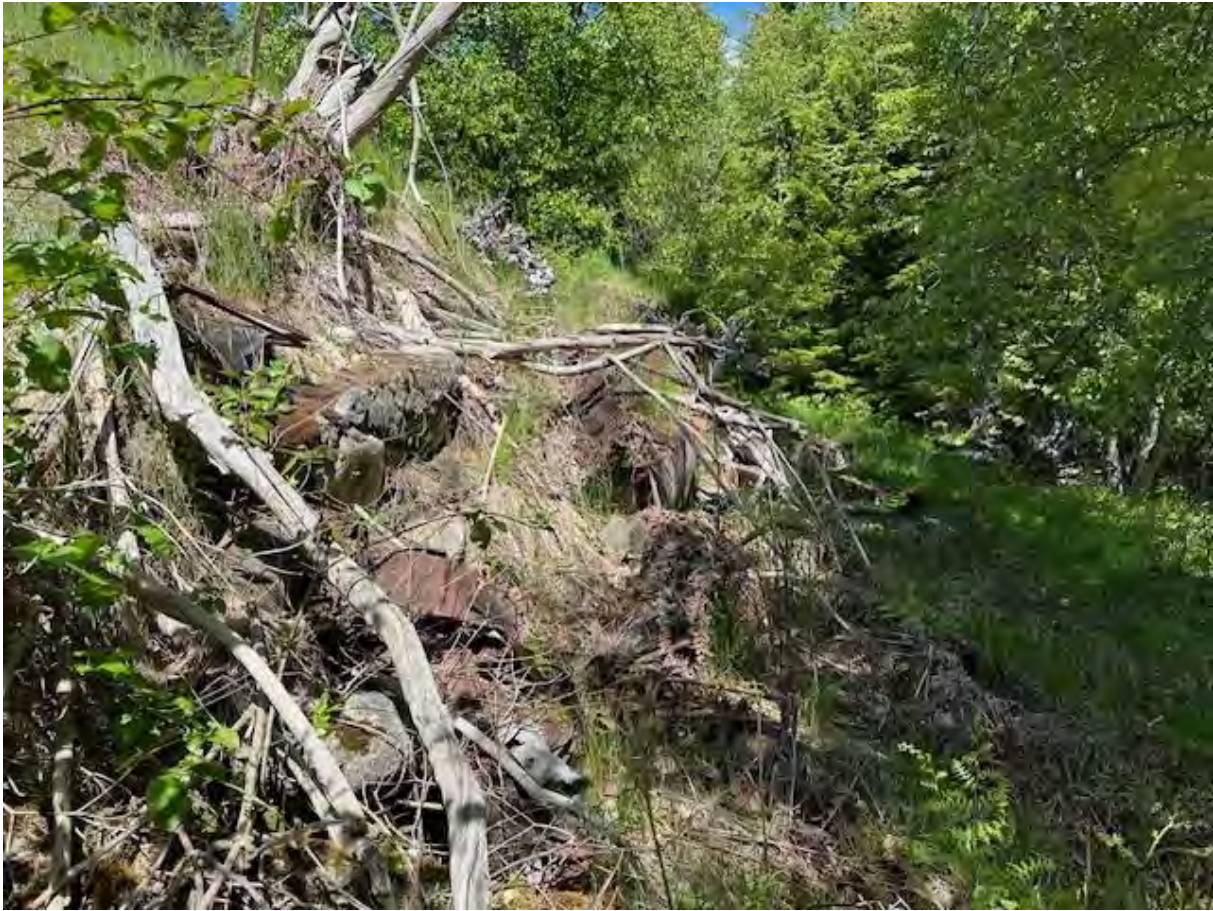
**Photo 11: Metal and debris exposed within steep slope just East of pit toilet area.**

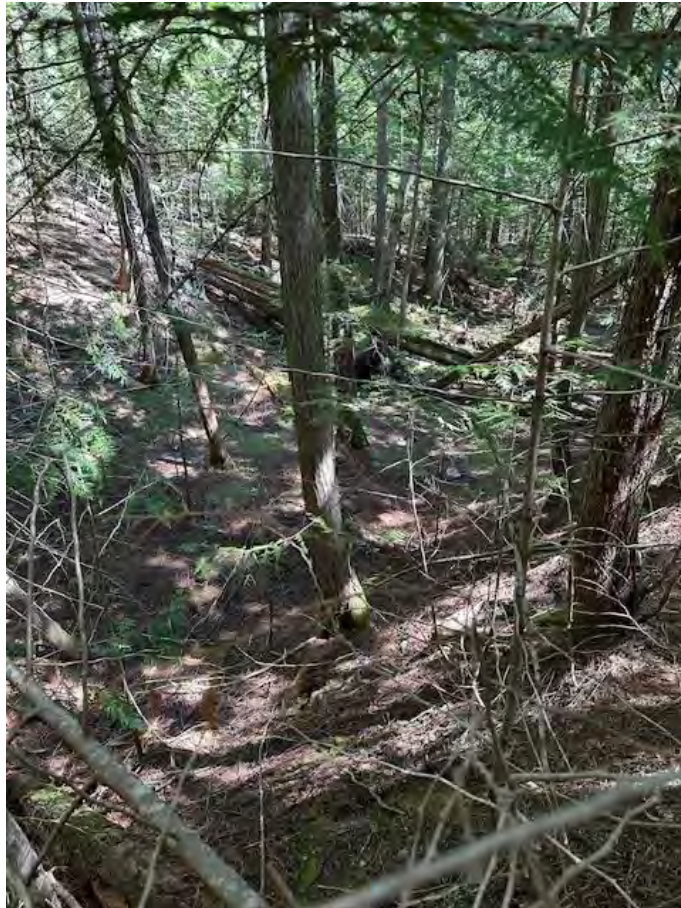
**Photo 12: Drainage visible adjacent to site. Was dry at time of visit and did not appear to ever have substantial amounts of water.**

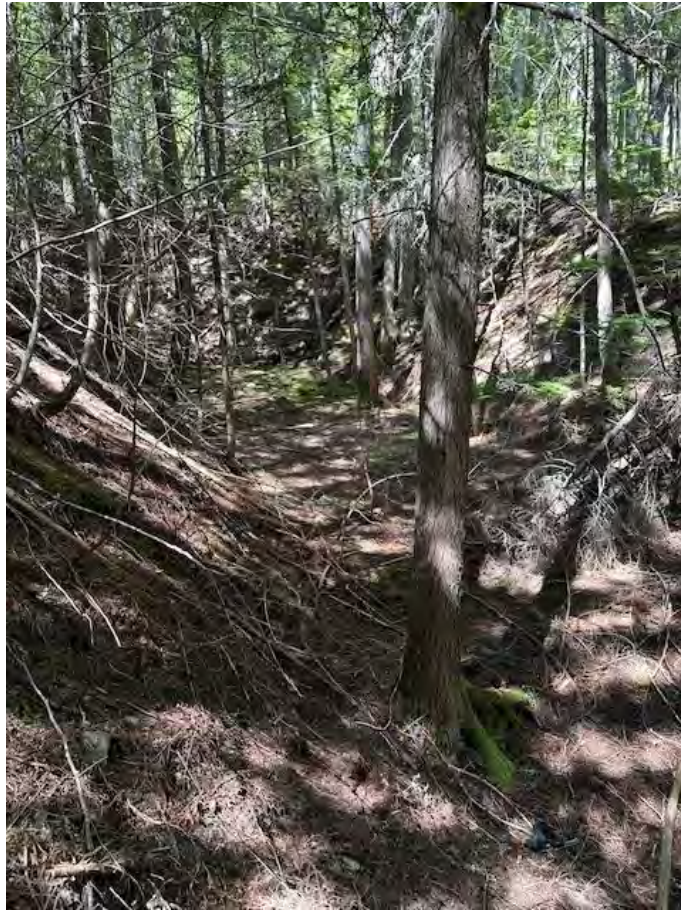
**Photo 13: Drainage visible adjacent to site. Was dry at time of visit and did not appear to ever have substantial amounts of water.**

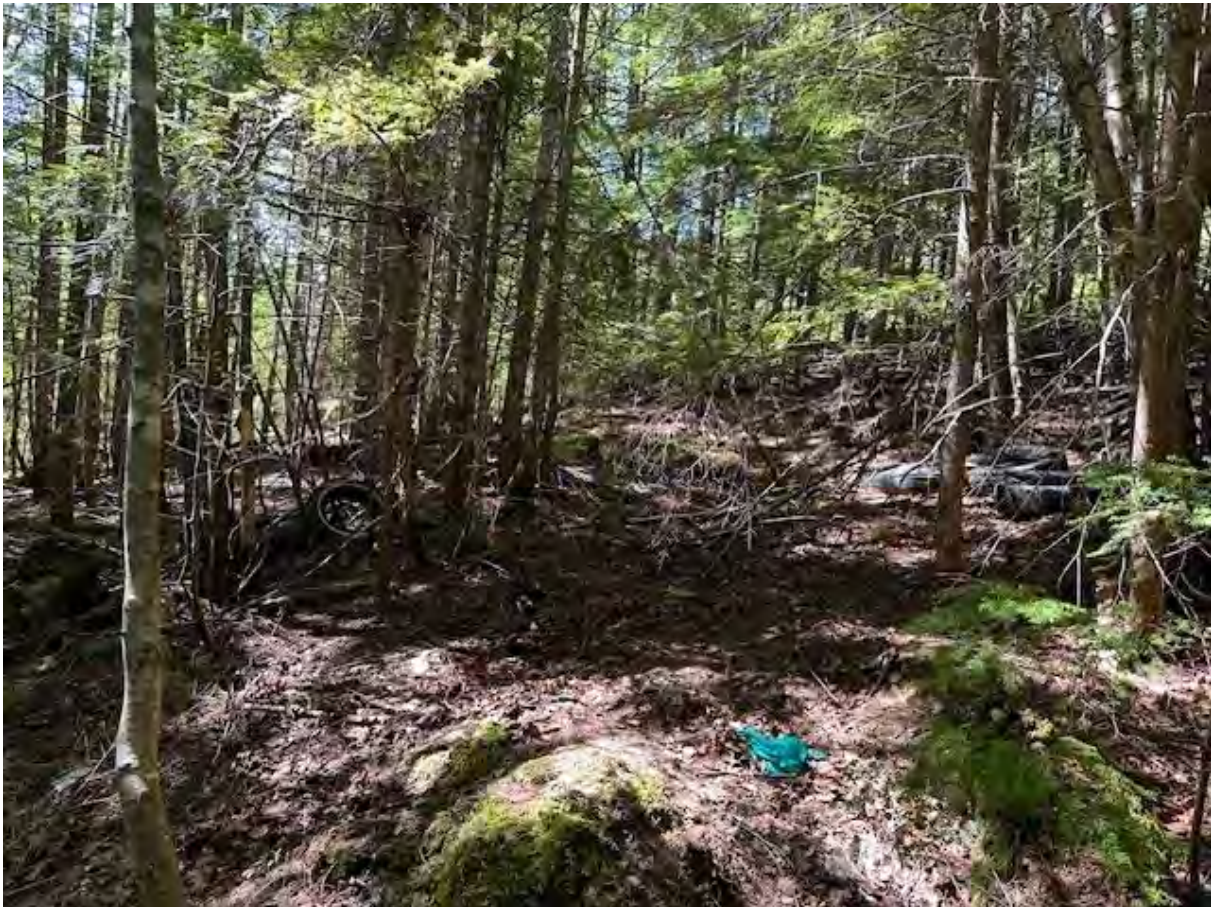
**Photo 14: Litter deposited on North side of landfill.**

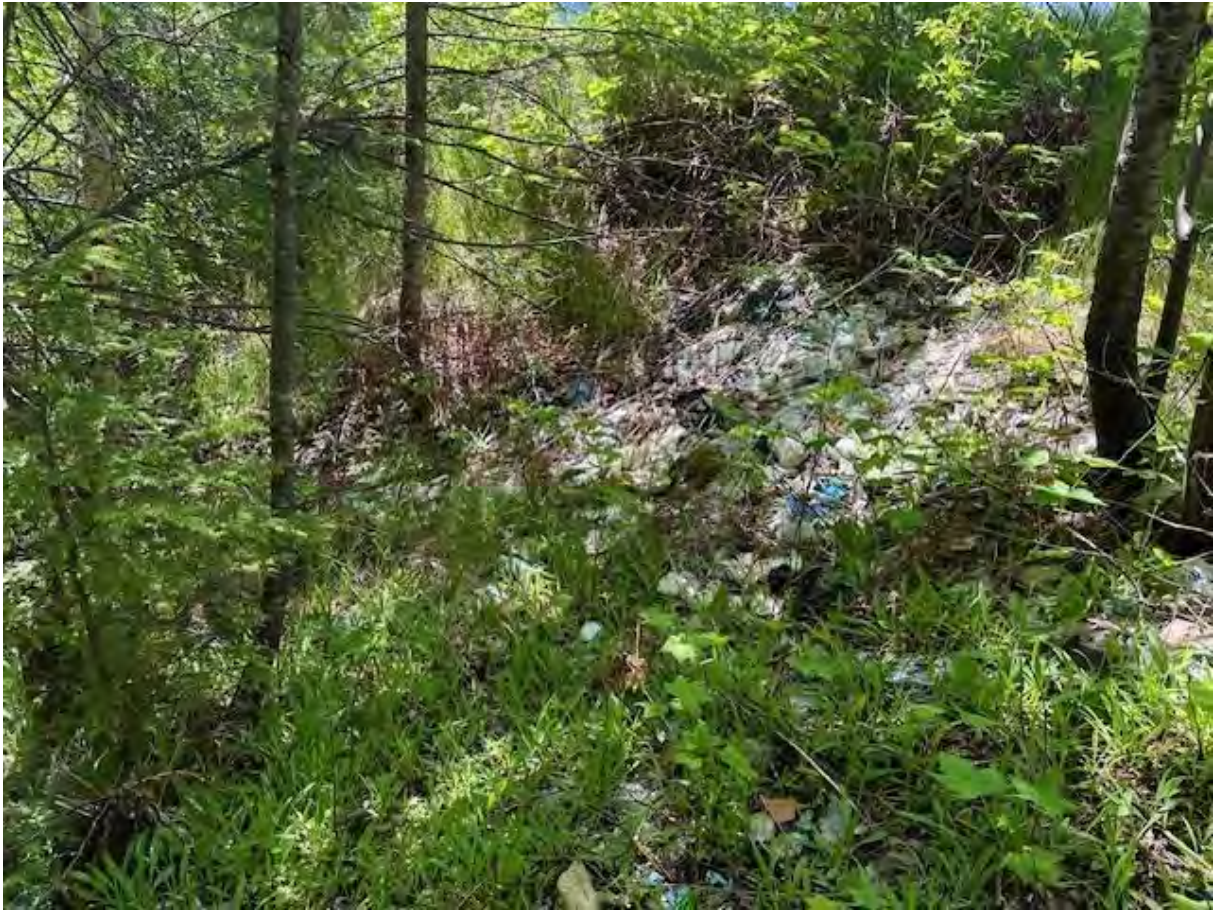
**Photo 15: Litter deposited on North side of landfill within treeline. Appeared to be MSW spread by wildlife.**

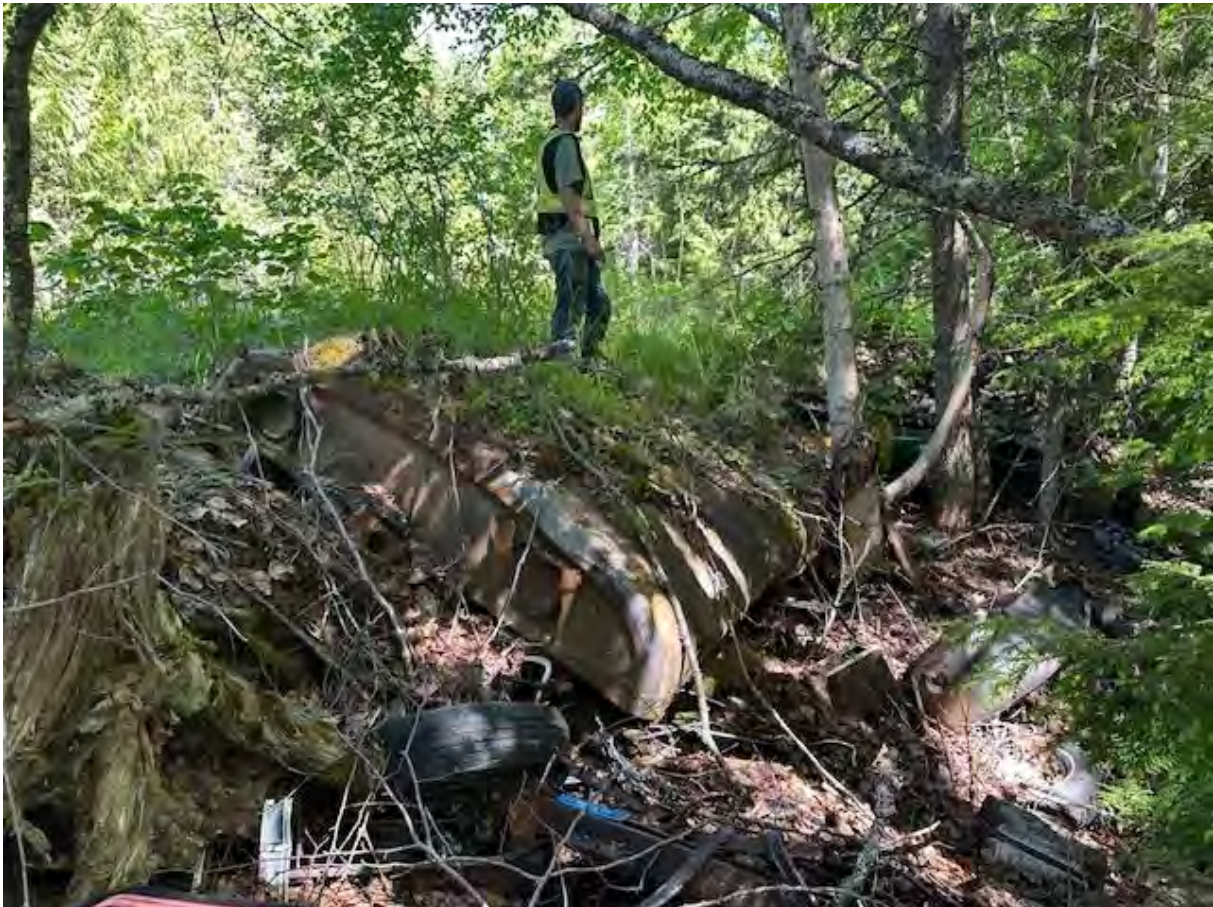
**Photo 16: Metal and debris located on East edge of site.**

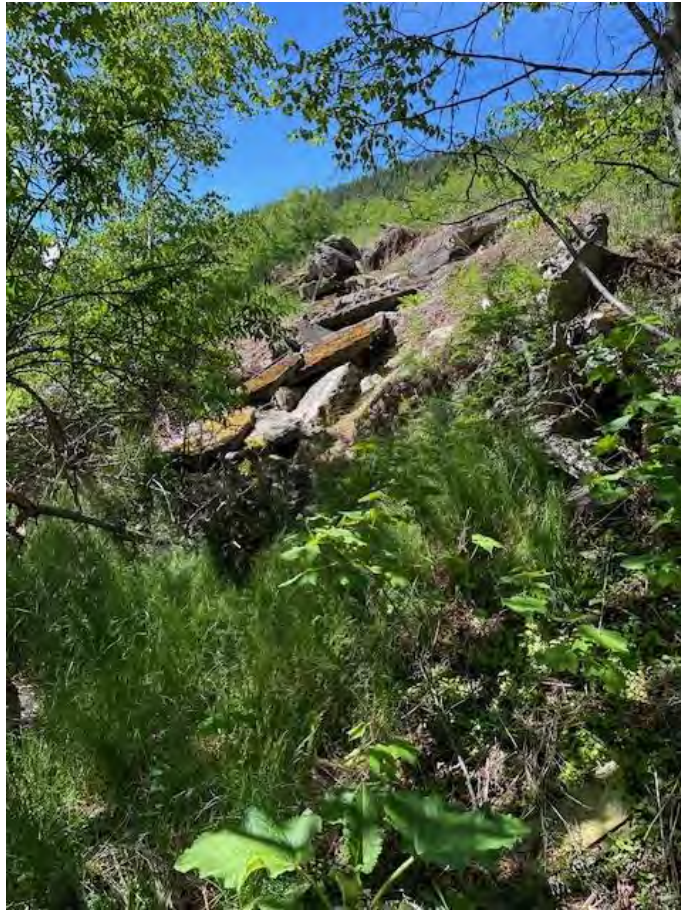
**Photo 17: Debris visible on East edge of site, within steep slopes.**
