# 2024 Dam Safety Review

## HB Tailings Facility

Salmo, BC

MAY 26, 2025  
ISSUED FOR USE (REVISION 01)  
704-ENG.DAMS03004-01

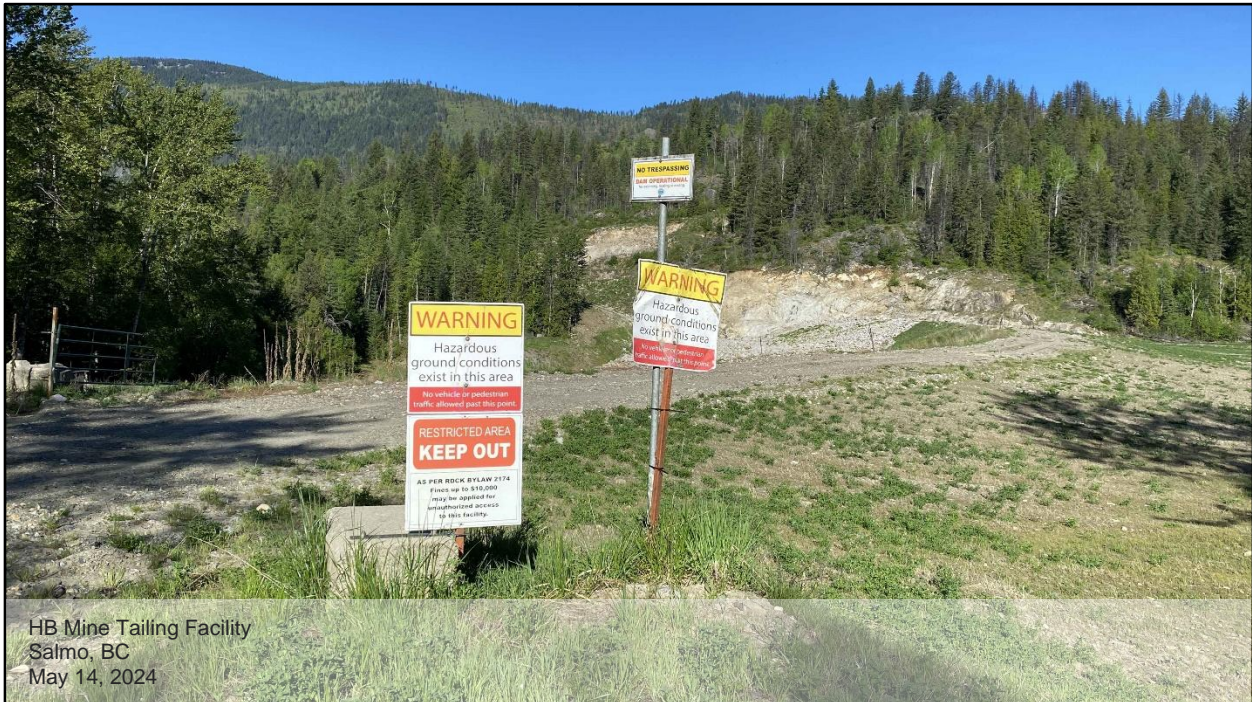
**Photo D.1: General view of HB Tailing Dam, looking west. Warning signs located near the crest gate indicate the restricted area with no trespassing and warning for hazardous ground conditions exist in this area.**

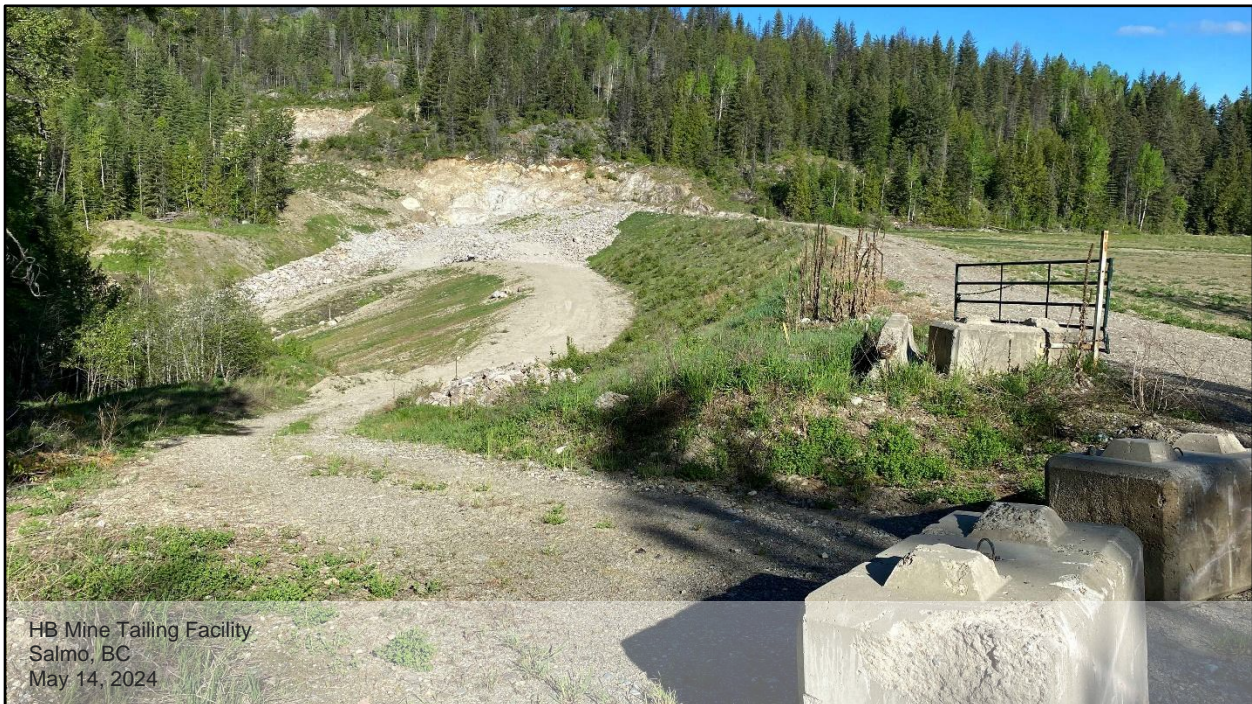
**Photo D.2: General view of the downstream face of the dam and expanded berm from left (east) abutment, looking west. Access to the downstream berm from the left abutment was restricted by a couple of concrete blocks.**

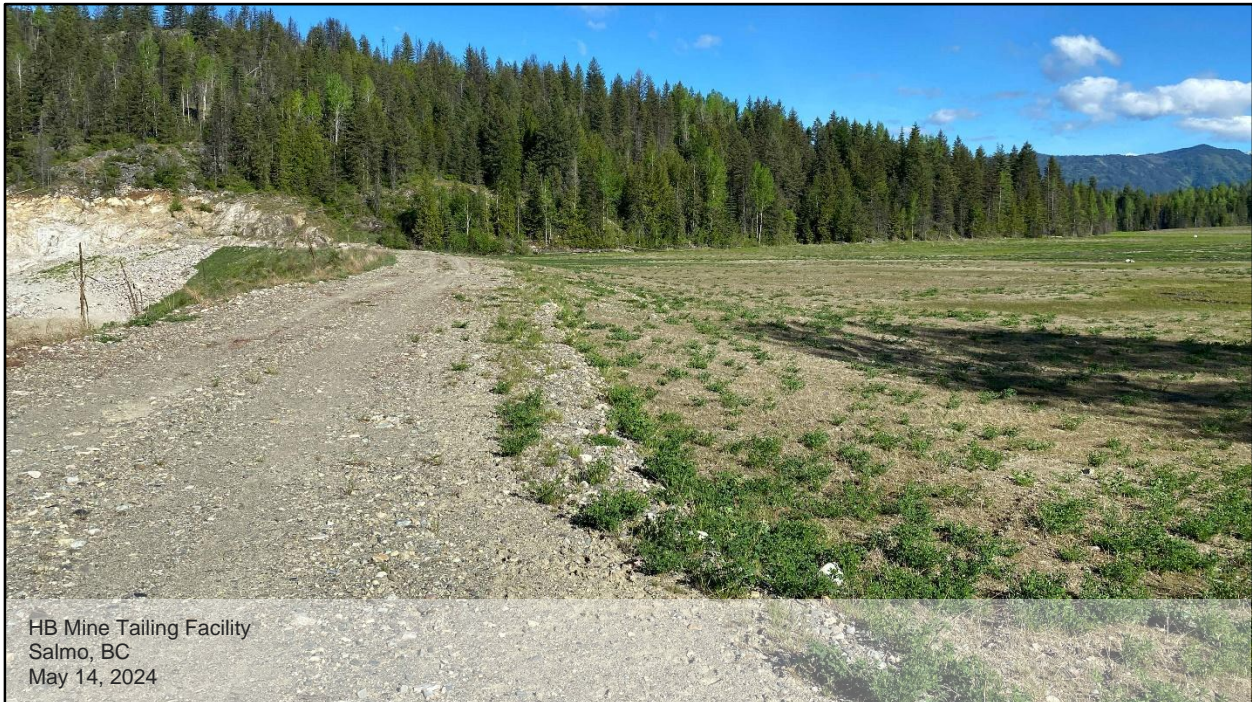
**Photo D.3: View of the dam crest and tailings impoundment area, looking west. The dam crest was found to be mainly clean with no vegetation. The upstream slope of the dam has been covered by deposited tailing material, tailing cover, and vegetation growing over it.**

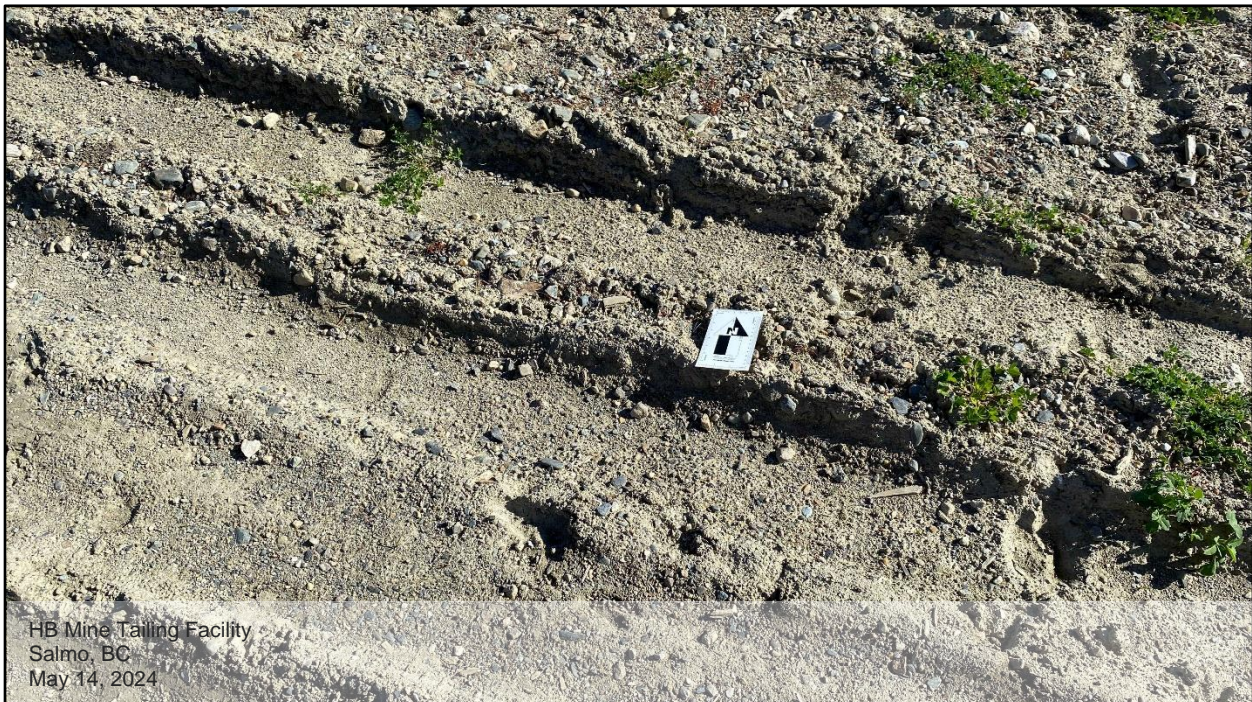
**Photo D.4: A close view of the dam crest. Some rutting from vehicle traffic was observed along the dam crest. The dam crest is in general good condition.**

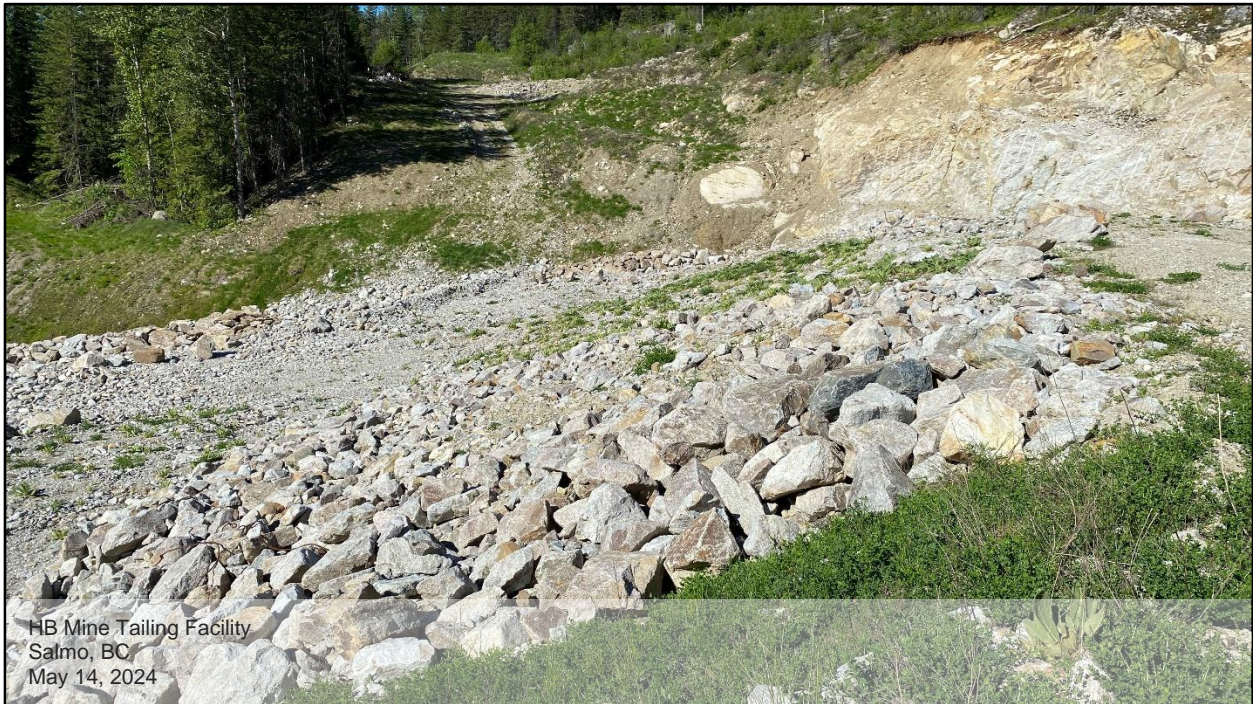
**Photo D.9: View of the downstream slope west side, looking southwest. The west side of the downstream slope was repaired in 2012 and a layer of riprap has been placed over this area.**

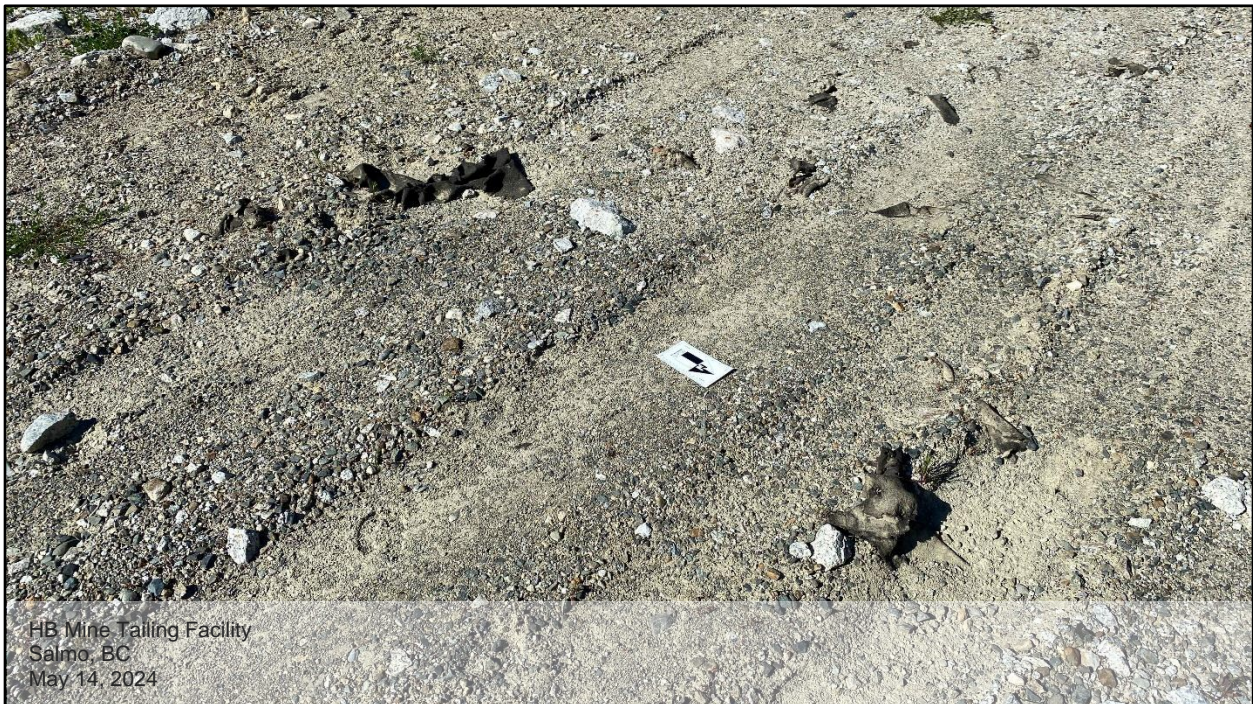
**Photo D.10: A close view of the dam crest, west side. Exposed geotextile was observed in multiple locations on the west side.**

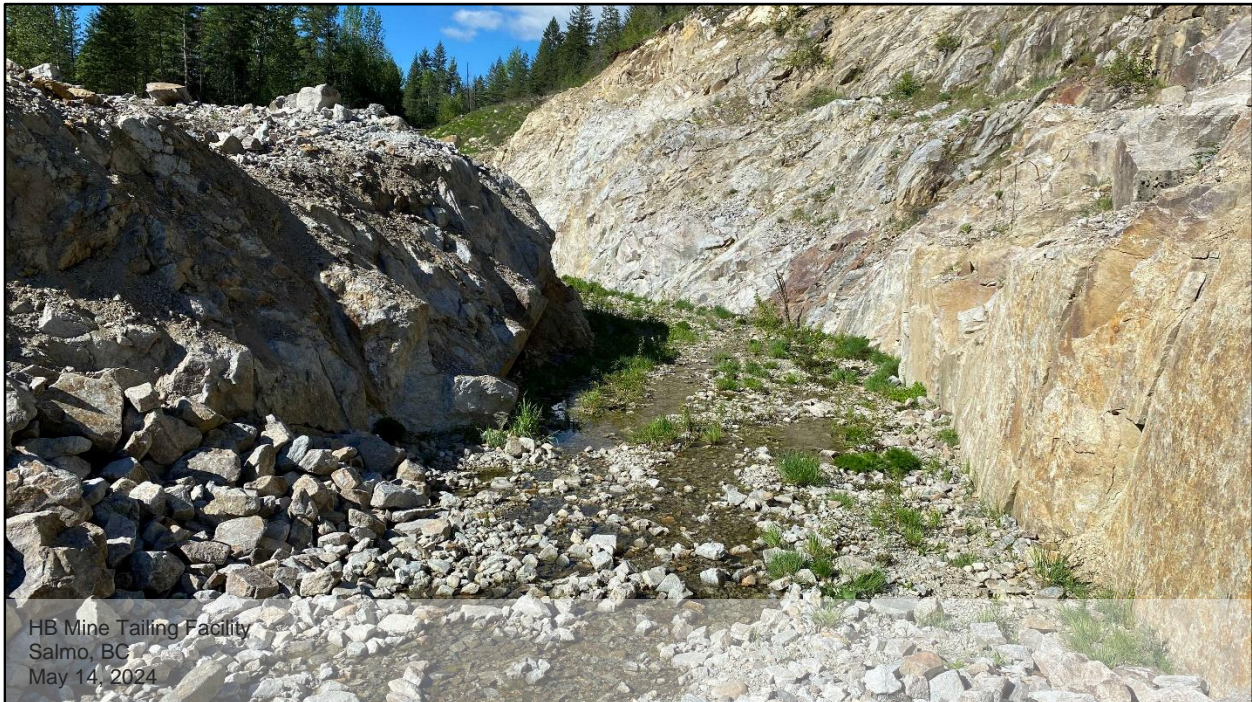
**Photo D.11: View of the bedrock spillway inlet, looking south. Flow with a few centimeters' depth was observed over the bedrock spillway. Some vegetation is growing along the bedrock spillway.**

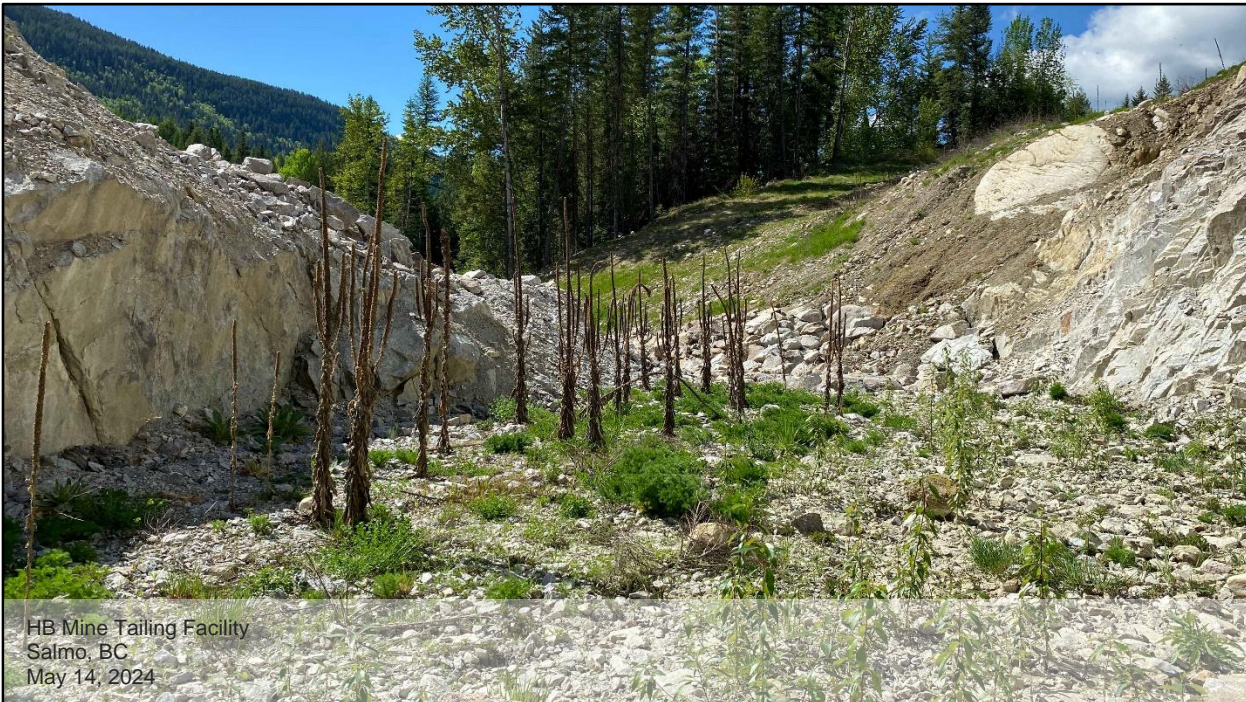
**Photo D.13: View of the south end of bedrock spillway, looking south. Vegetation is growing along the bedrock spillway that needs to be removed.**

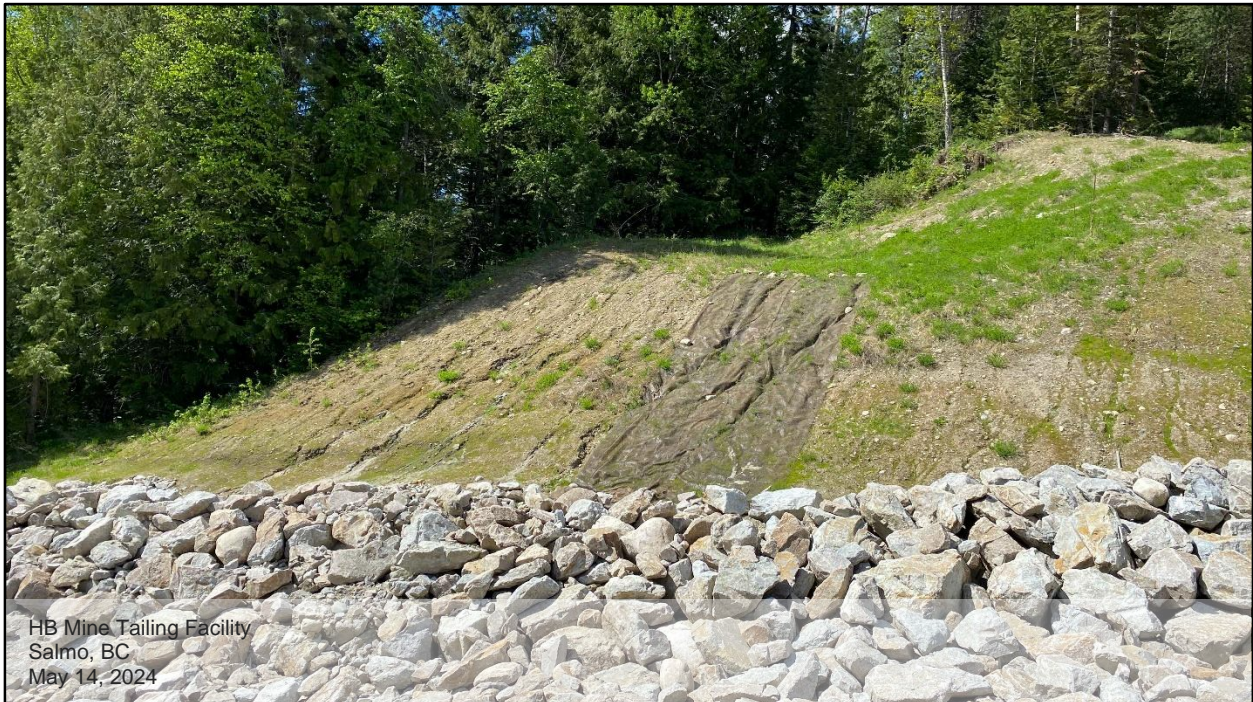
**Photo D.15: View of the western slope (exposed till) of the spillway outlet channel, looking west. Surface erosion rills/gullies were observed in multiple locations on the western slope the spillway outlet channel.**

ID #	Existing Condition/Issue	Recommendation Report Section	Deficiency / Non-Conformance	Recommended Action	Priority
2024-DSR-04	Several surface erosion rills/gullies were observed on the western slope (exposed till) of the spillway outlet channel. Major failure of this slope may fully/partially block the spillway outlet channel and decrease the spillway capacity.	5.2.3	–	Update inspection forms to ensure ongoing monitoring of this area for signs of excessive surface erosion or potential slope instability, and implement repairs if erosion exceeds acceptable levels or significant instability is detected.	Medium
2024-DSR-06	Surface eroded areas and tailings exposure were observed around the tailing impoundment area during the site inspection. Sparse vegetation was also found in some areas.	5.3	–	Repair the surface eroded areas and cover all tailing exposures with an approximate coverage of 30 cm and vegetation appropriately, as required.	Medium

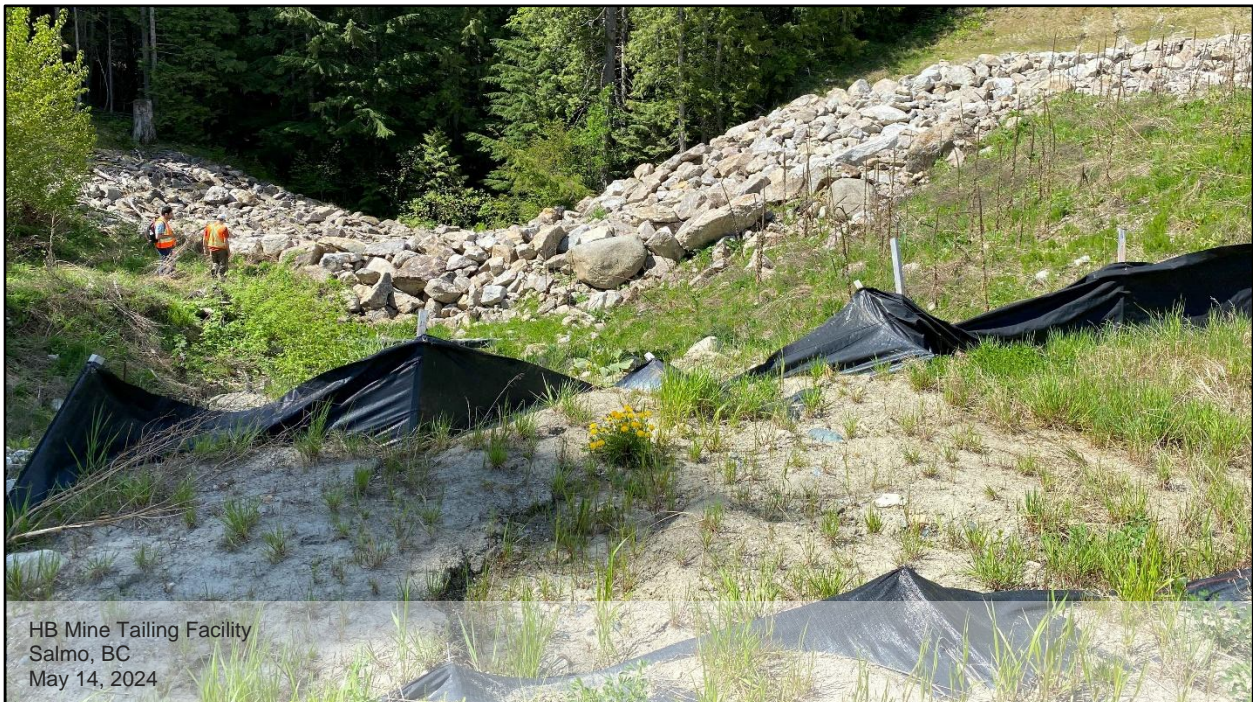
**Photo D.16: View of the downstream slope of the expanded berm and toe of the dam, looking south. A sediment control fence was found near the downstream toe. The sediment fence failed at some points and has been covered by sedimented material.**

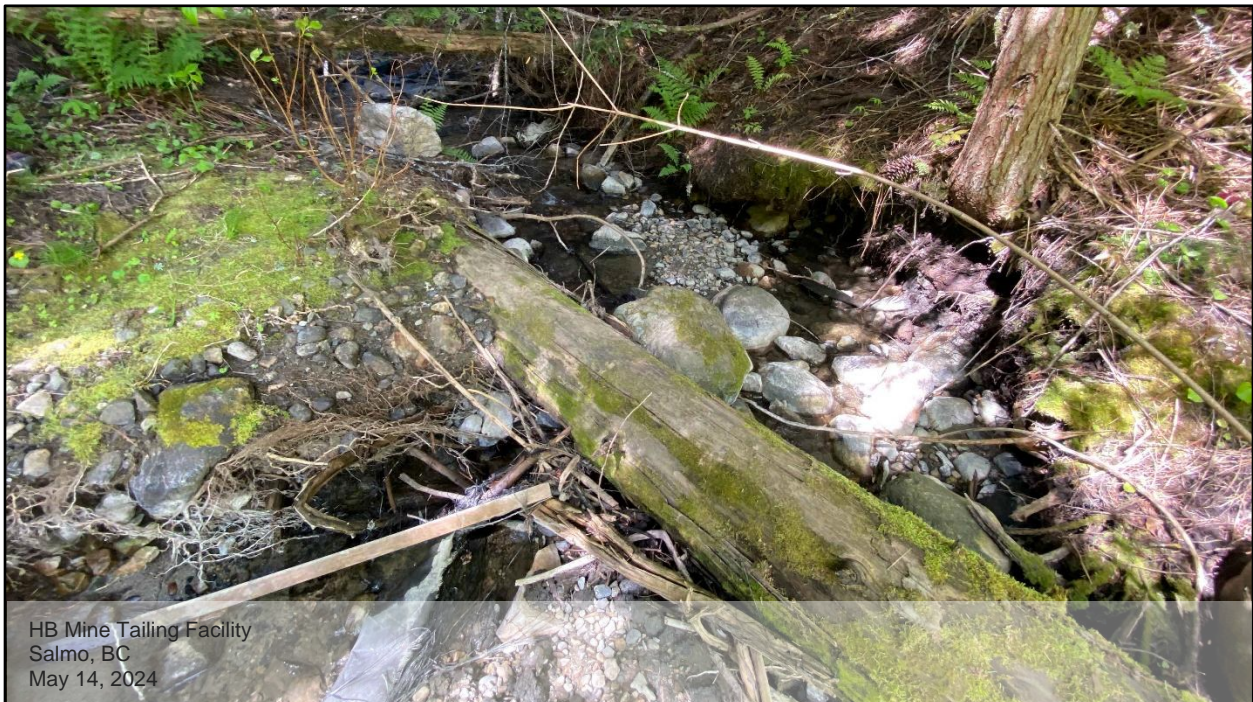
**Photo D.18: View of the downstream creek, looking southwest. The seepage drains into the downstream creek (narrow valley). Logs and boulders were observed along the inlet of the downstream creek that need to be removed.**

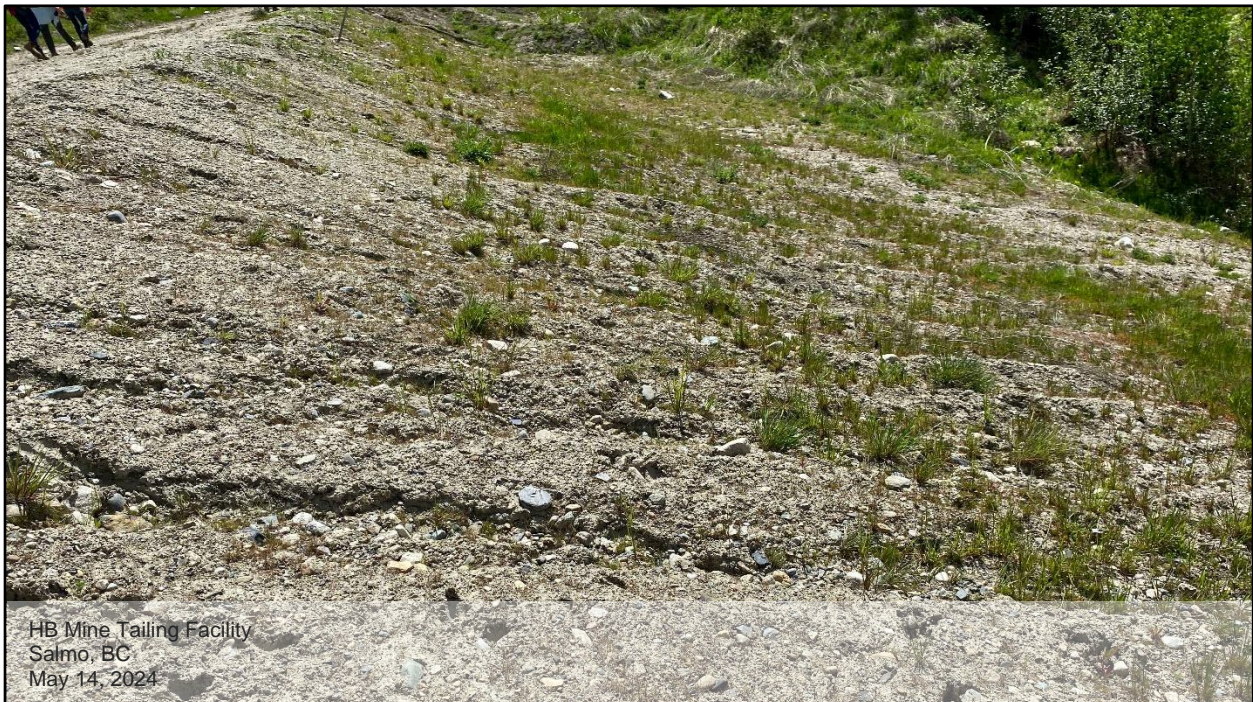
**Photo D.22: View of the downstream slope (east side) of the expanded berm, looking east. Multiple surface erosion rills and gullies were identified along the eastern slope of the expanded berm.**

2024-DSR-05	A series of surface erosion rills/gullies were noted along the east slope of the berm. Some gullies have been developed considerably near the east abutment of the dam. The downstream east slope of the extended berm is prone to surface erosion and sloughing.	5.2.4	–	Repair this area, develop a surface water management plan (e.g., establish vegetation, install drainage ditches, etc.), and implement mitigation measures to control the runoff water along the crest and downstream slope of the extended berm.	High
2024-DSR-08	The seismic shear strength and deformation behavior of the original dam fill is not well understood and there is a risk of potential large-scale deformation due to seismic liquefaction.	6.1.3.1	Deficiency	The shear strength and deformation behavior of the original dam fill should be further investigated to fully understand seismic liquefaction hazard. Conduct further investigation on the material properties and a post-seismic deformation analysis to evaluate their performance under seismic loading.	High

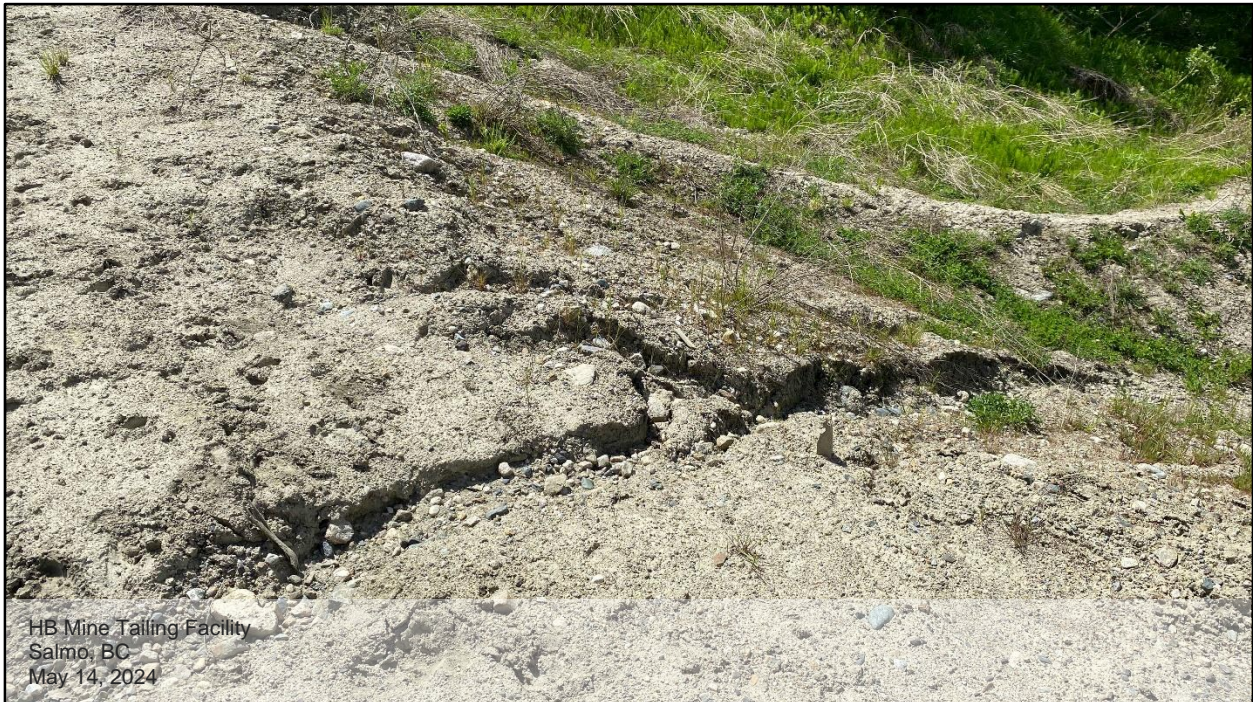
**Photo D.23: A close view of the downstream east slope of the expanded berm. The downstream eastern slope of the extended berm is prone to surface erosion and sloughing.**

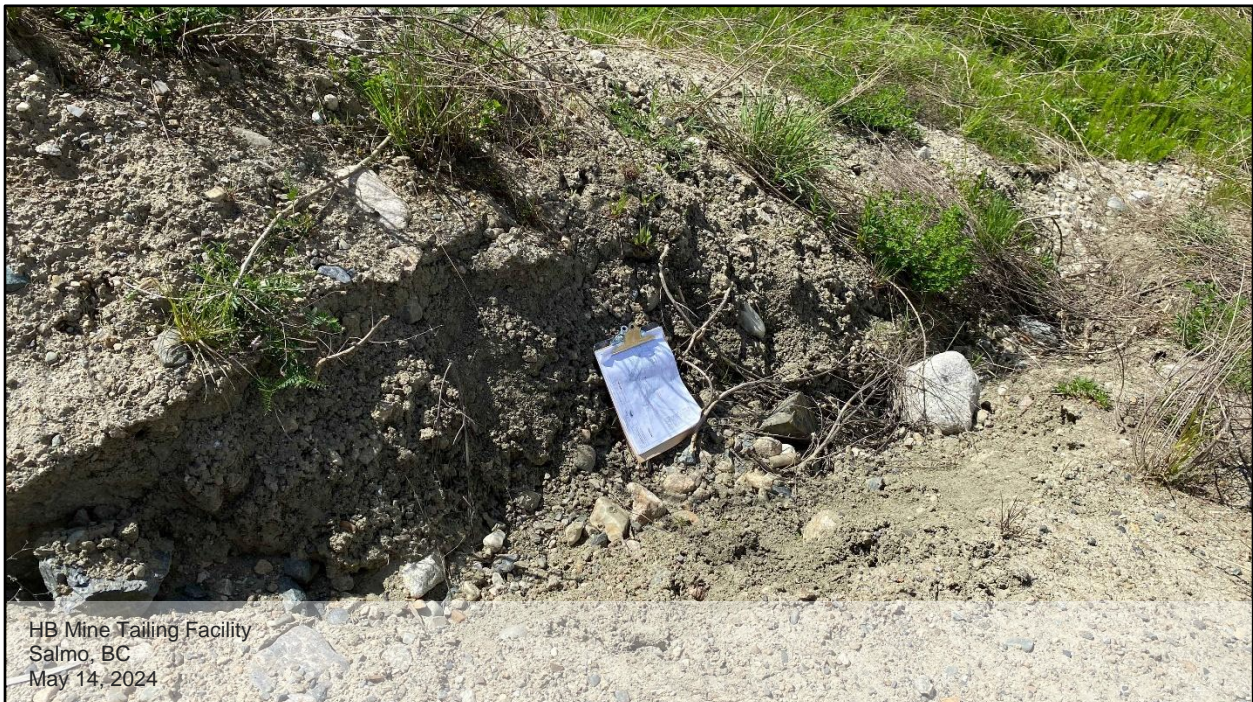
**Photo D.24: A close view of the downstream east slope of the expanded berm. Gullies have been developed considerably near the east abutment of the dam.**

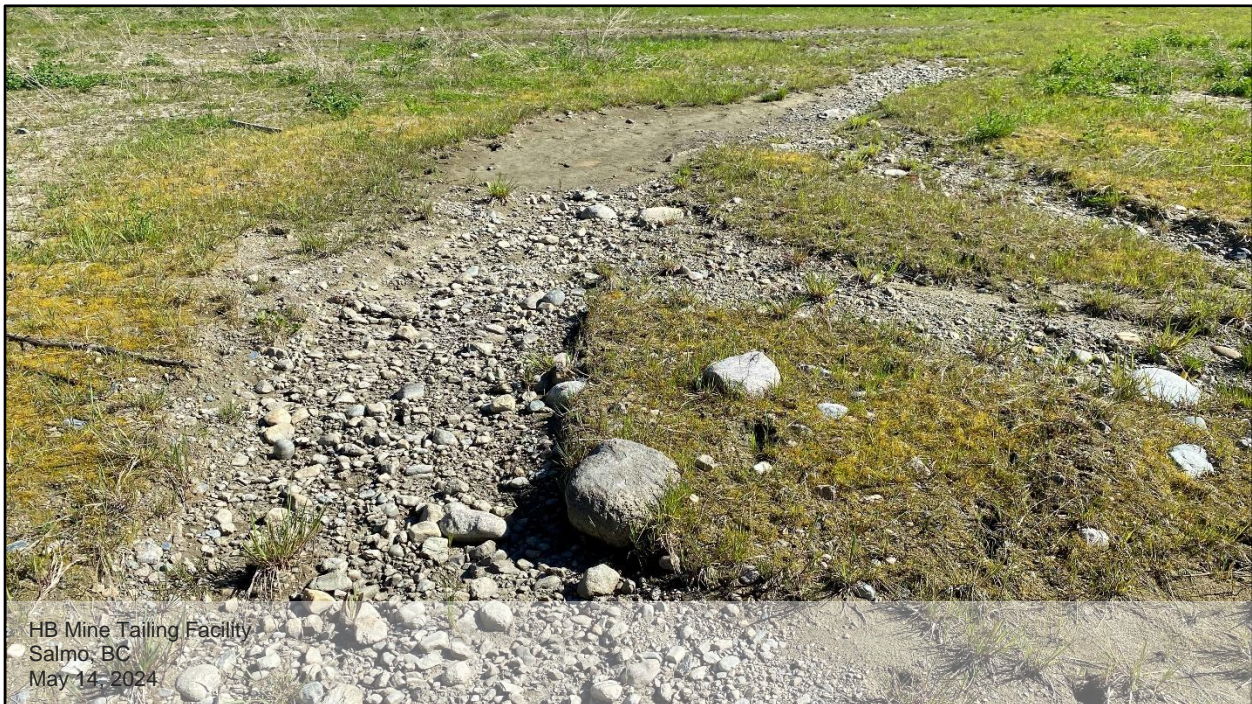
**Photo D.26: Multiple surface eroded areas with several centimeters of depth were observed around the tailing cover perimeter.**

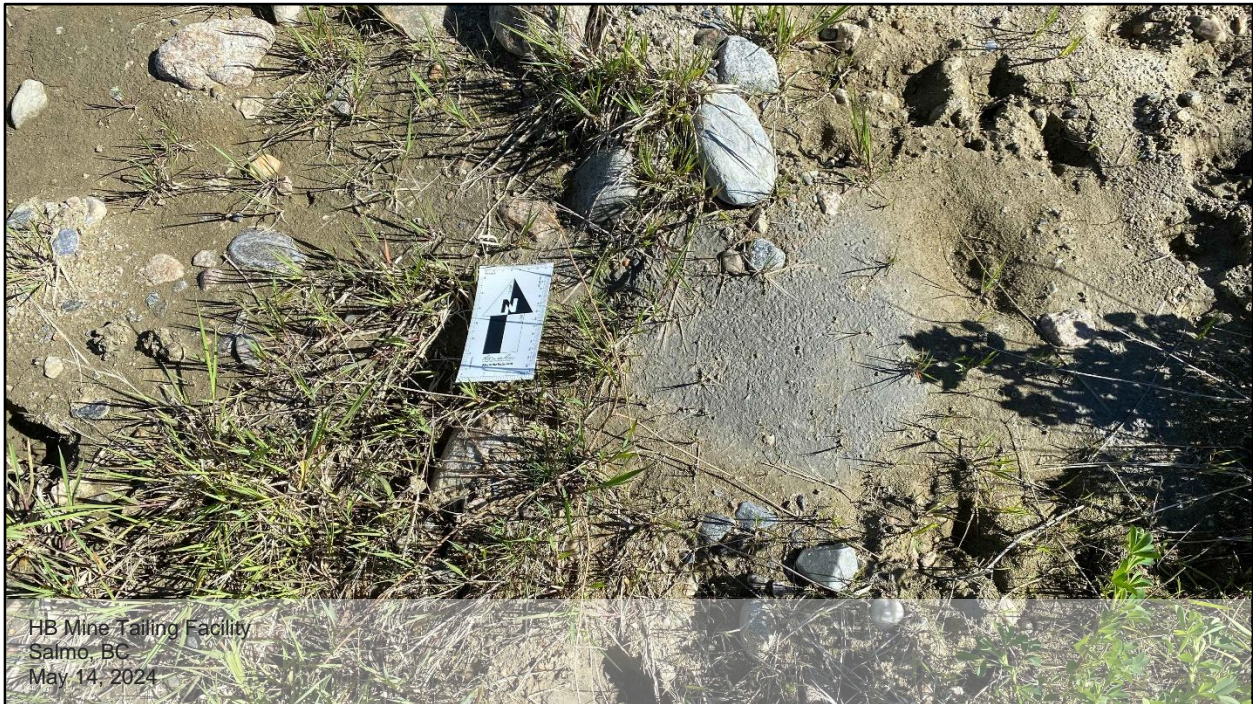
**Photo D.27: A close view of the tailings exposure around the tailing cover perimeter.**

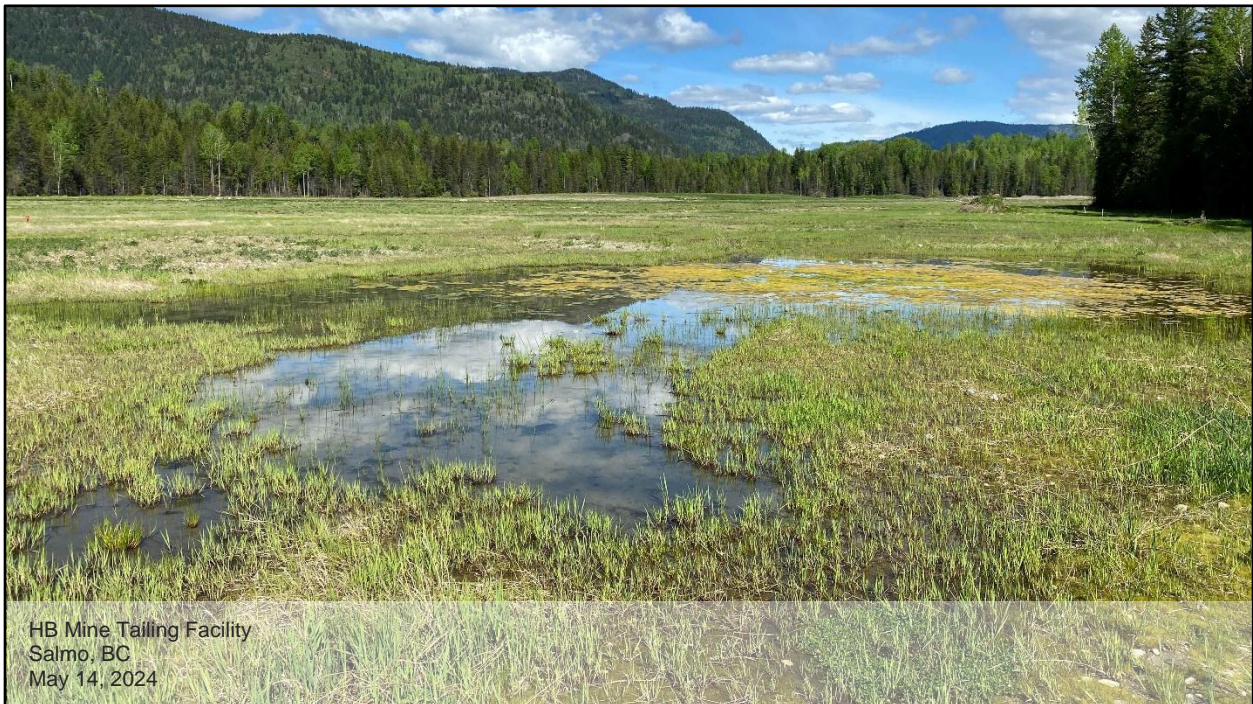
**Photo D.28: General view of the tailing impoundment area, looking northwest. Water ponding and wetland areas were observed mainly along the east side of the tailing impoundment area.**

2024-DSR-07	Water ponded areas were observed along the east side of the tailing impoundment area, north of the North Spur Channel. The low point areas and water ponding within these areas appear to be likely the result of the differential settlement.	5.3	–	Continue regular monitoring of the ponded areas in accordance with the OMS Manual and develop a plan to repair if needed.	Medium
2024-DSR-11	The current OMS Manual needs to be updated to meet the HSRC requirements.	7.3	Non-Conformance	<ul style="list-style-type: none"> <li>▪ Incorporate the recent changes in the HSRC regarding the AFPR, as well as revising the annual DSI to the AFPR and ensuring that its scope meets the requirements of the most recent HSRC revision.</li> <li>▪ Ensure that the AFPR includes an analysis and interpretation of the data collected during site surveillance, instrumentation monitoring, and other relevant.</li> <li>▪ Include an annual review of the OMS by a qualified TSF or dam professional, as applicable, and the EOR, with updates implemented as deemed appropriate by the EOR.</li> </ul>	Medium

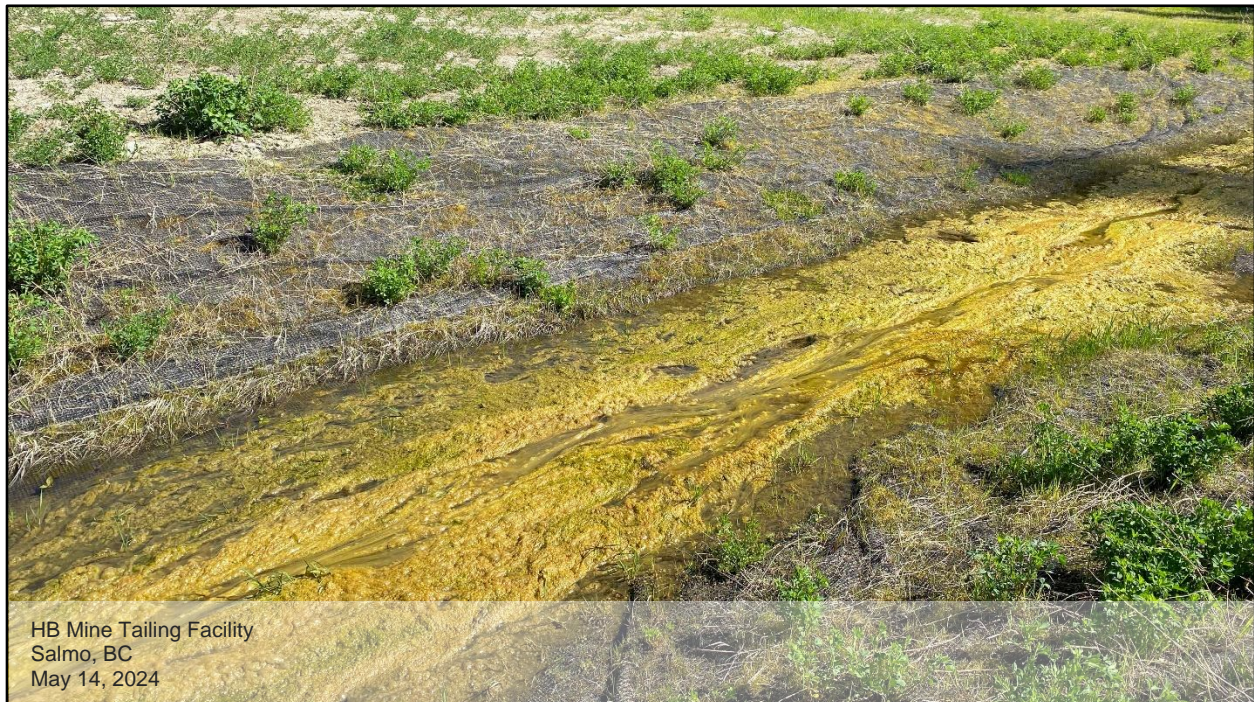
**Photo D.30: Standing Water along with growing algae were found in the east portion of the South Spur Channel, near the SSCED. It apparently occurred due to excess vegetation within the eastern portion of the channel.**

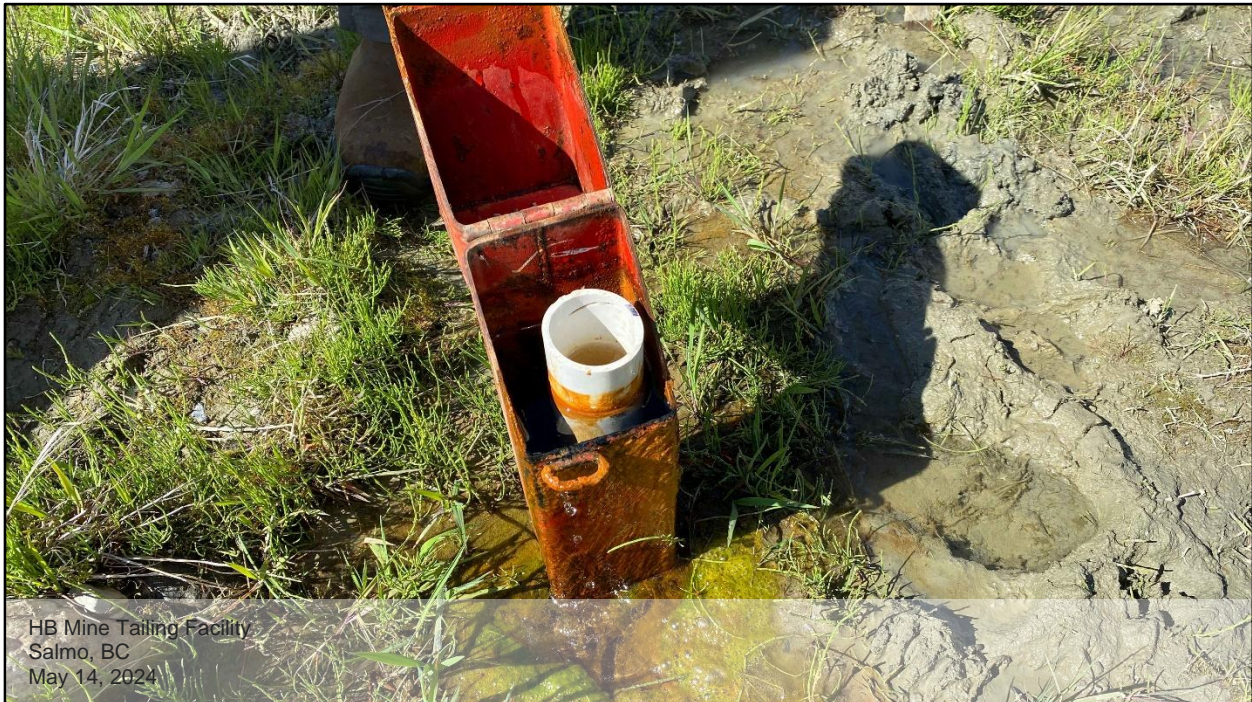
**Photo D.31: A close view of the monitoring well MW-04-S-05 located in the tailing impoundment area. The pipe of the monitoring well was broken and found to be in flowing artesian condition.**

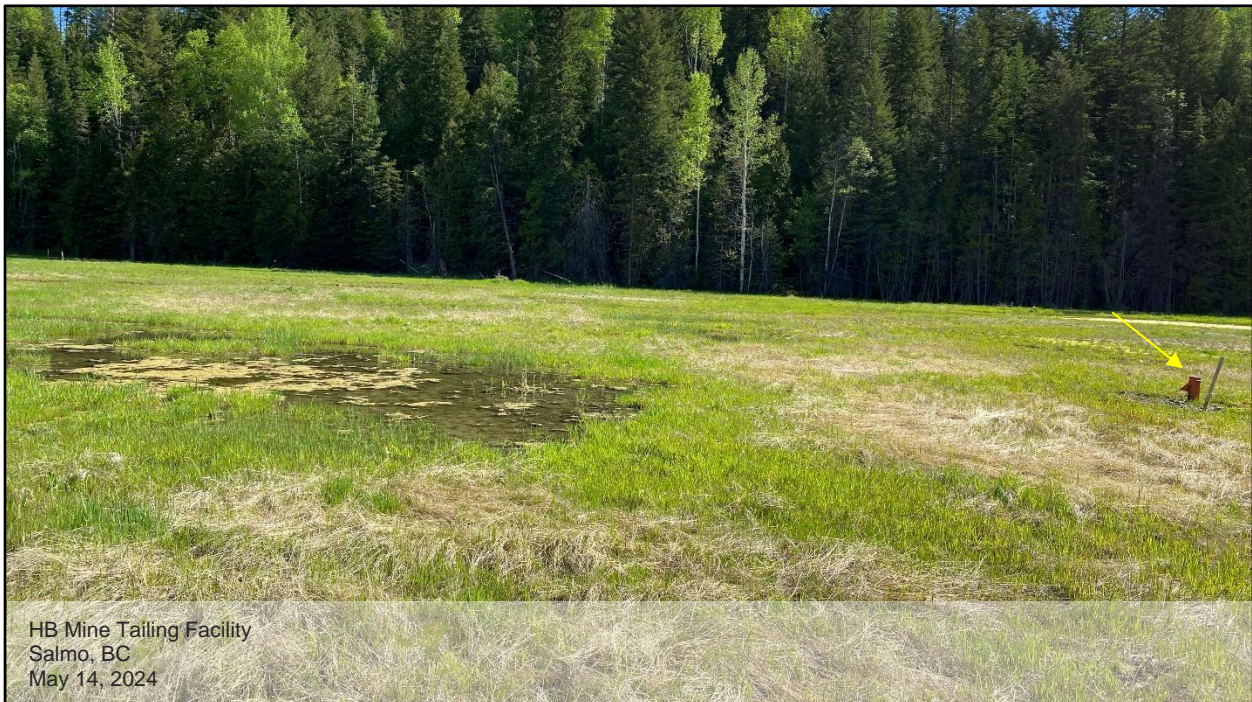
**Photo D.32: View of the tailing impoundment area, looking east. A water ponding area was found near the monitoring well MW-04-S-05 (yellow arrow).**
