2025 Annual Facility Performance Report – HB Mine Tailings Facility

Salmo, BC

SRK Consulting (Canada) Inc. ■ CAPR003603 ■ February 2026

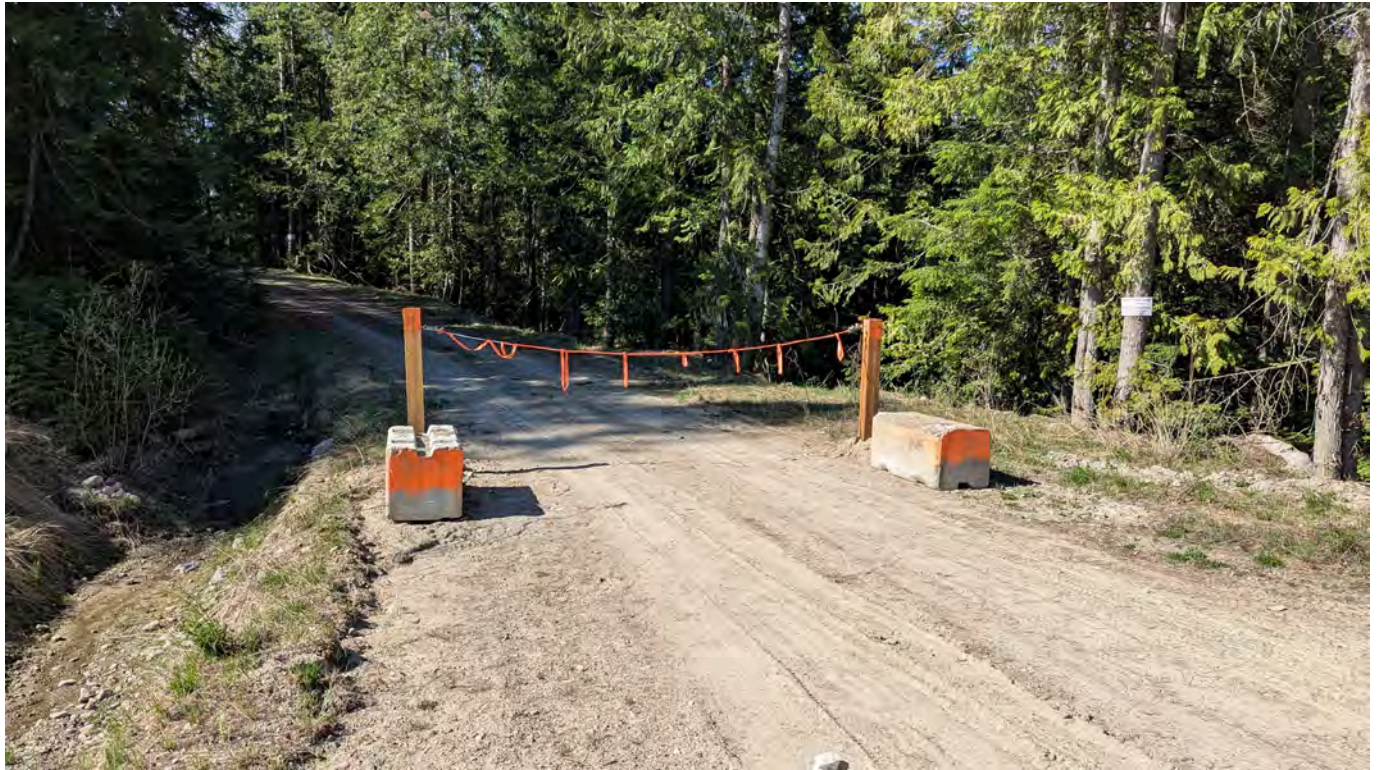
Photo 1: New gate installed on the road from the Central Landfill to the HB Dam to restrict access.

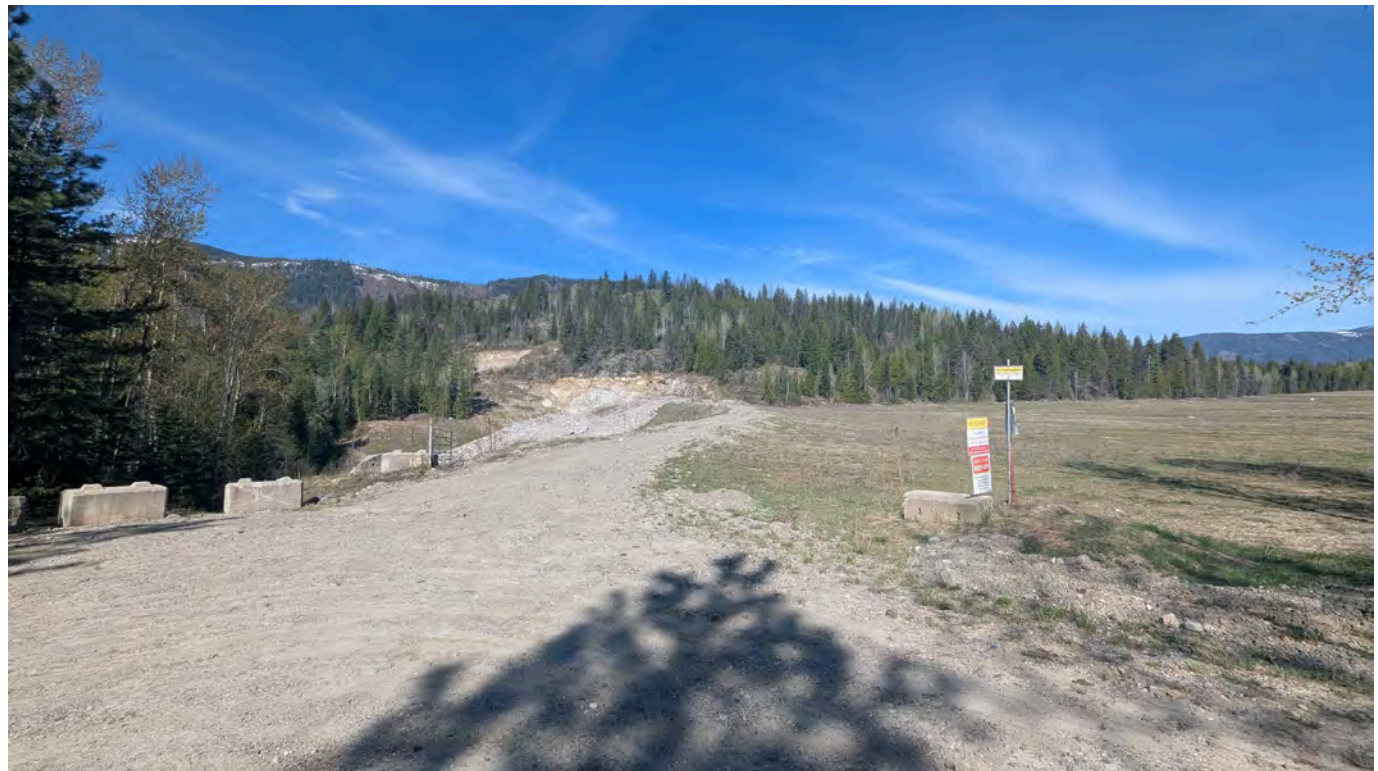
Photo 2: East abutment of the Dam crest looking west.

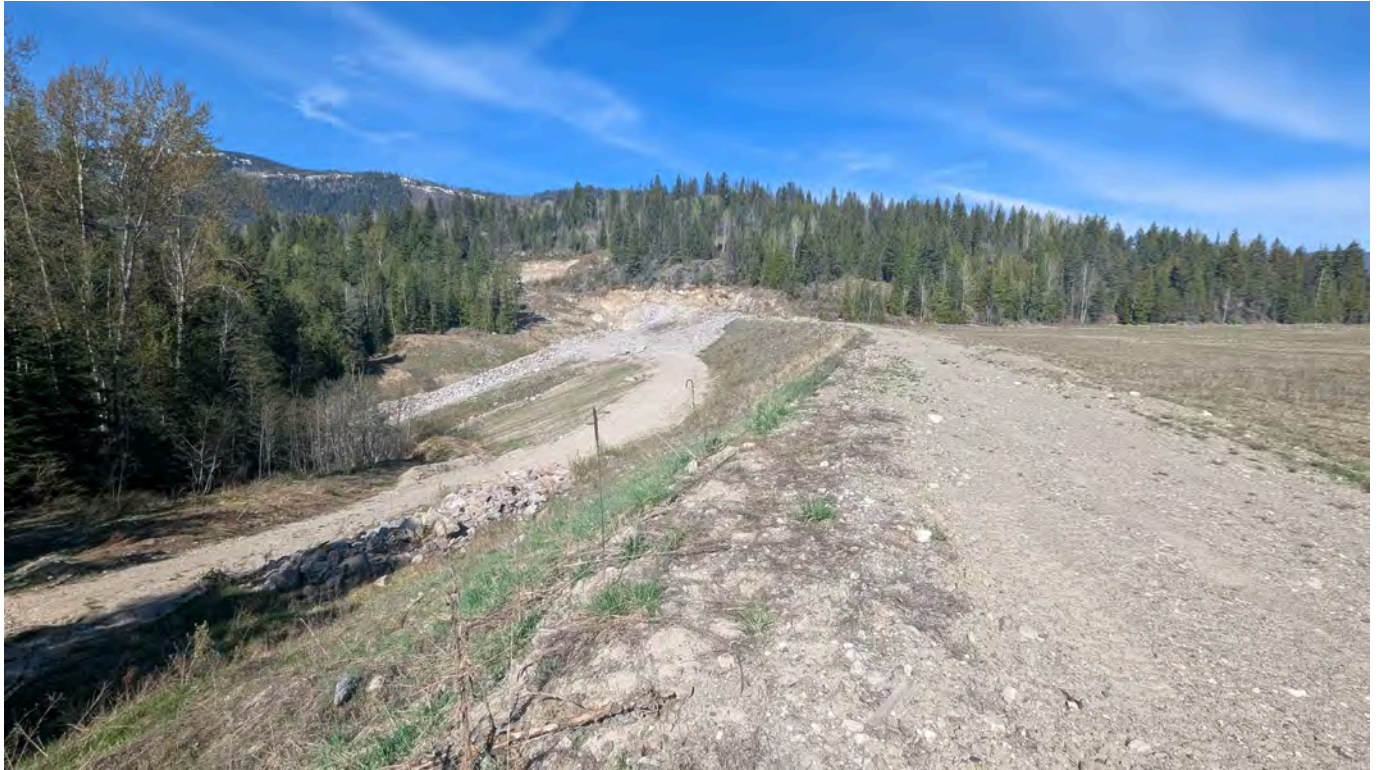
Photo 3: Dam crest and downstream slope looking west from the east abutment.

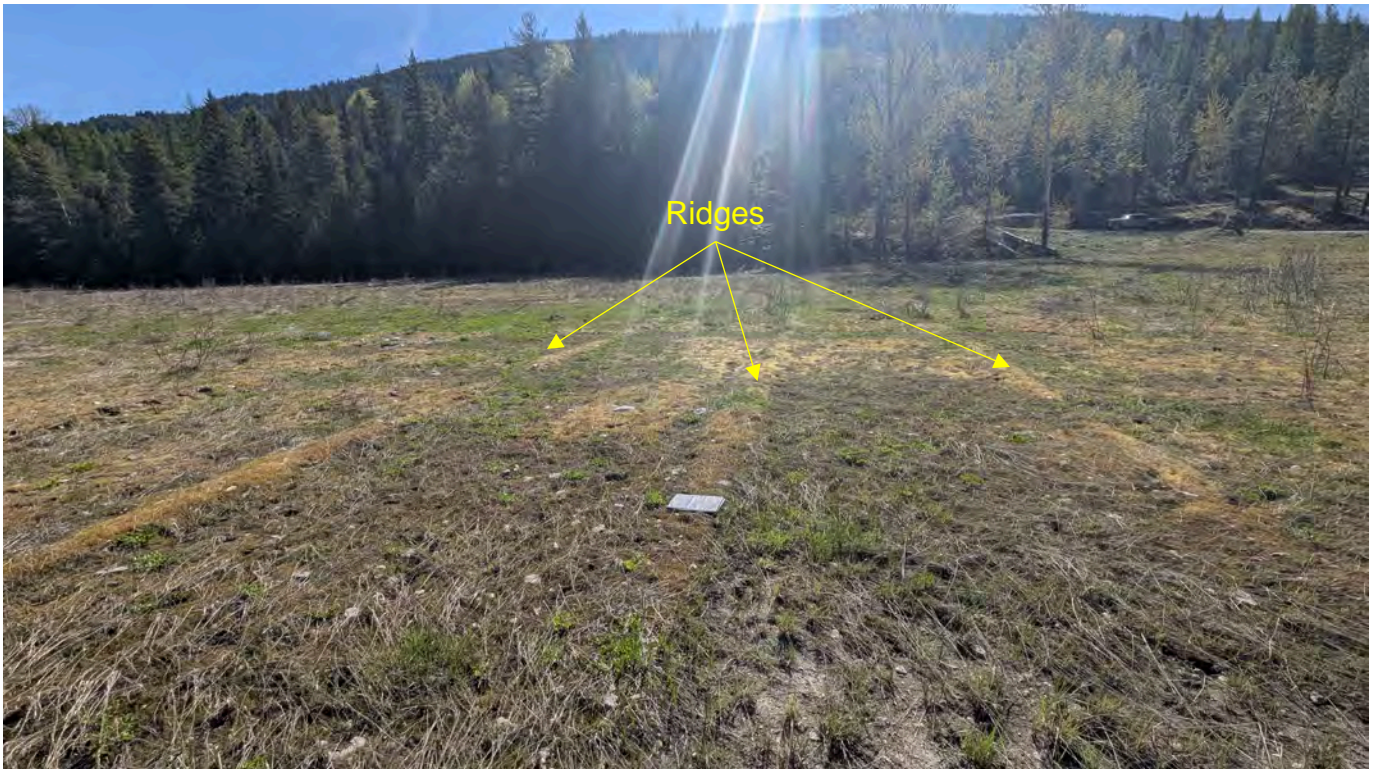
Photo 4: Small ridges are present in the tailings pond backfill area that are about 10 cm high and spaced 3.0-3.5 m apart. Ridges are suspected to be located where the Combigrid overlaps occur from the 2021-2022 construction.

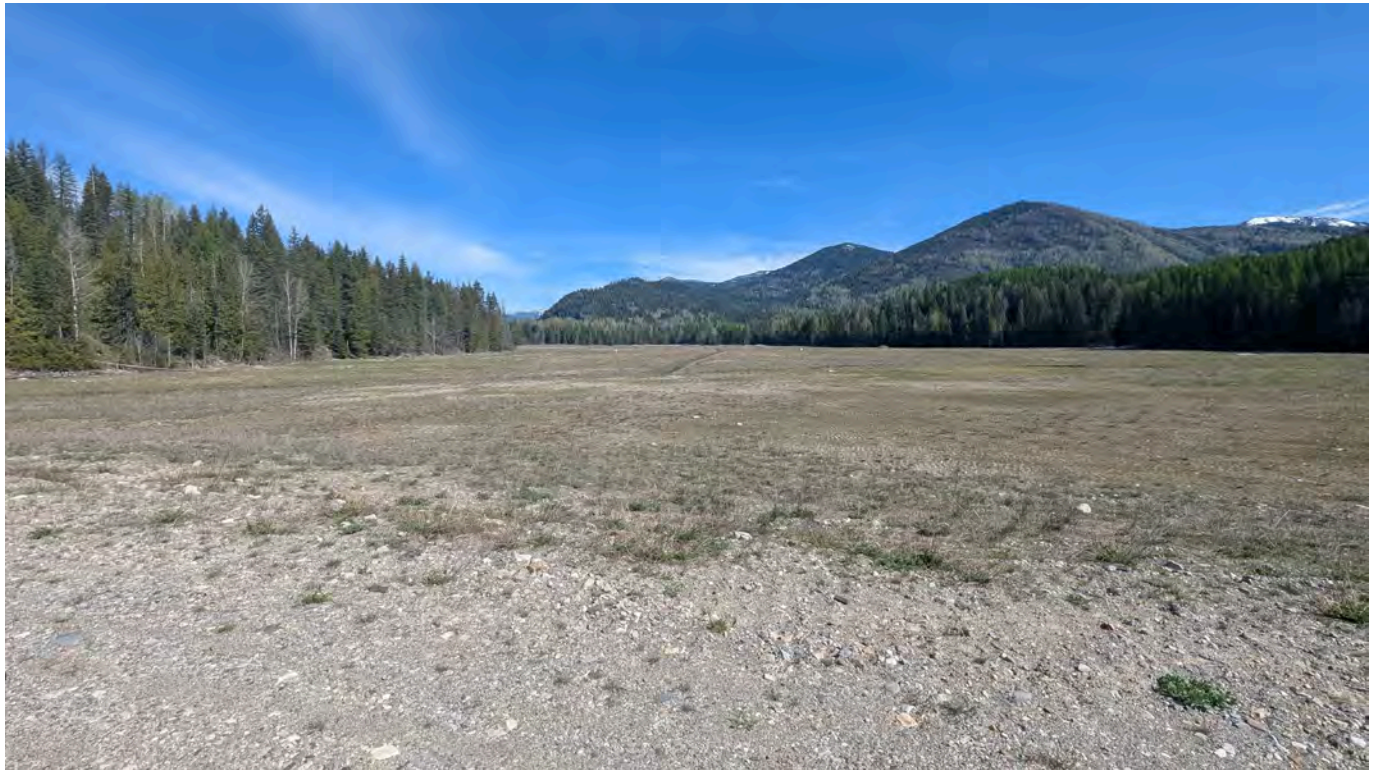
Photo 5: Tailings impoundment looking north from the dam crest.

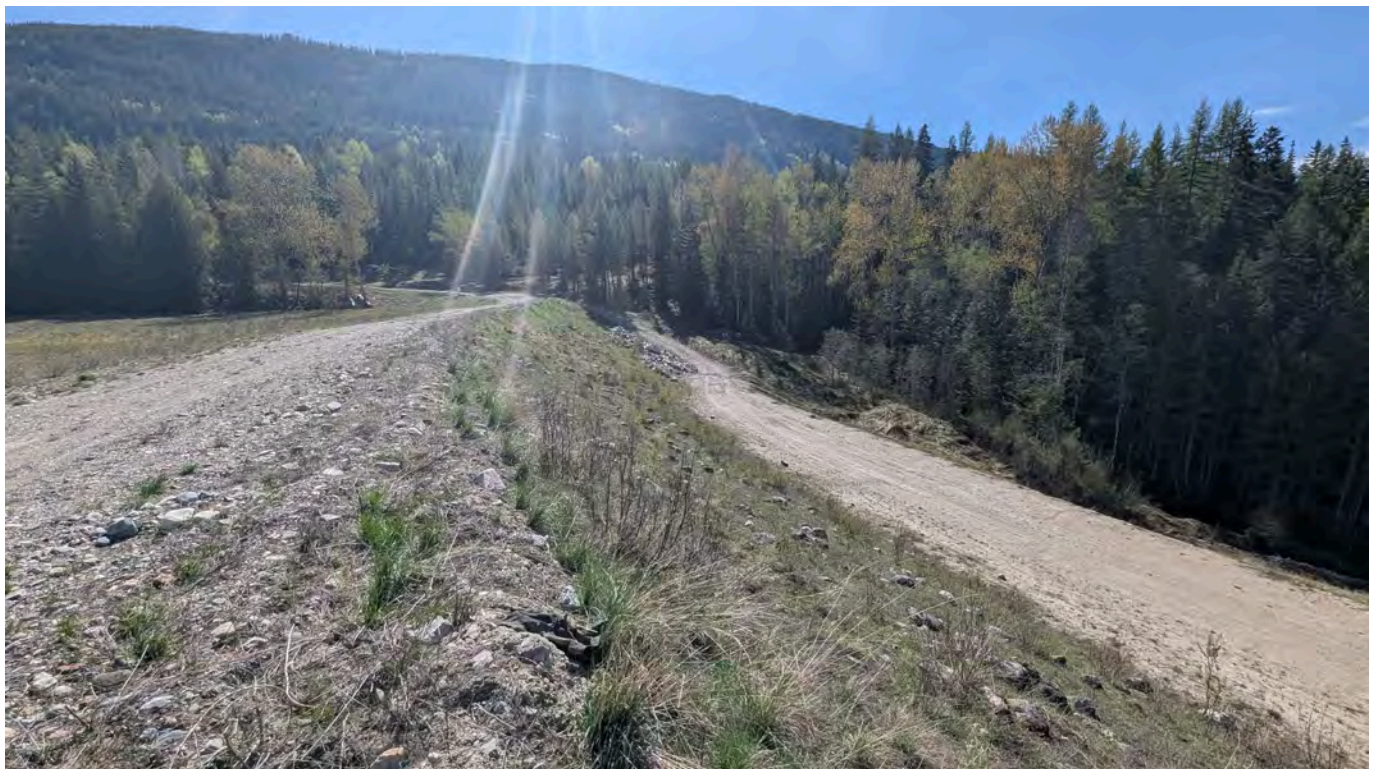
Photo 6: Dam crest and downstream slope looking east from near piezometers P1/P2.

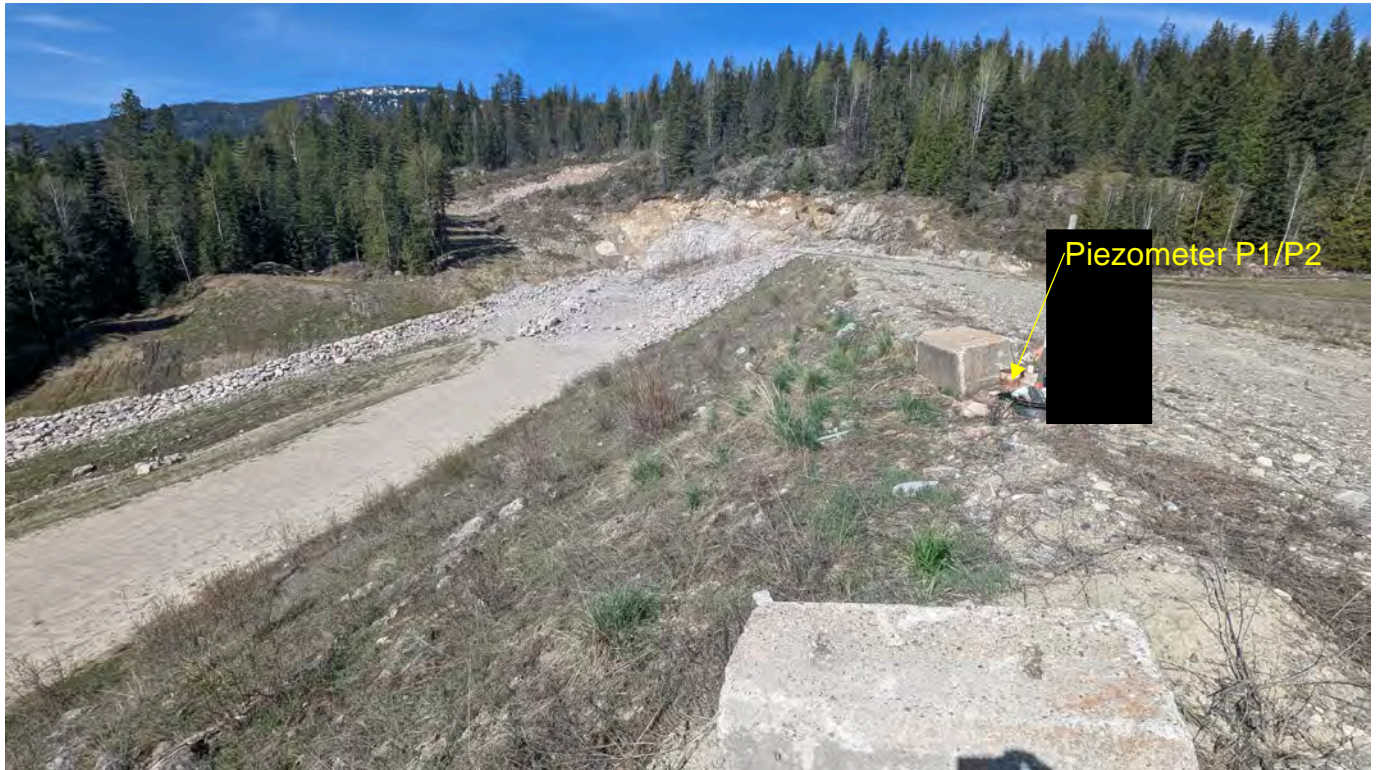
Photo 7: Dam crest and downstream slope looking west from near piezometers P1/P2.

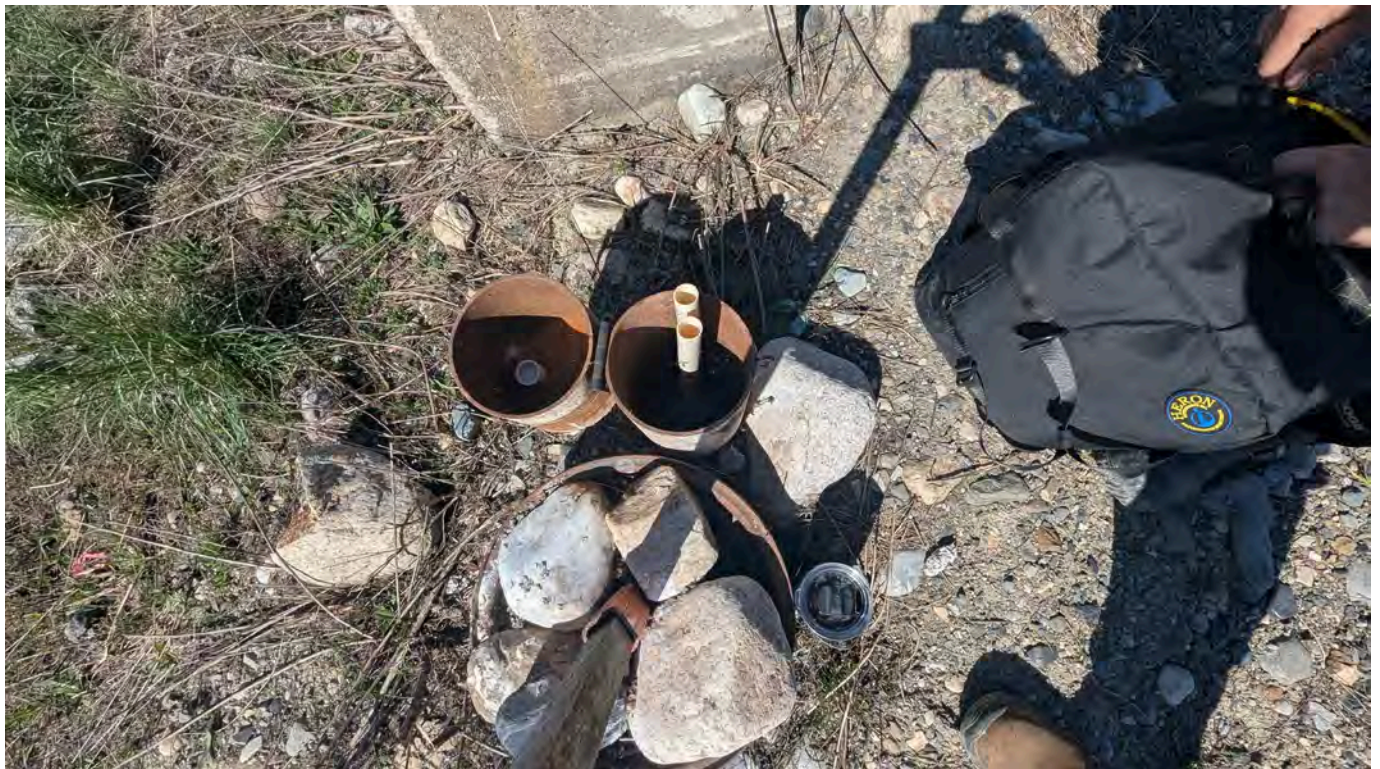
Photo 8: Piezometers P1/P2 at the dam crest.

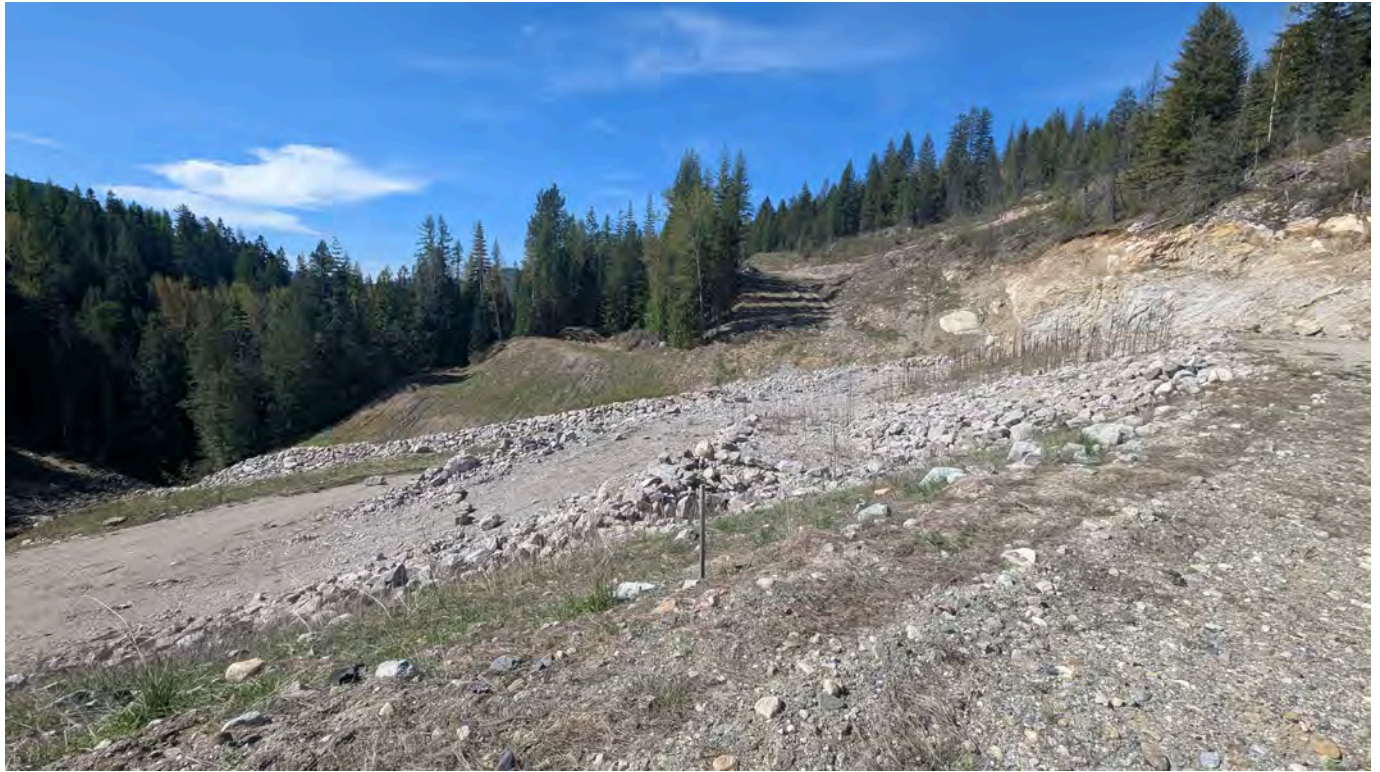
Photo 9: 2012 Blast Rock Repair area looking southwest.

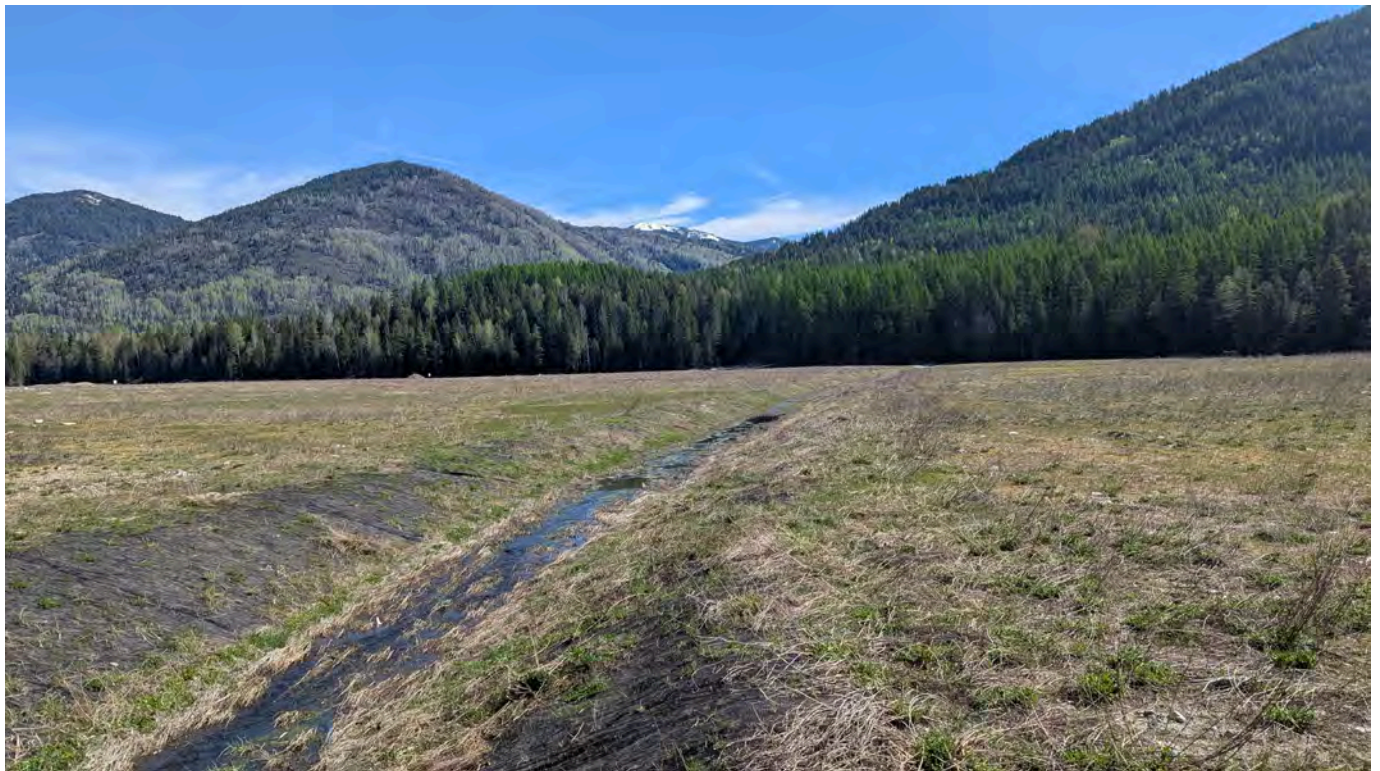
Photo 10: Main Tailings Surface Drainage Channel looking upstream from near the spillway inlet.

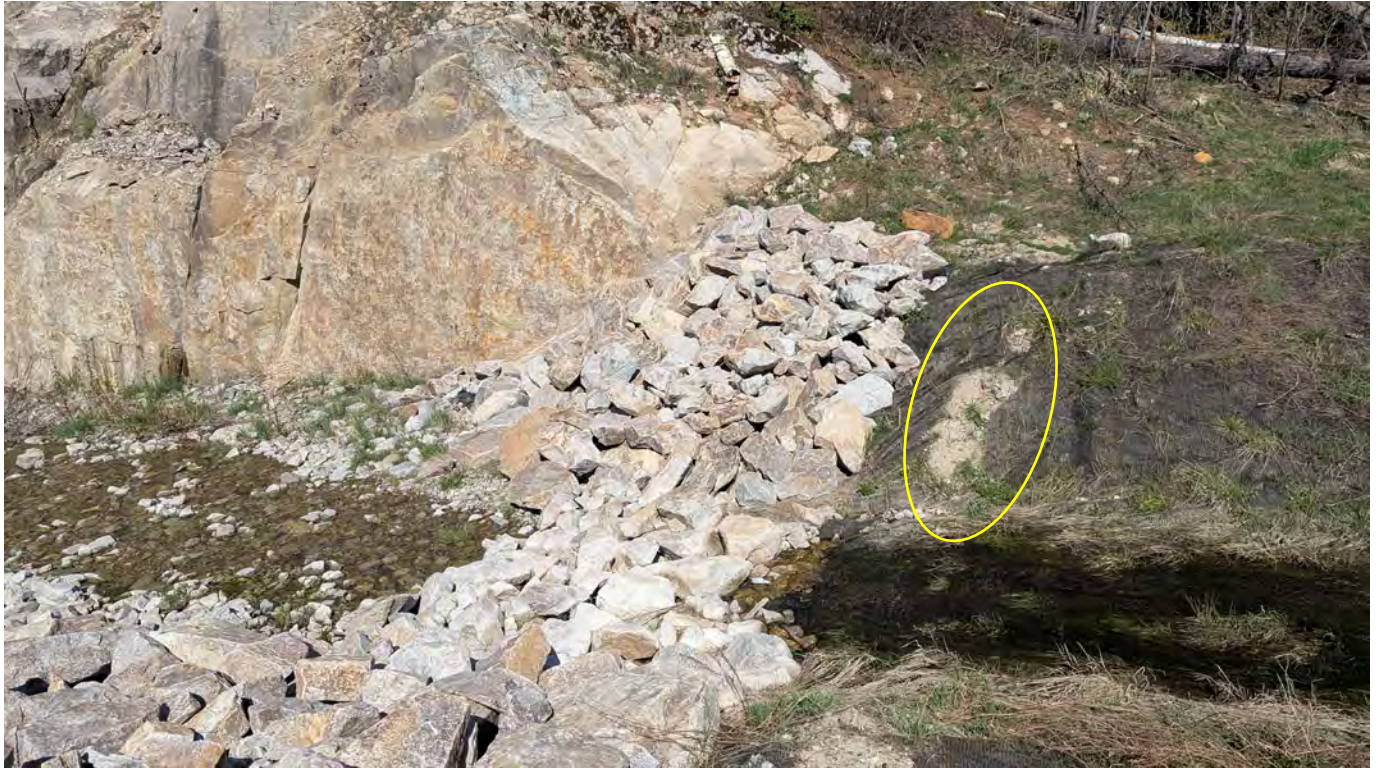
Photo 11: Riprap at the spillway inlet. The sand material upstream of the inlet (circled) is overtop the Turf Reinforcement Mat (TRM) and is not a tear of the TRM. Sand was likely deposited during the riprap placement in 2023.

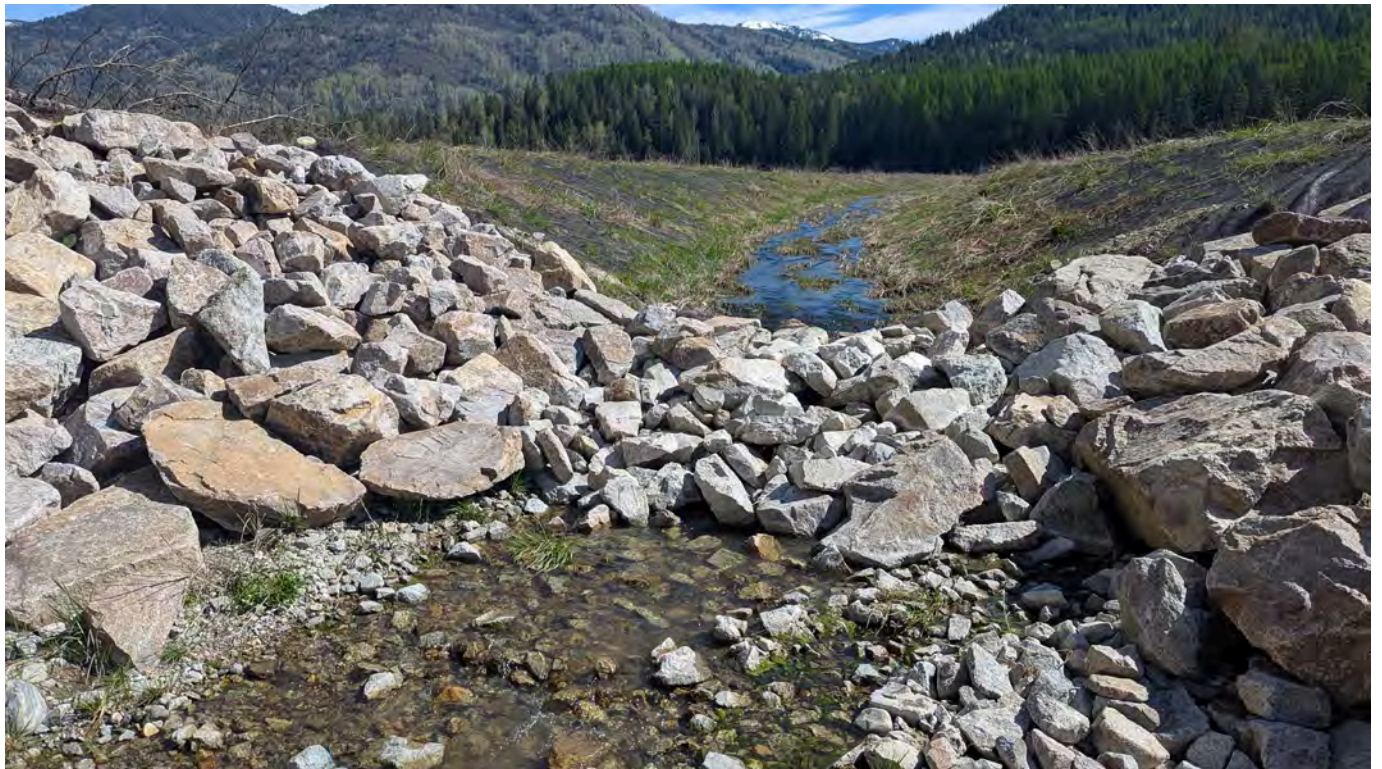
Photo 12: Riprap at the spillway inlet. No signs of riprap movement observed.

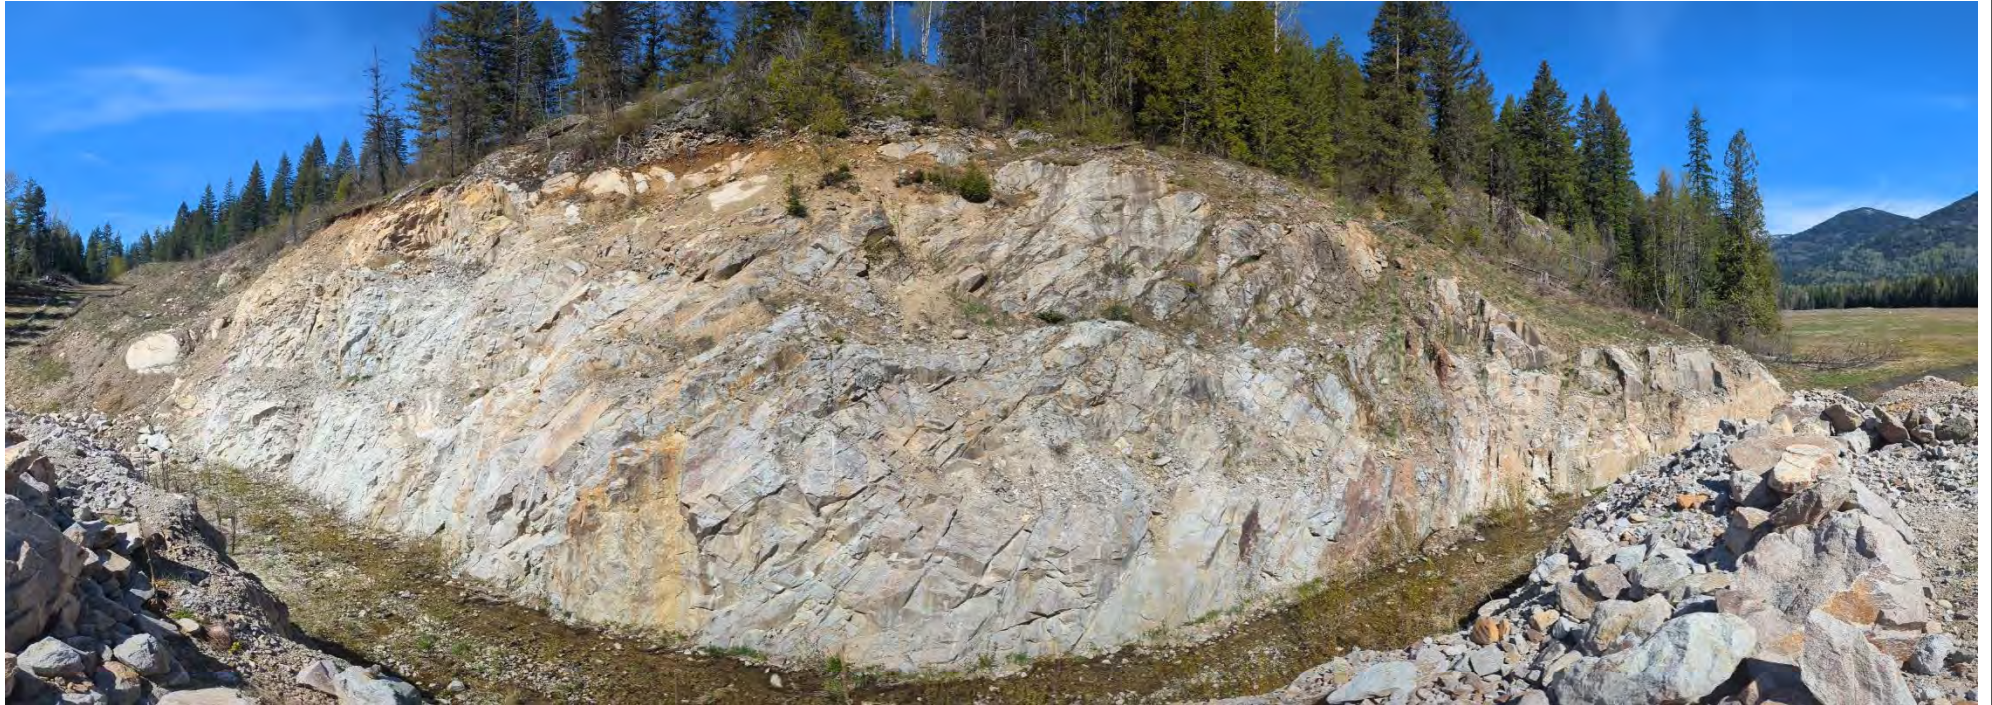
Photo 13: Spillway highwall.

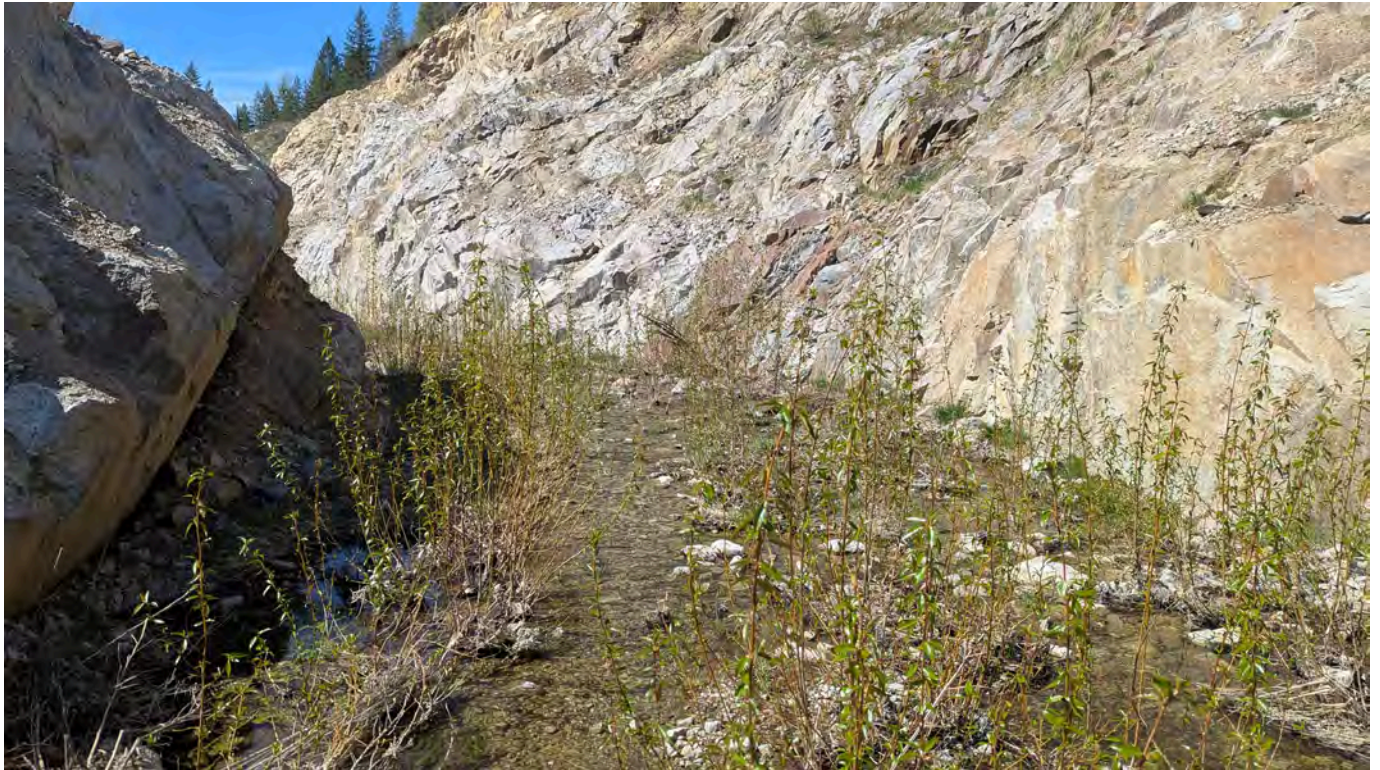
Photo 14: Bedrock spillway looking downstream.

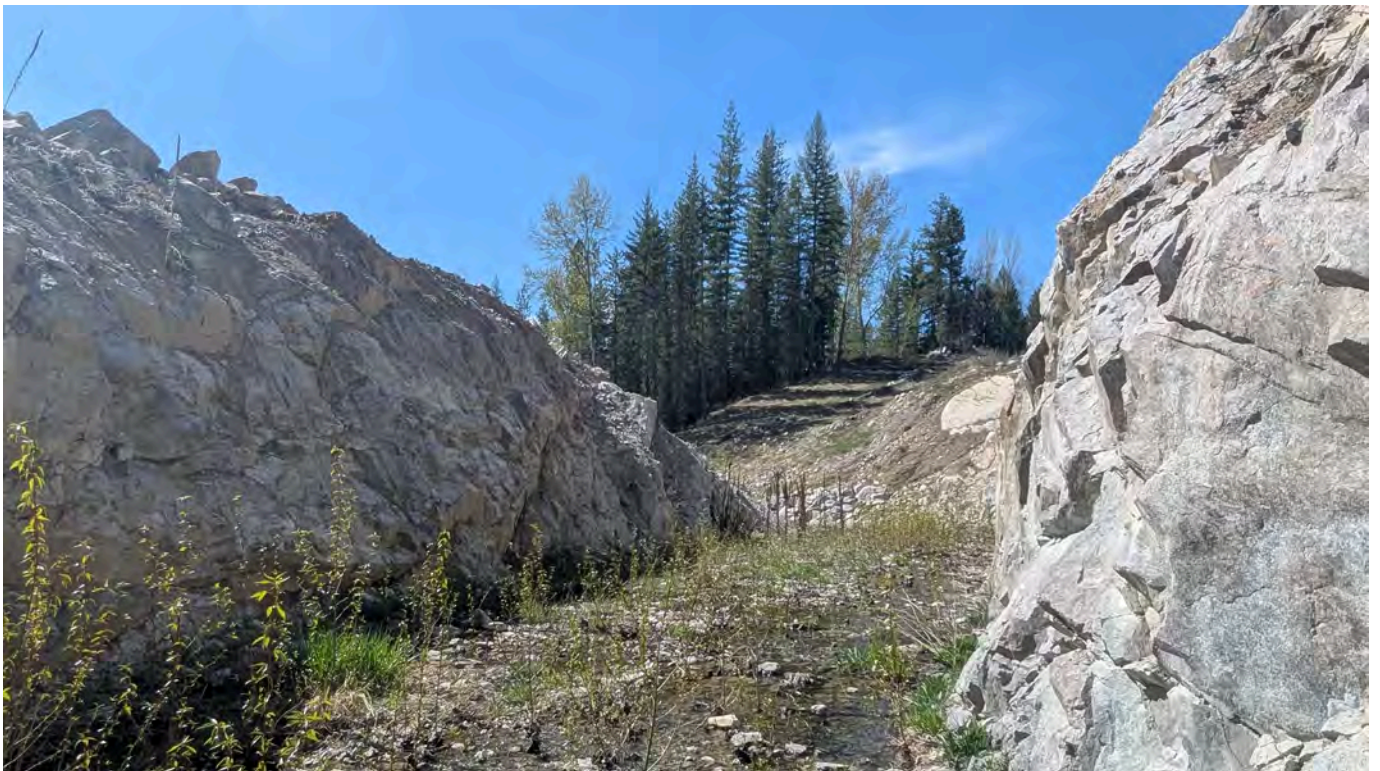
Photo 15: Bedrock spillway looking downstream.

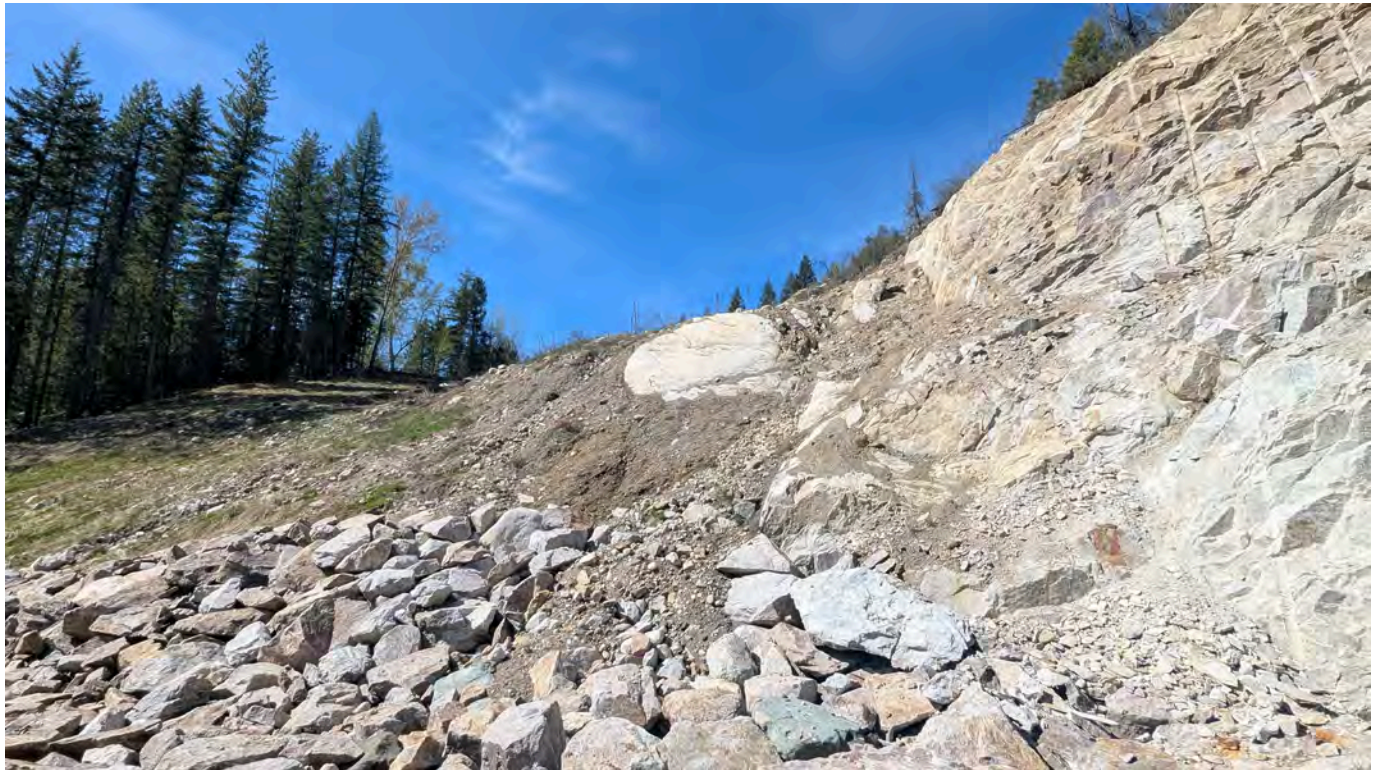
Photo 16: Erosion gully at the downstream end of the bedrock highwall adjacent to the spillway. The gully is self-armouring and the conditions are unchanged compared to the 2024 inspection.

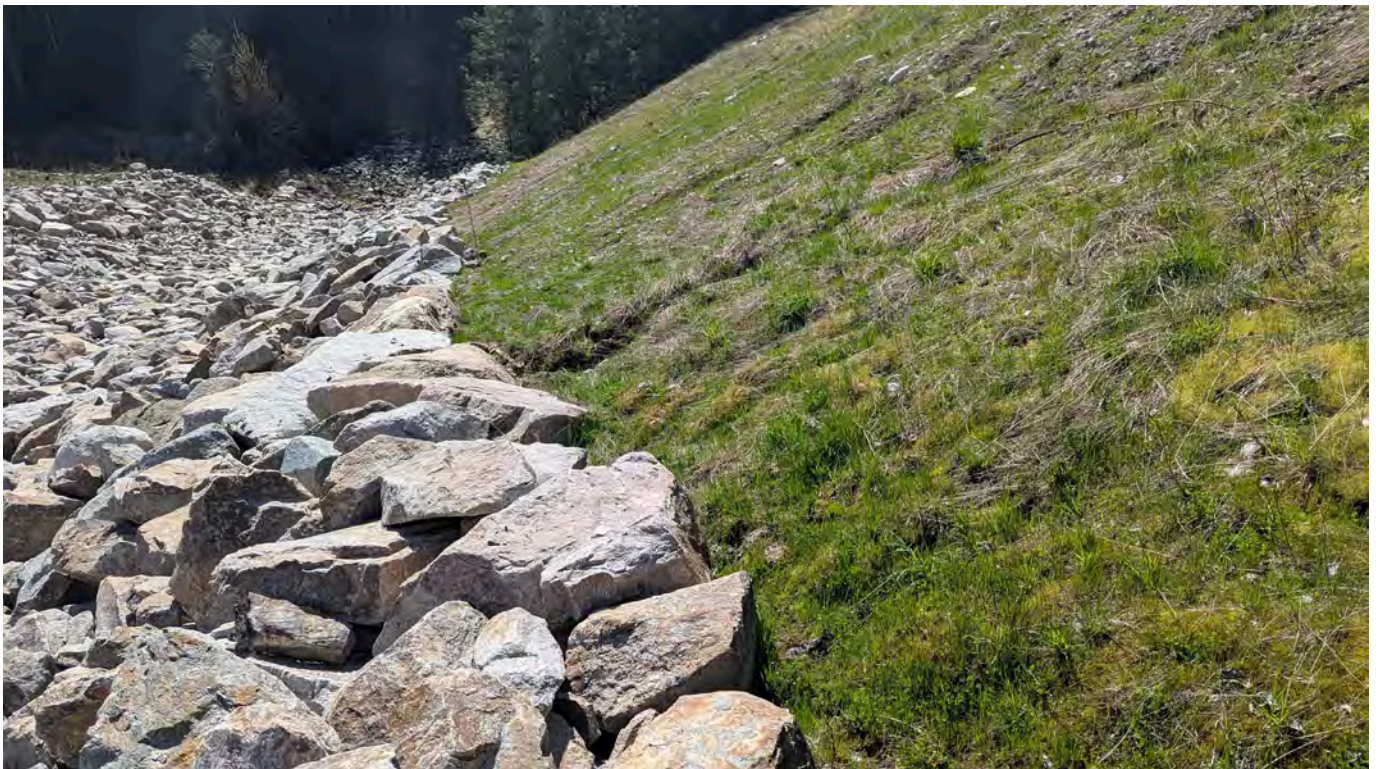
Photo 17: Right bank of the spillway looking downstream. A small erosion gully is present. Any water flowing down the gully flows overtop the geotextile and into the spillway. No actions are required.

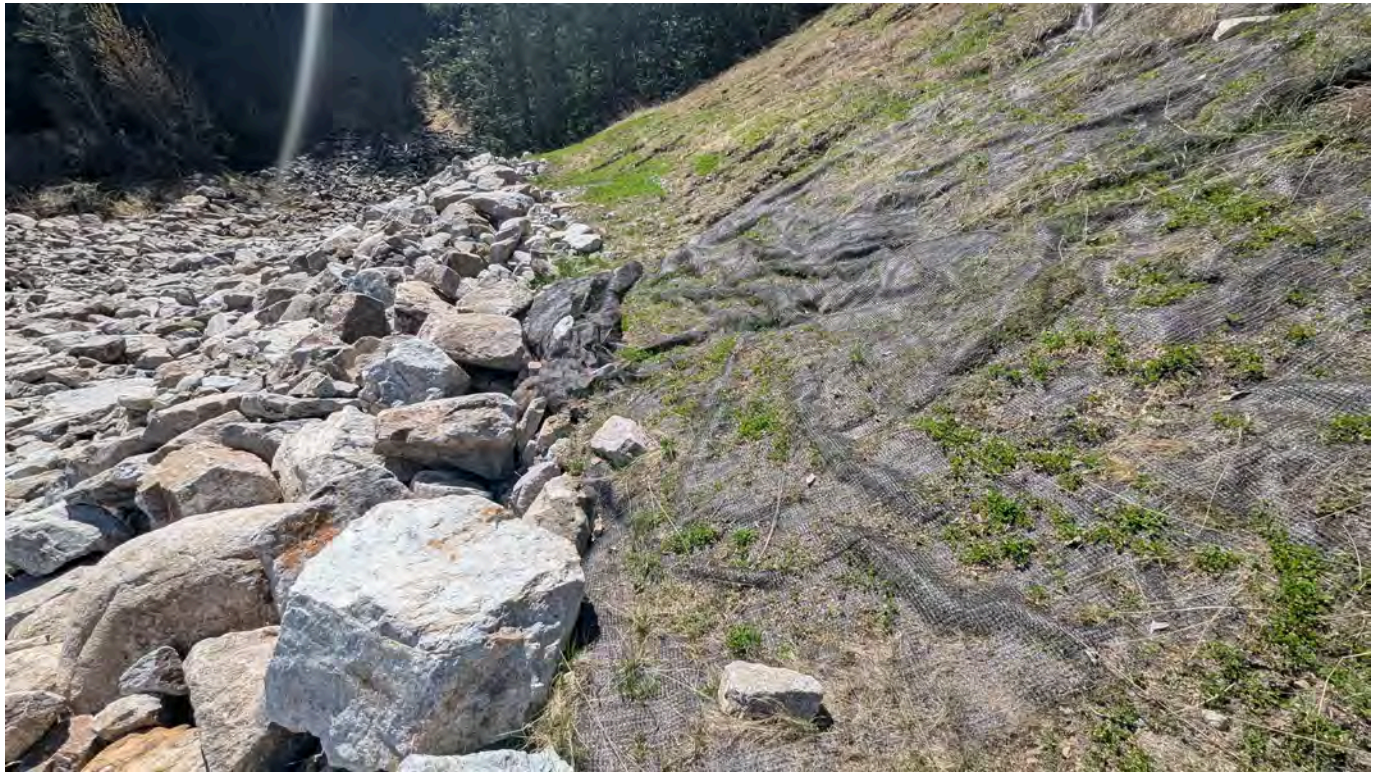
Photo 18: Right bank of the spillway looking downstream showing the area repaired in 2023. The repair is in good condition with no signs of instability.

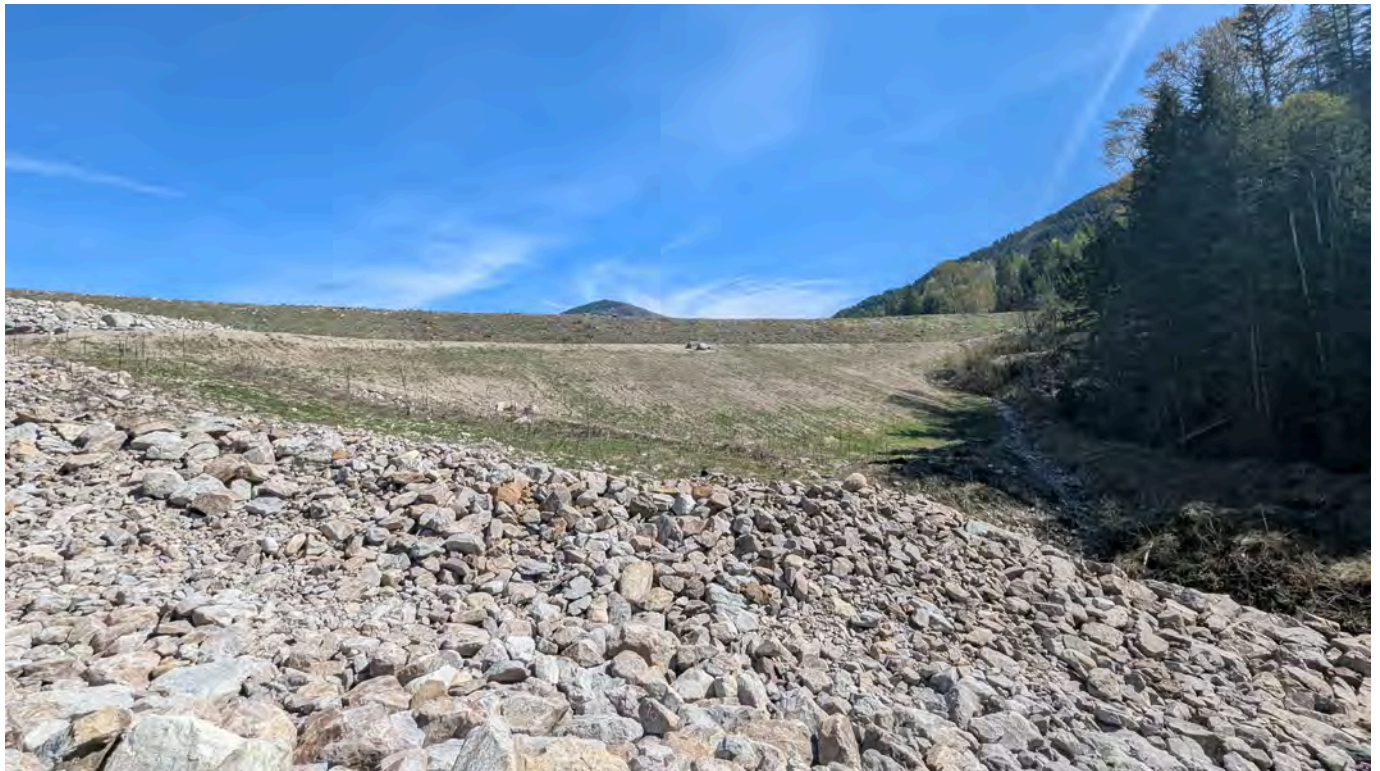
Photo 19: Downstream slope of the dam and left bank of the spillway looking north.

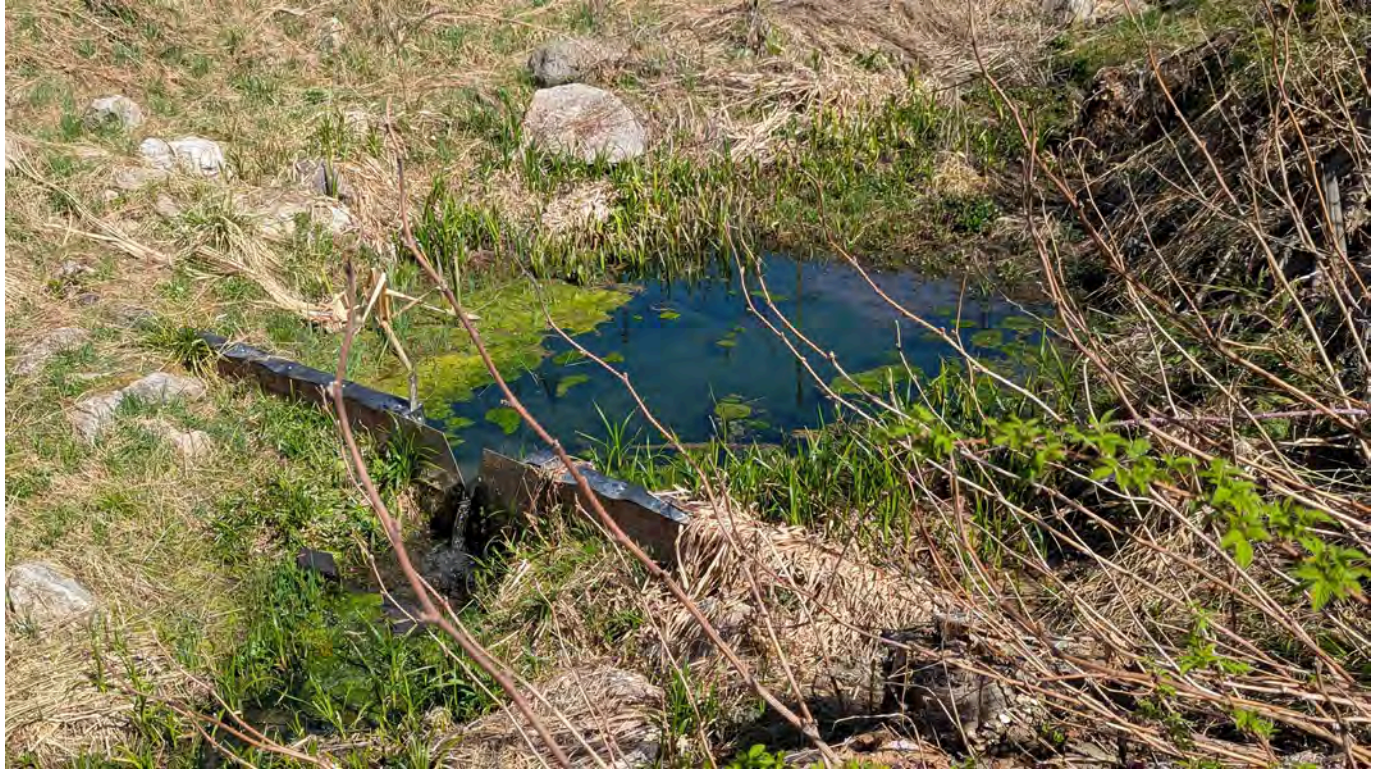
Photo 20: V-notch seepage weir. Seepage was clear with no signs of sediment deposition..

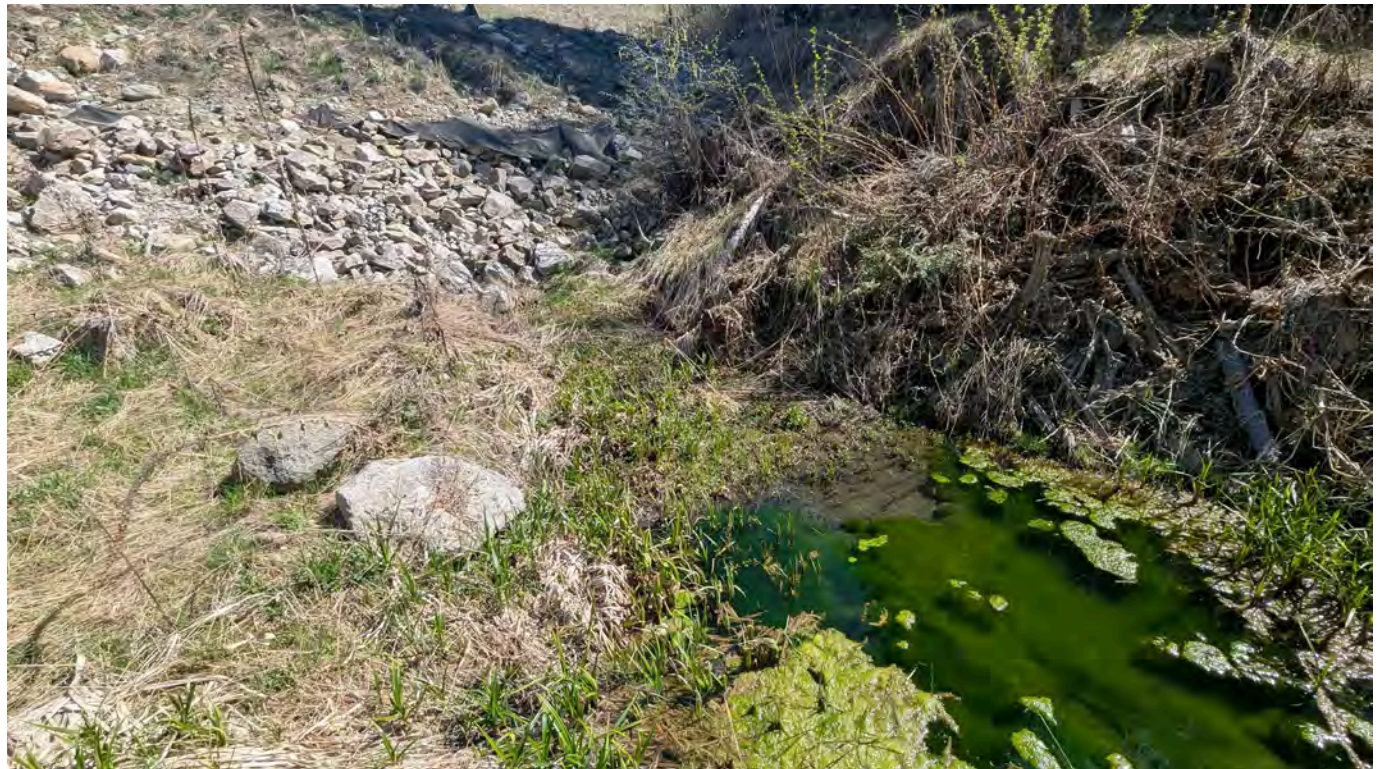
Photo 21: Area between the dam toe and seepage weir.
