2025 Annual Facility Performance Report – HB Mine Tailings Facility

Salmo, BC

SRK Consulting (Canada) Inc. ■ CAPR003603 ■ February 2026

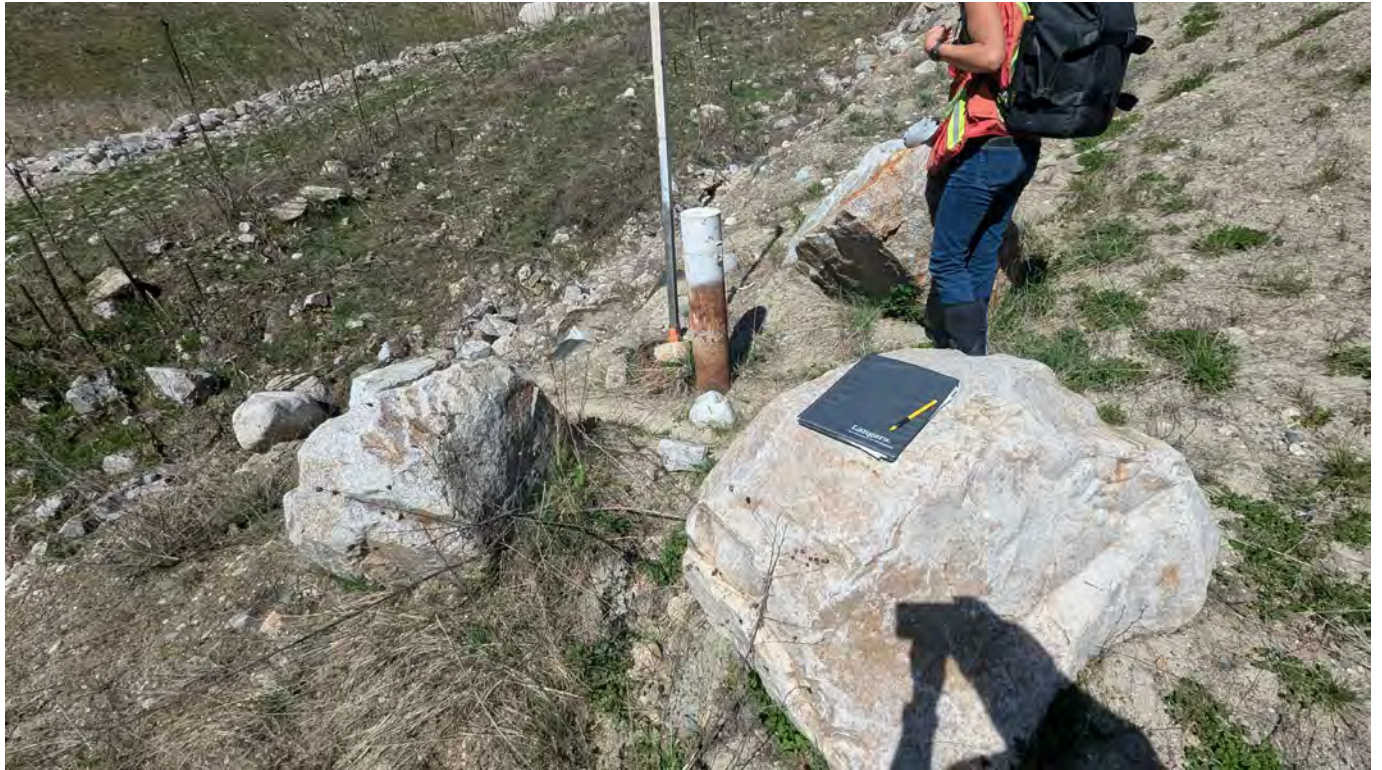
Photo 22: Piezometer P3.

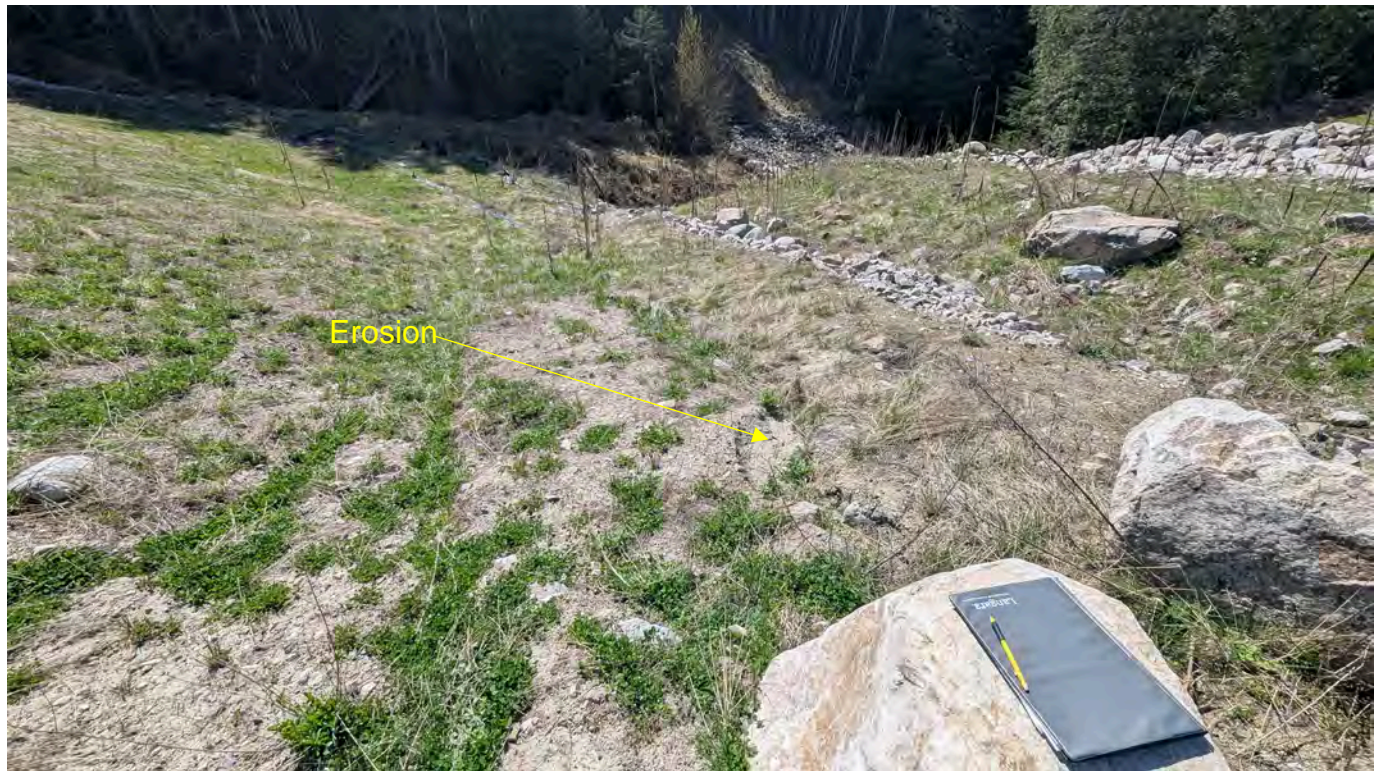
Photo 23: Downstream slope of the toe berm at the west abutment looking downslope from Piezometer P3. A small erosion gully is present orientated parallel to the slope approximately 5 cm deep, 5 cm wide. Continue to monitor.

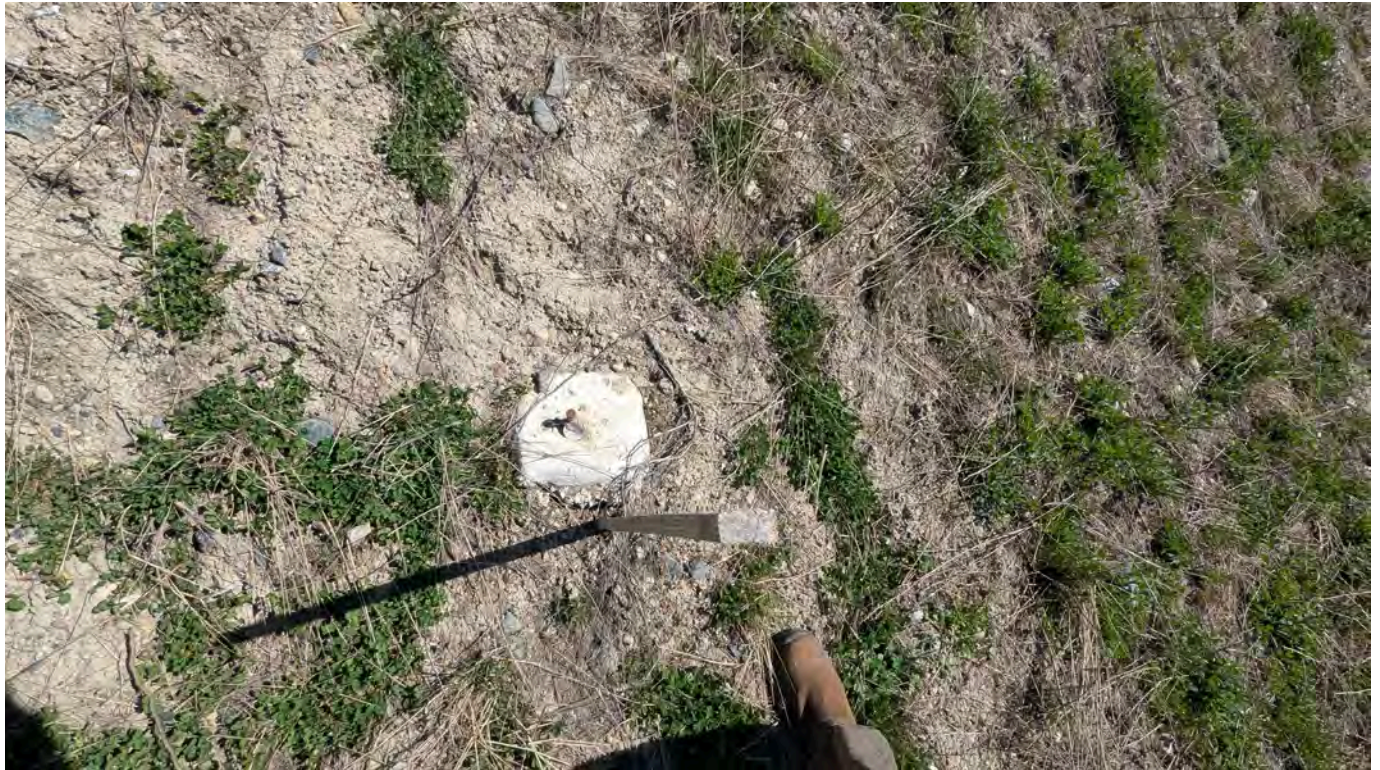
Photo 24: Survey hub H-10.

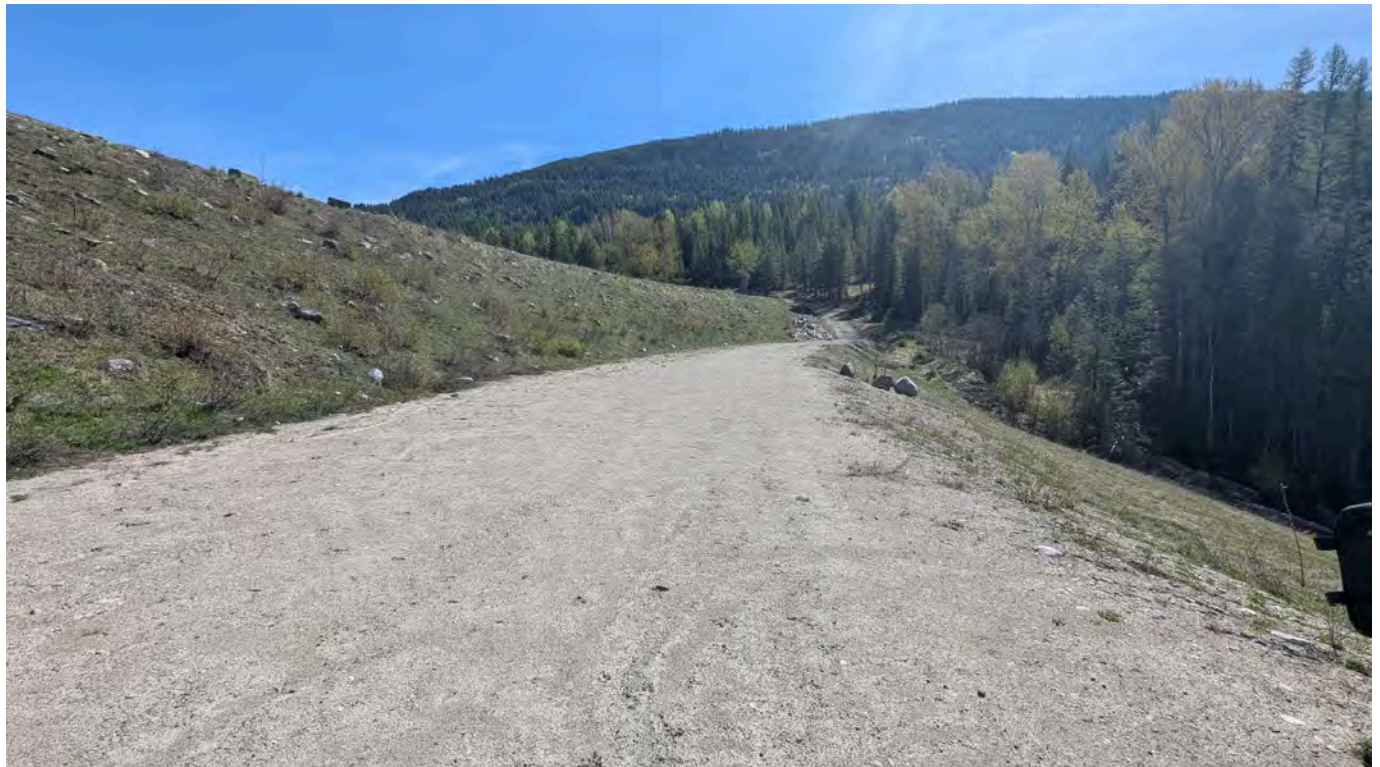
Photo 25: Crest of the toe berm looking east.

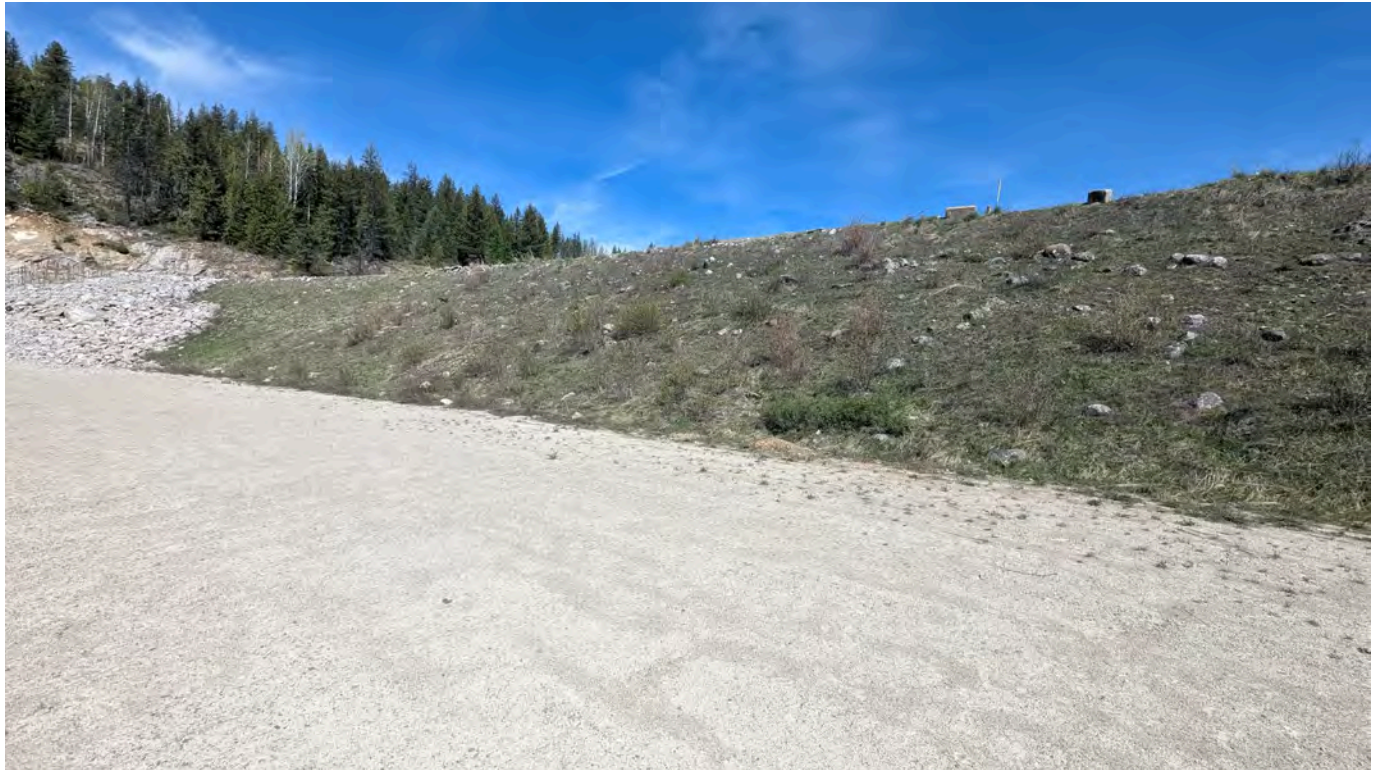
Photo 26: Downstream slope of the dam looking northeast from near piezometers P5/P6.

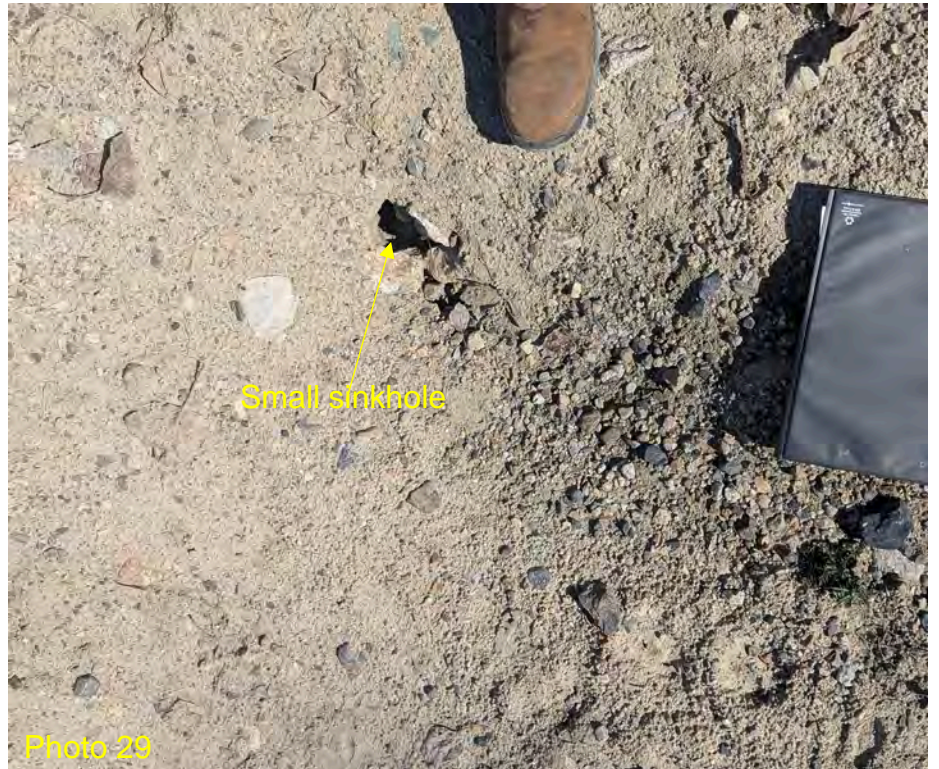
Photo 29

Photo 28 and 29: Small sinkhole on the toe berm crest near the east abutment caused by settlement of till into the underlying weighted filter. Approx 10 cm diameter; 15 cm deep.

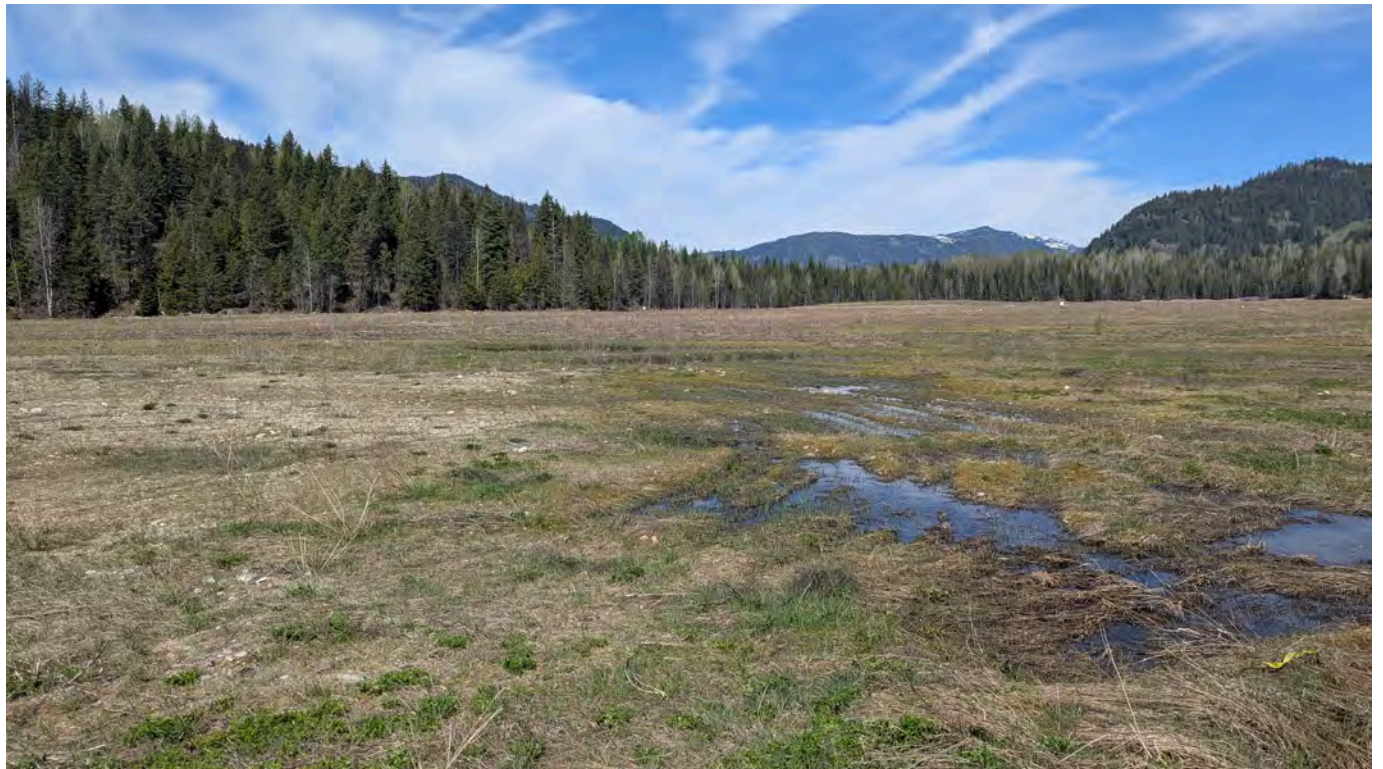
Photo 30: Area of ponding in the tailings pond backfill area. A review of the 2022 and 2025 cover surveys indicates no to minimal (i.e.. < 10 cm) differential settlement in the area.

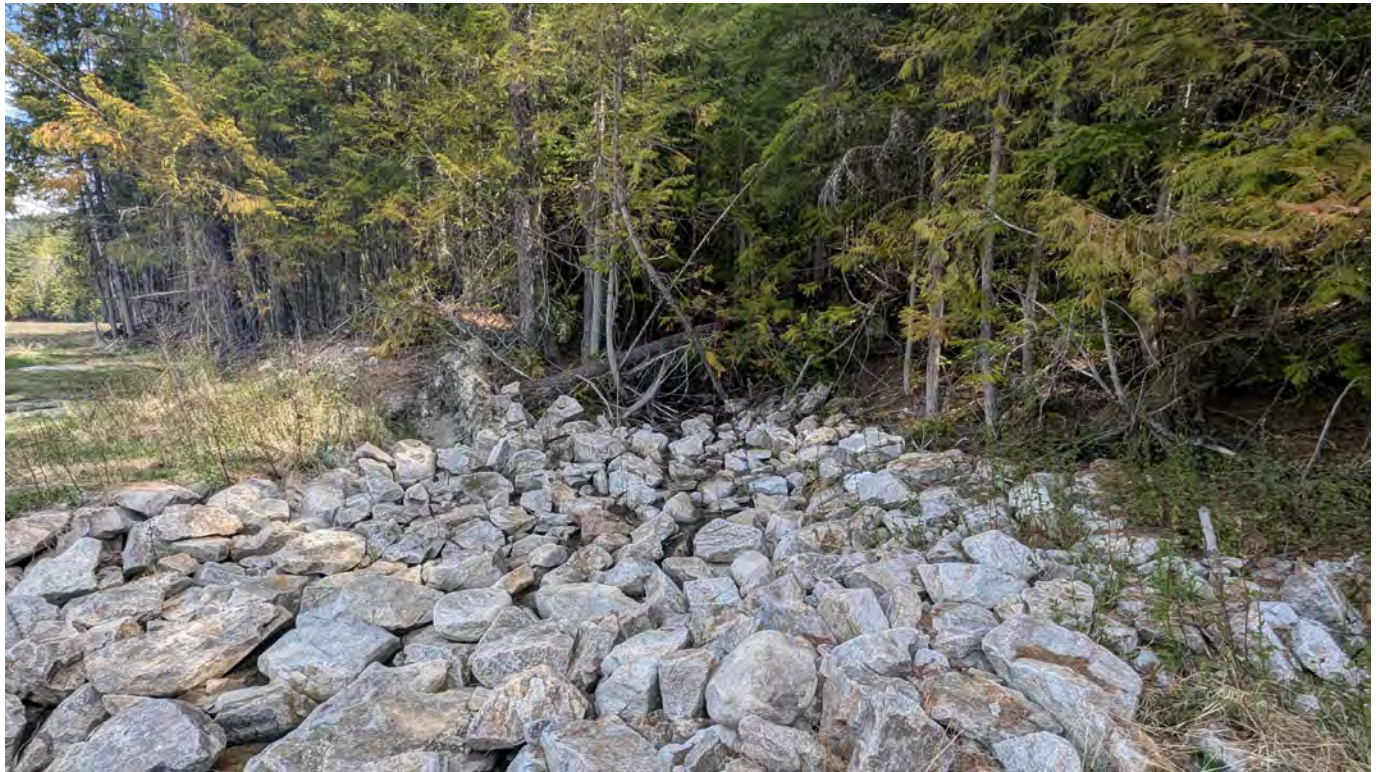
Photo 31: South Spur Channel Energy Dissipation Structure looking upstream.

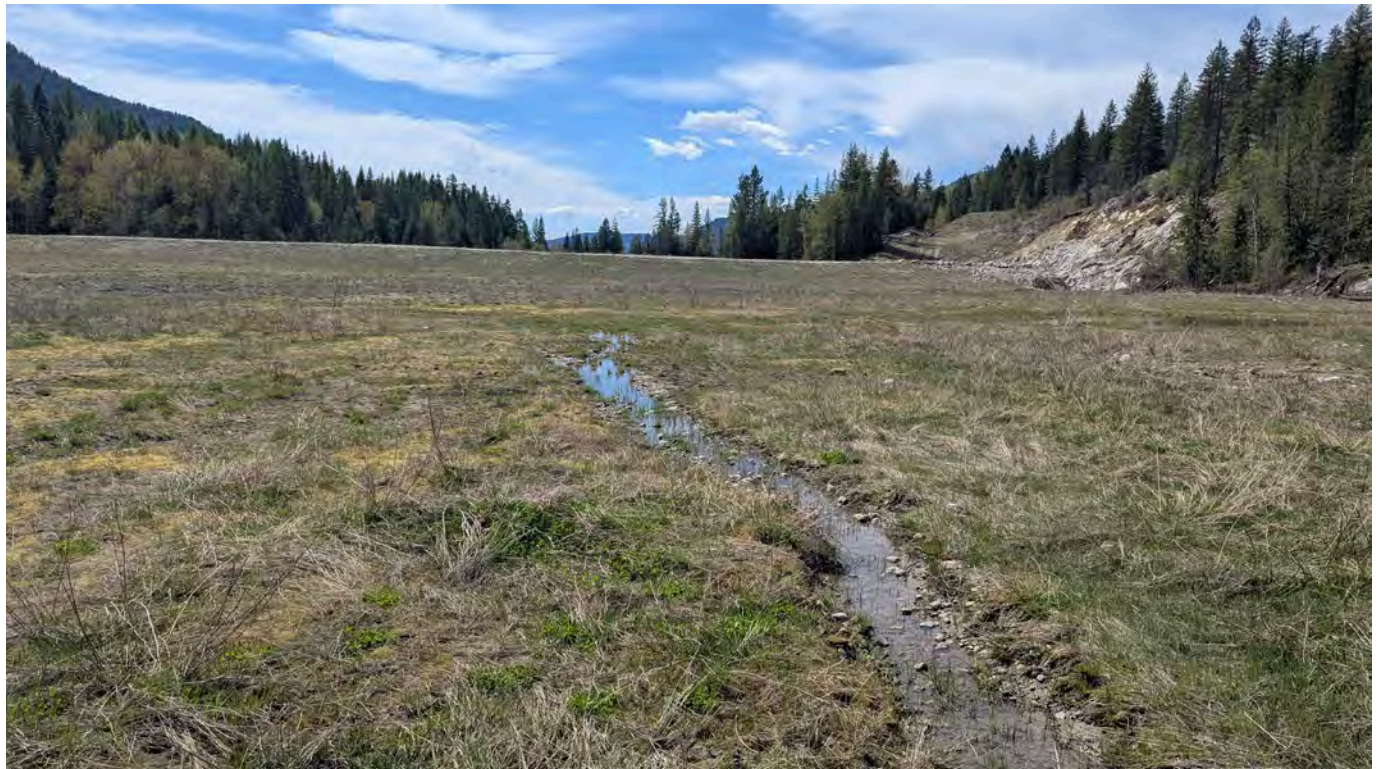
Photo 32: Small channel formed from runoff on the west side of the TSF looking south. Water flows parallel to the Main Channel and enters the Main channel near the spillway. No change compared to the 2024 inspection.

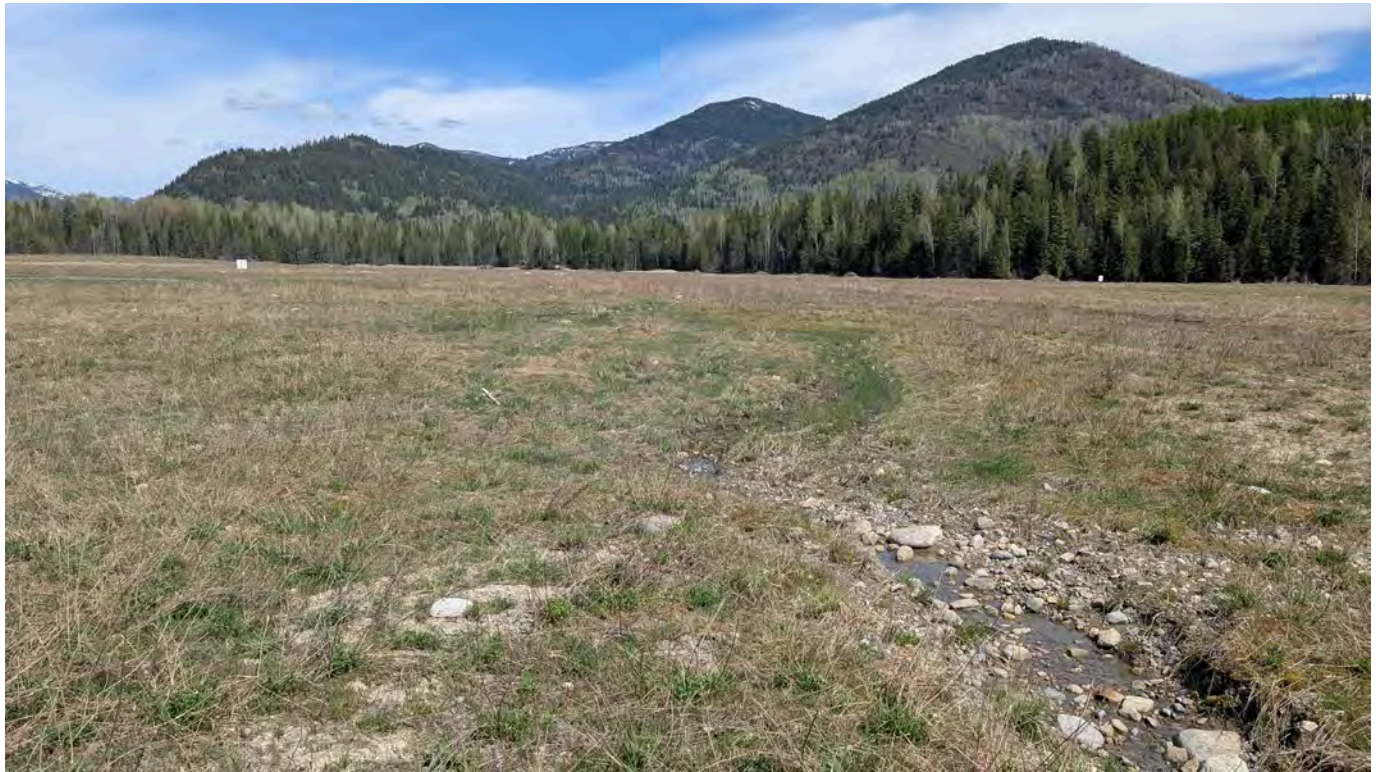
Photo 33: Small channel formed from runoff on the west side of the TSF looking north. Water flows parallel to the Main Channel and enters the Main channel near the spillway. No change compared to the 2024 inspection.

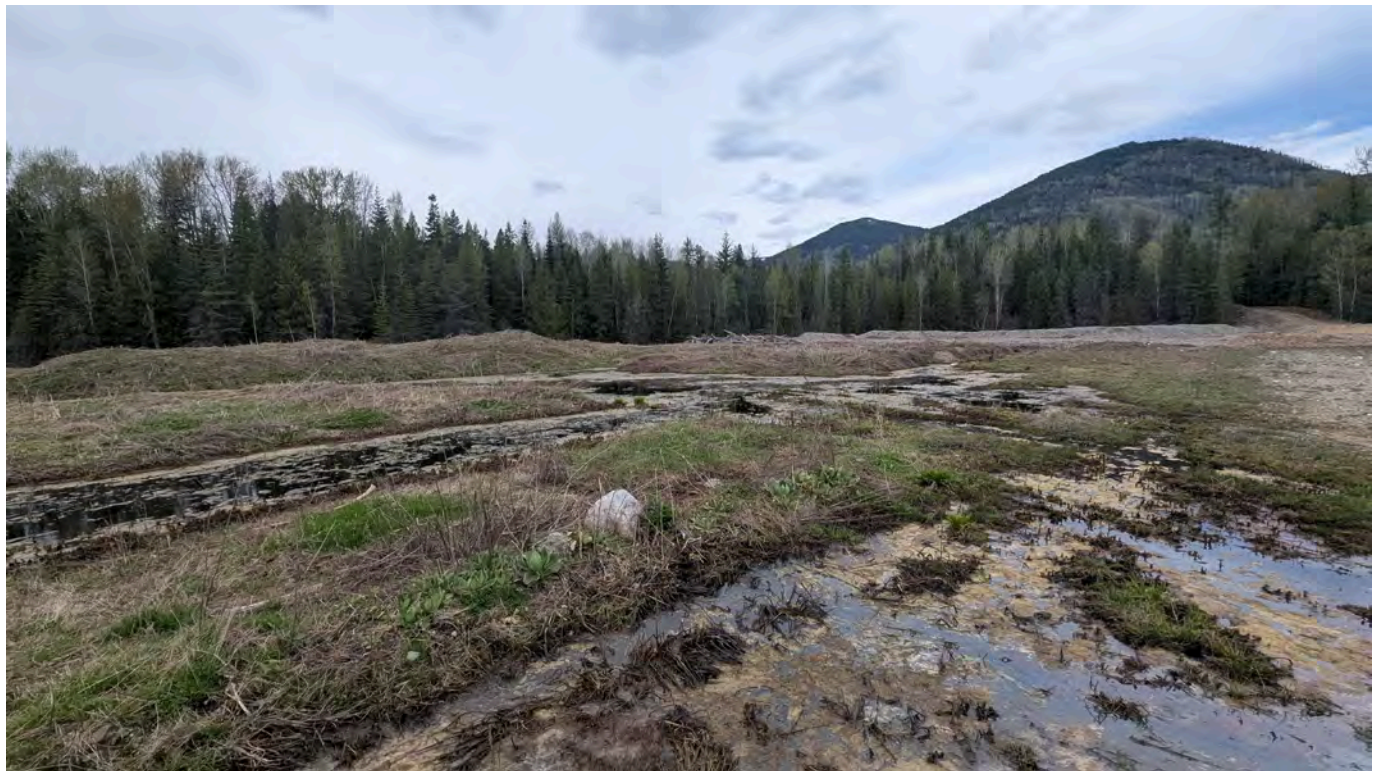
Photo 34: Small misc. stockpiles from the Central Landfill operations at the north end of the tailings impoundment. Several areas of ponded water are present with watering having a reddish colour.

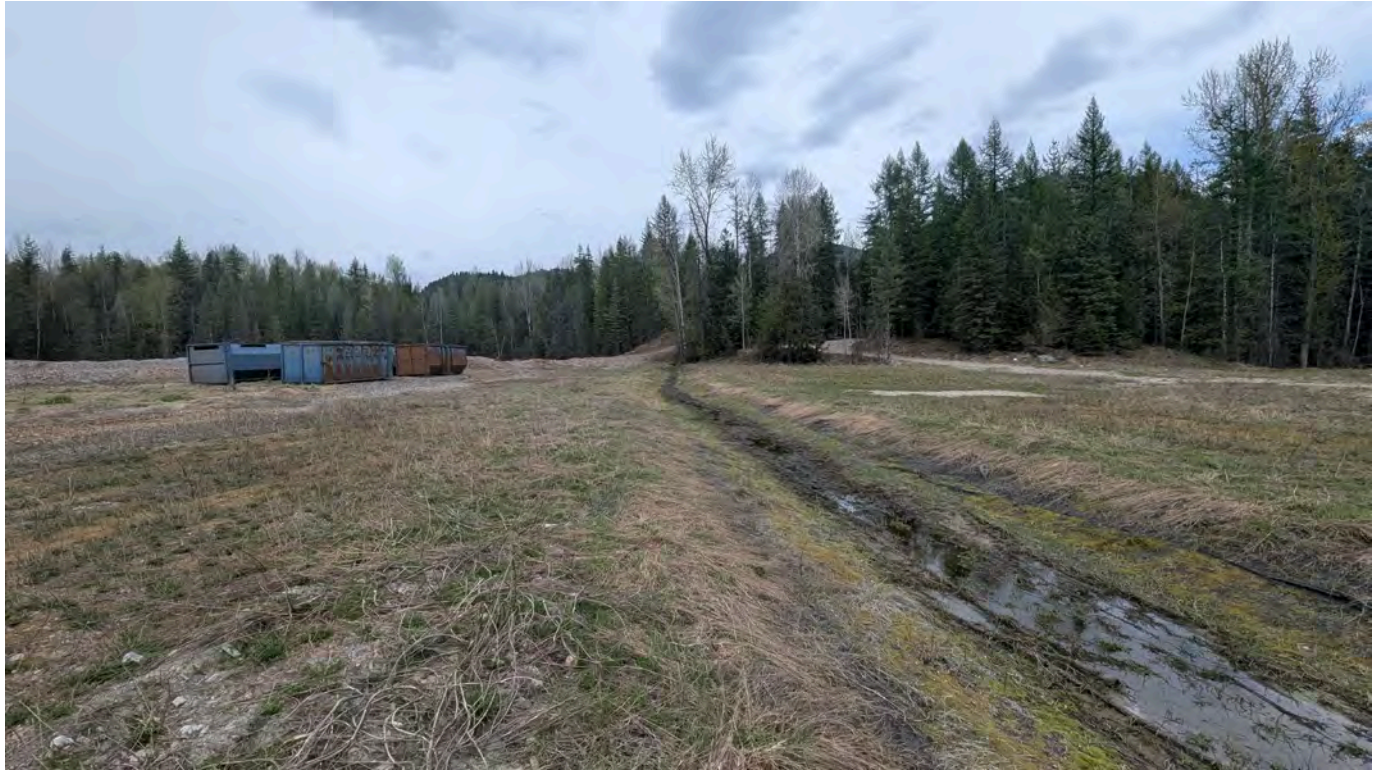
Photo 35: Main Tailings Surface Drainage Channel looking upstream.

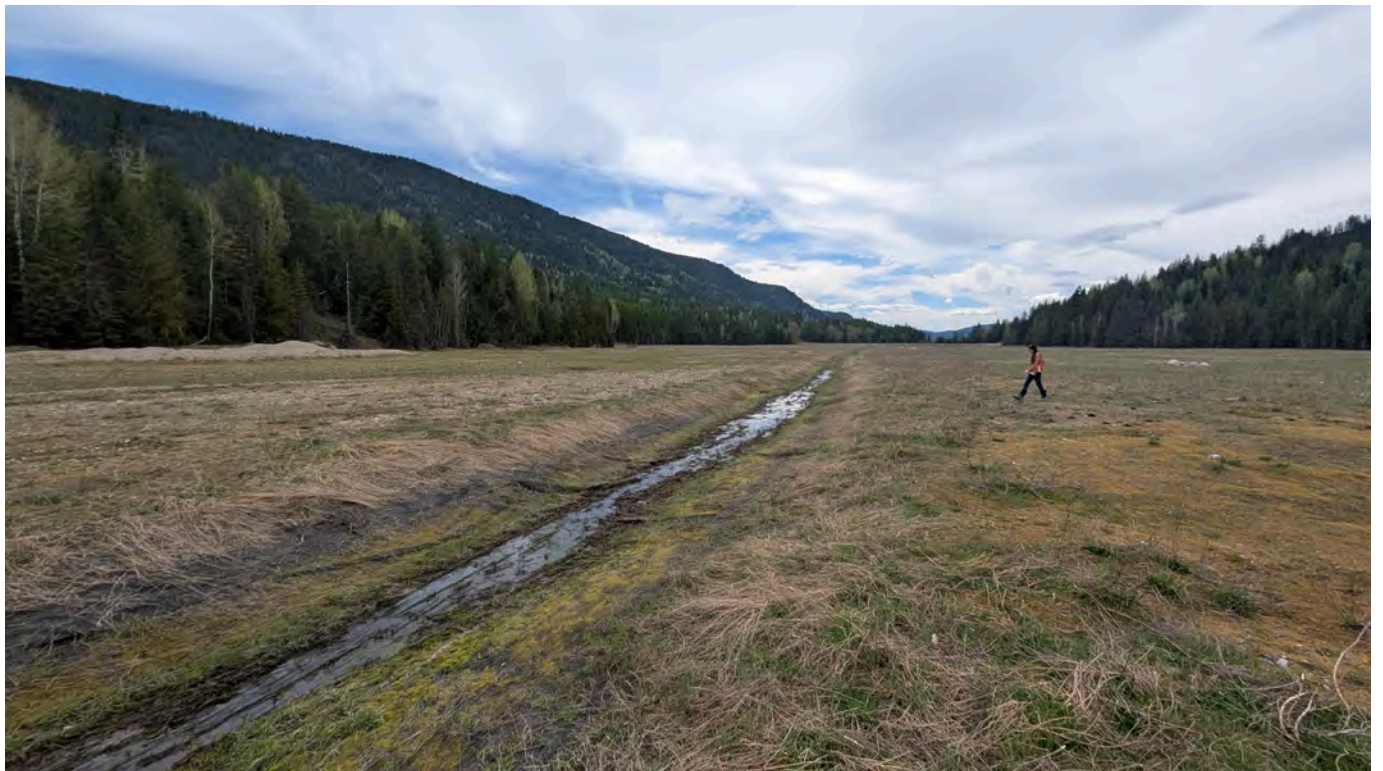
Photo 36: Main Tailings Surface Drainage Channel looking downstream.

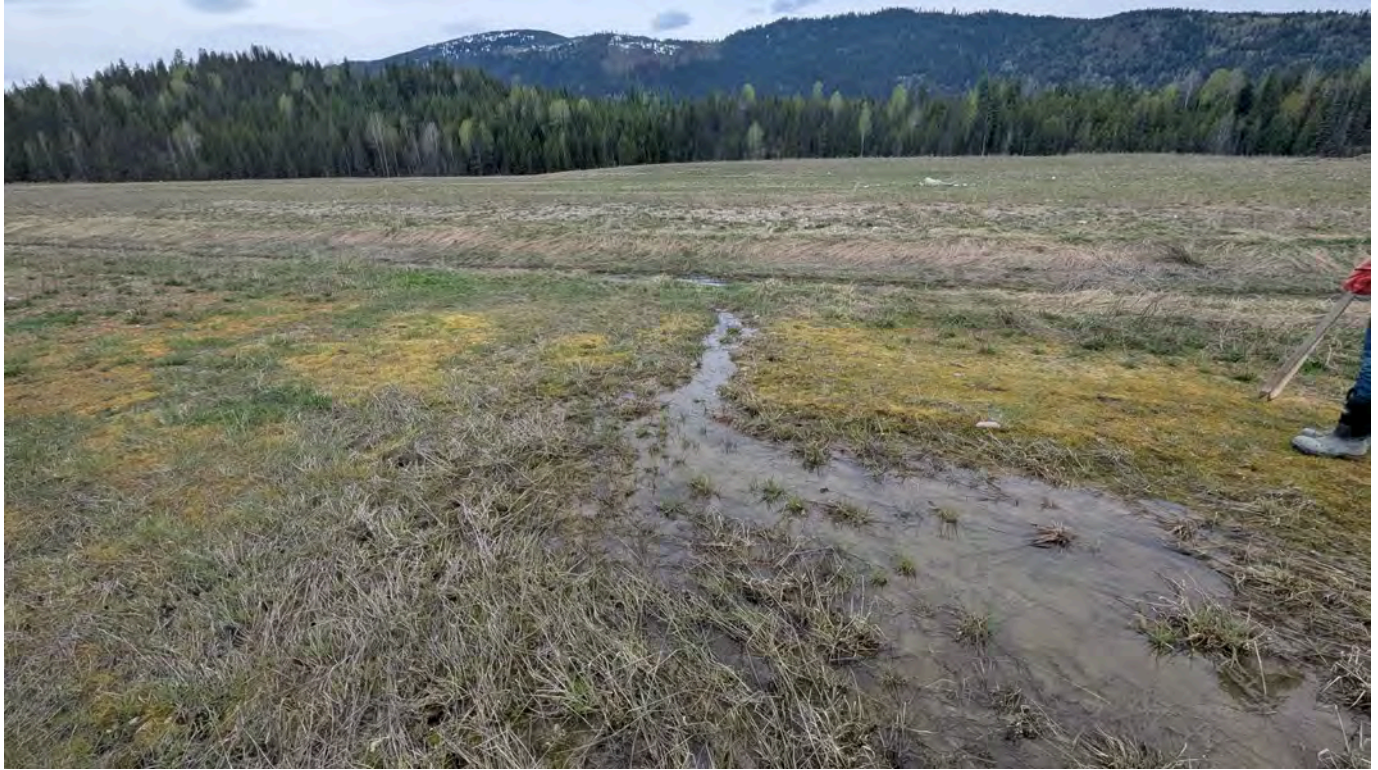
Photo 37: Area where surface run-on from east of the tailings area enters the Main Channel.

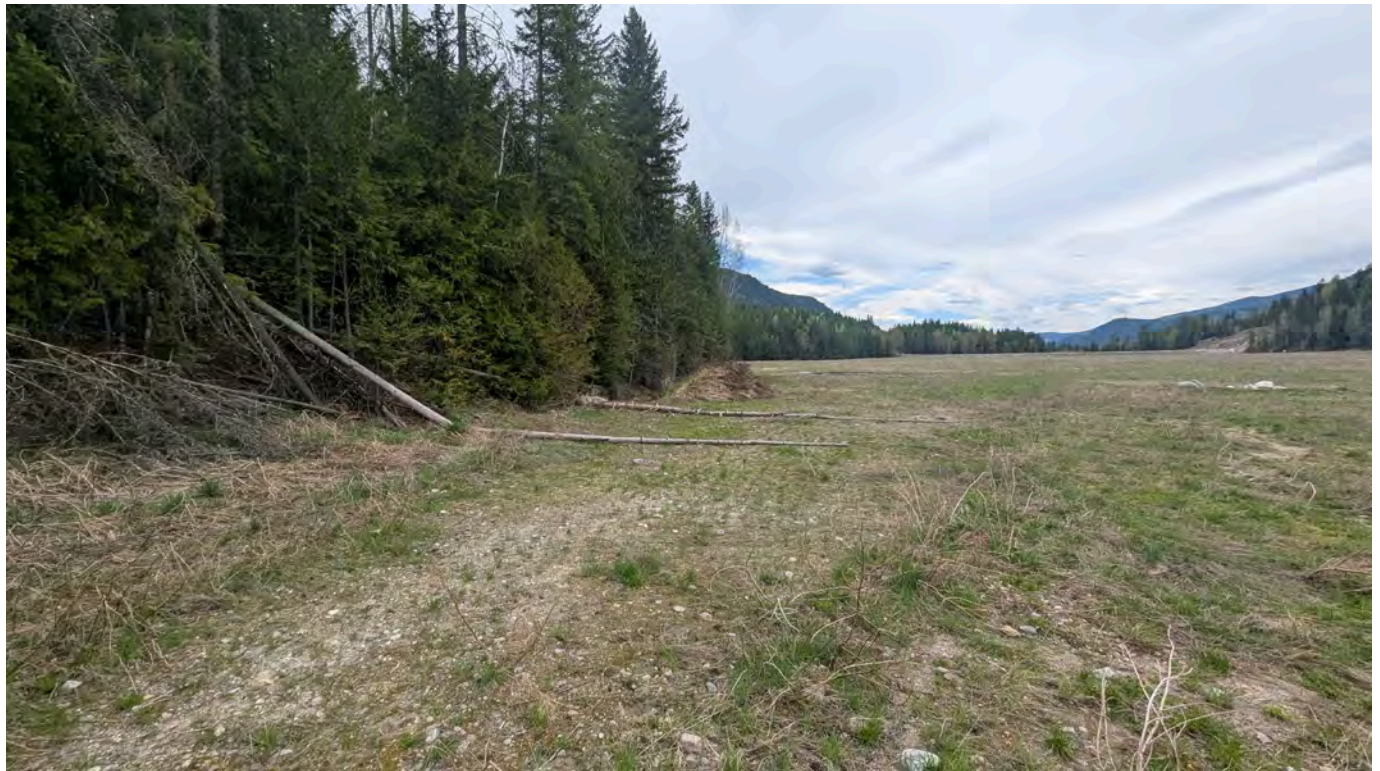
Photo 38: Several dead trees are present around the perimeter of the TSF as a result of the cover placement.

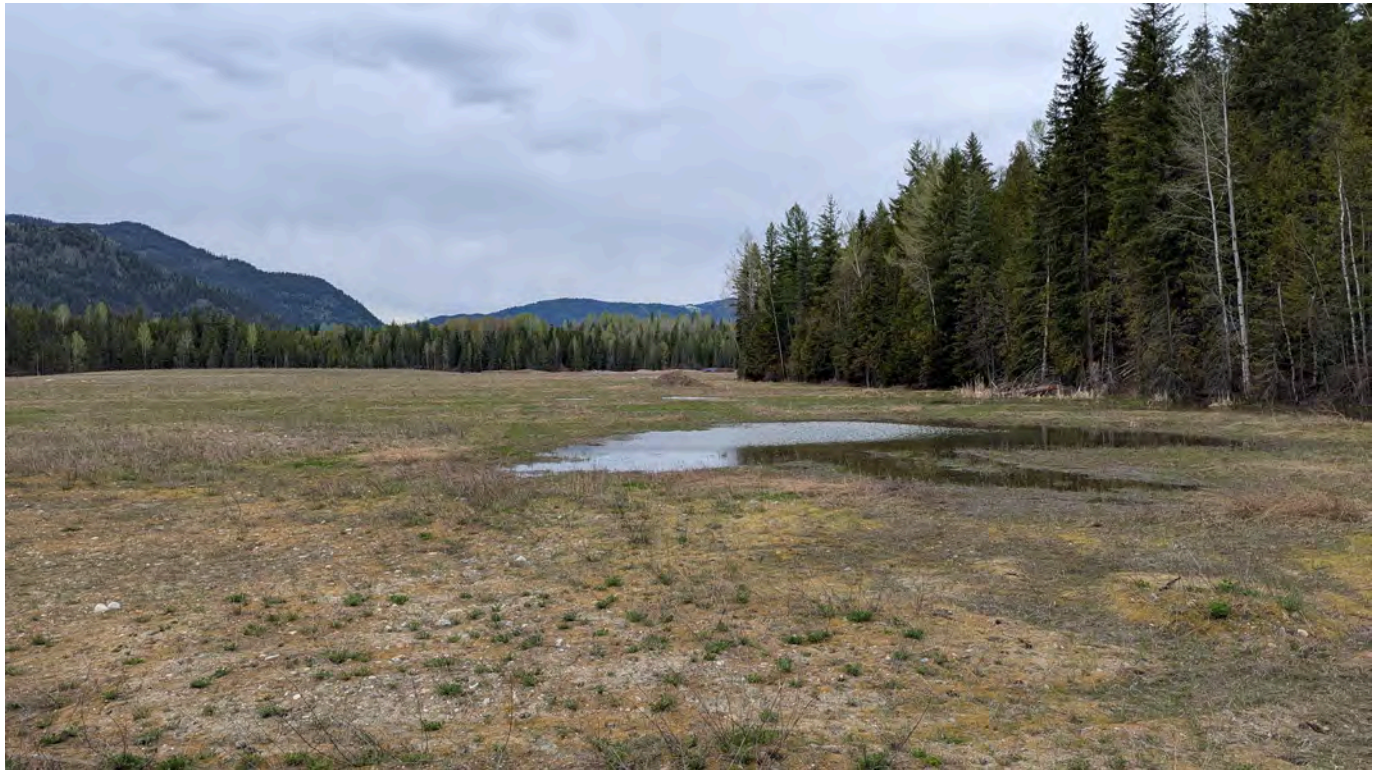
Photo 39: Area of groundwater discharge to surface water and ponding located north of the North Spur Channel.

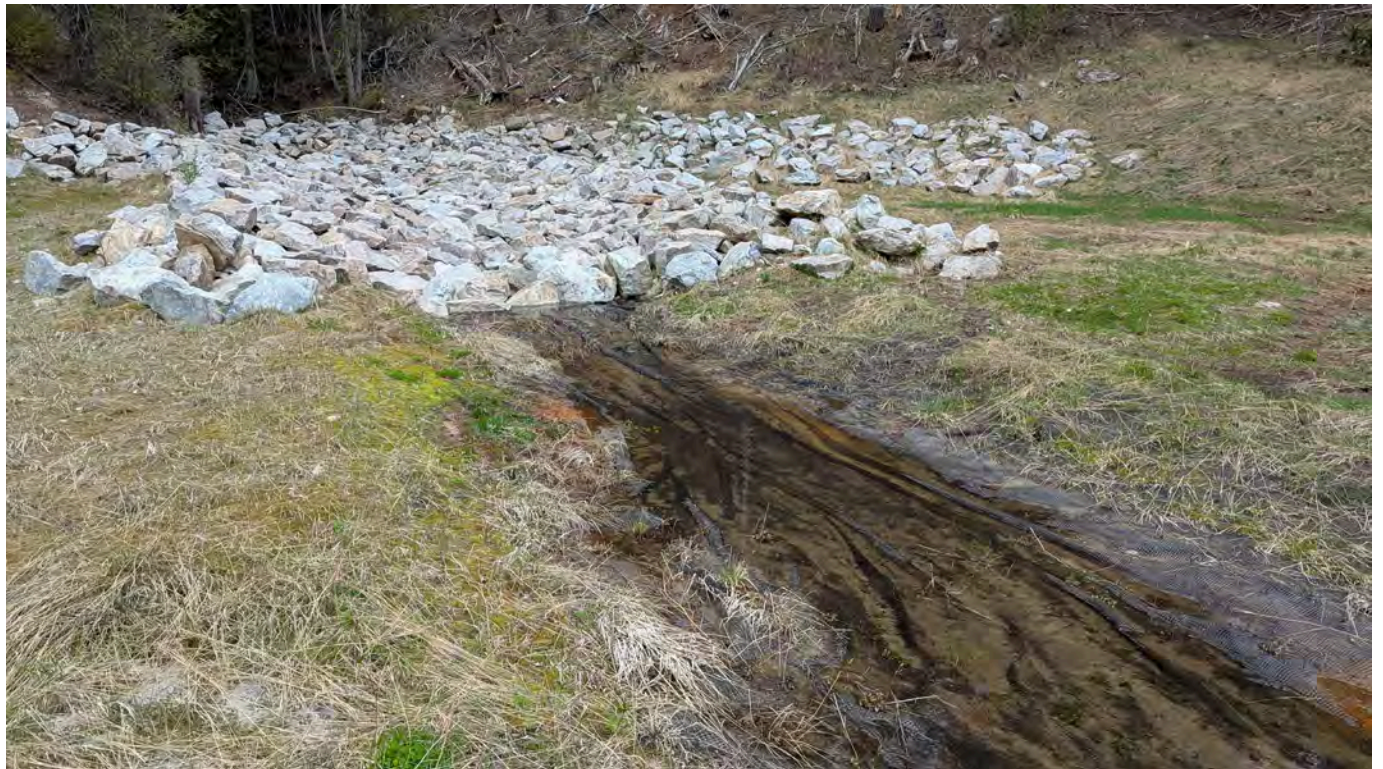
Photo 40: North Spur Energy Dissipation Structure looking upstream.
