March 26, 2026

To: Regional District of Central Kootenay (RDCK) and Emergency Management and Climate Readiness (EMCR)

From: Sarah Crookshanks, P.Geo., Ministry of Forests

Re: Poplar Creek avalanche debris slush flow event

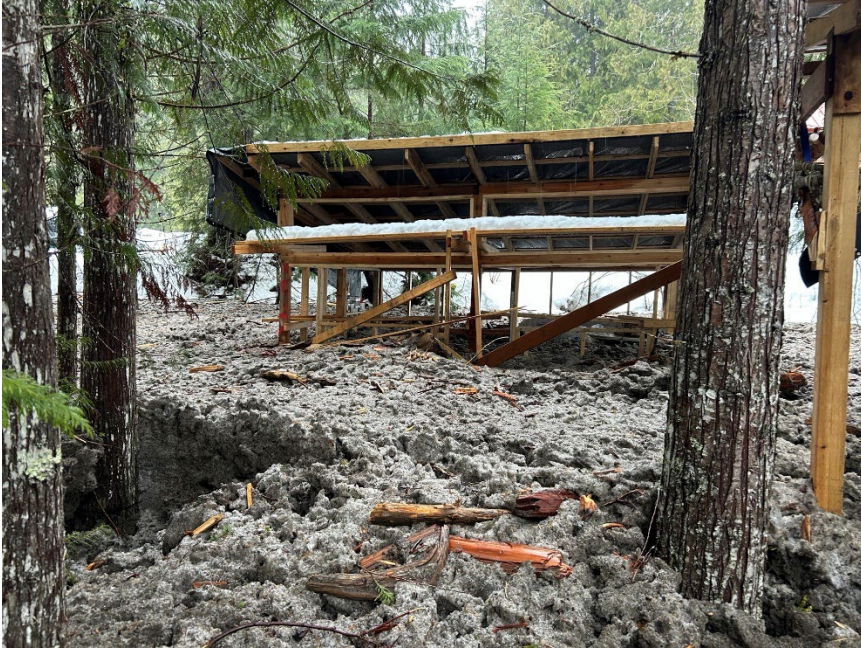
Photos of the fan after the Poplar Creek flow event that occurred on March 19th show slushy snow, large logs and sediment deposited on the fan (Photos 1 through 3). The deposit was primarily composed of slush and ice up to ~1 m thick, though sediment and debris were also mixed into the frozen water. Large logs were also transported as part of the flow event. The debris was deposited on the highway and on several private lots (PIDs 027-771-610, 027-007-448, 024-383-198, 016-080-360, 016-080-378, 015-376-966) to the west of the channel (see Photo 4 for an overview of the fan).

Photo 1. Slush and debris deposit on Poplar Creek fan (photo credit: RDCK Emergency Operations Centre).

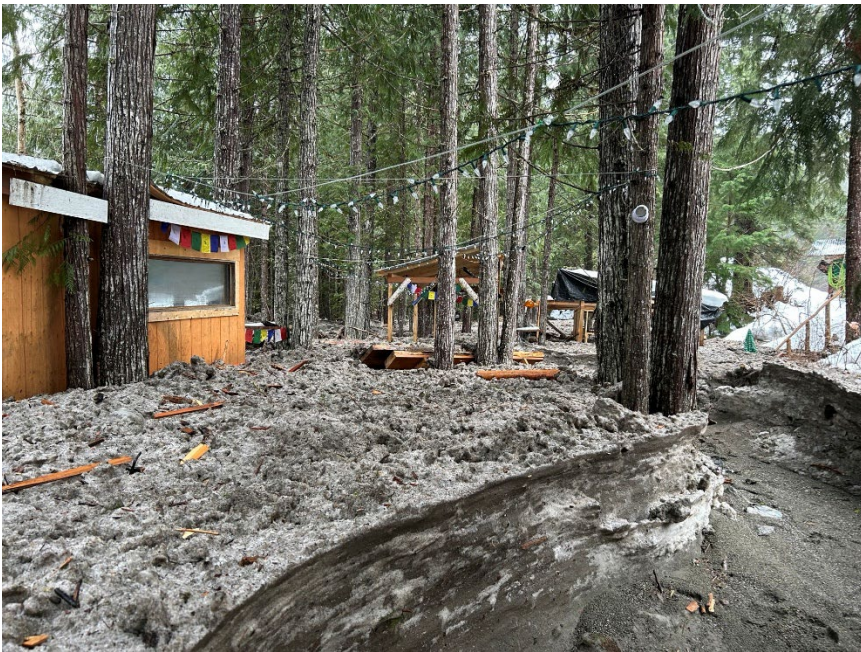
Photo 2. Slush and debris deposit on Poplar Creek fan (photo credit: RDCK Emergency Operations Centre).

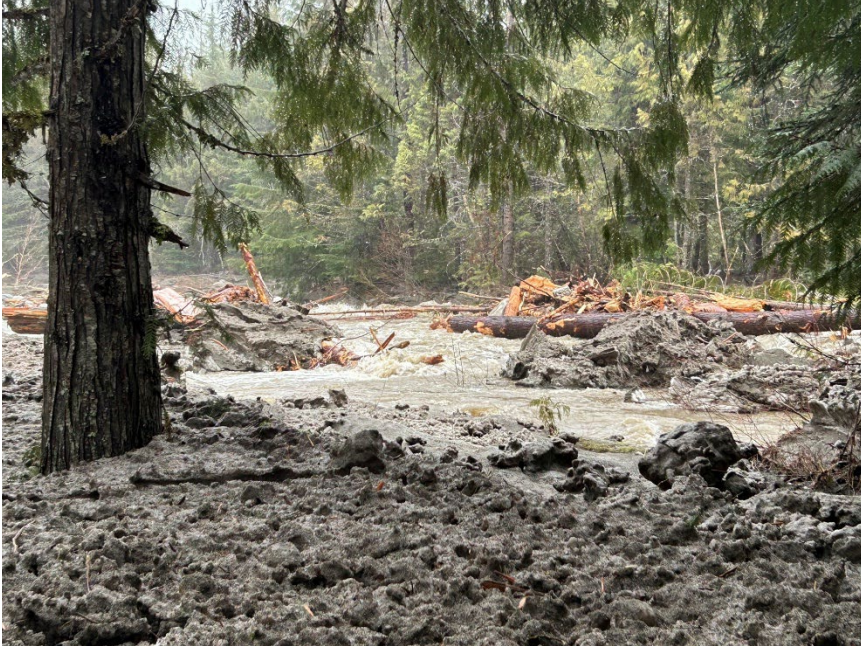
Photo 3. Slush and debris deposit on Poplar Creek fan (photo credit: RDCK Emergency Operations Centre).

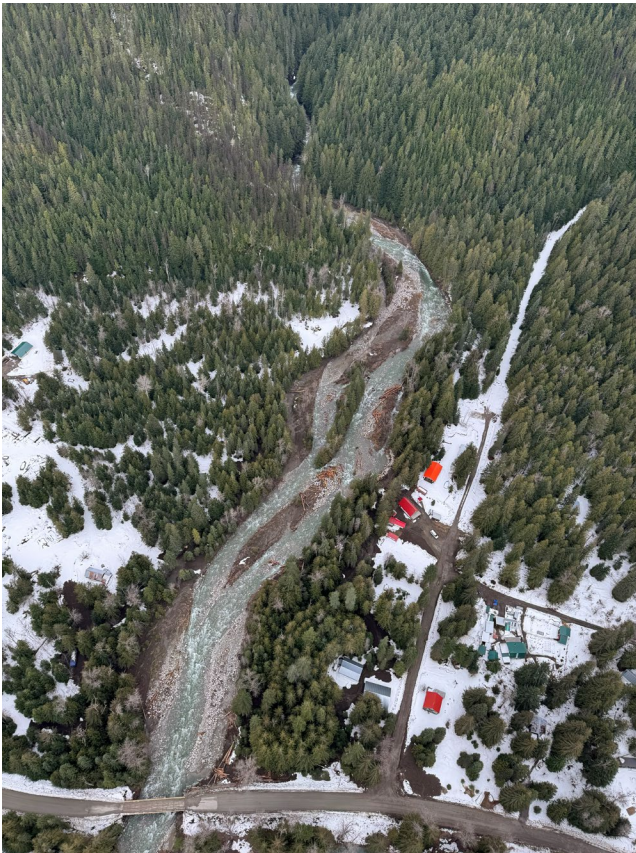
Photo 4. Overhead photo of Poplar Creek fan.

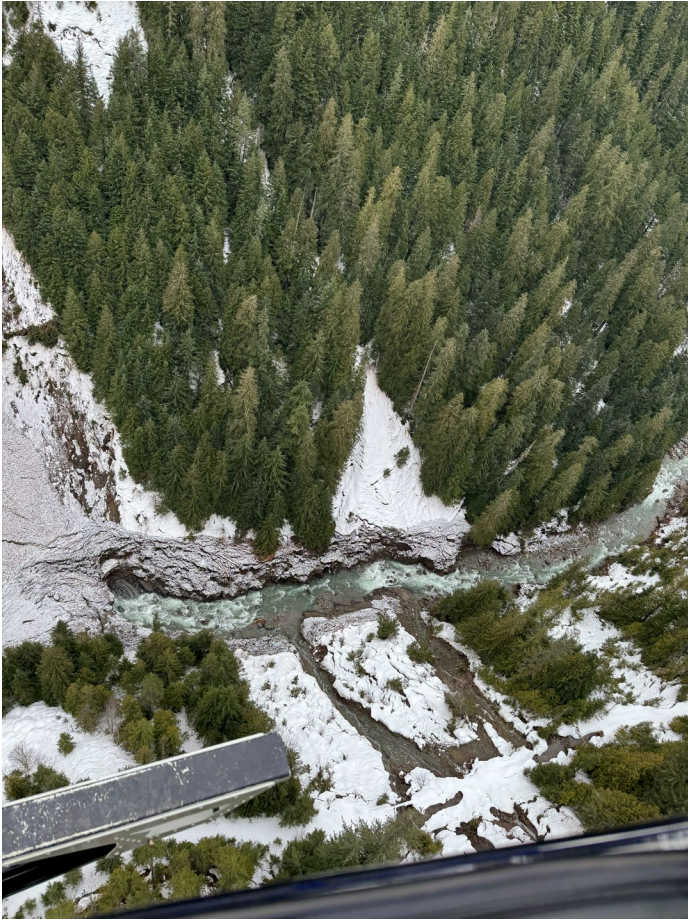
The source of the slush that was deposited on the Poplar Creek fan on March 19th appears to be from avalanche debris transported to mainstem creek channel from multiple avalanche paths. A highwater and/or erosion trim line (~1- 3 m above the current water level) is visible along Poplar Creek from the fan apex to 6.5 km upstream (Photos 5 - 6). Several avalanche debris deposits span the creek channel, including one particularly large deposit located 6.5 km upstream (Photos 7 - 8). The depth of the debris over the creek channel at this large deposit is estimated to be 20 m thick. Evidence of water ponding is visible upstream of this avalanche deposit. The area of the ponding is estimated to be approximately 12,000 m². Upstream of this large avalanche deposit, there is no visible bank erosion or significant highwater trimline. The large avalanche deposit does not appear to have been overtopped, and the water is currently flowing unimpeded underneath the overlying debris.

Photo 5. Evidence of a highwater/erosion mark along Poplar Creek.

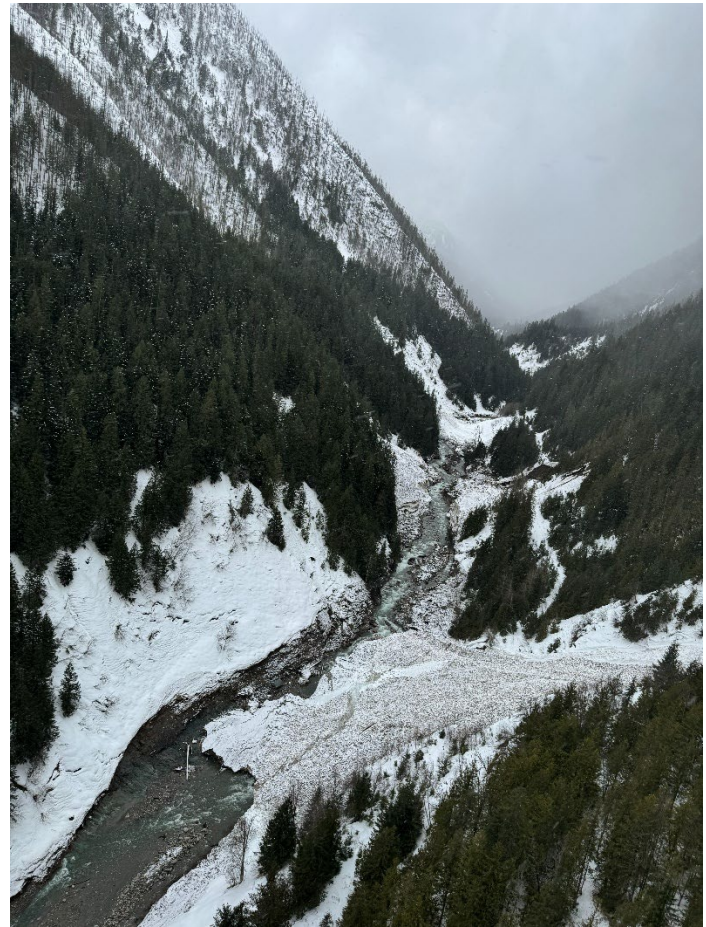
The slopes adjacent to the mainstem Poplar Creek channel appear to be regularly susceptible to large avalanches, as many large avalanche paths are visible in satellite photos. Avalanche Canada reported that the region experienced a widespread, natural avalanche cycle from March 17-20 associated with an atmospheric river that brought warm temperatures and significant rainfall. The Avalanche Canada forecasts for March 18th and 19th state that “avalanches will be large and may run full path”. The helicopter overflight on March 26th confirmed that many of the avalanche paths in Poplar Creek had already released, some of them eroding right to ground.

Photo 6. Multiple avalanches along Poplar Creek.

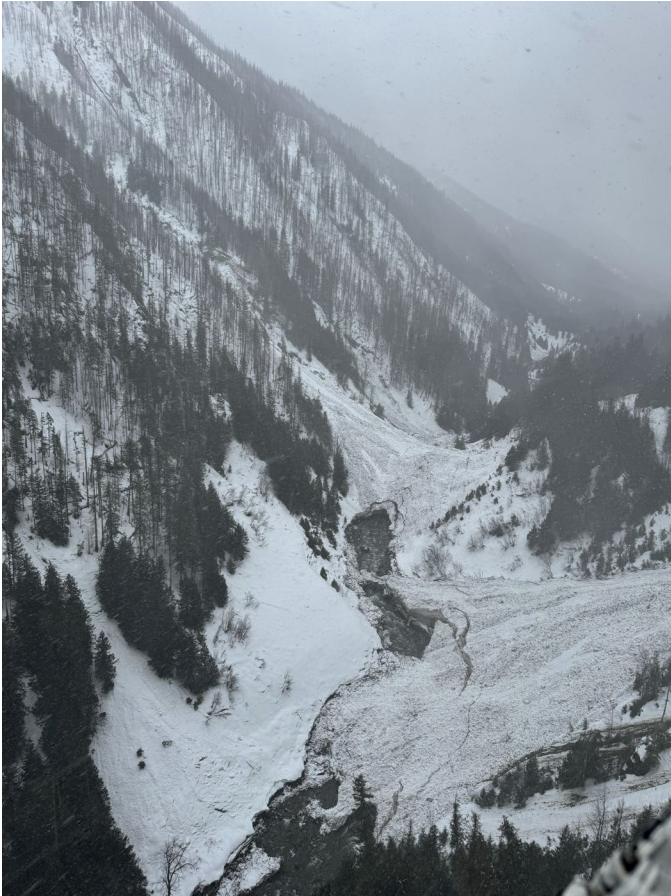
Based on these observations, we suggest that during the rainfall and warming event on March 19th, a number of avalanches released, one of which at 6.5 km upstream temporarily blocked Poplar Creek. Likely shortly thereafter, the creek eroded underneath the avalanche debris. This small flood wave is thought to have proceeded downstream, eroding and picking up recently deposited avalanche debris (e.g. Photo 9), logs and channel material and transitioning to a “slush flow”. This slushy debris was then deposited on the fan.

Photo 7. View upstream of avalanche bridge at 6.5 km upstream of fan.

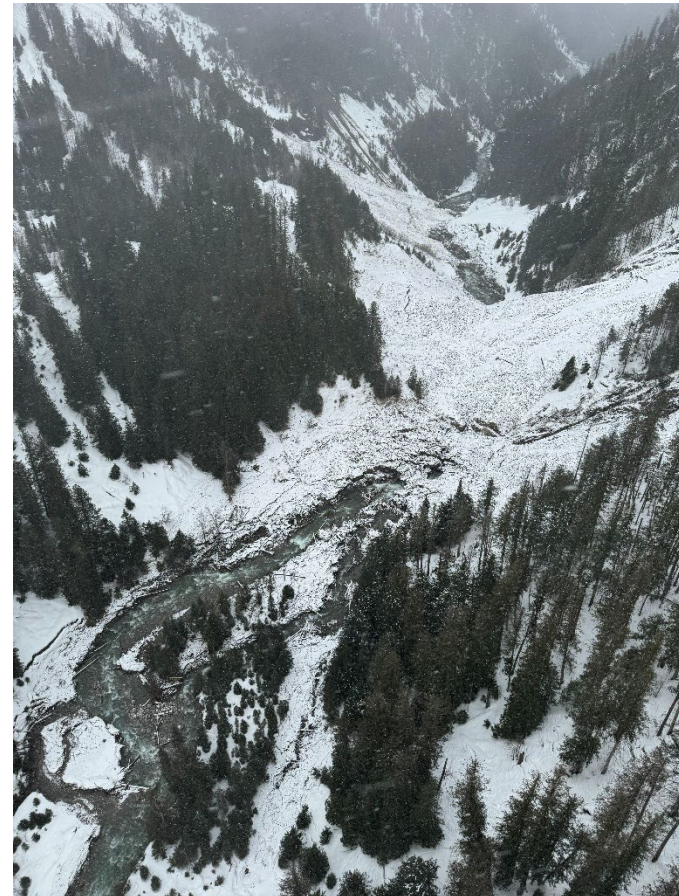
Photo 8. View downstream of avalanche bridge at 6.5 km upstream of fan.

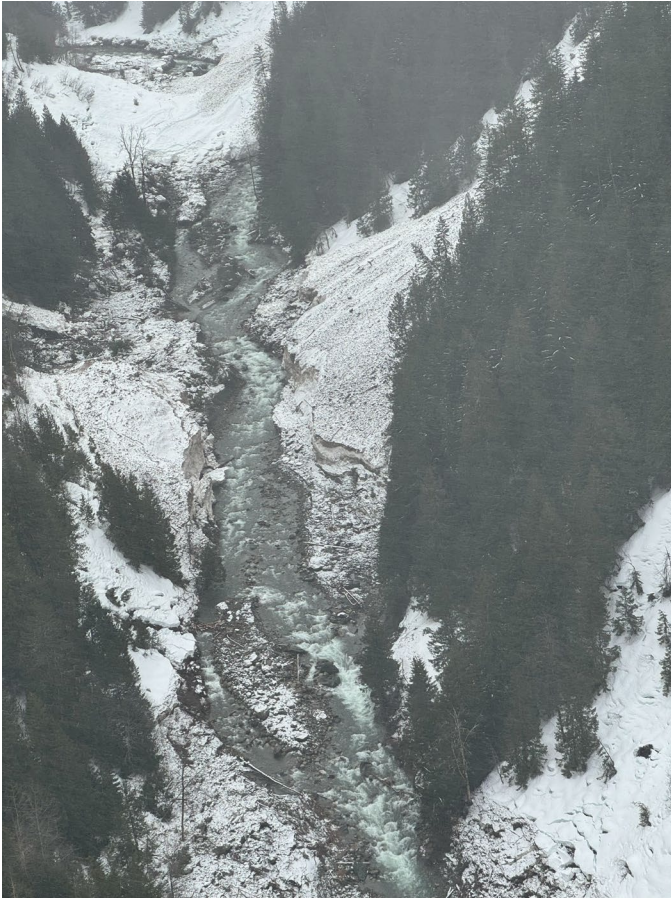
While several avalanche deposits remain bridged over Poplar Creek, the most likely scenario is that these deposits will slowly melt out over the course of the spring. No large accumulations of logs or mud or other debris were observed along the Poplar Creek channel. Therefore, the likelihood of future flooding, slush flows or debris floods on Poplar Creek is not higher due to the avalanche slush flow that occurred on March 19th. As with many locations in the area, residents should be aware of any rapidly changing creek conditions, such as abnormally dirty water or sudden changes in flow, particularly during periods of very warm weather and/or significant rainfall events this spring.

Photo 9. View of collapsed or eroded avalanche debris.

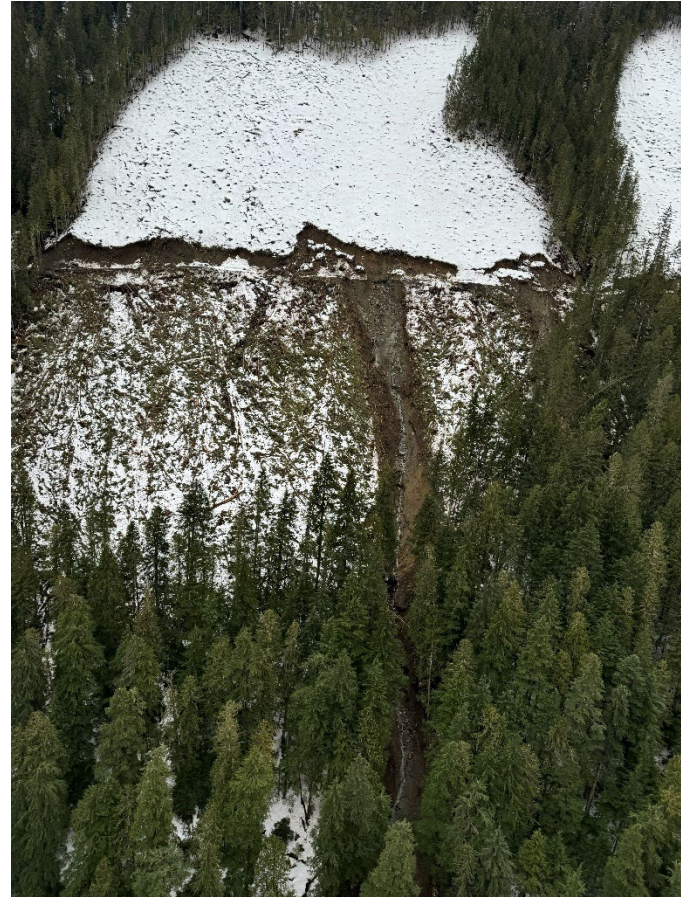
Four landslides initiating at a forestry road (Forest File ID R14907 - 10) were also observed (Photos 10 - 11). These four landslides deposited their material directly into Poplar Creek, as there is no break in slope from the road down to the channel. These landslides likely occurred during the heavy rainfall and warming event (March 18th - 20th), though the exact date is not known. It is recommended that the licensee responsible for R14907 - 10 forestry road assess the current drainage configuration and landslide damage as soon as is possible. Landslide damage and deficient drainage infrastructure should be repaired

Photo 10. Landslide from forestry road.

and/or upgraded immediately. The likelihood of additional landslide events that may cause dirty water in Poplar Creek remains high until remediation occurs.

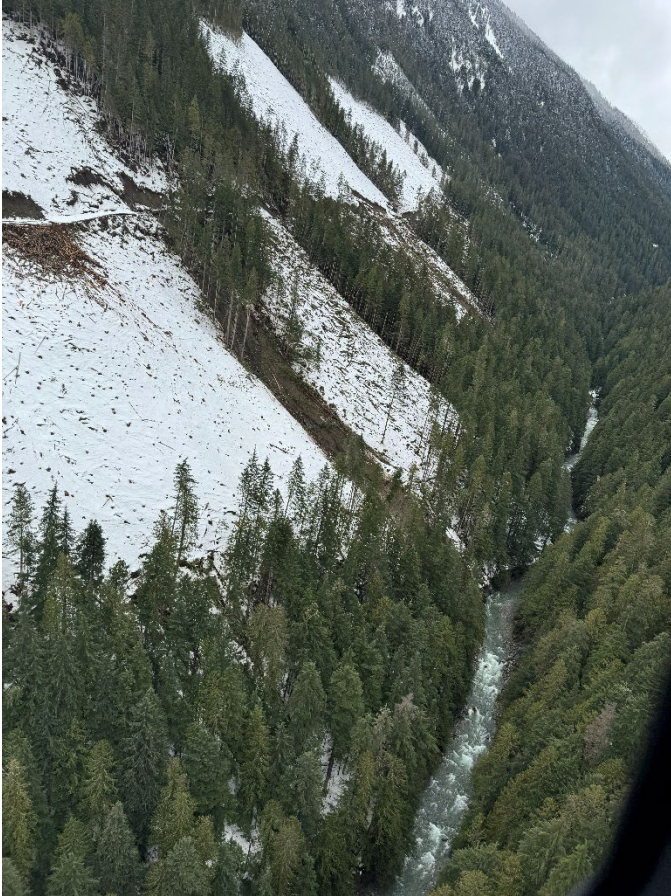
Photo 11. Landslides from forestry road.
