# **MINISTRY OF FORESTS, LANDS AND NATURAL RESOURCE OPERATIONS, POST-WILDFIRE RISK ANALYSIS – PRELIMINARY REPORT**

| <b>FIRE:</b> N71691 Morley Creek | | <b>FIRE YEAR:</b> 2017 | <b>DATE OF REPORT:</b> 28 August 2017 |

# Post-Wildfire Natural Hazards Risk Analysis, Fire N71691, Morley Creek

Sarah Crookshanks, MFLNRO, 28 August 2017

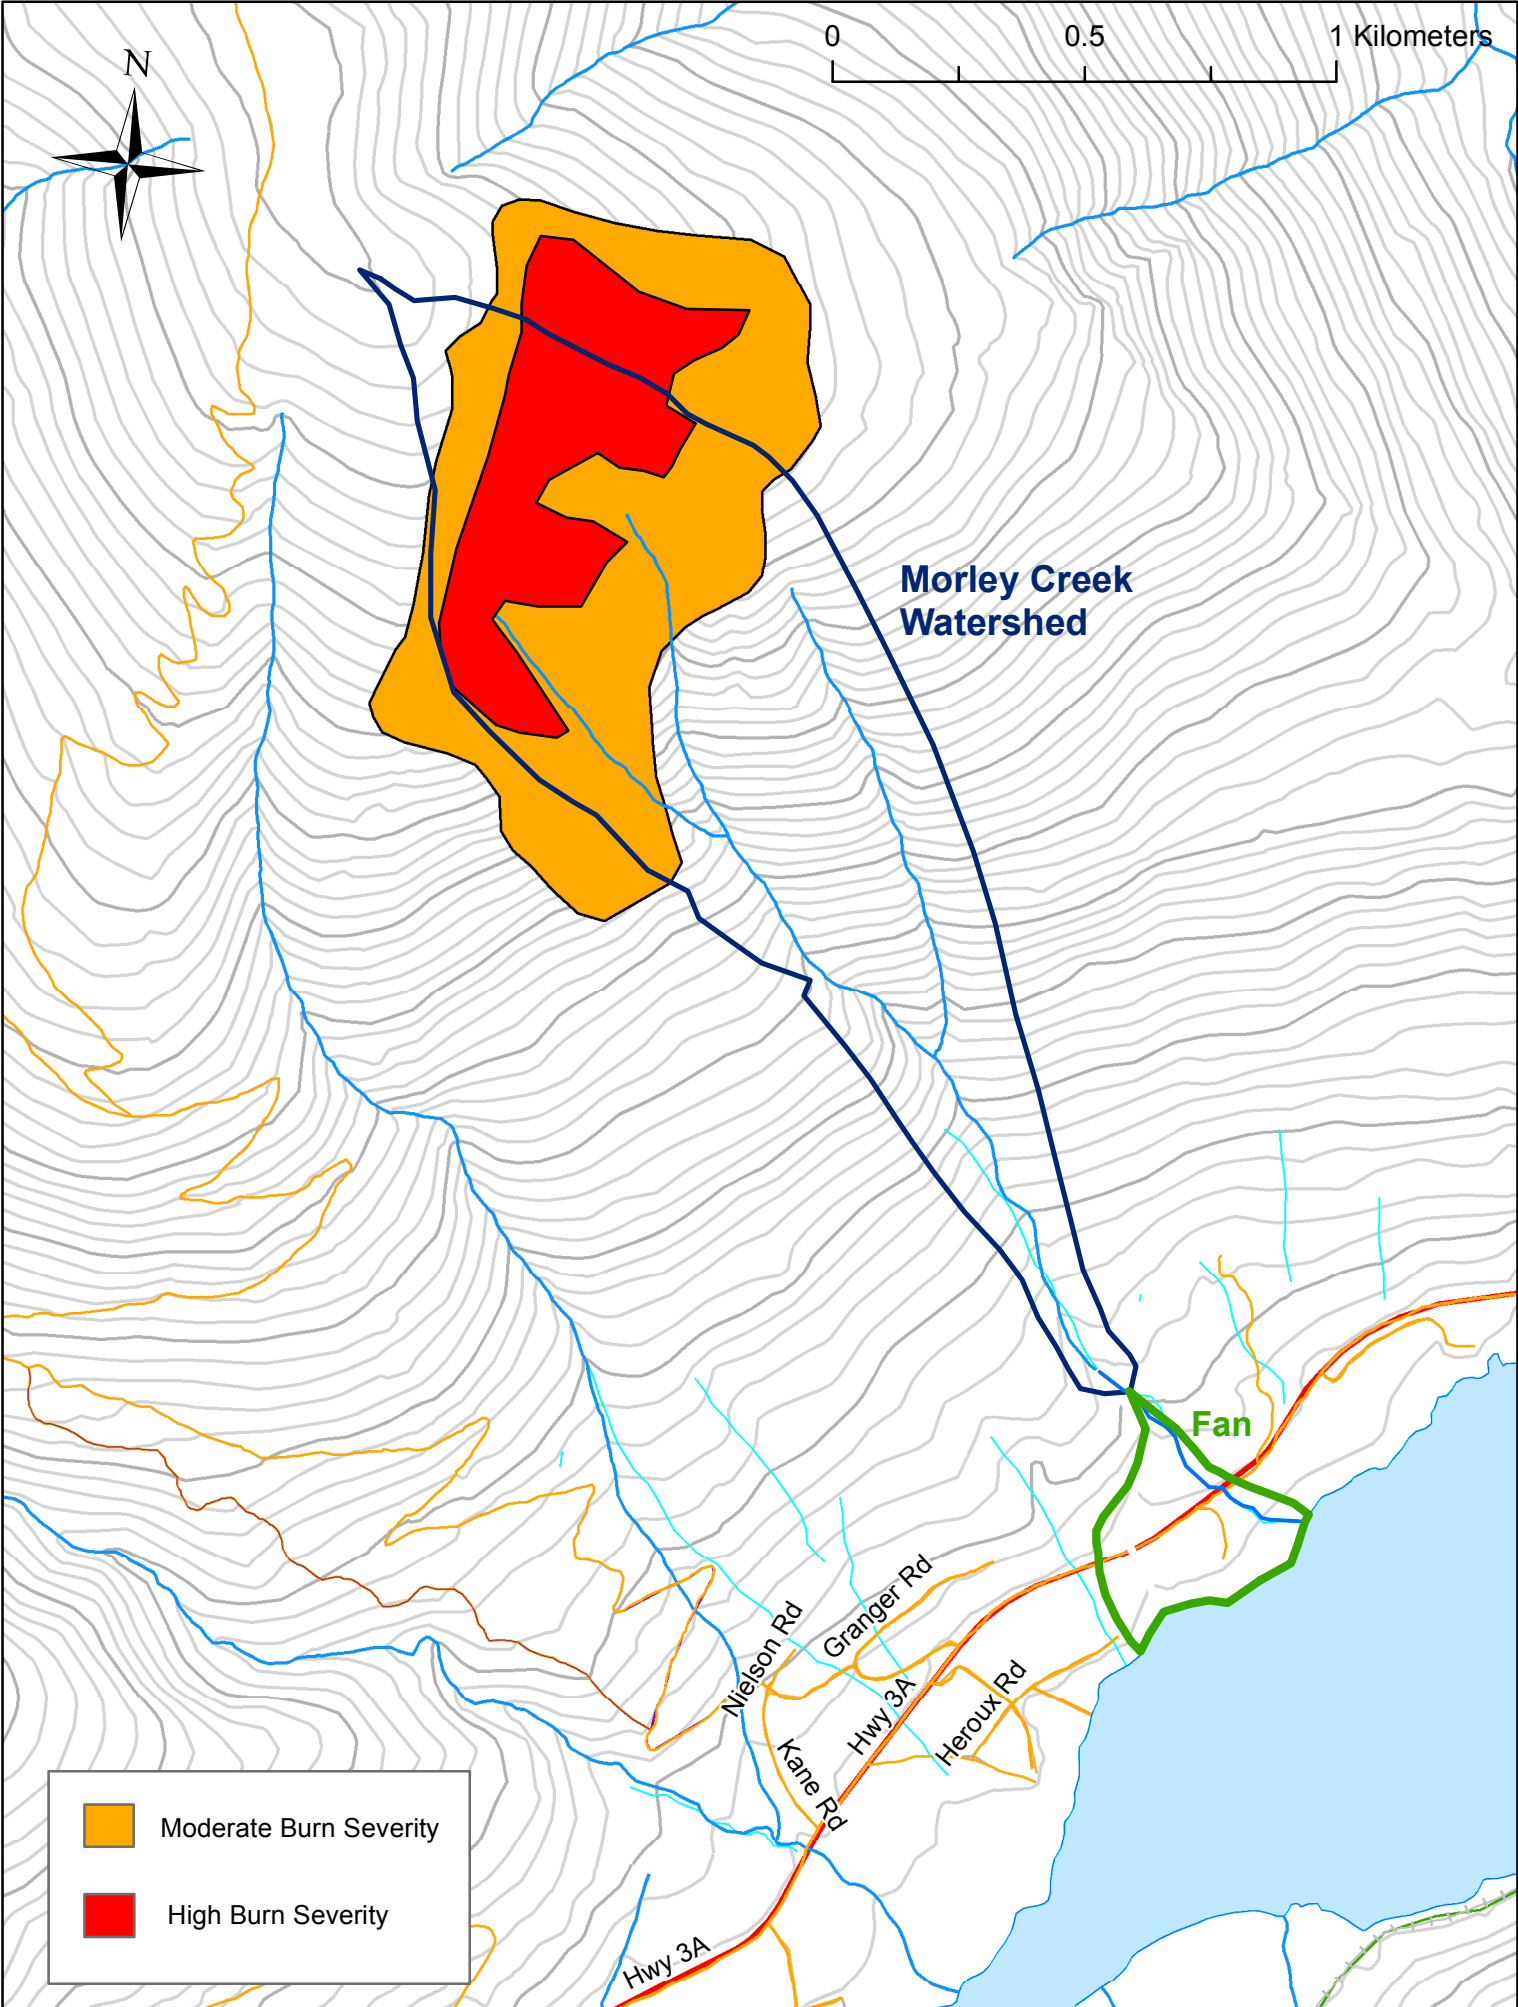
Figure 1 is a map of the Morley Creek watershed and of the fire showing the burn severity mapped from photographs taken from a helicopter (e.g. Figure 2) and ground data. The fire occupies 43% of the watershed area. Of the burned area, 38% is high burn severity. ***The burn severity areas are very approximate and subject to review once satellite imagery is obtained.*** The burn area is located in the headwater area of the watershed. The gullies that form the headwaters of Morley Creek steepen downslope away from the fire. The table below summarizes some of the watershed statistics for Morley Creek.

Figure 1. Map of fire, showing preliminary burn severity (on next page). Scale 1:15,000. Burn severity polygons were drawn manually from photos taken from the air on 22 August 2017. A more accurate burn severity map will be prepared from satellite imagery when this is available.

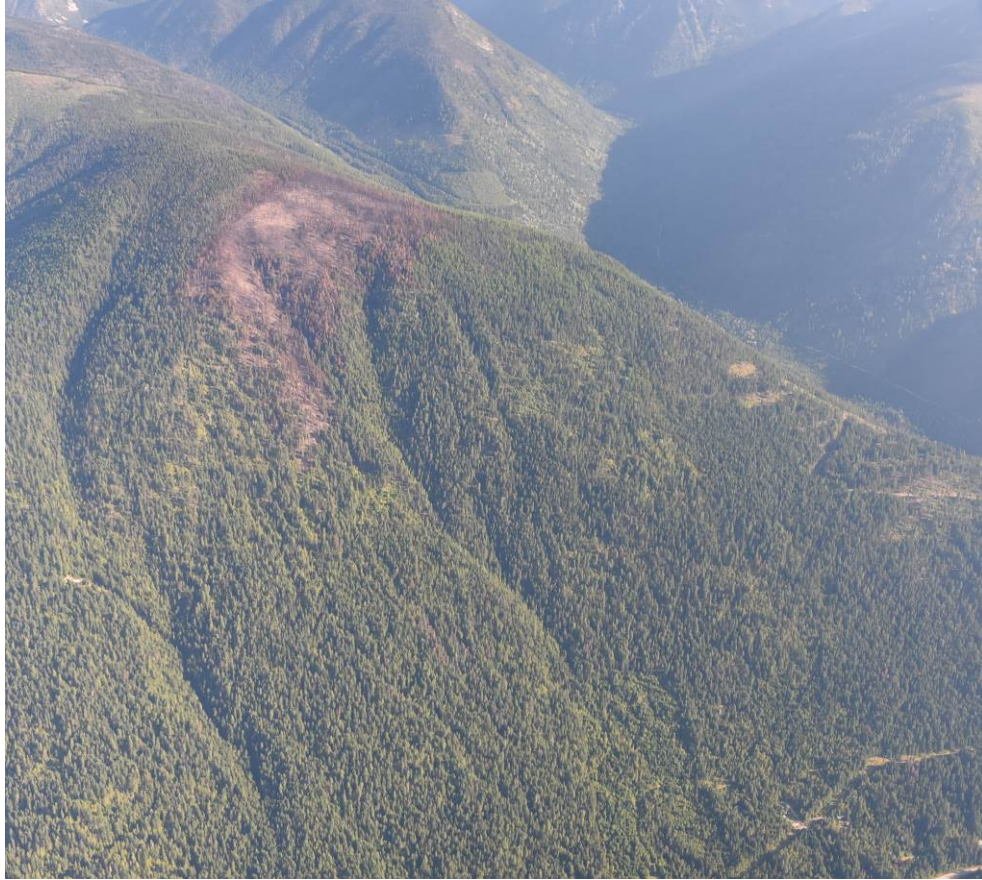
Figure 2. Overview of fire N71691. Photo taken on August 22, 2017.

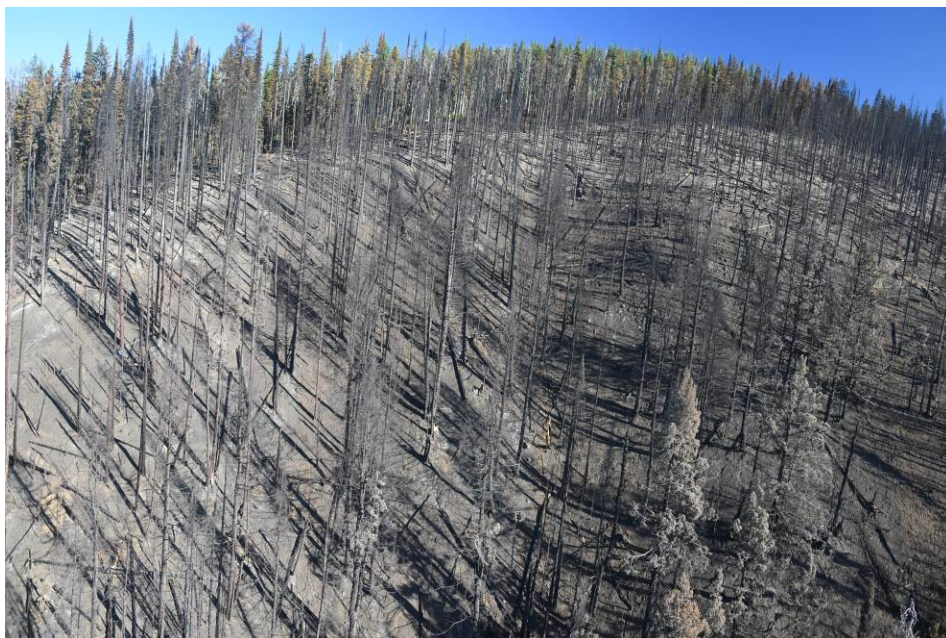
Ground observations of the burn severity showed high soil burn severity at most plots. All duff and organic matter were consumed in high burn severity zones, leaving grey ash and mineral soil exposed (Figure 3). Remnants of charred large woody debris were scattered throughout the burn area. Strongly water repellent soils were widespread and consistent, even where moderate vegetation burn severity was observed. Compared with other fires that have caused post-wildfire debris flows (e.g. the 2007 Springer fire), soil burn severity in this fire is somewhat higher.

Figure 3. Aerial view of high burn severity area. Photo taken on August 22, 2017.

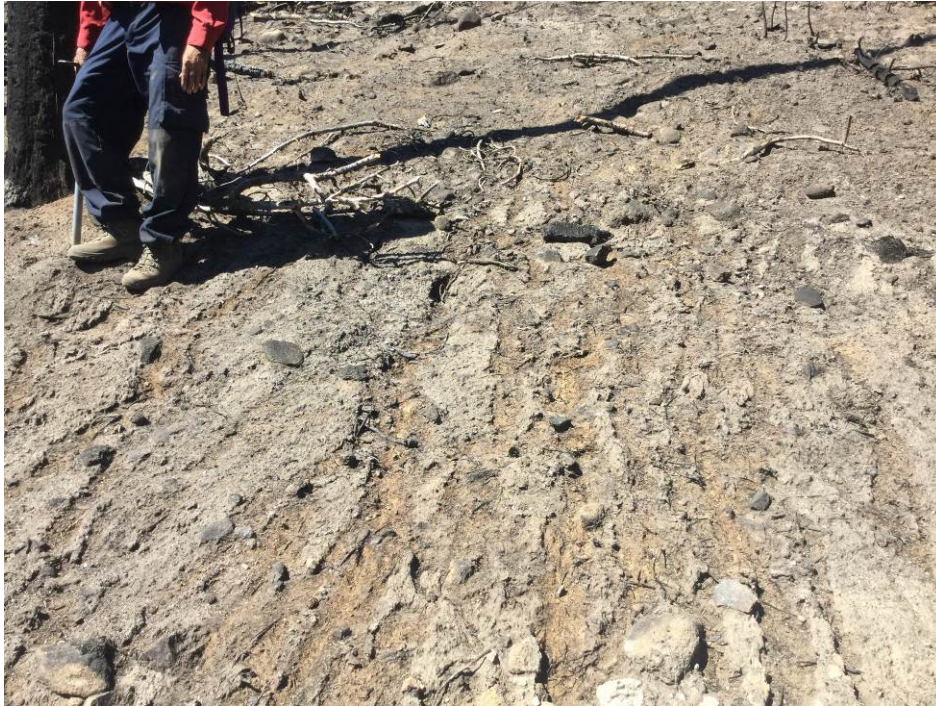
Widespread rilling was observed on steep slopes throughout the burned area (Figure 4). It is assumed that they were produced during a rainfall event that occurred on August 13. A fire weather station installed at Harrop recorded a total of 21.6 mm that day with a max intensity of >14 mm in one hour.

Figure 4. Widespread rilling was observed in the burn area.

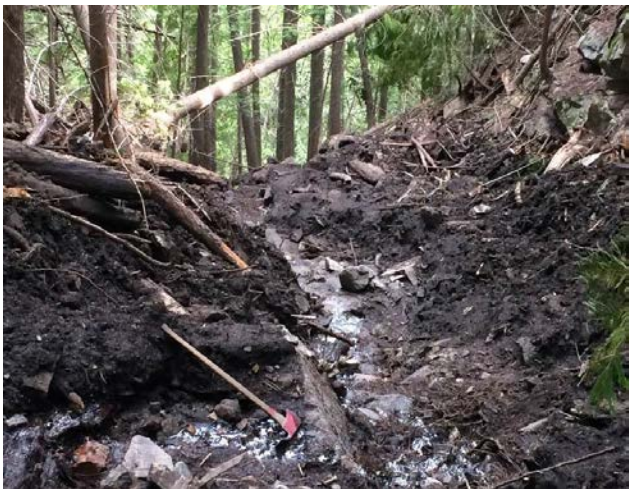
A BC Wildfire Service fire fighter documented a small debris flood event that occurred after a rainfall event that occurred on August 13 (Figure 5). A weather station installed at Harrop recorded a total of 21.6 mm that day with a max intensity of >14 mm per hour. Therefore, if a rainfall event with a similar or higher intensity (and/or duration) occurs within the next few years before vegetation has a chance to re-establish, then a similar or larger debris flood or flow event may be expected to occur.

Figure 5. A view of the western Morley Creek headwater channel after a debris flood event that likely occurred following a rainstorm on August 13 (photo by Nick Davis).

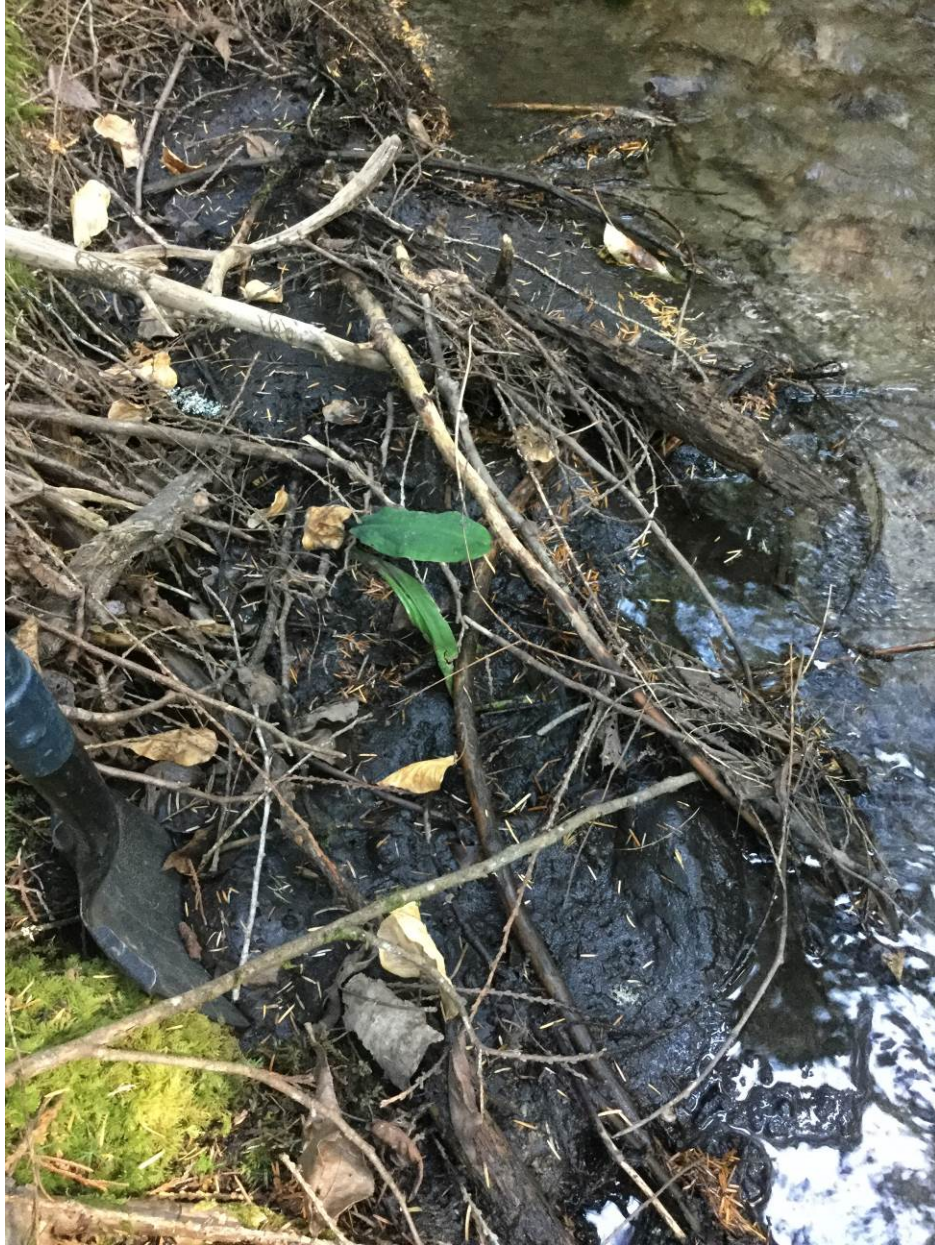
After the rainfall event of August 13, several water users reported fine black sediment that plugged up their intakes and caused water quality issues (Figure 6). This sediment appears to be composed of primarily organics (char/soot from the fire) with some fine particulate matter. This type of sediment has been observed in other watersheds in the West Kootenays following wildfires. This black sediment has been deposited throughout the lower channel of Morley Creek and will likely be remobilized during future high flow events.

Figure 6. Black sediment deposited in the lower reaches of Morley Creek after the August 13 rainstorm.

There is also a high likelihood of ongoing periodic water quality (turbidity) effects due to the large area of exposed mineral soil in the headwaters of Morley Creek and the high connectivity between the burn area and the headwater channels. Past experience from fires in the West Kootenays indicates that these effects are usually minor in nature and of short duration. Water quality impacts could be improved by installing filtration on water systems.
