BC Ministry of Forests

# POST-WILDFIRE NATURAL HAZARDS RISK ANALYSIS KOMONKO CREEK FIRE (N51210)

November 29, 2024

Report Number: 24.540.21

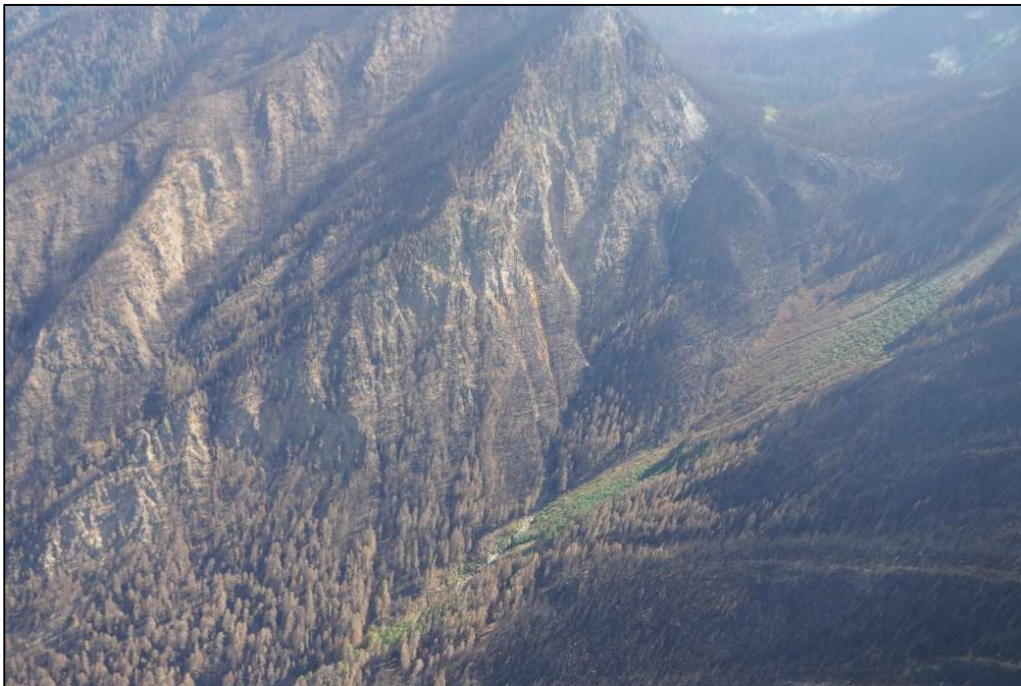
**Photo 3:** Moderate and high VBS within the mid-slope canyon of Aylwin Creek watershed.

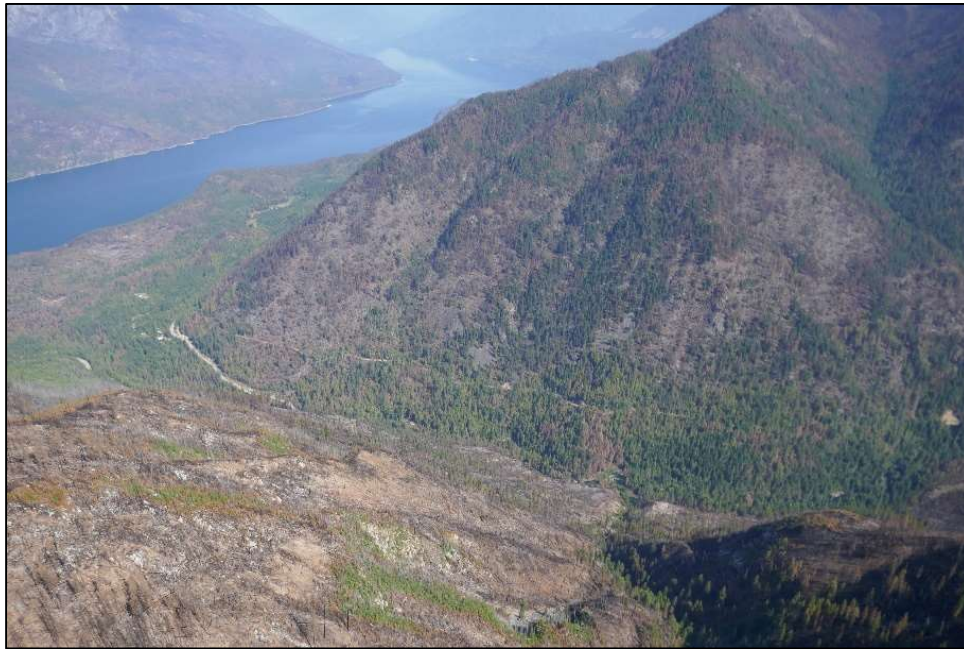
**Photo 4:** View of the south-facing slope of Enterprise Creek which has mostly mixed moderate and low VBS (see Map 1). The Highway can be seen at left, Enterprise Creek FSR cuts across the lower portion of the slope in the area of mixed low VBS and unburned forest.

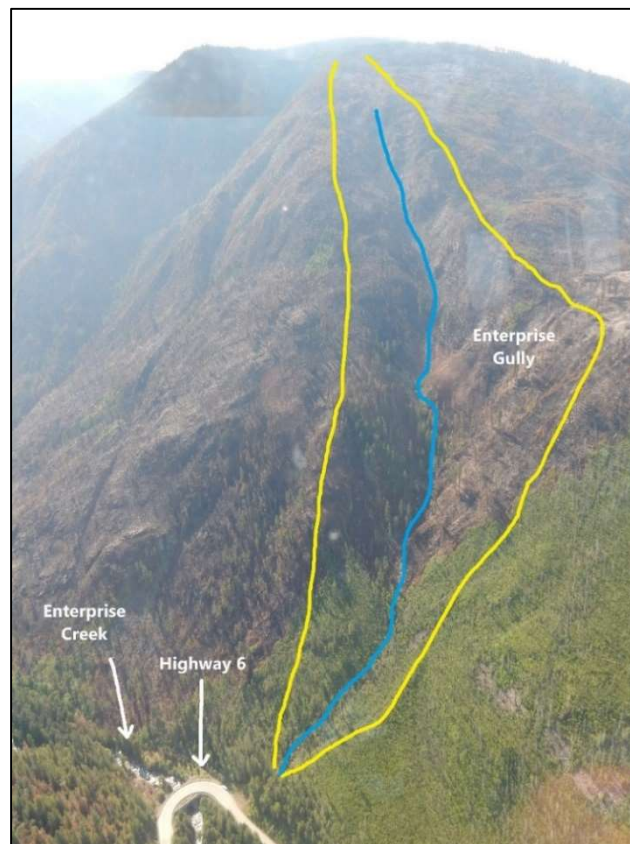
**Photo 5:** View of the steep gullied draw on the south side of Enterprise Creek at the Highway crossing. Much of the drainage burned at high VBS and is a reburn of ground burned during the 2007 Springer Creek Fire.

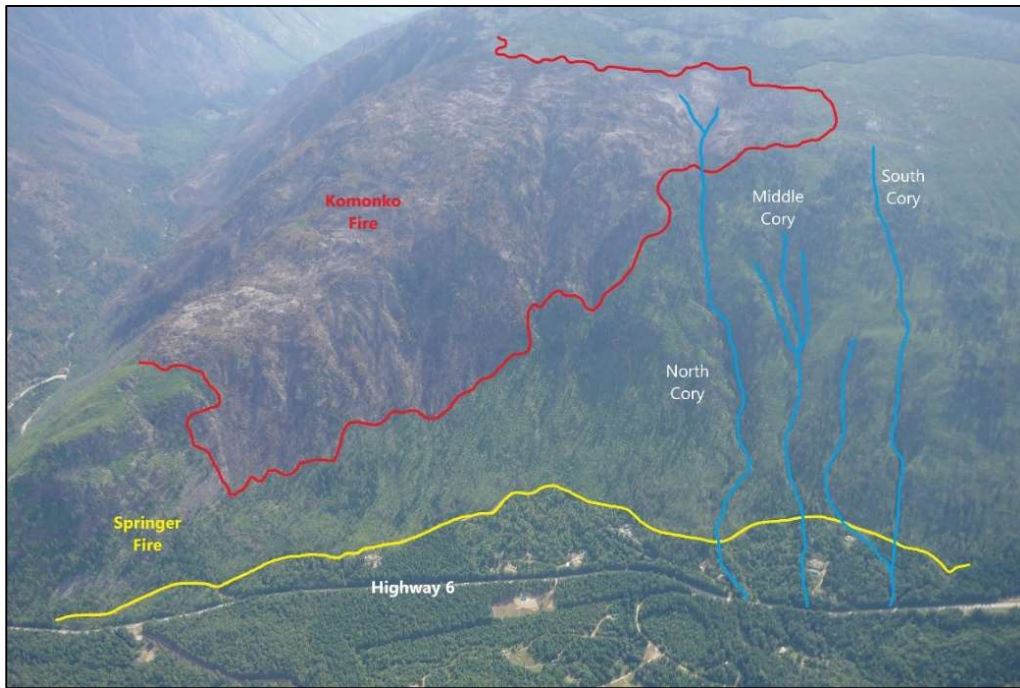
**Photo 6:** View of the Fire (outlined in red) on the Allen and Cory Creek face above The Highway. The Springer Creek Fire (outlined in yellow) burned much of this slope in 2007 and immature regrowth covers much of the lower slopes. The various Cory Creeks are shown as blue lines.

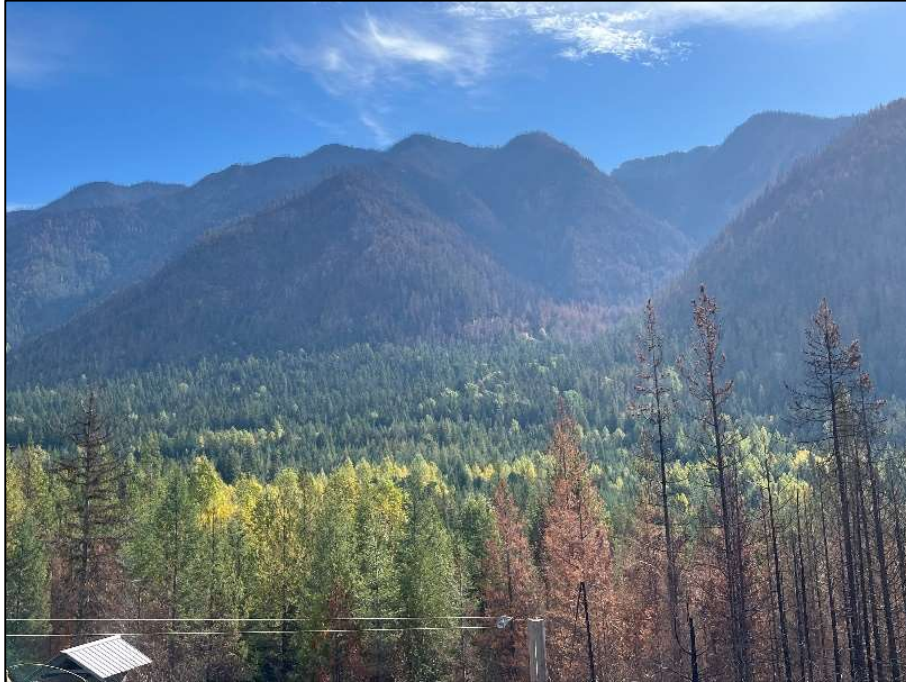
The elements at risk are a residence on the lower fan below the Highway and the two Highway crossings on lower Vevey Creek and Aylwin Creek (Field Observation Site K8) which have potential for floods and increased sediment movement. The residence is located downslope of the Highway on an elevated site above Vevey Creek to the north (160 m distance) and Aylwin Creek to the south (165 m distance). The Aylwin Creek crossing at Field Observation Site K8 is discussed individually below in Section 8.3. Aylwin Creek has been rated as having a LOW incremental post wildfire hazard with a LOW likelihood of spatial impact; the overall partial risk is rated as VERY LOW.

**Photo 7:** View of the lower reaches of the Aylwin Creek watershed. The upper slopes are burned at moderate and high VBS, but the large alluvial fan formed where the creek leaves the confined valley is completely unburned.

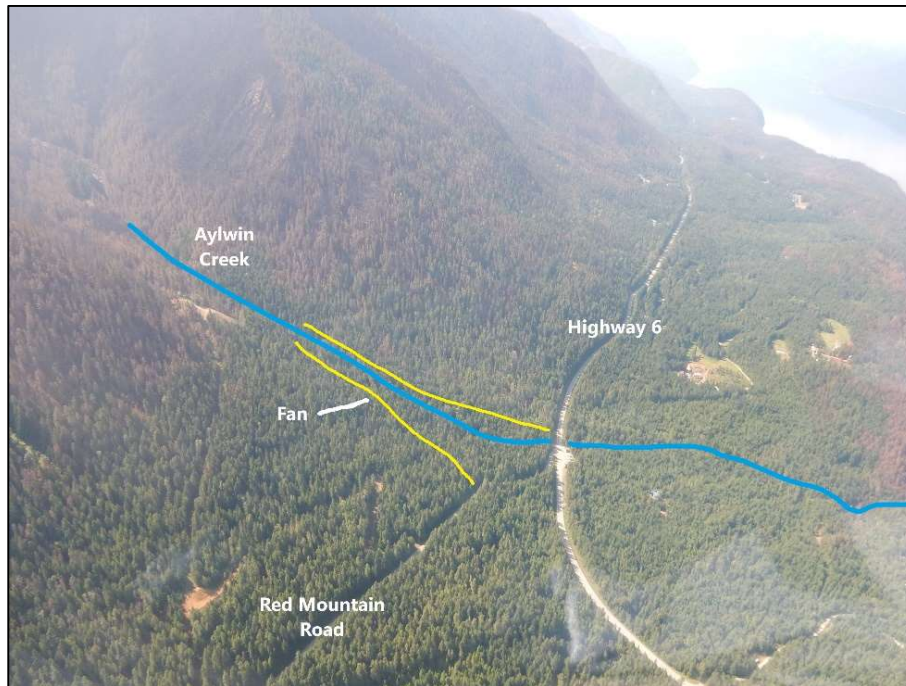
Aylwin Upper Creek has been rated as having a HIGH incremental post wildfire hazard with a HIGH likelihood of spatial impact to the Highway and RMR; the overall partial risk is rated as VERY HIGH to the Highway and RMR.

**Photo 8:** Oblique view of the alluvial fan at the outlet of Aylwin Upper Creek watershed. The Highway runs along the base of the slope and RMR leaves the Highway on the south side of the crossing and rises upslope to the northeast. Much of the upper watershed is severely burned but the alluvial fan is completely unburned.

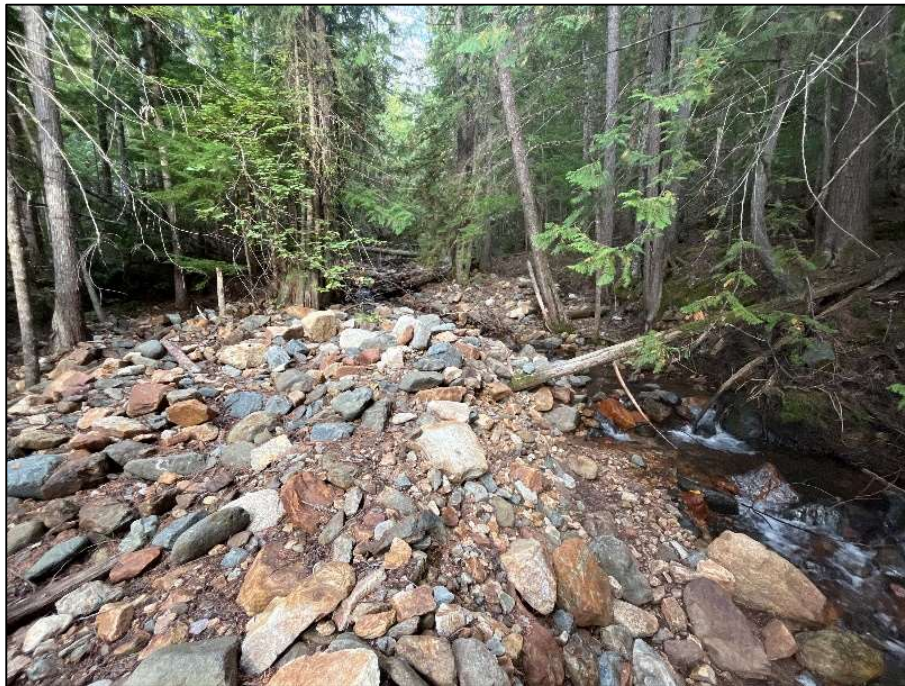
**Photo 9:** View upstream along Aylwin Creek immediately upstream from the Highway crossing (a 2000 mm steel plate culvert). The creek is filled with coarse cobble and boulder gravels and large wood pieces. Streamflow is diverting around the elevated sediment accumulations (aggradation).

**Photo 26:** Construction of a wide channel through an armoured catch basin with a trash rack at the culvert inlet, such as shown in this image, may be a suitable solution at the highway crossing of Aylwin Creek.

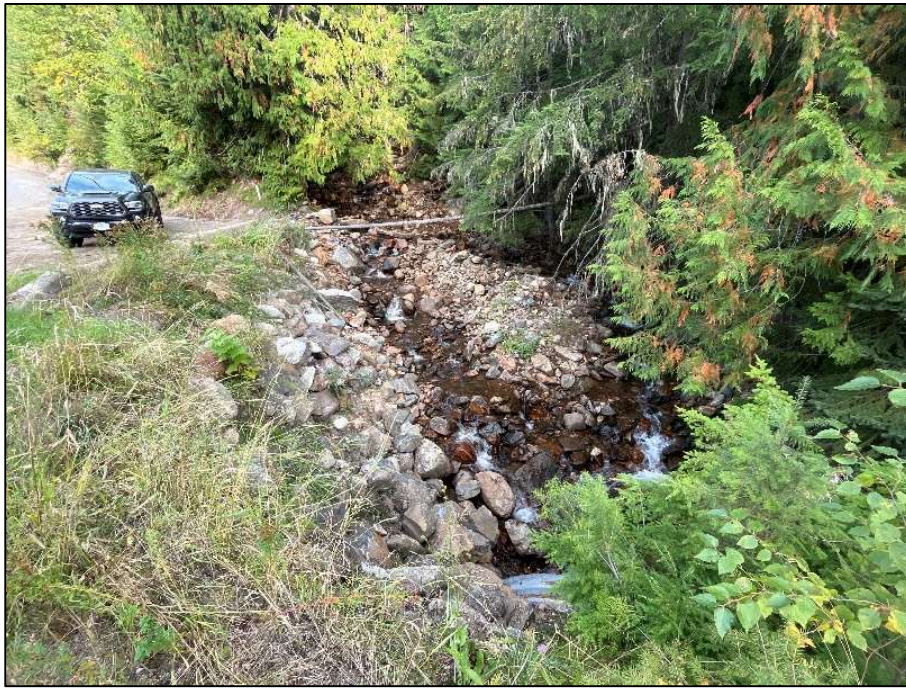
**Photo 10:** Looking upstream along Aylwin Creek from the Highway crossing (Field Observation Site K8). Note the low freeboard on the left side of the image where avulsion of the creek could easily occur and flow could be diverted onto the Highway.

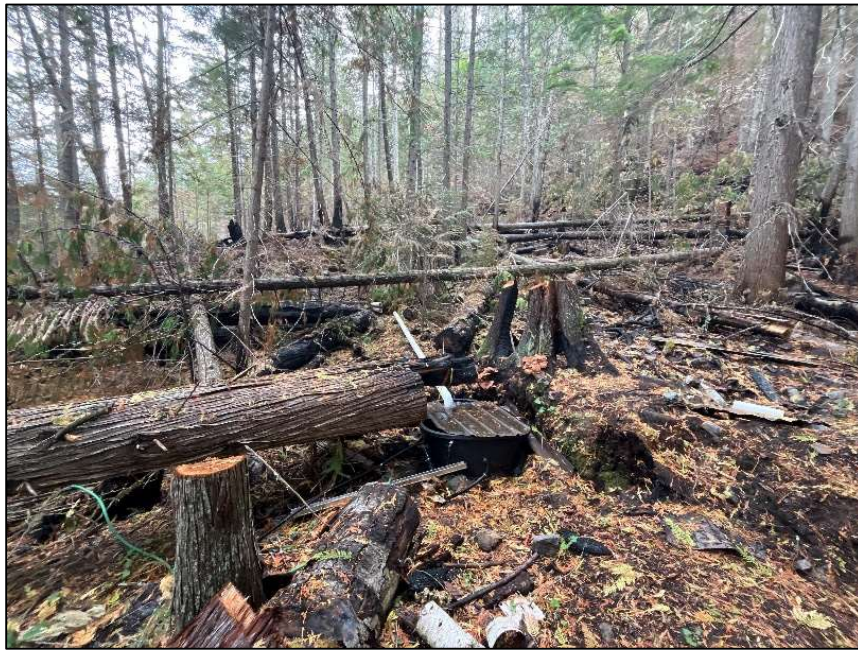
The elements at risk are two residences (8876 and 8906 Highway 6) along the lower slope and the Highway. Both residences are located on gentle slopes relatively close to the Highway and are sufficiently far enough away from the drainage channels on the steeper slopes to have a low likelihood of impact. Cabin Creek has been rated as having a LOW incremental post wildfire hazard with a LOW likelihood of spatial impact to residences and the Highway; the overall partial risk is rated as VERY LOW.

**Photo 11:** Cabin Creek is a small creek in a shallow swale on the lower slope above the Highway (Field Observation Site K20).

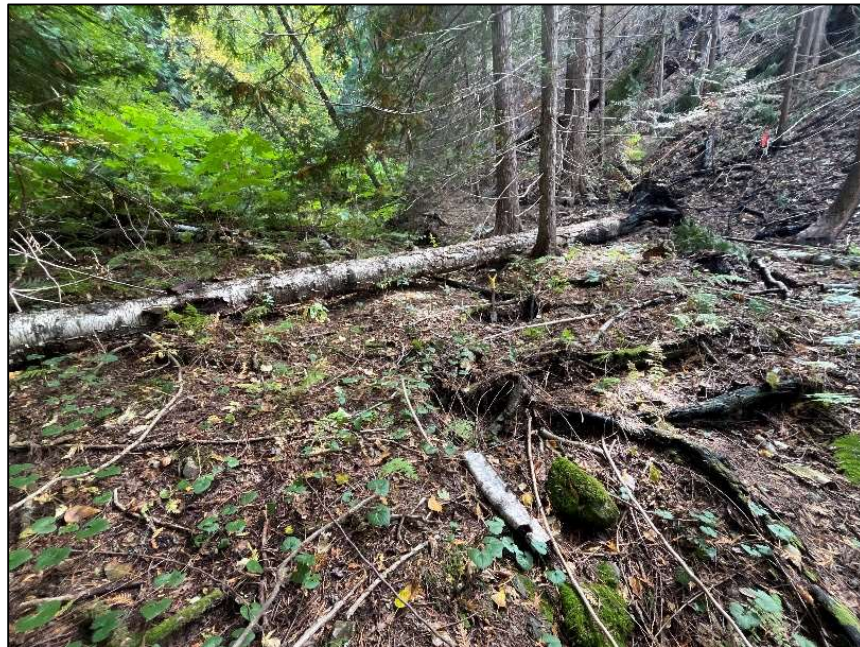
Congo Creek has been rated as having a MODERATE incremental post wildfire hazard with a LOW likelihood of spatial impact to the residence at 8596 RMR and to RMR; the overall partial risk to the residence at 8596 RMR and to RMR is rated as LOW.

**Photo 12:** View upstream along Congo Creek on the upper alluvial fan (Field Observation Site K34). Congo Creek was a small creek with very limited flow at the time of observation, but there is a narrow channel armoured with coarse cobbles and boulders.

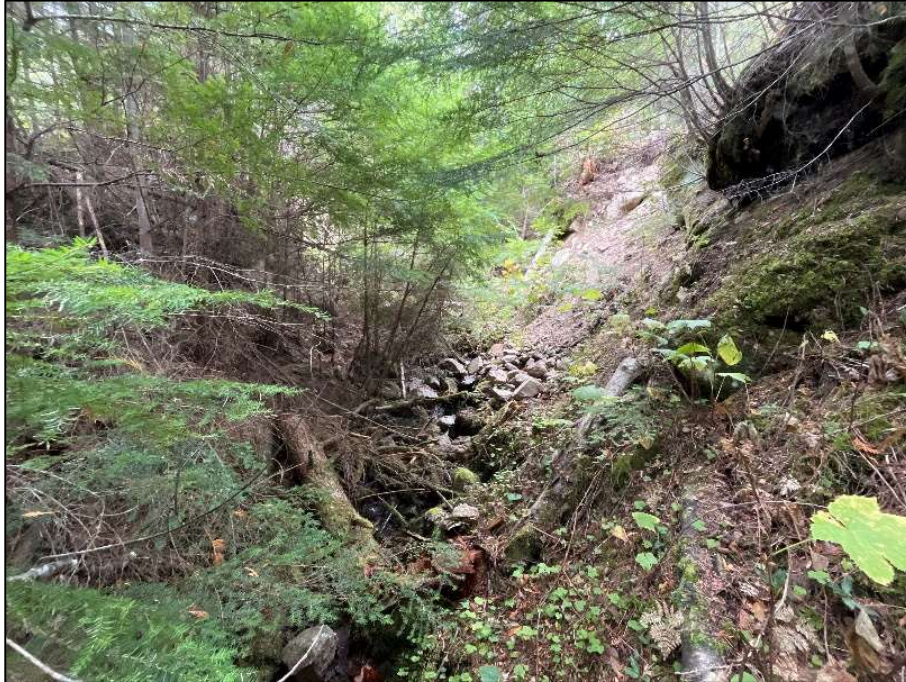
Modelling of the flows on the Cory Middle Creek watershed shows channel on the steep upper slopes losing confinement at the top of the gentler alluvial fan and water and sediment spreading out across the fan surface.

**Photo 13:** Cory Middle Creek along the fire guard (Field Observation Site K54). Note the trim line along the bank to the right, this is evidence of passage of a recent debris flow.

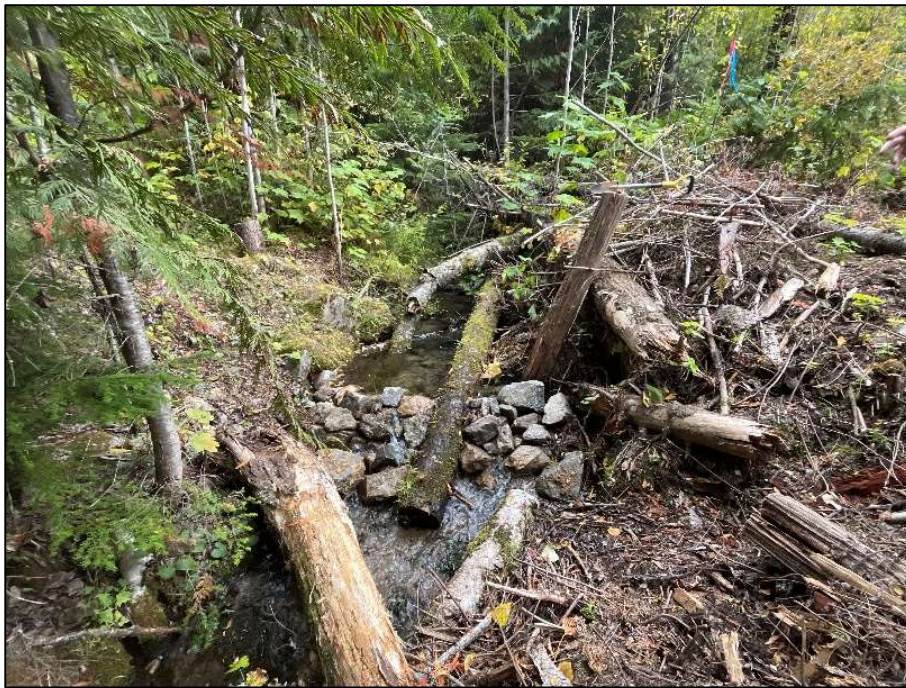
Two water licences are located on Cory North Creek below the Highway; one is joint use domestic and irrigation and the other is for residential power (PD27897).

**Photo 14:** Cory North Creek along the fireguard (Field Observation Site K55).

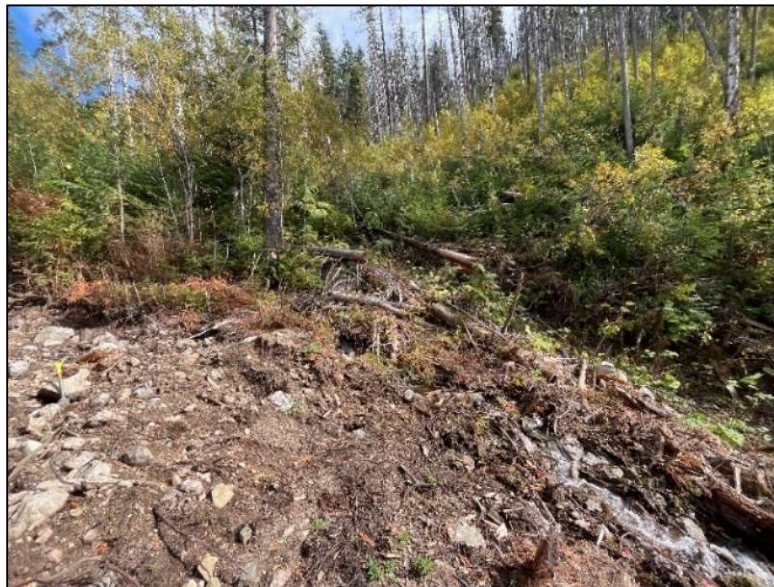
Cory South Creek has been rated as having a LOW incremental post wildfire hazard with a LOW likelihood of spatial impact to the residence and the Highway; the overall partial risk is rated as VERY LOW.

**Photo 15:** The south branch of Cory South Creek crossing the fireguard constructed across the upper portion of the alluvial fan (Field Observation Site K53).

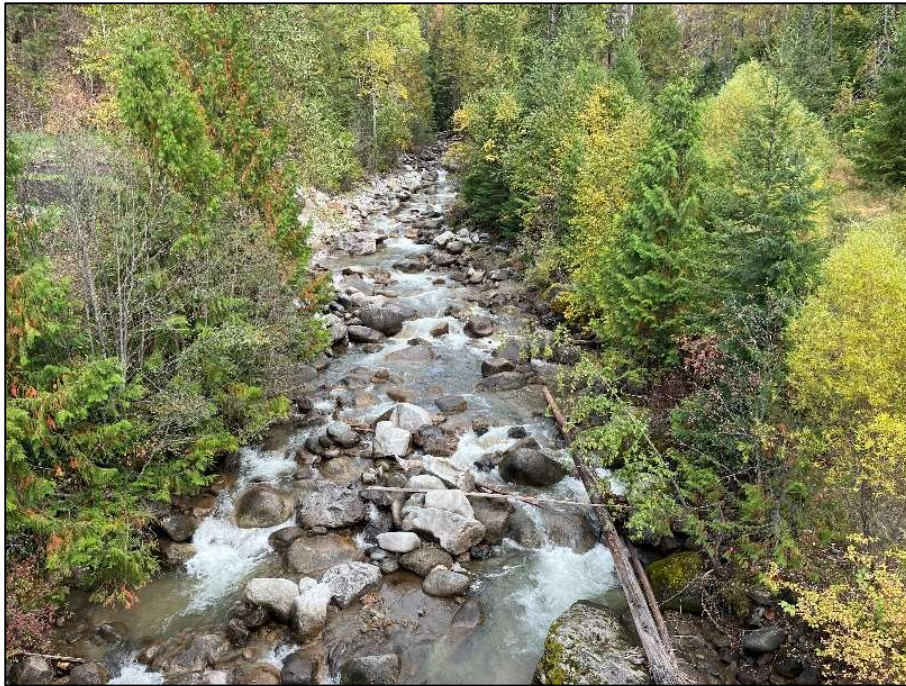
**Photo 16:** View looking upstream along Enterprise Creek from the Highway crossing (Field Observation Site K43).

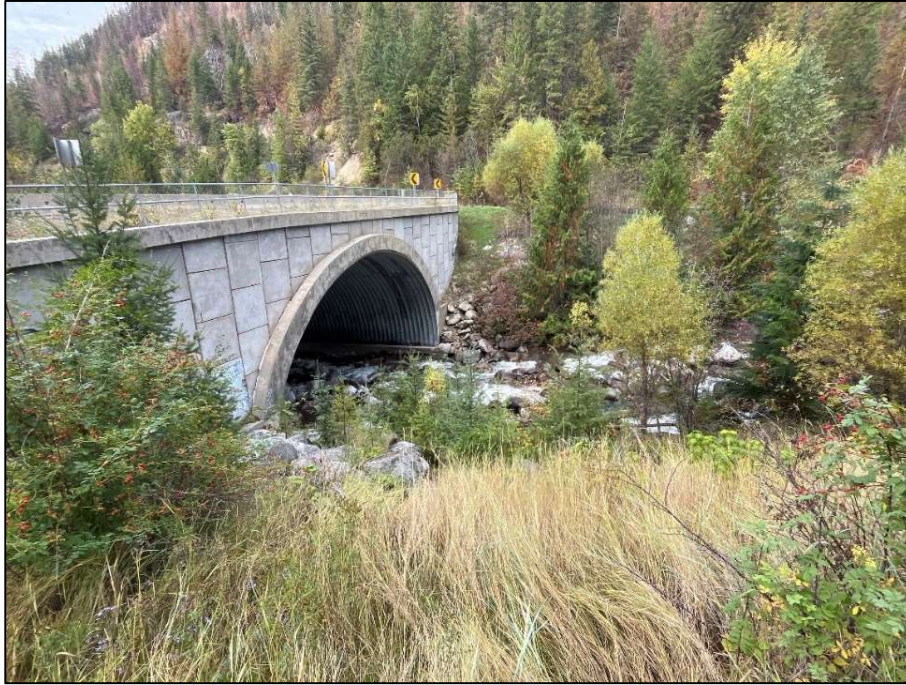
The element at risk is the Highway crossing over Enterprise Creek. The creek passes under the Highway through a very large arch culvert (Photo 17) which was constructed after the 2007 Springer Creek Fire and is believed to be appropriately sized to pass the design flood event which might be generated within the watershed. Enterprise Main Creek has been rated as having a VERY LOW incremental post wildfire hazard with a LOW likelihood of spatial impact to the Highway; the overall partial risk to the Highway is rated as VERY LOW.

**Photo 17:** View of the inlet of the large arch culvert on Enterprise Creek at the Highway crossing (Field Observation Site K43).

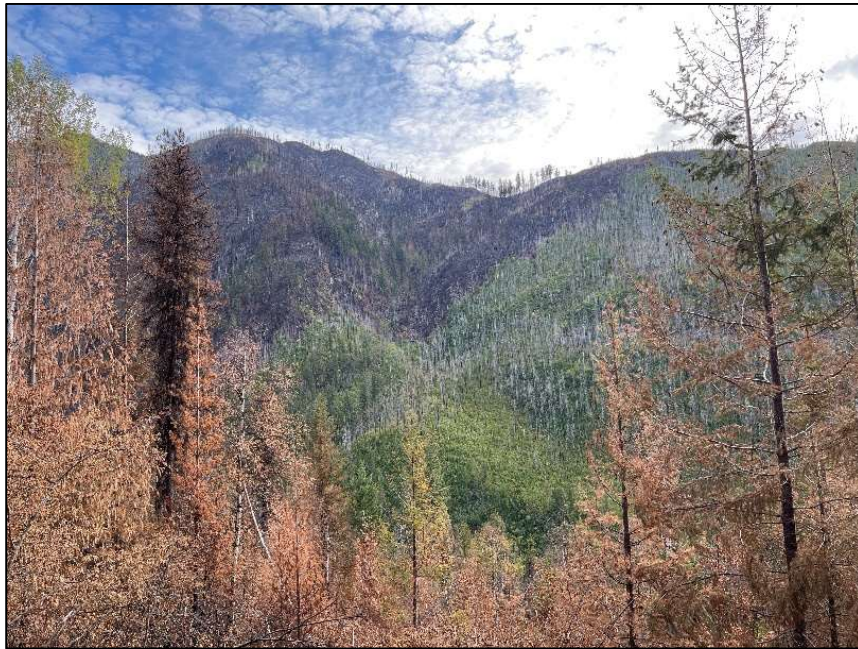
Enterprise Gully has been rated as having a HIGH incremental post wildfire hazard with a HIGH likelihood of spatial impact to the Highway; the overall partial risk is rated as VERY HIGH.

**Photo 18:** View south up Enterprise Gully.

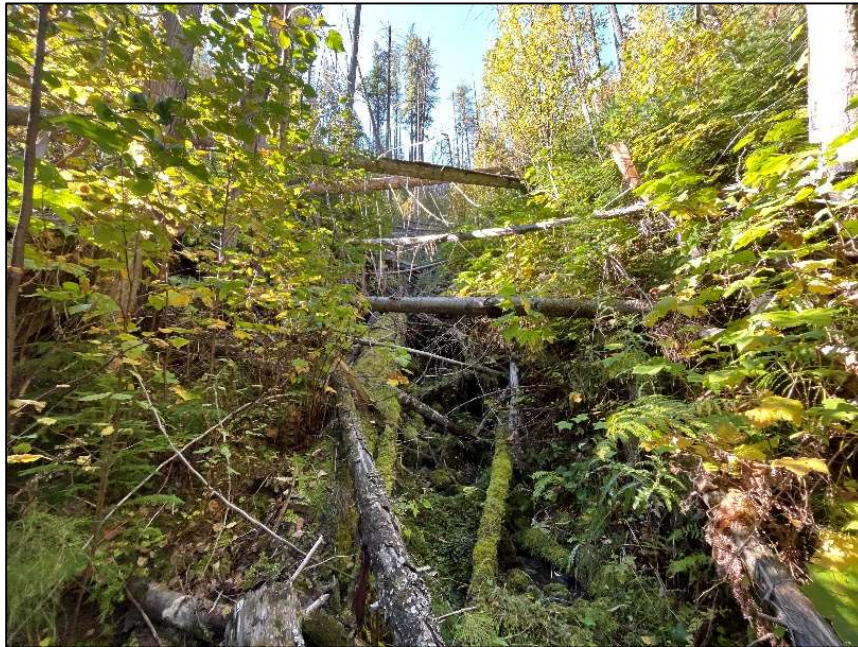
**Photo 19:** View upslope along Enterprise Gully (Field Observation Site K44) on the lower slope above the Highway. The channel has a steep gradient (35-45%), is deeply incised (3-5 m deep) and infilled with large woody debris.

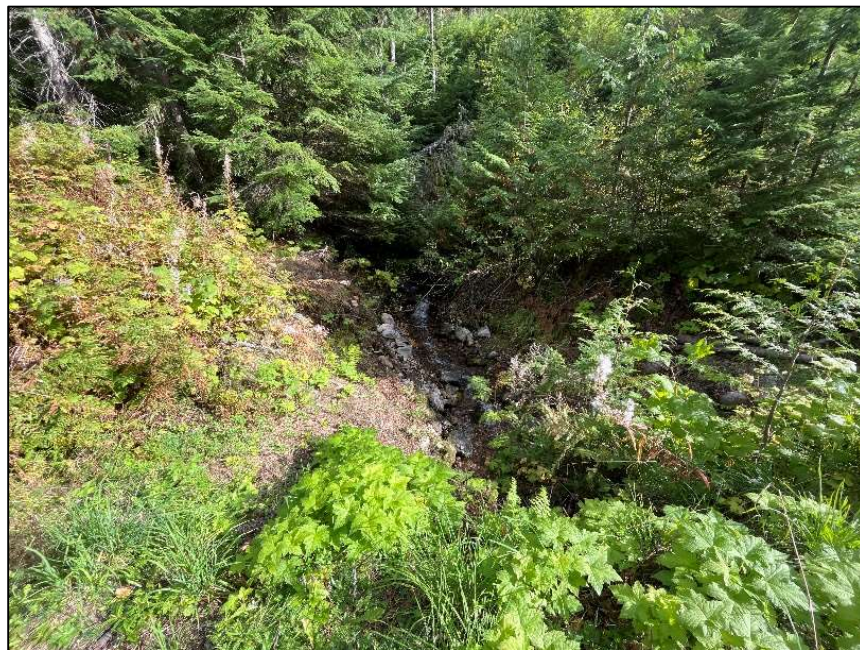
Fingland Creek passes under RMR through a 1200 mm culvert which has the potential to be blocked by elevated sediment and debris carried by floodwaters in the creek. Fingland Creek has been rated as having a LOW incremental post wildfire hazard with a MODERATE likelihood of spatial impact to RMR; the overall partial risk to RMR is rated as LOW.

**Photo 20:** View upstream along Fingland Creek. The creek is contained in a deep, low gradient draw as it reaches RMR at Field Observation Site K3.

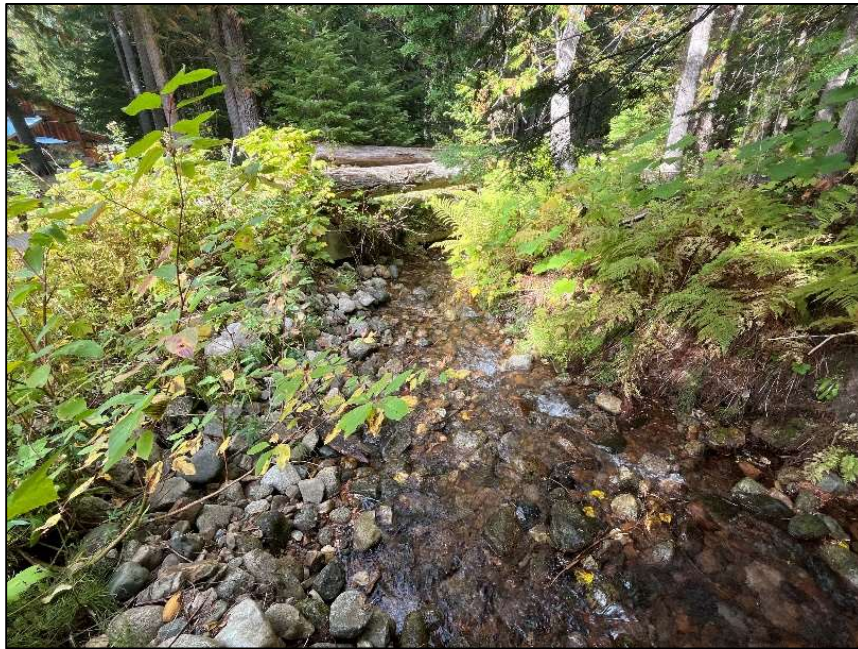
**Photo 21:** View downstream along Finland Creek from the access road to 8473 RMR (Field Observation Site K4). The creek has a low gradient and is contained in a shallow swale. The residence, visible at upper left, is located 50 m from the creek on a flat bench and is potentially vulnerable to flooding or creek avulsion.

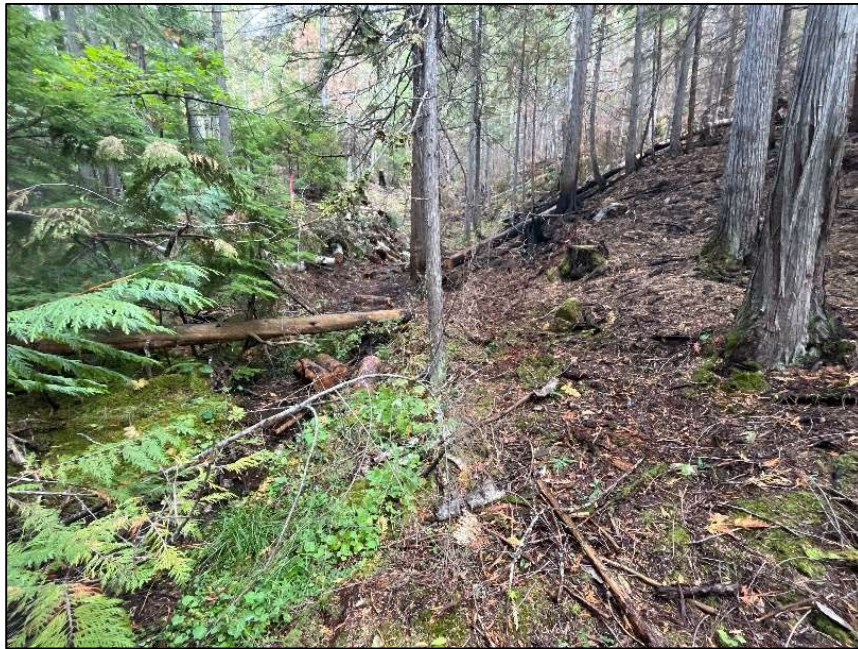
The element at risk is the Highway which crosses well below the gently sloped fluvial fan and has low potential of impact from any event occurring in the Harte Creek watershed. Harte Creek has been rated as having a VERY LOW incremental post wildfire hazard with a LOW likelihood of spatial impact to the Highway; the overall partial risk is rated as VERY LOW.

**Photo 22:** Harte Creek is a small creek in a shallow swale on the lower slope above the Highway (Field Observation Site K19).

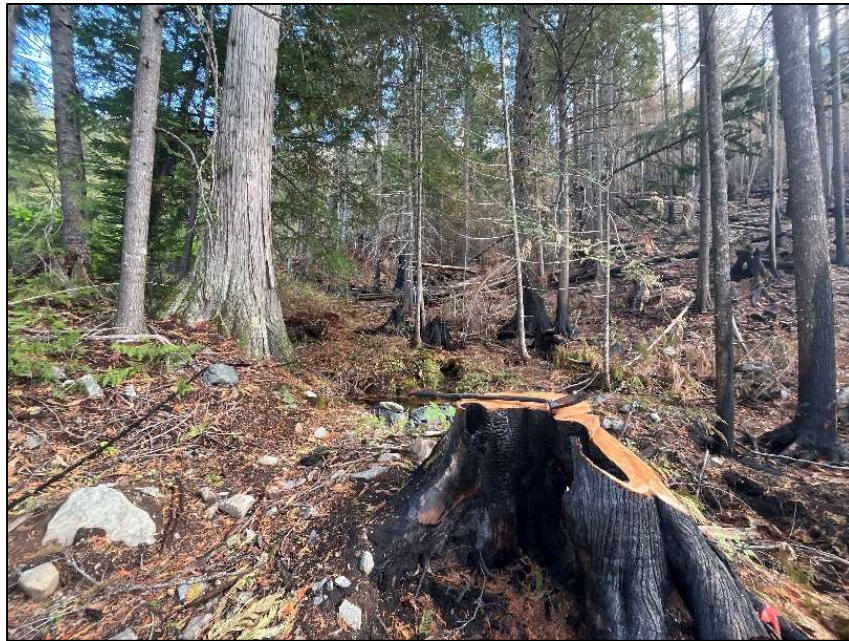
**Photo 23:** View upslope along Highland View Creek at Field Observation Site K17. A small water intake is located in the base of the draw. The upslope channel is small and contained within a well defined draw. Downslope the creek crosses across a broad mid-slope alluvial fan above the Highway.

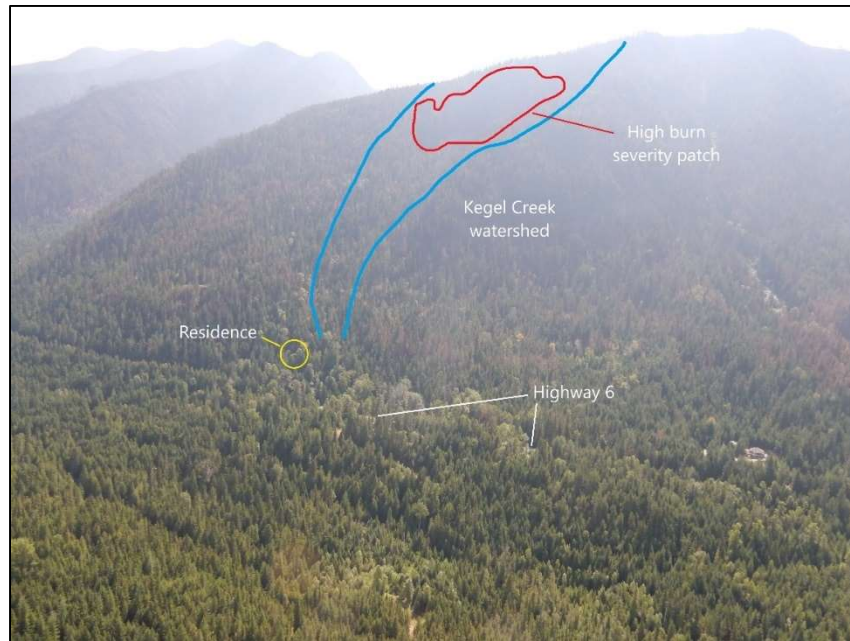
**Photo 24:** View of Kegel Brook watershed above the Highway corridor with the high burn severity patch across the upper watershed including the riparian zone. (Photo courtesy of Sarah Crookshanks, MOF).

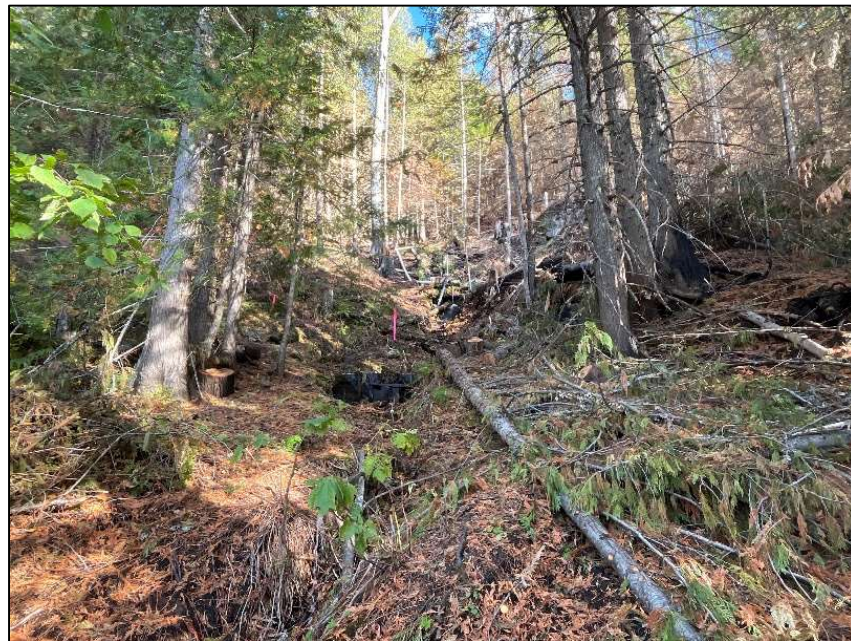
**Photo 25:** View upslope along Kegel Brook at Field Observation Site K24. This creek is small and flows within a well defined draw which leads on to a short steep alluvial fan above the Highway.

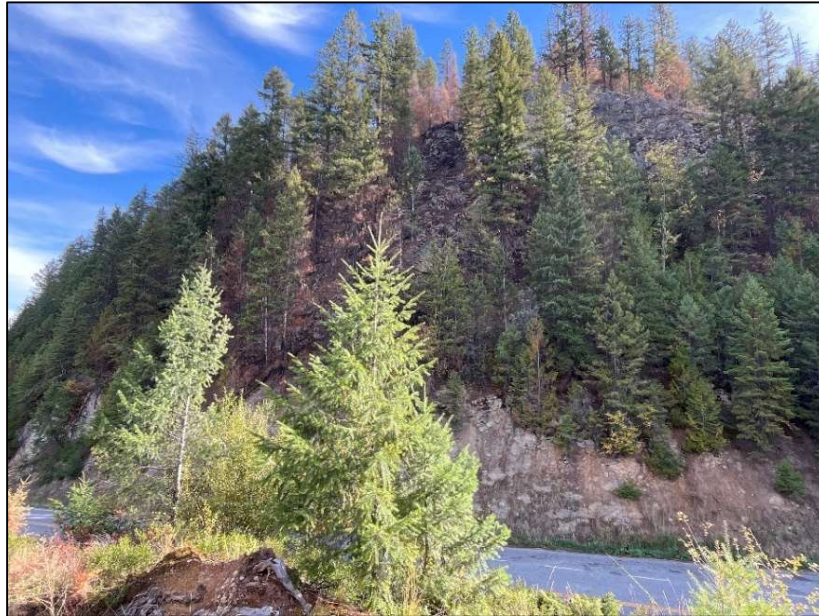
**Photo 27:** View of exposed rock above the Highway near the Slocan Lake View Point (Field Observation Site K28). The upper slope has a few burned patches from which vegetation cover has been removed and is the likely source of the rock that fell during the summer.

first year and the MoTT should be aware of this hazard and should inspect the slopes regularly and maintain as required.

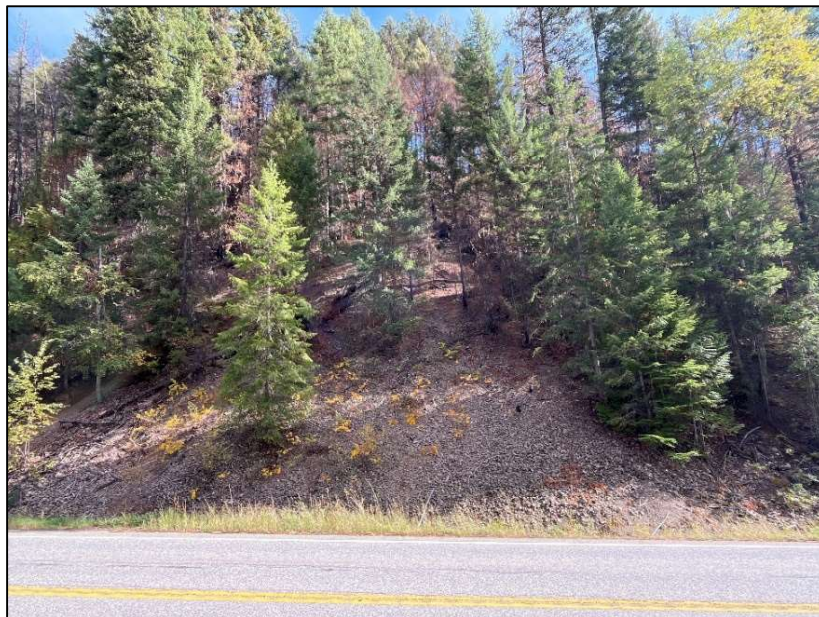
**Photo 28:** View of a moderately steep rubbly talus cone exposed above the Highway near the Slocan Lake View Point (Field Observation Site K29). Removal of the surface vegetation has decreased the stability of the slope and rock fragments are moving downslope into the ditch.

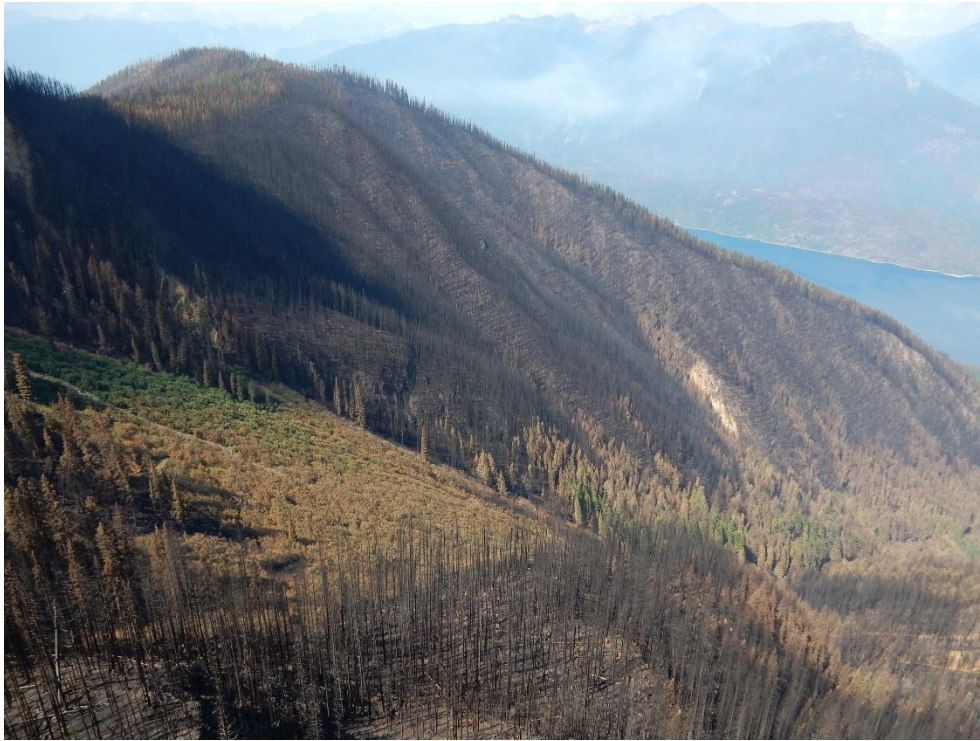
*Figure 4. Photo of high burn severity in the Aylwin Creek watershed.*
