BC Ministry of Forests

# POST-WILDFIRE NATURAL HAZARDS RISK ANALYSIS PONDEROSA FSR FIRE (N51069)

December 18, 2024

Report Number: 24.510.01.03.01.04

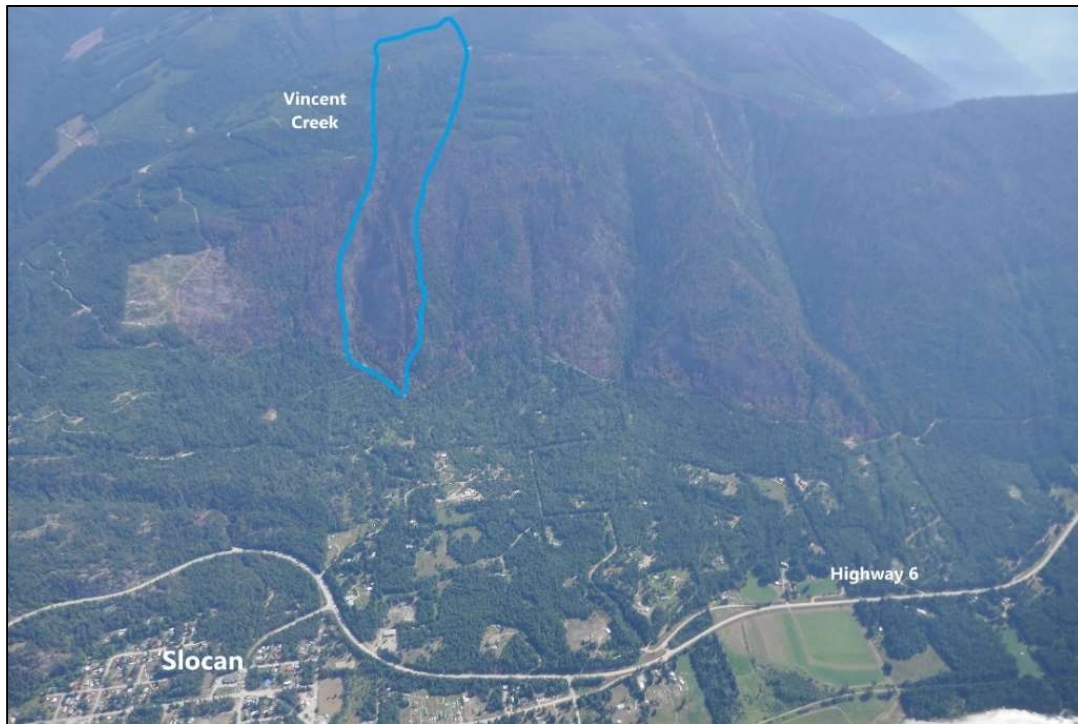
**Photo 3:** Mixed burn severities on the north end of the Fire. Vincent Creek is outlined; a small patch of high VBS can be seen low in the watershed on the north side of the creek draw.

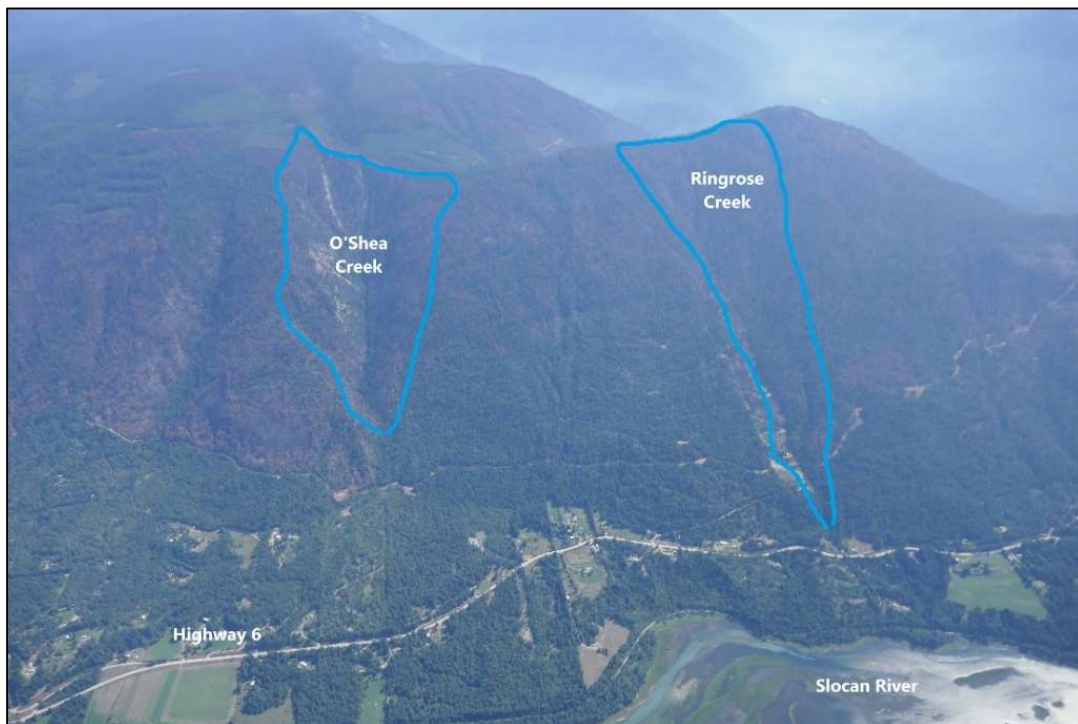
**Photo 4:** Variable burn severity on the face slopes across O'Shea Creek (outlined) and Ringrose Creek (outlined). Much of the lower slope burned at low VBS while the upper slope was mixed low and moderate VBS.

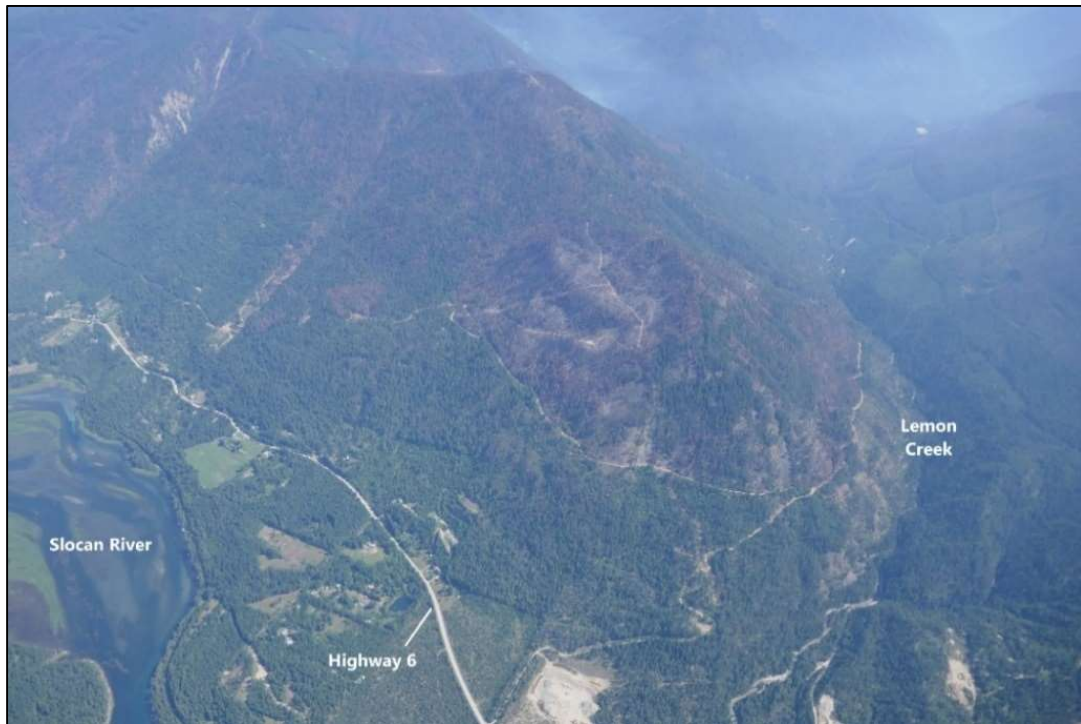
**Photo 5:** View of the southern end of the Fire. The Ponderosa FSR ascends the slope from the gravel pit at lower centre and has two branches; one extends east along the slope above Lemon Creek and the second continues upslope to the northeast.

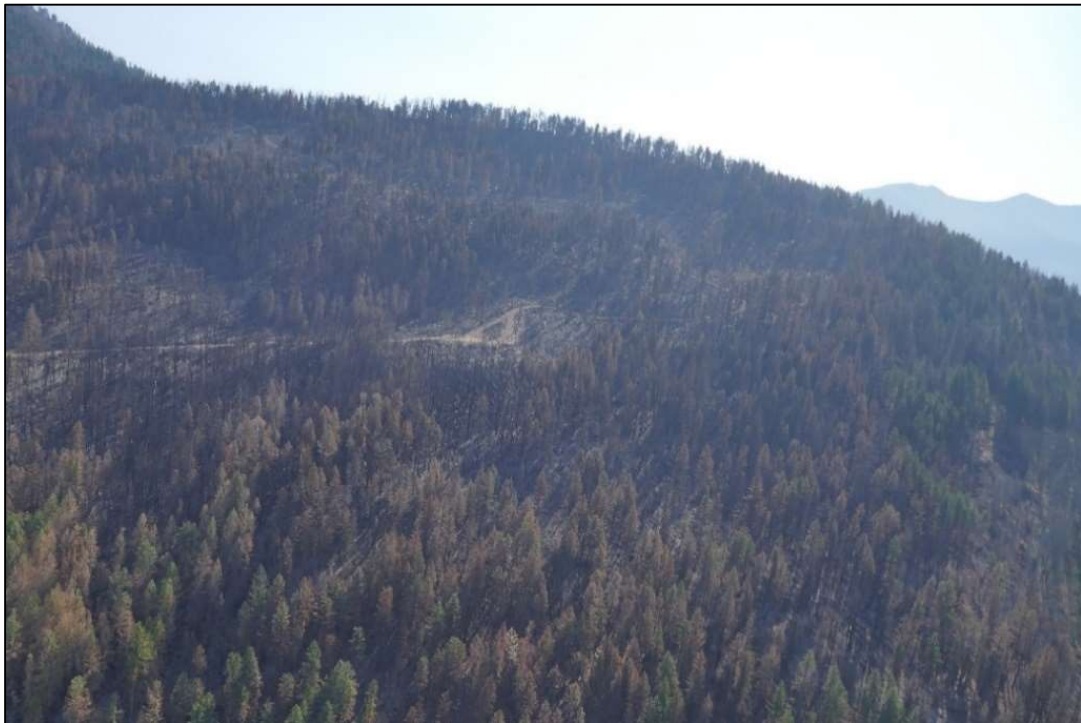
**Photo 6:** Mixed high, moderate and low VBS on the south end of the Fire. A section of the Ponderosa FSR can be seen in the middle of the image.

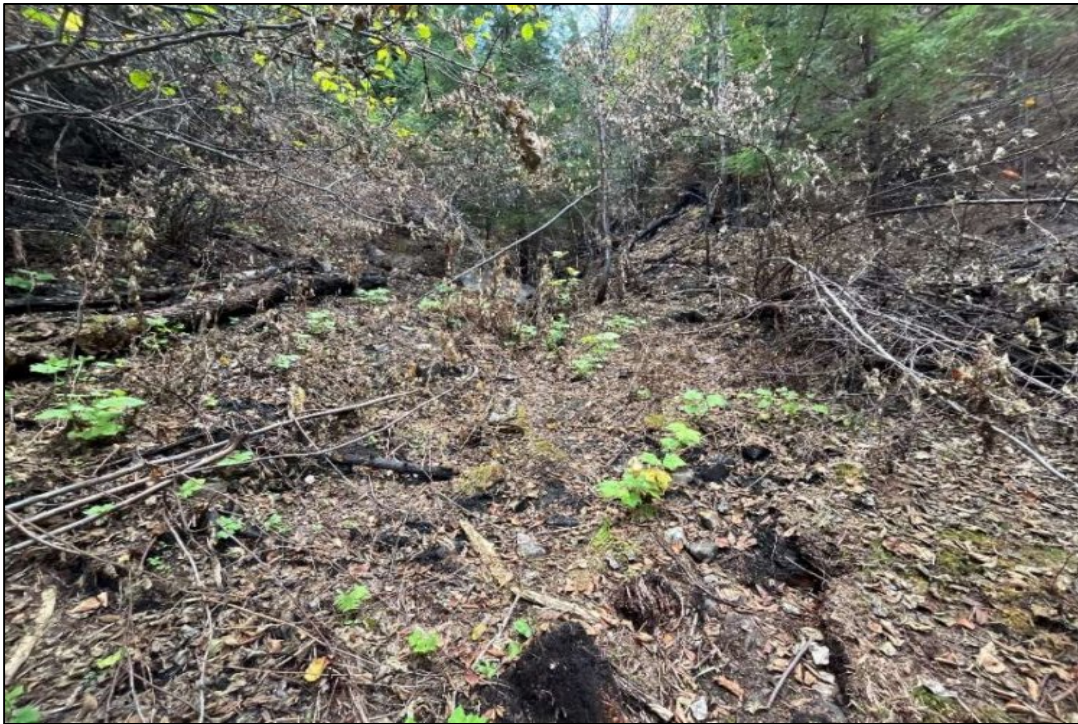
**Photo 7:** Erhard Creek was a dry creek in a well-defined draw on the lower slopes (Waypoint P25).

The fire burned 43% of the watershed with 18% moderate and less than 1% high burn severity; the calculated EBSI is 9.1 which is considered to be very low and the incremental post wildfire hazard is unlikely to be elevated. A small portion of the gentle slopes in the upper watershed were burned but this area is disconnected from the main channel. The burning that did occur within the watershed was concentrated on the steep, south facing valley slope. The calculated EBSI value is considered satisfactory for this watershed.

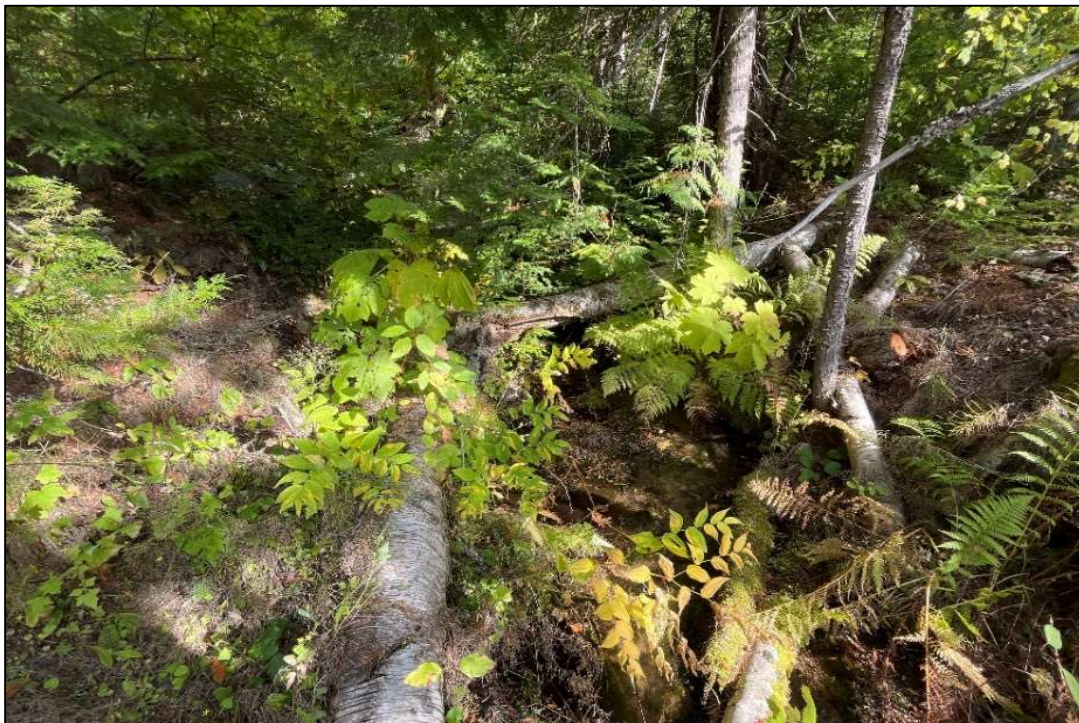
Grant Creek has been rated as having a LOW incremental post wildfire hazard with a LOW likelihood of spatial impact to the residence at 8946 Austyn Road; the overall partial risk to the residence at 8946 Austyn Road is rated as VERY LOW.

**Photo 8:** Grant Creek is a small creek in a shallow swale on the open slopes above Austyn Road (Waypoint P28).

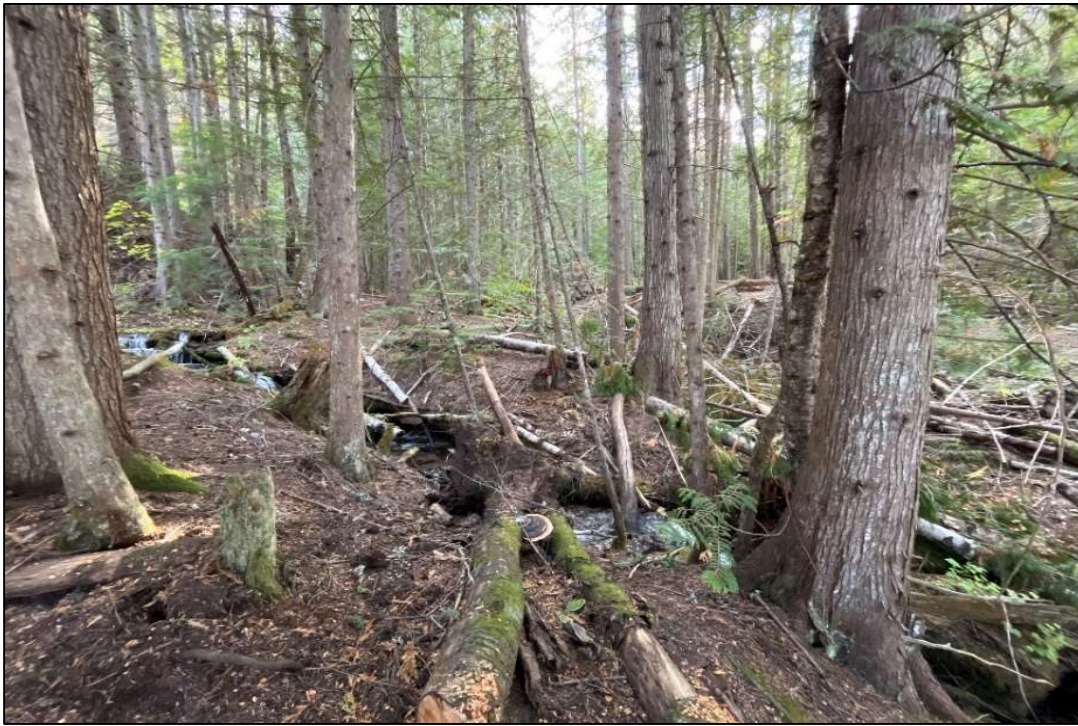
O'Shea Creek is a very small watershed which leads down to a very large, gently to moderately sloped (10-21%) alluvial fan. The watershed is 1.31 km<sup>2</sup> in size, has a Melton ratio of 0.88, an average channel gradient of 43.0%, and a length of 2.43 km. O'Shea Creek is considered to be a debris flow or debris flood watershed. The steep headwaters have exposed bedrock cliffs and several open rubbly talus cone or debris tracks. The creek was viewed along the upper reaches of the alluvial fan near the lower boundary of the Fire and along the Highway. The creek was noted to have strong continuous streamflow across the fan (Photo 9) and in the ditch along the Highway. Flow was carried in the Highway ditch from P29 to P30 where it is conveyed under the Highway through a 600 mm culvert and runs out across a field in a diversion ditch towards the Slocan River. The culvert appears to be adequately sized for expected increases in flow.

**Photo 9:** View of O'Shea Creek on the upper reaches of the gently sloped alluvial fan at Waypoint P22.

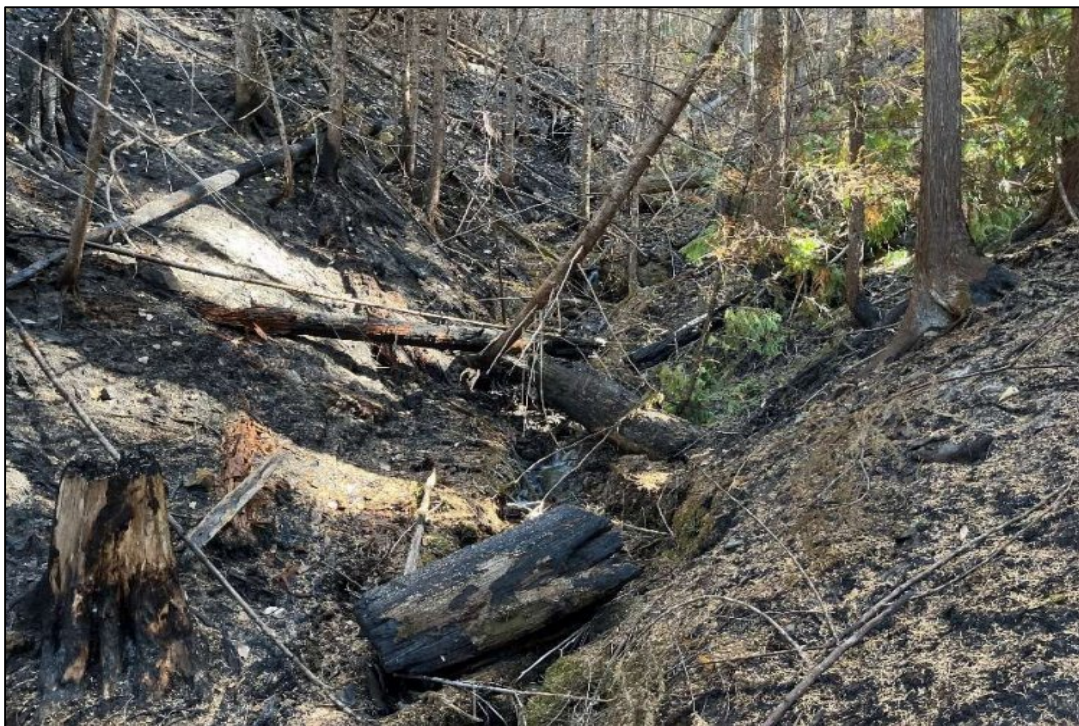
**Photo 10:** View looking upslope along the Ringrose Creek draw on the mid-slopes of the watershed (Waypoint P7). The creek is confined in a deep, steep-sided draw with a moderate gradient channel.

Modelling of the flows on the Ringrose Creek watershed shows the channel on the steep upper slopes losing confinement at the top of the alluvial fan and flow spreading out across the fan surface in the two shallow draws.

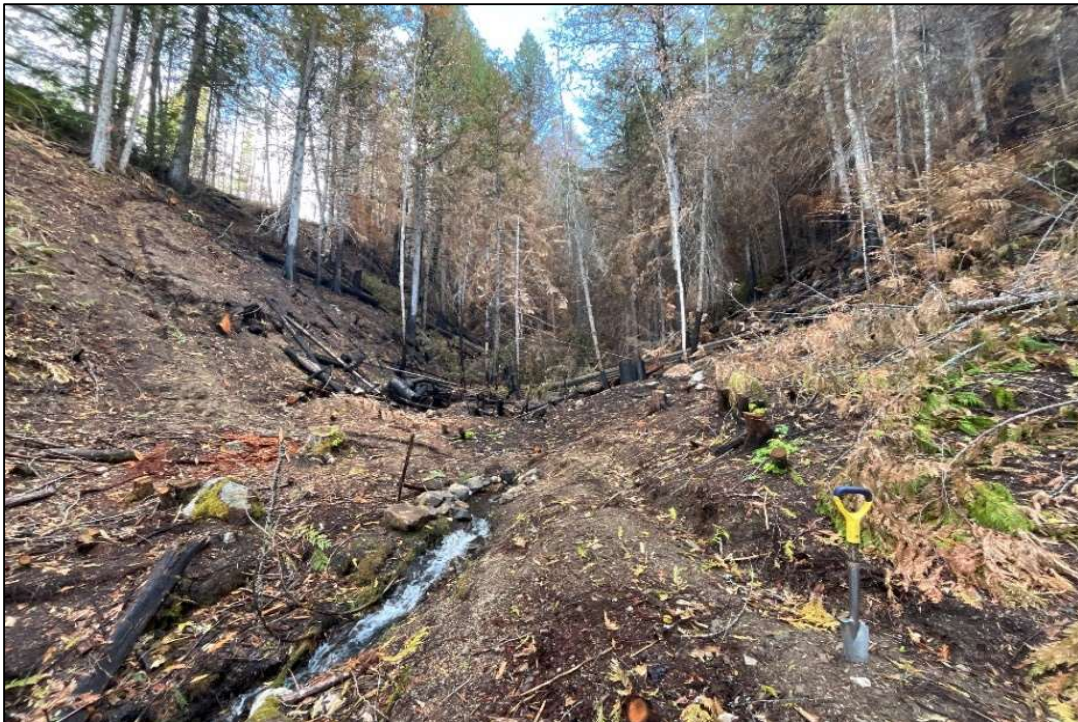
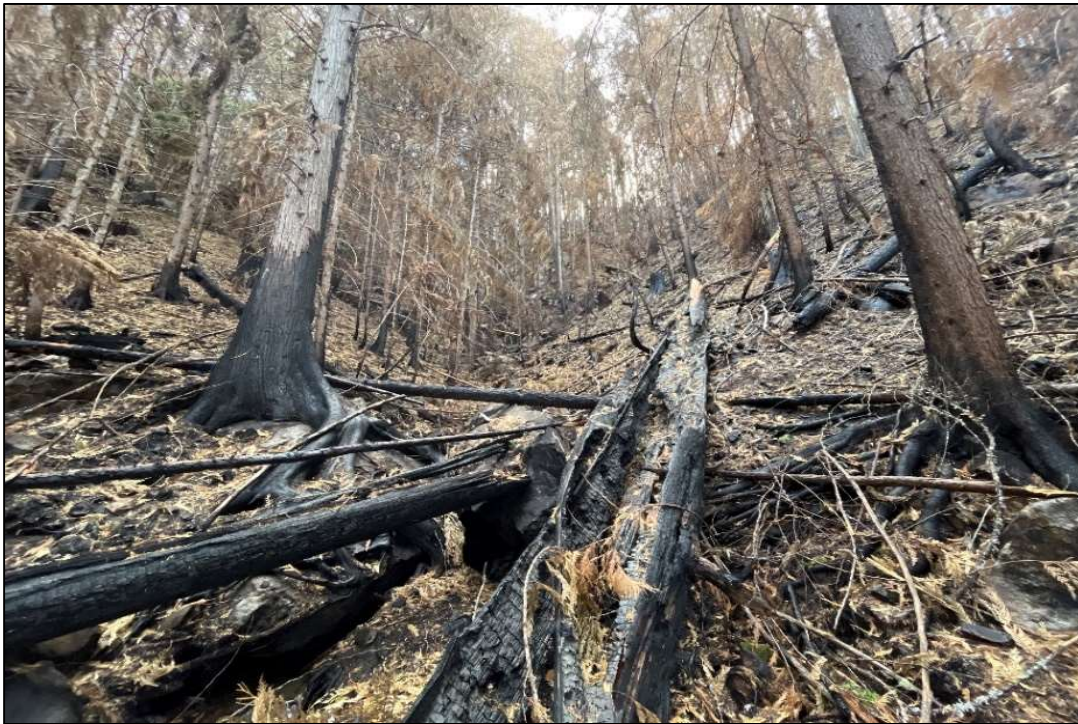
**Photo 11:** View upstream along Vincent Creek (Waypoint P32).

**Photo 12:** View looking upstream along Vincent Creek (Waypoint P32).

Vincent Creek has been rated as having a LOW incremental post wildfire hazard with a MODERATE likelihood of spatial impact to the residences at 8990 and 9006 Springer Creek Road; the overall partial risk to the residences at 8990 and 9006 Springer Creek Road is rated as LOW. This is supported by modelling of debris flow runout through the Vincent Creek watershed.

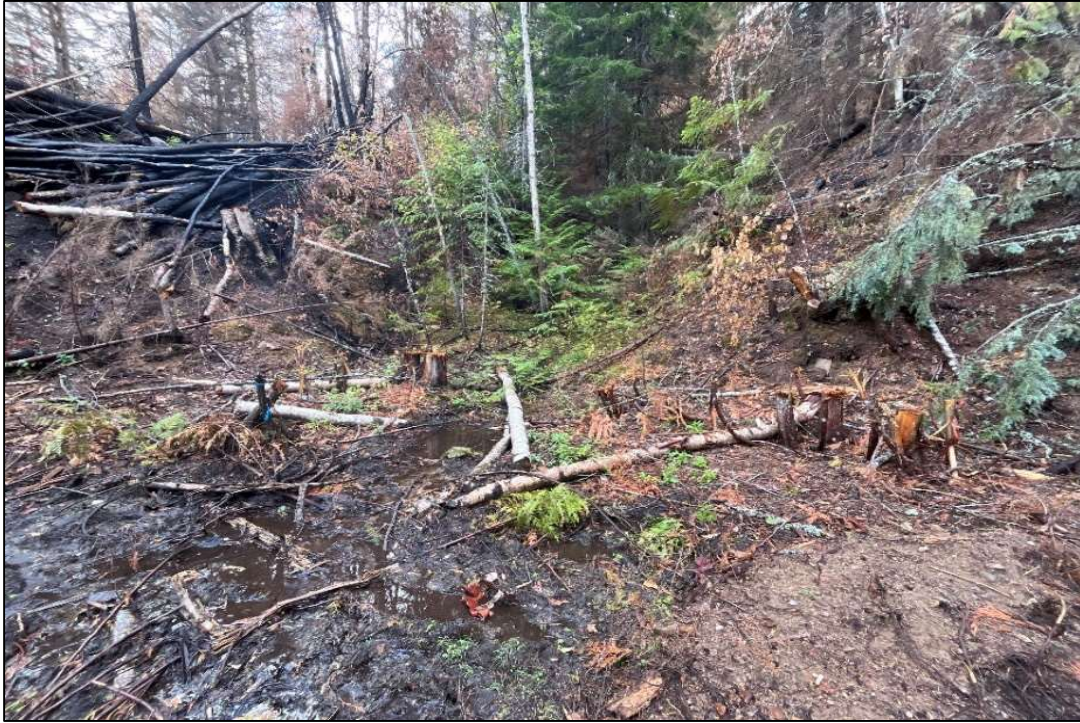
The element at risk is the Springer Creek FSR. Vincent North Creek has been rated as having a VERY LOW hazard with a LOW likelihood of spatial impact; the overall partial risk is rated as VERY LOW.

**Photo 13:** View of Vincent North Creek crossing an old road which was cleared as a fireguard (Waypoint P31).

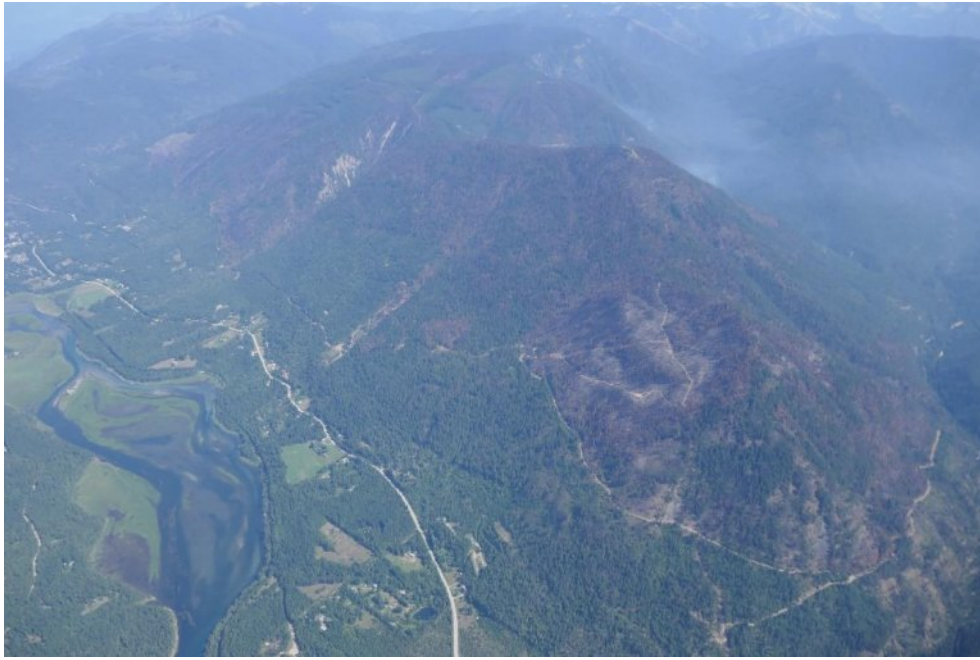
*Figure 2. Overview of the Ponderosa FSR fire looking north (Photo: T. Giles, SNT Geotechnical).*

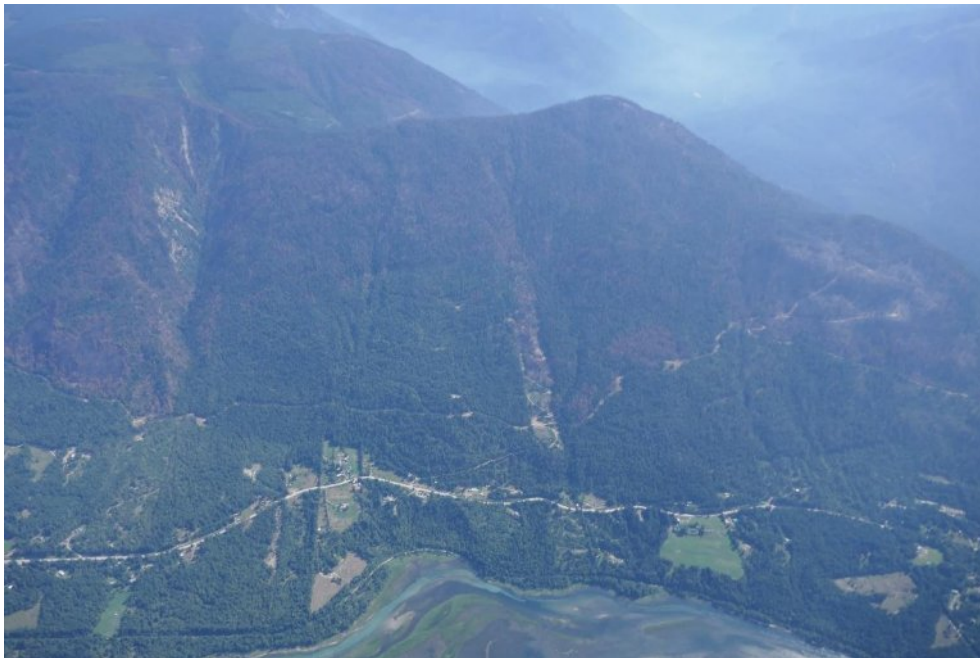
*Figure 3. Overview of the Ponderosa FSR face including O'Shea Creek and Ringrose Creek (Photo: T. Giles, SNT Geotechnical).*

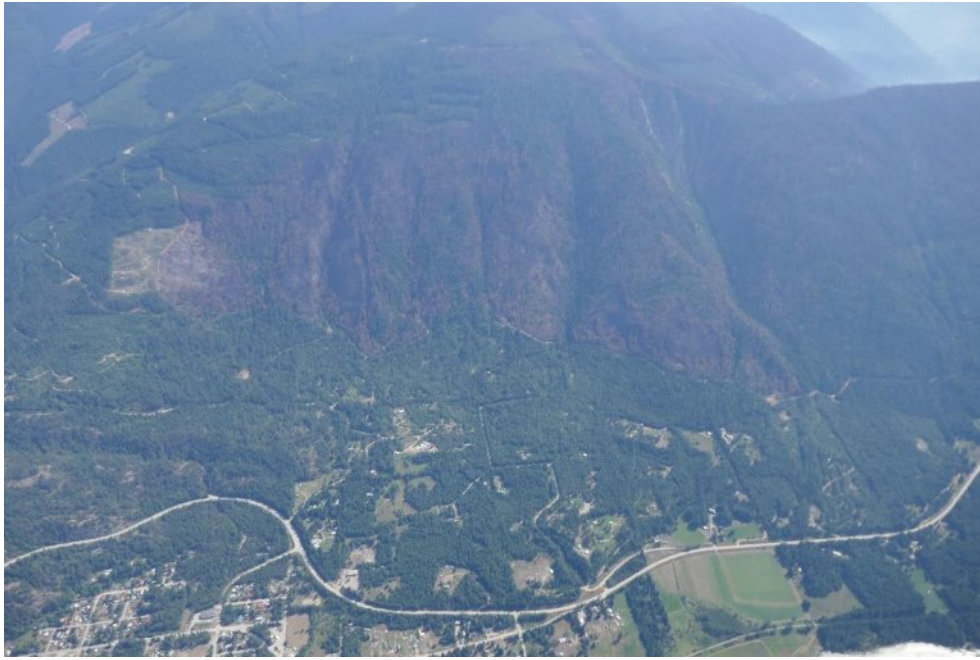
*Figure 4. Overview of the Ponderosa FSR face including the drainages to the north of the O'Shea Creek (Photo: T. Giles, SNT Geotechnical).*

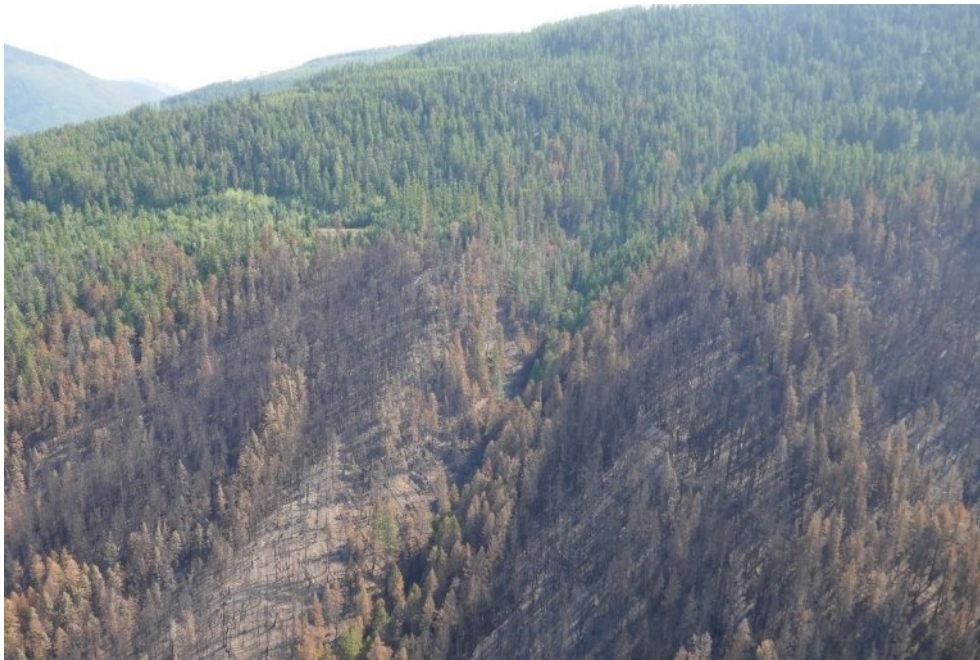
*Figure 5. Headwaters of Vincent Creek (Photo: T. Giles, SNT Geotechnical).*
