**MINISTRY OF FORESTS, LANDS AND NATURAL RESOURCE OPERATIONS,
POST-WILDFIRE RISK ANALYSIS – PRELIMINARY REPORT**

FIRE: N50320 Slocan Park		FIRE YEAR: 2014	DATE OF REPORT: 10 Sept. 2014		
AUTHOR: Peter Jordan					
REPORT PREPARED FOR: Selkirk Resource District (Arrow-Boundary FD), and Southeast Fire Centre					
FIRE SIZE, LOCATION, AND LAND STATUS: 90 ha. Fire is on upper part of Slocan Ridge, about 3 km east of Slocan Park. Crown land.					
VALUES AT RISK: Several houses along Hwy 6 near Radcliffe Creek and unnamed creek to SE, may vulnerable to flooding or possible debris flow hazard. One water intake on Radcliffe Creek.					
WATERSHEDS AFFECTED: Radcliffe Creek (watershed 1) unnamed creek (watershed 2)		TOTAL AREA 619 ha 220 ha	AREA BURNED 25.4 ha 63.8 ha	BURN SEVERITY 12% H, 12% M, 76% L 4% H, 20% M, 76% L (of area burned)	
SUMMARY OF HAZARDS AND RISKS: <u>Hazard:</u> There is a pre-existing moderate hazard of debris flows on Radcliffe Creek. There is a low to moderate hazard of debris flows on creek 2. Incremental hazard due to the fire is low on both creeks. (See attached report for details.) <u>Risks:</u> 1. Risk to houses and highway near mouth of Radcliffe Cr – consequence

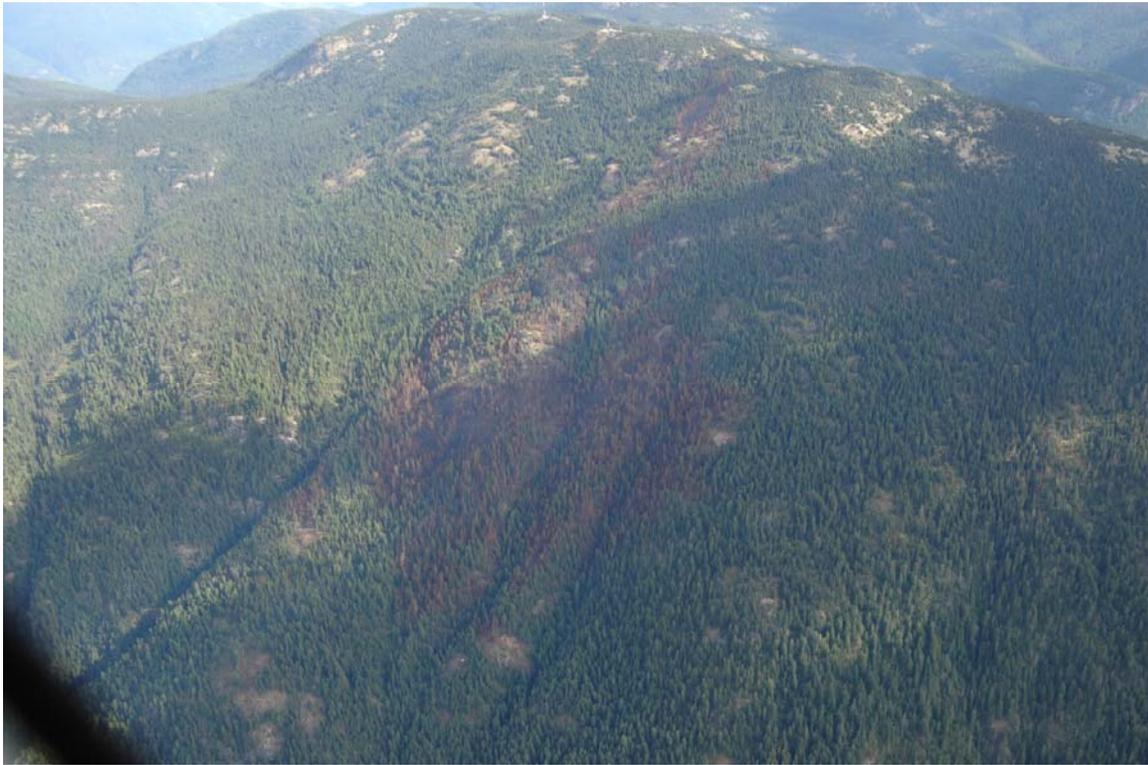
The fire and adjacent creek channels are on steep (40-70%), mainly rocky, ground. Creek 2 has two branches in the fire (photo 1). Where inspected in the field, the channel bed and banks were in bedrock or coarse colluvium, and there appeared to be little material that could be entrained in a debris flow. Also, the creek channels are bordered by a strip of unburned or lightly burned vegetation and intact soil, probably because of moister soil conditions than on nearly high ground. This makes it unlikely that a debris flow would start in the burned area.

Photo 1. Overview of Fire 320, taken on 28 August 2014. Radcliffe Creek is on left; the two branches of creek 2 are in lower centre.

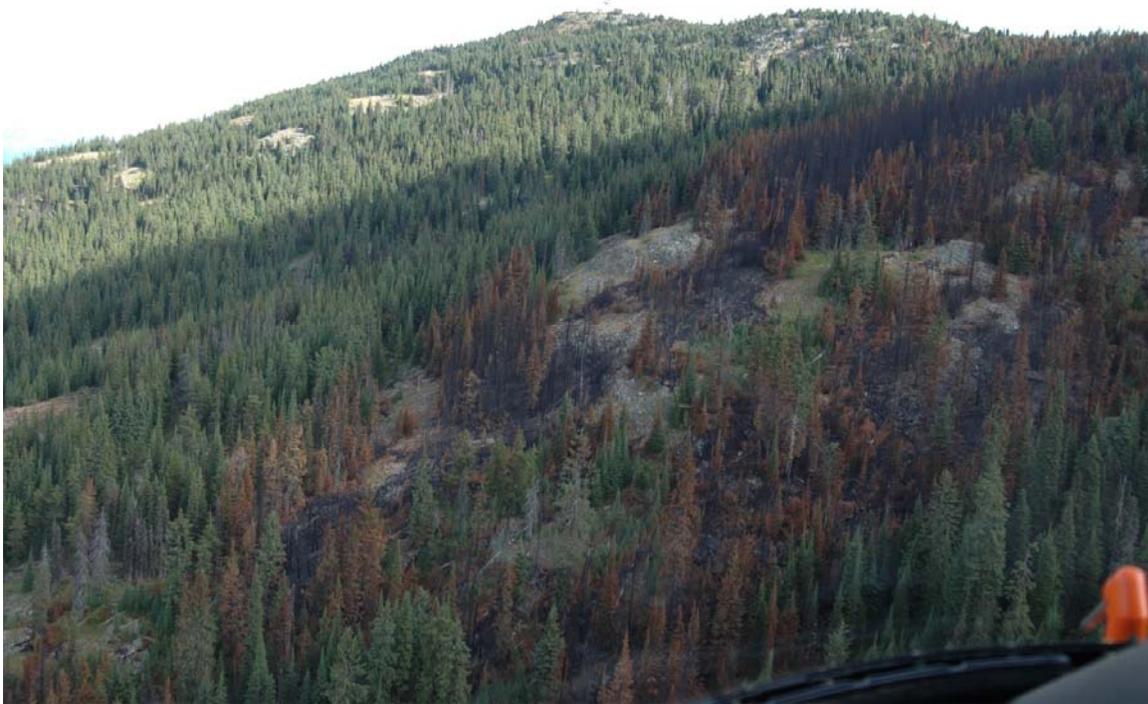
Photo 2. Patchy burn in rocky terrain in upper part of the fire.

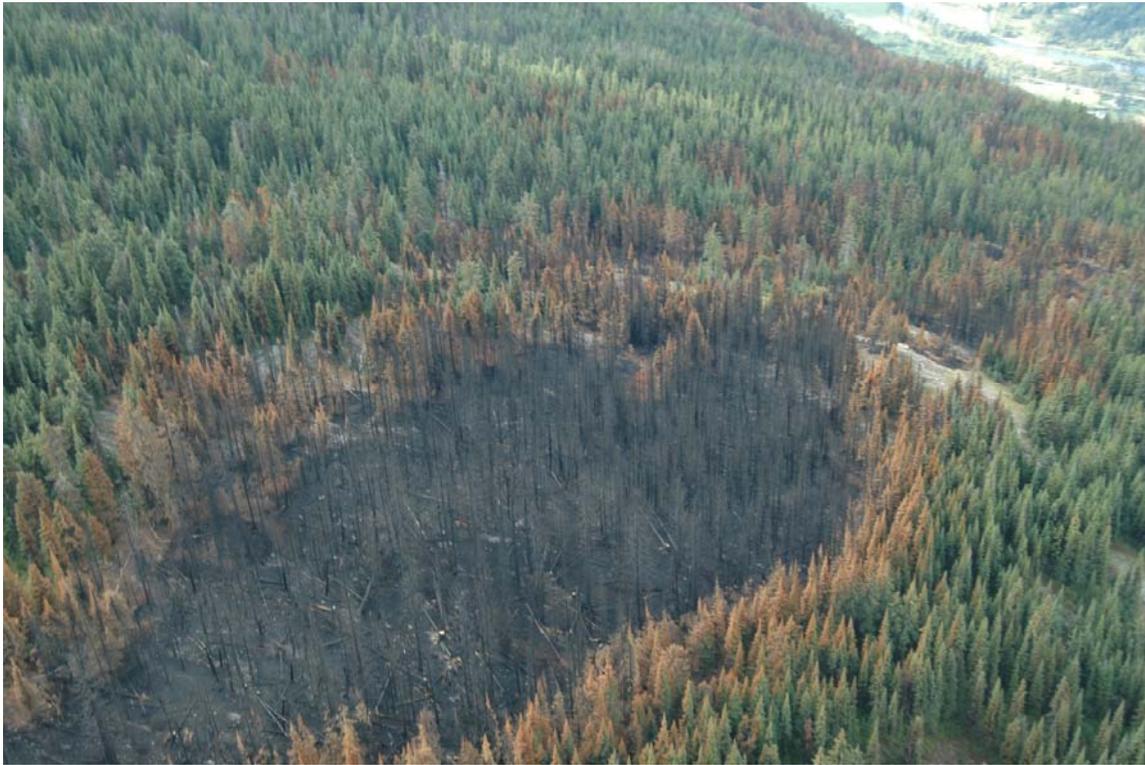
There is a patch, about 2 ha in area, of high severity burn at the top of the fire (a separate fire start), which was not checked in the field. From the air, this patch appeared to have higher soil burn severity than was seen in the lower part of the fire.

The high elevation, high burn severity patch (photo 3), sits on a steep slope above a small, steep tributary of Radcliffe Creek. There is a remote possibility that if a small landslide occurred in this burned patch, it could trigger a small debris flow which could descend Radcliffe Creek.

Photo 3. Patch of high-severity burn in upper part of the fire, above Radcliffe Creek tributary (right); looking down the slope toward Slocan River.

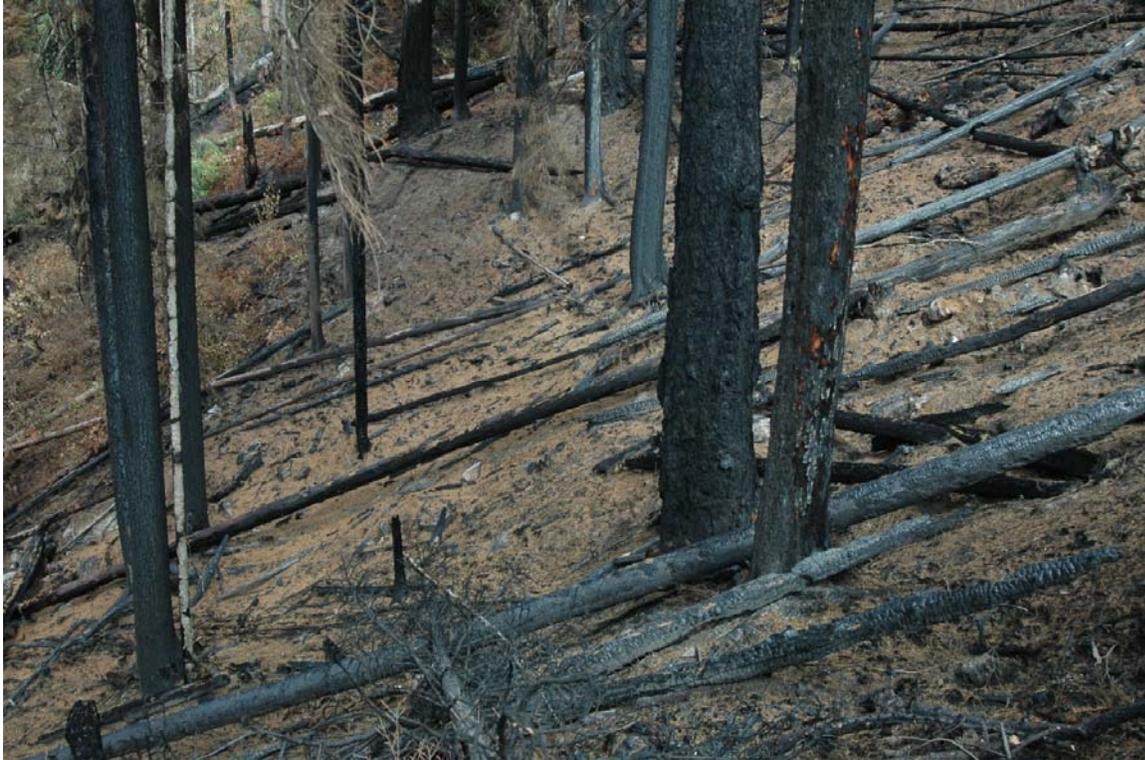
Photo 4. Moderate severity burn in lower part of the fire. Note natural mulching from needle fall, which protects the soil from erosion.
