**MINISTRY OF FORESTS: POST-WILDFIRE NATURAL HAZARD RISK ANALYSIS –
SUMMARY OF HAZARDS AND RISKS FOR WEST KOKANEE FIRE (N72615)**

Post-Wildfire Natural Hazards Risk Analysis, Fire N72615, West Kokanee

Sarah Crookshanks, P.Ge., Ministry of Forests

November 2, 2023

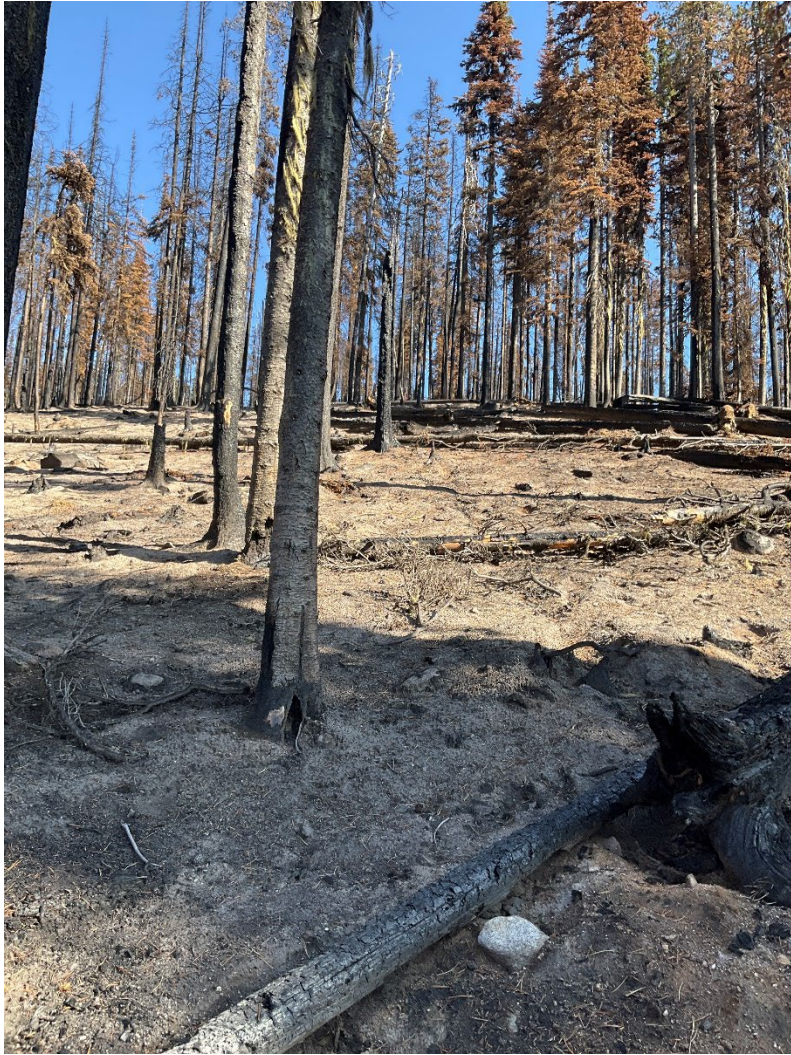
Figure 2. Moderate burn severity in the Bourke Creek watershed.

The fire burned 22% of the Bourke Creek watershed and is located in the headwater area. The vegetation burn severity is mostly moderate with small patches of high and low burn severity (Figures 1 through 5). Soil burn severity generally aligns with the vegetation burn severity. In the moderate soil burn severity areas, the forest floor was mostly consumed leaving grey ash. Many of the twigs and logs were charred, not consumed, and shallow live roots were noted at some plots. Despite the moderate soil burn severity, severe water repellency was observed throughout the burn area (Figures 6 and 7). Most test plots had ~1 cm of grey ash overlying the mineral soil, with strong water repellency 3 cm below the surface. This 3 cm of “wettable” soil may provide some storage before overland flow is generated. Water repellency was also observed this year in test plots in the area burned by the 2017 Morley Creek fire, suggesting the repellency may be attributed to widespread drought as well as or instead of the fire.

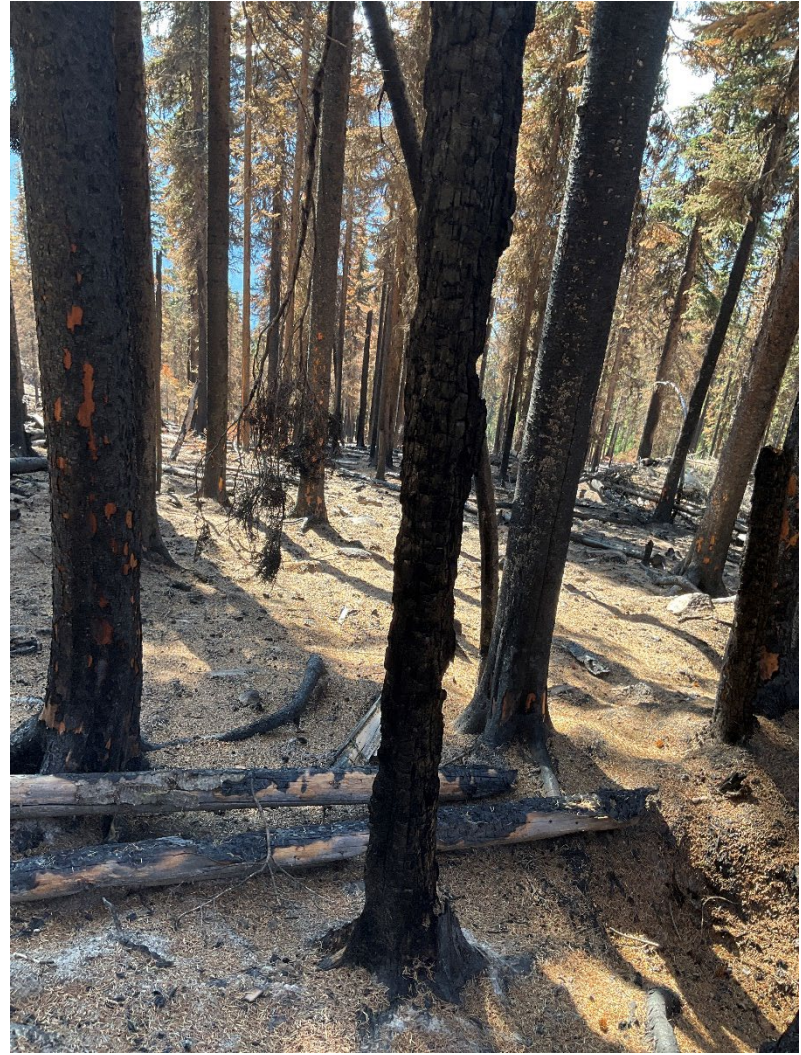
Figure 3. Needlecast in the Bourke Creek watershed.

Rain splash erosion is widespread, but evidence of overland flow was not observed. Many of the moderately burned trees have dropped orange needles on the soil, which should provide some protection from erosion.

The post-wildfire debris flow or flood hazard in Bourke Creek is rated as moderate. The burned area is in the headwater area of a steep debris flow prone watershed. The strong and widespread water repellency observed throughout the burned area is somewhat mitigated by the needlecast, moderate soil burn severity and water storage capacity of the soil above the water repellent layer.

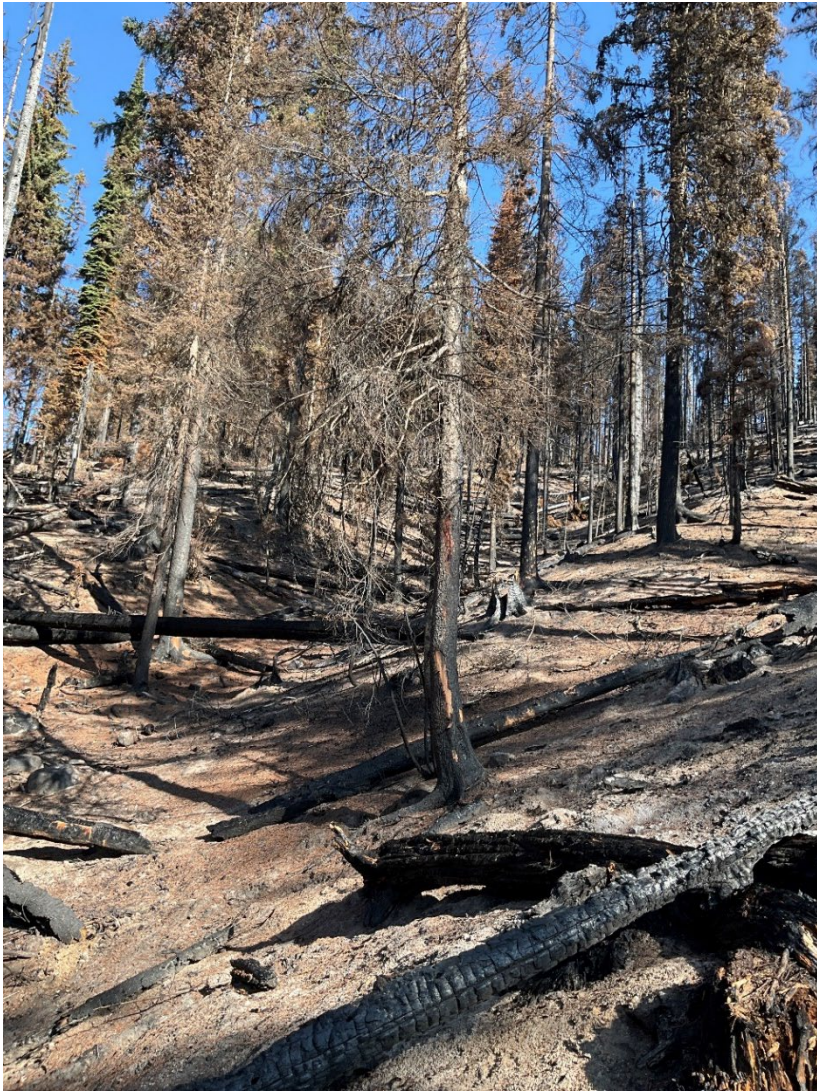
Figure 4. Swale and moderate burn severity in the Bourke Creek watershed.

The headwater area of Bourke Creek is composed of convex slopes, from 15% near ridgetop up to > 60%. The lidar hillshade imagery shows a series of minor swales entering the main channel from the east.

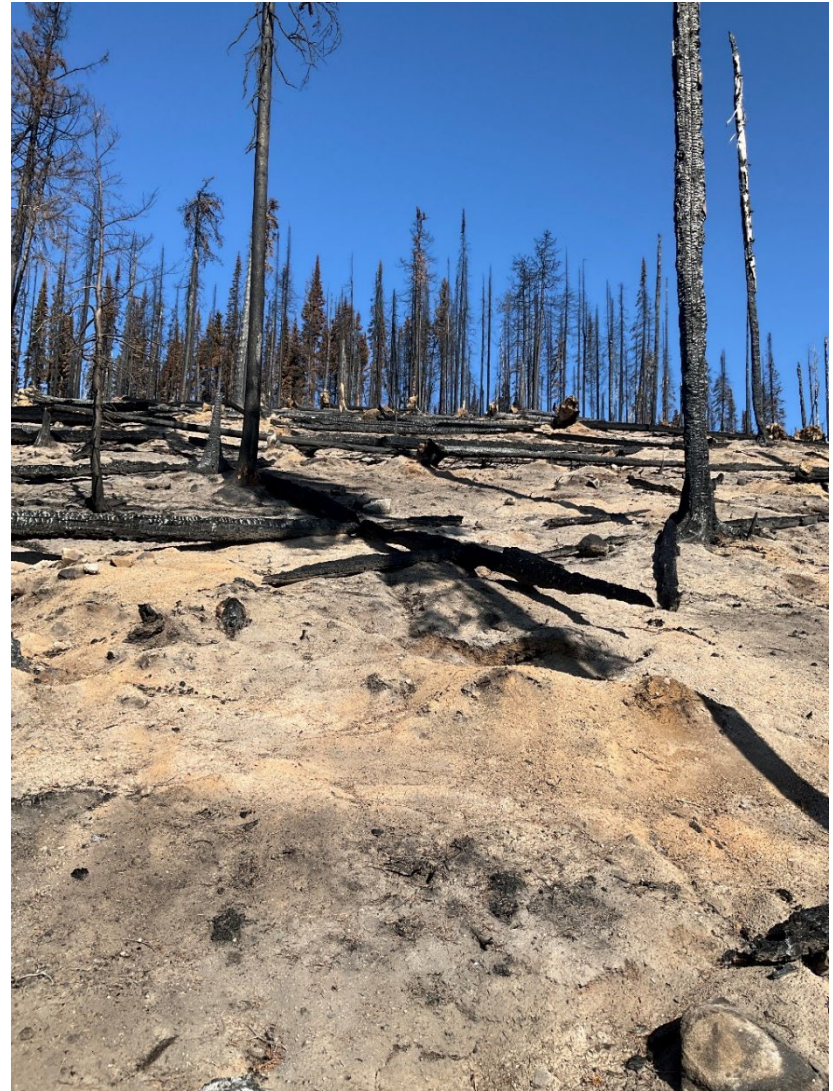
Figure 5. High burn severity in the Bourke Creek watershed.

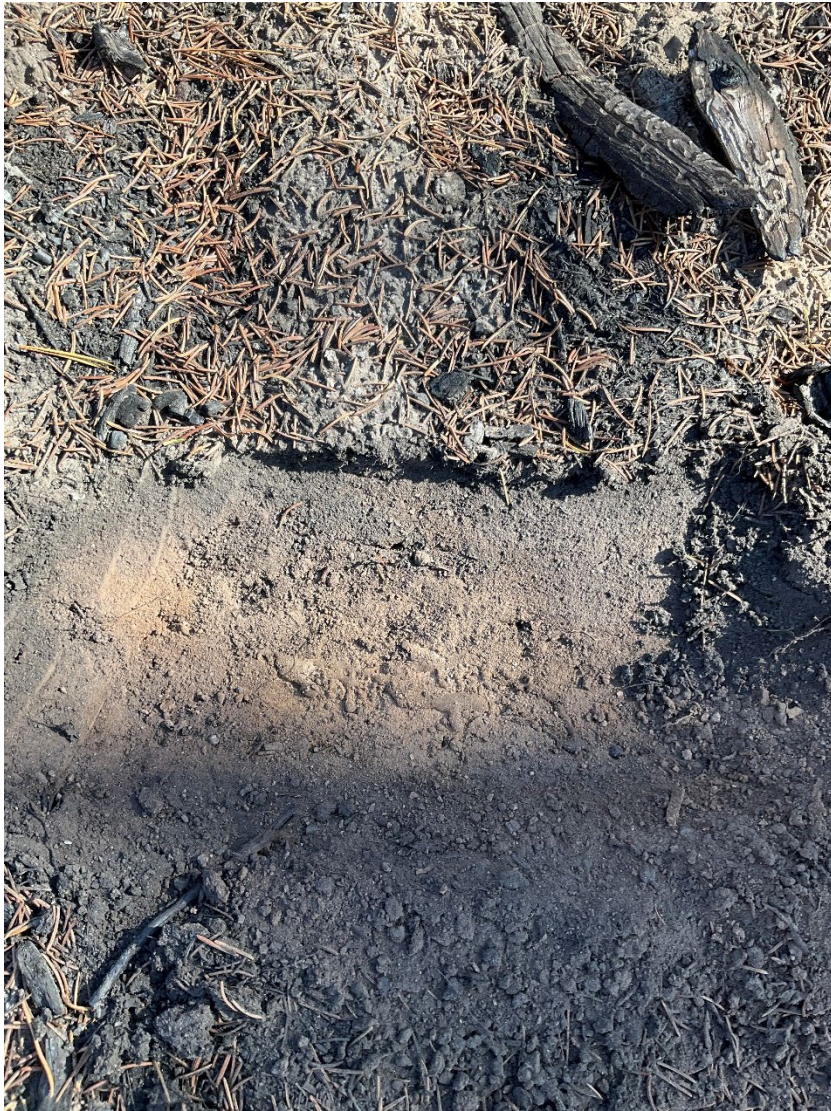
Figure 6. Strong water repellency, needlecast, grey ash, charred small woody debris, and rain splash erosion.

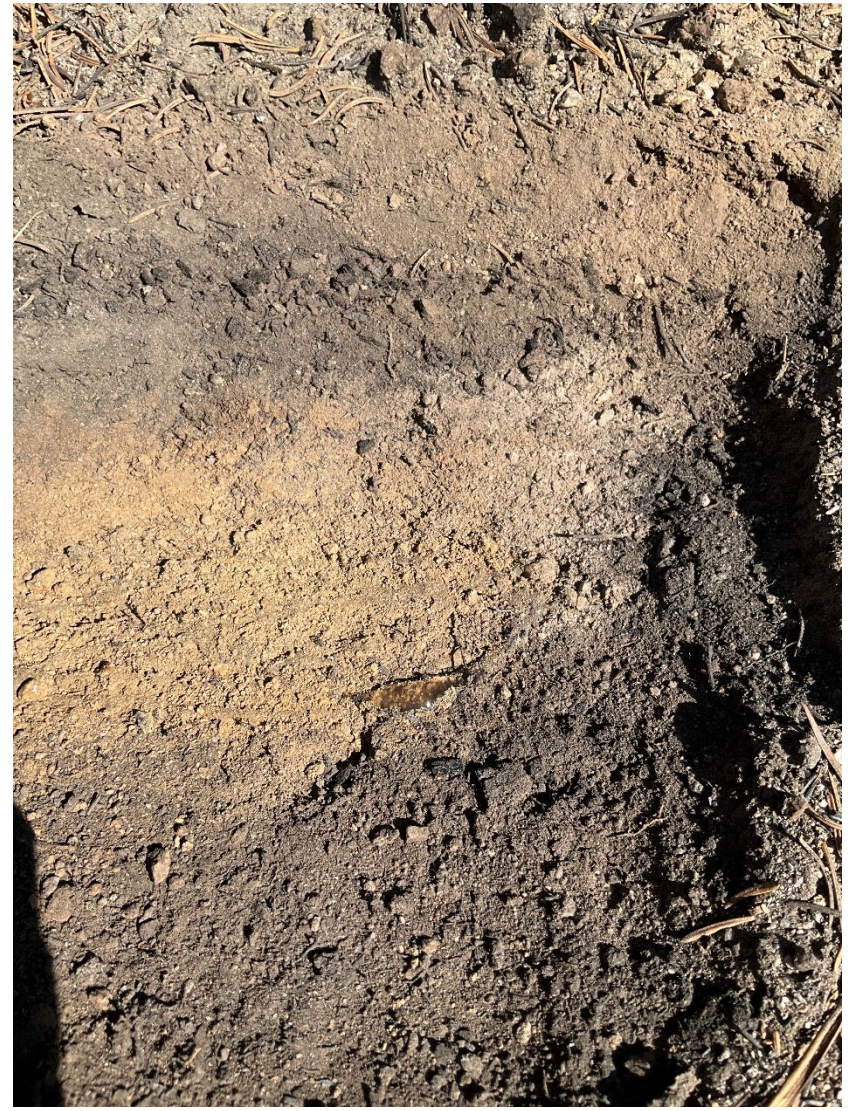
Figure 7. Strong water repellency at 3 cm depth.

The Bourke Creek drainage is adjacent to the Morley Creek fire, where a post-wildfire debris flood occurred in 2019 two years after the fire. The West Kokanee burn severity is more moderate than the Morley Creek fire, yet widespread and strong water repellency was observed in both cases immediately after the fires. During the field assessment on October 12th, the burned area from the 2017 Morley Creek fire was traversed. Vegetation regrowth in the high burn severity areas was minimal (~25% coverage), and comprised of mostly fireweed, grasses, herbs, along with isolated lodgepole pine, aspen, huckleberry, and other deciduous shrubs. Patches of strong water repellency were observed at many locations, which may be due to the dry conditions as opposed to a relict from the fire from 6 years ago. Further research on post-wildfire and drought-related water repellency is needed.

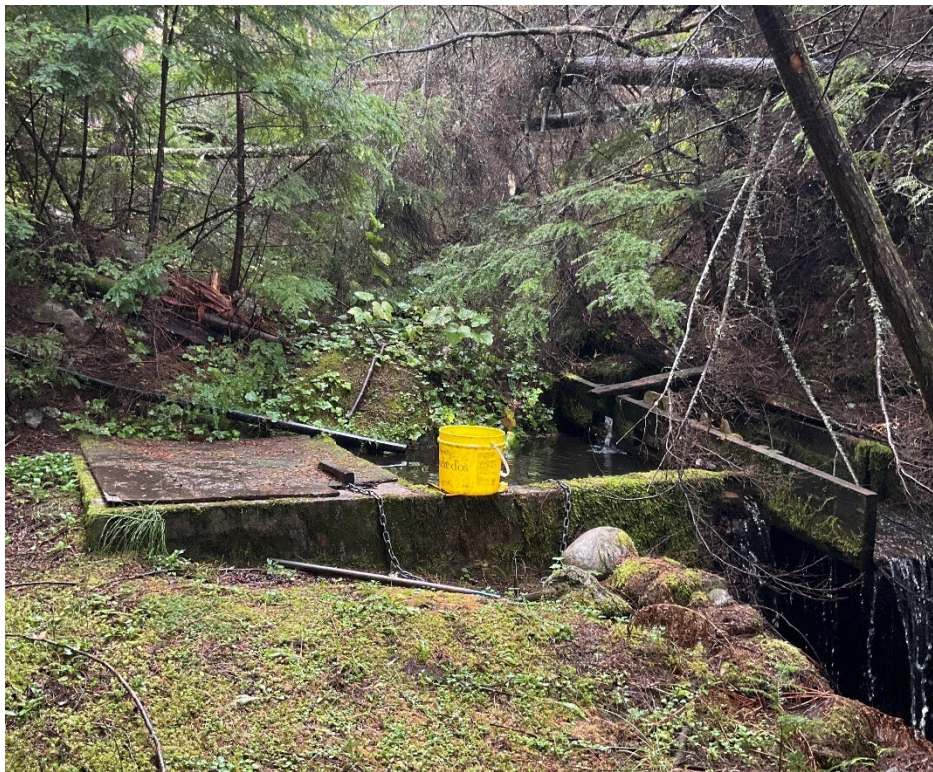
Several debris flow or debris flood avulsion scenarios on the fan were investigated during the field assessments. At the apex of the fan, the water diversion structure composed of a concrete open tank and culvert (Figure 9) presents another low likelihood of avulsion. Given the terrain, it is more likely that a flood or flow event will continue down the main channel. At the private road crossing at the end of Nielson Road, a 1 m culvert is overlain by 3 m of fill on the upstream side and 5 m of fill on the downstream side (Figure 10). The culvert crossing is at a prominent grade dip in the road, minimizing the likelihood of an avulsion down the west side of the Bourke Creek fan. Downstream of the private road crossing, the channel is incised with a minimal gradient for 30 m until just upslope of Alpine Road. The water diversion structure, private road crossing, and incised channel all provide opportunities for partial debris deposition of material upstream of any houses.

Figure 9. Water diversion structure at the apex of the Bourke Creek fan.

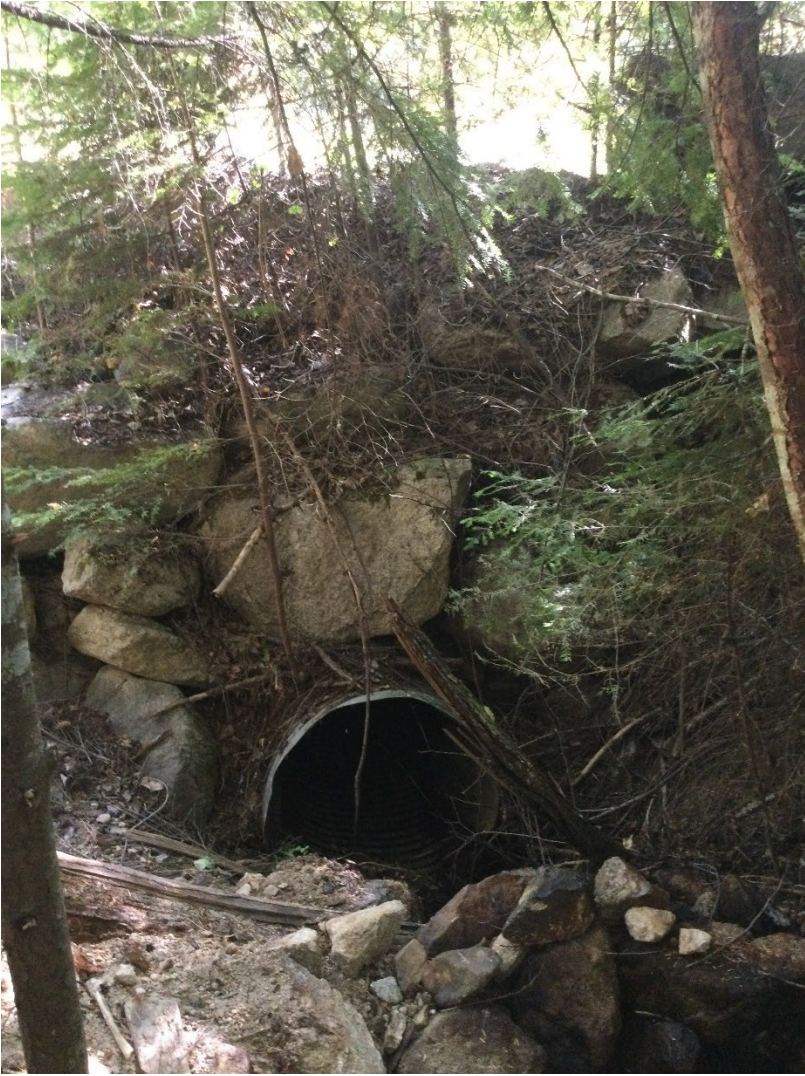
If a debris flow or flood were to occur on Bourke Creek, the most likely scenario is that the culvert at the private road crossing would be plugged, and water and debris would overtop the private road and run through the property at 4163 Alpine & Granger (Revision 1) Road perhaps impacting or flowing around several small guest cabins built along the channel. Following the 1999 debris flow event, muddy water reportedly ran down the driveway at this site. The flow would then most likely cross Alpine Road and continue down Granger Road, with a low likelihood of impacting homes further downslope.

Figure 10. Private road crossing with culvert at the end of Nielson Road.

I recommend that the RDCK forward this report to residents on the Bourke Creek fan and the Bourke Creek Improvement District. During freshet and high intensity summer or fall rainstorm events, residents should be aware of any sudden changes in stream conditions, such as a rapid increase or decrease in flow, flow pulses or unusually high sediment load/debris transport.

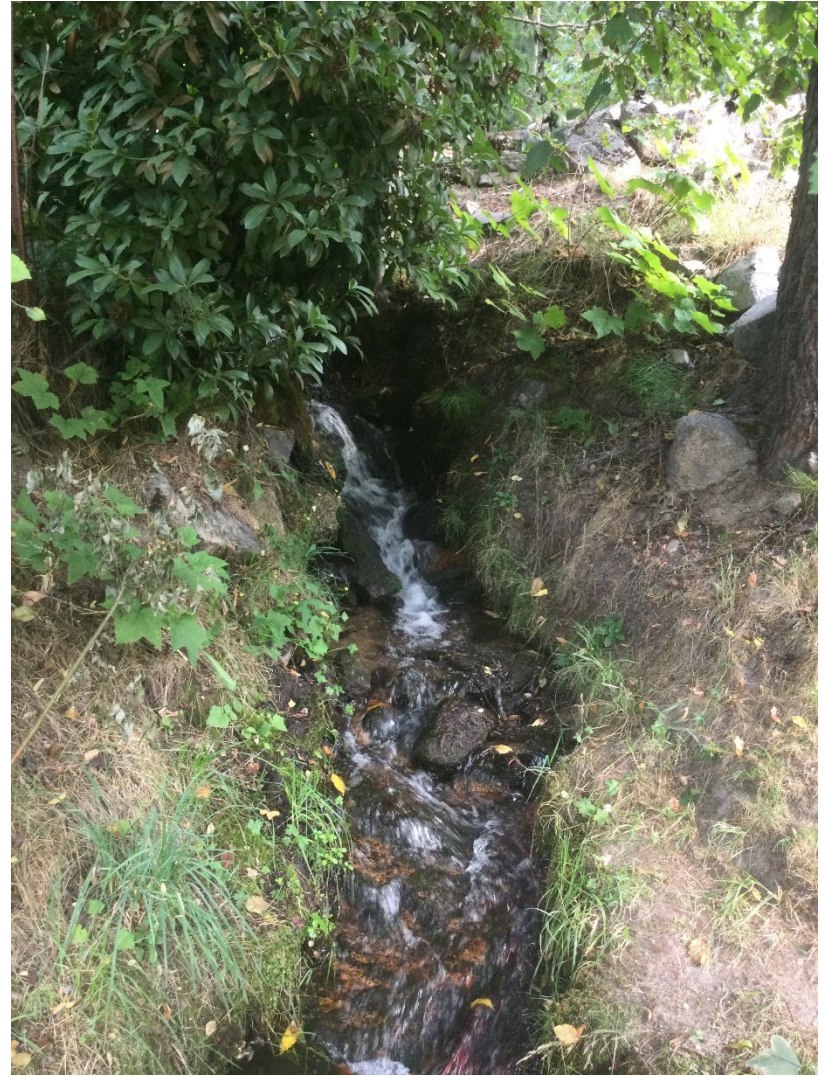
Figure 11. Bourke Creek upslope of Alpine Road.
