# **Kemp Creek Fire, N70171 Post-Wildfire Risk Analysis**

**Prepared for BC Ministry of Forests and Range:  
Kootenay Lake Forest District, Southern Interior Forest Region,  
and Southeast Fire Centre**

3 October, 2007

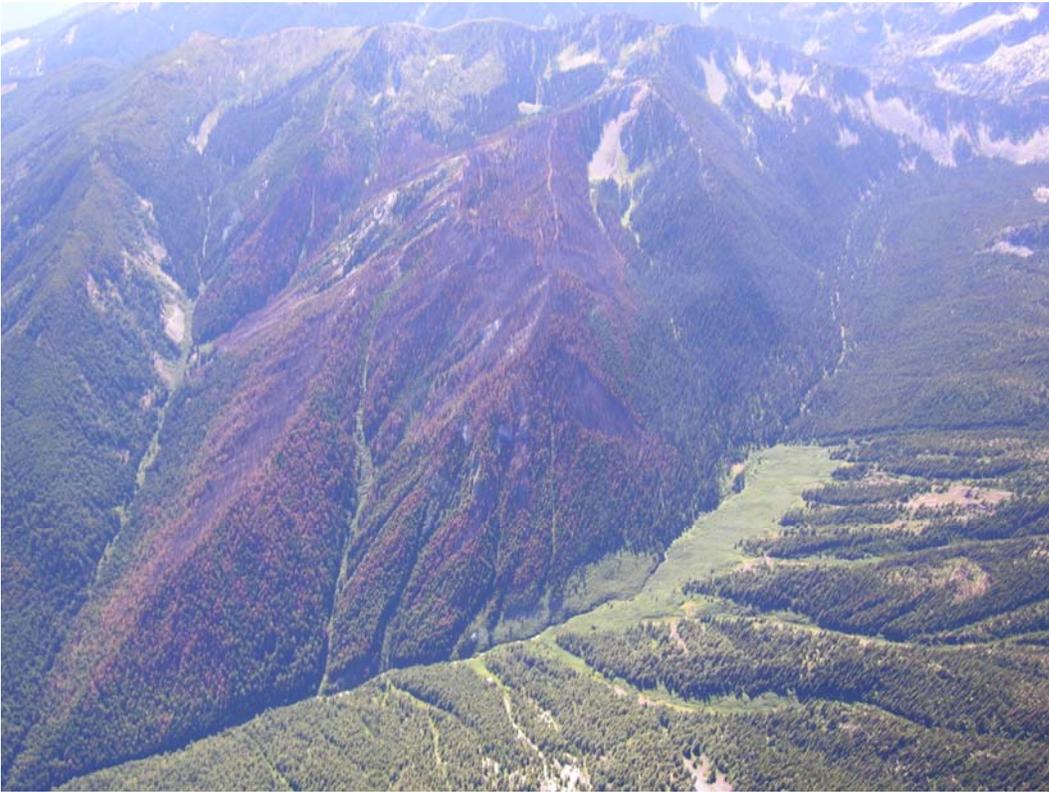
Photo 1. View of Kemp Creek fire from the north, looking towards headwaters of Kemp creek. Gullies subject to debris flows are in centre left.

Kemp Creek. Severe burn in areas of potentially unstable terrain will increase the likelihood of such events. The area which is probably most subject to increased debris flow hazard is the steep gully system in the west-central part of the burn (location B on Figure 1, and photo 1), which is an area mapped as unstable and which probably experiences frequent small debris flows. If debris flows occur in this area, and possibly other parts of the burn as well, they will enter Kemp Creek, adding suspended sediment and bedload (gravel) to the creek. It is less likely, but possible, that such events could cause a debris flow or debris flood which could reach the lower channel of the creek (see discussion below).

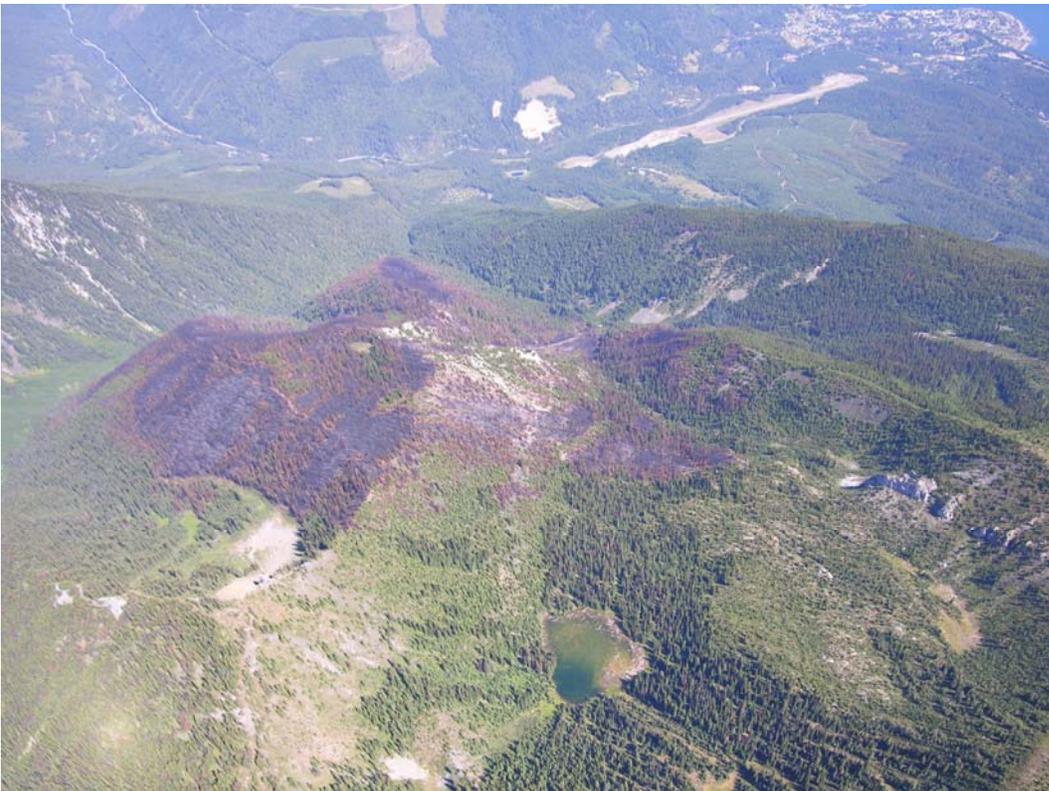
Photo 2. View across upper part of the fire, and down Kemp Creek towards Kaslo.

Figure 2 is a map of vegetation burn severity based on the aerial photographs (Photos 1 and 2 are examples). Our ground traverse in the northeastern tip of the fire covered an area mapped as low and moderate (we did not continue further up the slope into the high severity area due to danger from snags and falling rock). In the moderate vegetation burn severity area, the soil burn severity was rated high, although it was patchy in some areas, and water repellency was moderate to strong. Based on this very limited sample, and on experience at other fires (Springer and Sitkum), it is likely that all of the area mapped on Figure 2 as high, and much of the area mapped as moderate, will have severe soil burn severity, and moderate or strong water repellency.
