RDCK FLOODPLAIN AND STEEP CREEK STUDY

Kokanee Creek

Final March 31, 2020

Prepared by BGC Engineering Inc. for: **Regional District of Central Kootenay**

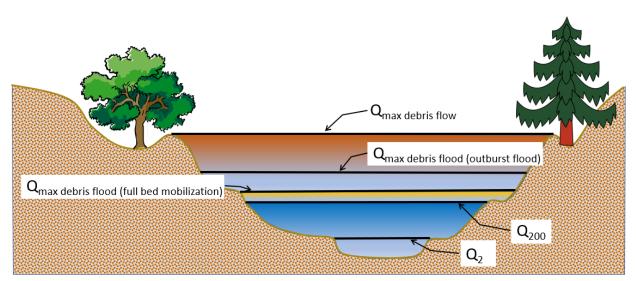
Figure 2-4. Conceptual steep creek channel cross-section showing peak discharge levels for different events. Note that for some outburst floods or debris flows the discharge may well exceed what is shown here.

This difference in peak discharge is one of the reasons that process-type identification is critical for steep creeks. For example, if a bridge is designed to accommodate a 200-year flood, but the creek experiences a debris flow with a much larger peak discharge, the bridge would likely be damaged or destroyed. For clearwater floods, a longer duration is more likely to saturate protective dikes, increasing the likelihood for piping and dike failure prior to, or instead of, the structure being overtopped. For debris floods, the duration of the event will also affect the total volume of sediment transported and the amount of bank erosion occurring.

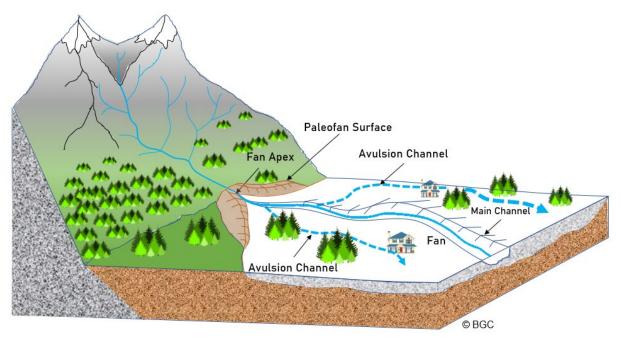
Figure 2-5. Schematic of a steep creek channel with avulsions downstream of the fan apex. Artwork by BGC.

Also shown on Figure 2-5 is the fan apex, which is the uppermost point of the fan, where net deposition of sediment from the creek begins. It coincides with a change in slope and confinement where the creek debouches from the mountainous upstream portion of the watershed. The hillsides flanking the fan apex are also preferential locations for remnants of paleofans. These represent remaining portions of an ancient (early Holocene or some 10,000 years ago) fan that developed during a different climate, sediment transport regime or base level. Paleofan surfaces will not be inundated by contemporary debris flows, debris floods, or clearwater floods as they are well above the maximum flow depths achieved by such modern-day processes. For this reason, they are often suitable for development from a geohazard point of view.

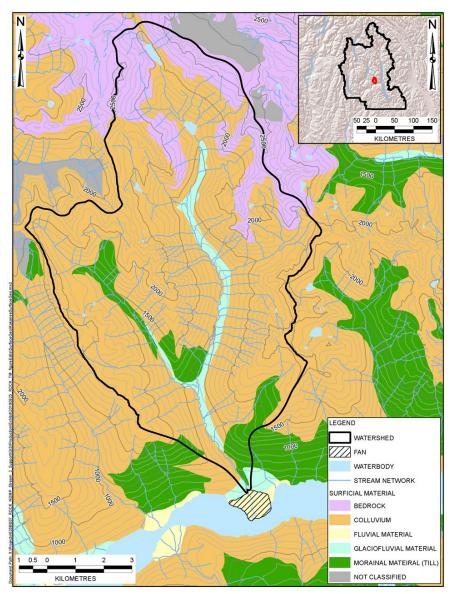
Figure 3-1. Surficial geology of the Kokanee Creek watershed (adapted from Province of BC, 2016).

Along Kokanee Creek, the surficial material is glaciofluvial in origin, while the West Kokanee Creek tributary is mostly underlain by till (Figure 3-1, Province of British Columbia. (2016)). The valley walls are composed of either till or colluvium overlying bedrock, and the highest ridges are composed of mixed colluvium and bedrock outcrops (Jungen, 1980). The abundant colluvium in the watershed, as well as the rockfall-prone bedrock outcrops, indicate that the watershed is likely largely supply unlimited, which implies a quasi-unlimited amount of sediment available in the watershed to be mobilized during extreme hydroclimatic events. Debris flows sourced within till deposits are expected to contain a higher proportion of fine-grained sediment (fine sands, silts, and clays). All other factors being equal, they can flow further than debris flows sourced from the coarser-grained colluvium with a largely sandy matrix.

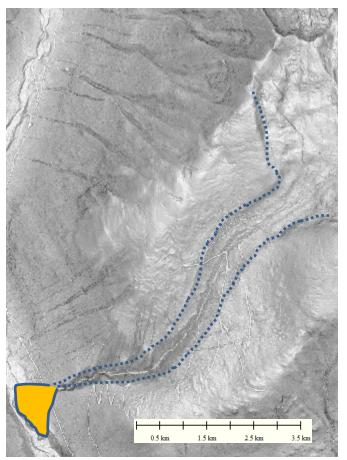
Figure 3-2. Old interpreted flowslide (blue dashed line) on Busk Creek upstream of the Kokanee Creek fan apex.

A conspicuous feature was identified on Busk Creek (Figure 3-2), the tributary to Kokanee Creek closest to the fan apex (Drawings 03, 06). This feature has the appearance of a rapid very large flowslide resulting in a sizable (100,000 m²) fan in Kokanee Creek which indicates a possible impoundment height of 10 to 20 m. The fan has since been deeply incised by Kokanee Creek. The fan surface is approximately 25 m above the present thalweg. The feature has not been visited in the field as it was detected on lidar after completion of the field component of this study. The materials and geomechanics of the presumed flowslide are unknown. However, in BGC's assessment, this is likely a unique event in the Holocene era as no other signs of a repeat events were found in this or other tributary watershed. It is therefore believed to be outside the return period range considered in this study.

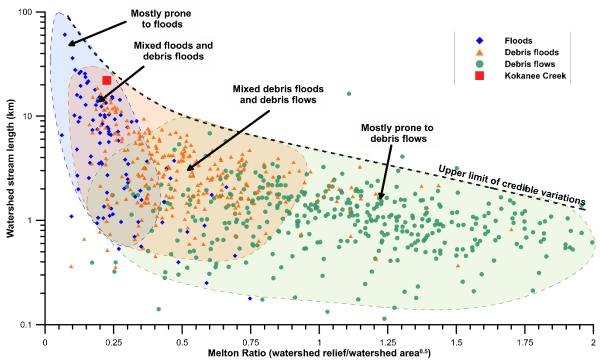
Figure 3-4. Tendency of creeks to produce floods, debris floods and debris flows, as a function of Melton Ratio and stream length (data from Holm et al., 2016 and Lau, 2017). See Table 3-1 for Kokanee Creek watershed data.

BGC assessed the potential steep creek process types and hazards on Kokanee Creek based on the Melton Ratio and historical and field evidence. In comparison with a large dataset of steep creeks in B.C. and Alberta, Kokanee Creek plots in the zone of floods to debris floods (Figure 3-4). The points shown on the plot are subject to some error and watersheds can be subject to multiple processes at different timescales. For example, it is not possible from this plot to determine if a small tributary near the fan apex could produce a debris flow that reaches the fan apex or travels beyond. For this reason, it is important to consider additional evidence to supplement the assessment of process type.

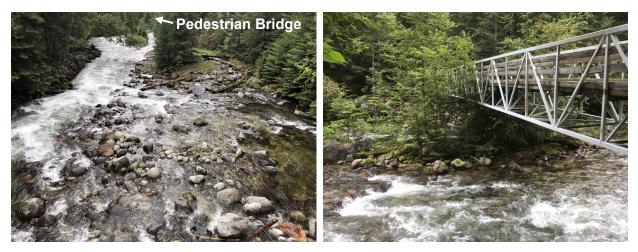
C) Standing on Kokanee Highway Bridge, looking south and downstream of the creek. Pedestrian Bridge visible downstream (top of the photo).

D) Standing on the upstream right bank looking at the upstream face of the Pedestrian Bridge.

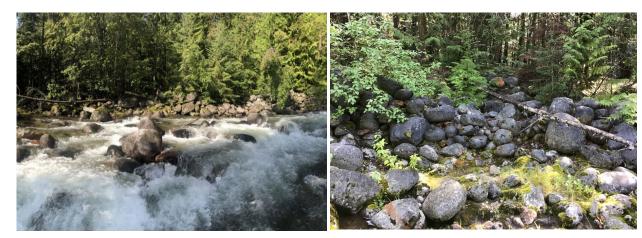
A) On the left bank looking across Kokanee Creek at B) On the left bank looking east at the low point along KKN-KKN-FP-01.

locations of KKN-FP-03 and KKN-FP-04 were not mapped in the field and approximate extents are shown on Drawings 02A, 02B. KKN-FP-01 is located on the right bank (Figure 3-7a), approximately 100 m upstream the Kokanee Highway Bridge and consists of bank protection over an approximate distance of 120 m. KKN-FP-02 is an approximately 1 to 1.5 m high riprapped dike located immediately upstream of the Kokanee Highway Bridge on the left bank that extends approximately 140 m upstream. A small breach or a low point (by 0.5 to 1 m compared to the dike height) along KKN-FP-02 was noted by BGC approximately 90 m upstream of the bridge (Figure 3-7b).

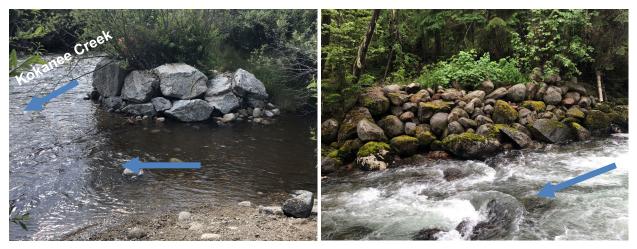
E) On the left bank of the Fish Spawning Channel outlet F) On the left bank looking across Kokanee Creek at looking north at the end of KKN-FP-04 riprap.

KKN-FP-05 berm.

Downstream of Kokanee Highway Bridge both banks have varying degrees of bank protection. KKN-FP-03 is an approximate 1 to 1.5 m high berm⁴ that extends on the right bank from the Kokanee Highway Bridge to approximately 200 m downstream of the Pedestrian Bridge. A low spot along KKN-FP-03 was noted approximately 30 m downstream of the Pedestrian Bridge (Figure 3-7c, Drawings 02A, 02B). The material forming KKN-FP-03 appears similar to channel material (rounded cobbles and boulders, 0.2 to 0.5 m in diameter) and was likely placed during dredging and straightening of the channel. The fourth flood protection structure, KKN-FP-04, was noted on the left bank from the Kokanee Highway Bridge and extending to the outlet of the Fish Spawning Channel. The lower section of KKN-FP-04 has been riprapped (angular boulders, approximately 0.5 to 1.0 m in diameter) from approximately 150 m downstream of the Pedestrian Footbridge (Figure 3-7d, Drawings 02A, 02B) to the outlet of the Fish Spawning Channel (Figure 3-7d, Drawings 02A, 02B) to the outlet of the Fish Spawning Channel 0.5 to 1.0 m in diameter) from approximately 150 m downstream of the Pedestrian Footbridge (Figure 3-7d, Drawings 02A, 02B) to the outlet of the Fish Spawning Channel 0.5 to 1.0 m in diameter) from approximately 150 m downstream of the Pedestrian Footbridge (Figure 3-7d, Drawings 02A, 02B) to the outlet of the Fish Spawning Channel 0.5 to 1.0 m in diameter) from approximately 150 m downstream of the Pedestrian Footbridge (Figure 3-7d, Drawings 02A, 02B) to the outlet of the Fish Spawning Channel 0.5 to 1.0 m in diameter) from approximately 150 m downstream of the Pedestrian Footbridge (Figure 3-7d, Drawings 02A, 02B) to the outlet of the Fish Spawning Channel 0.5 to 1.0 m in diameter) from approximately 0.5 to 1.0 m in diameter) from approximately 150 m downstream of the Pedestrian Footbridge (Figure 3-7d, Drawings 02A, 02B) to the outlet of the Fish Spawning Channel 0.5 to 1.0 m in diameter) from approximately 0.5 to 1.5 m downstream 0.5 to 0.5 m downs

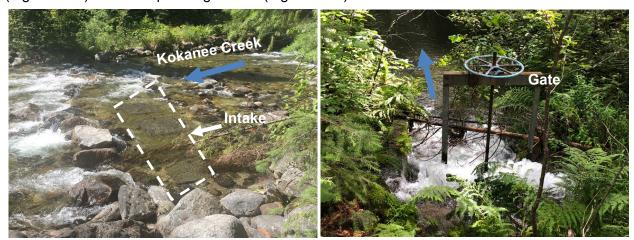
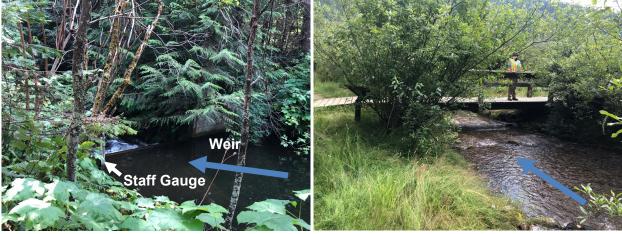
A) On the left bank, looking west at the Fish Spawning Channel intake in Kokanee Creek.

B) On trail, looking south and downstream at gate controlling flow into the Fish Spawning Channel.

C) On the left bank looking south-west and D) On the left bank of the Fish Spawning Channel downstream at weir and staff gauge for measuring looking south and downstream at the bridge just flow in Fish Spawning Channel. upstream of channel outlet.

Figure 3-8. Fish Spawning Channel observations during BGC's field work in July 2019.

A 330 m long fish spawning channel (Drawings 02A, 02B) was built in 1985 approximately 100 m downstream of the Kokanee Highway Bridge and runs along the eastern side of Kokanee Creek. Water enters the fish spawning channel through an intake embedded below the Kokanee bed and covered with a grate (Figure 3-8a). The intake flow is controlled by a gate at the head of the spawning channel (Figure 3-8b). Downstream of the gate, the channel flows over a weir (Figure 3-8c) and into spawning habitat (Figure 3-8d).

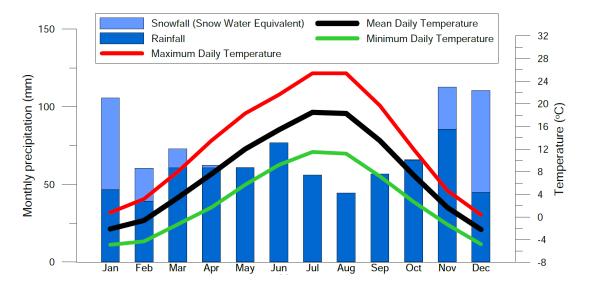
Figure 3-9. Climate normal data for Kaslo station from 1981 to 2010.

The measured precipitation at the Kaslo station is lower than the precipitation in the Kokanee Creek watershed, where the mountaintops extend more than 1600 m above Kootenay Lake. This is due to orographic effects, which occur when an air mass is forced up over rising terrain from lower elevations. As it gains altitude it quickly cools down, the water vapour condenses (forming clouds), ultimately resulting in precipitation.

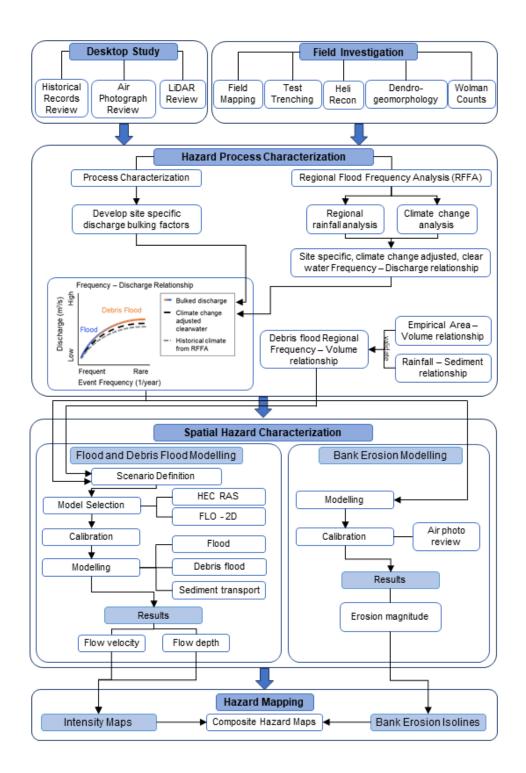
Figure 5-1. Flood and debris flood prone steep creeks workflow used for developing frequencymagnitude relationships, modelling, and preparing hazard maps.

In comparison to Figure 5-1, the field investigation at Kokanee Creek did not include test trenching or dendrogeomorphology.

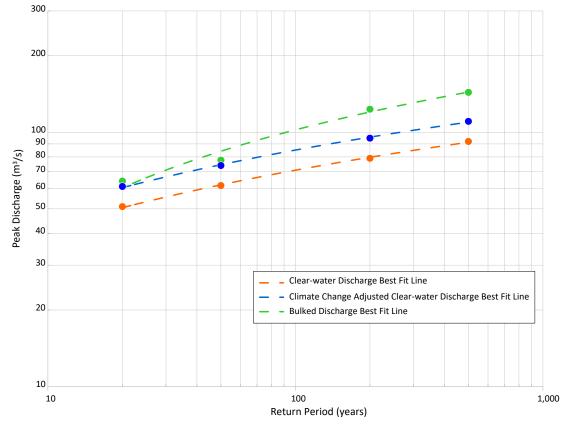
Figure 6-1. Frequency-discharge relationship for Kokanee Creek.

- Because there are no hydrometric stations on Kokanee Creek, non-adjusted peak discharges (flood quantiles) were estimated using a Regional FFA. The regional index-flood model was selected because it produced slightly higher peak discharges than the provincial model.
- The historic peak discharge estimates were adjusted by 20% to account for the projected impacts of climate change as per Section 4 of the Methodology Report (BGC, March 31, 2020b).
- The climate-adjusted, bulked peak discharges were used in the numerical modelling.

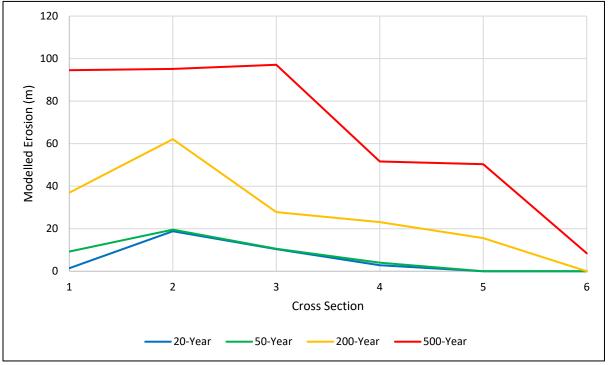
Figure 6-2. Kokanee Creek 50th percentile bank erosion model results at each cross-section.

Figure 6-2 shows the 50% percentile modelled bank erosion at each cross-section. The predicted erosion differs between cross-sections based on the cross-section characteristics (e.g., channel geometry, channel slope, D_{84} grain size). Erosion peaks at different cross sections depending on the return period considered, but it generally higher in the upper reaches and lower near the mouth.

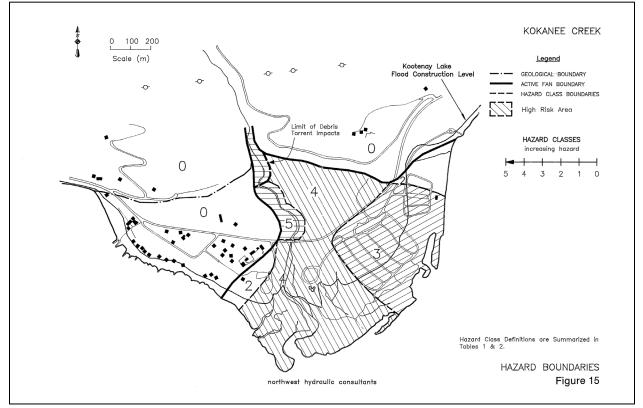
Figure 6-3. NHC/Thurber's (1990) Kokanee Creek individual life risk map. Class 4 and 5 imply individual life loss risk values exceeding 1:10,000. Class 3 1:10,000 to 1:20,000. Class 0, 1 and 2 < 1:20,000.

and 5 (highest hazard). However, since NHC/Thurber (1990) also included loss of life consequences as a second dimension in their hazard mapping, their hazard maps provided information on relative levels of risk. Specific risk zones were defined as those where individual life loss risk exceeds or falls below specified values. Areas with a hazard (risk) code of 3 or higher were interpreted to have a significant threat to loss of life defined as the annual probability of death of a select individual of > 1:20,000. Figure 6-3 shows the NHC/Thurber risk map for Kokanee Creek.

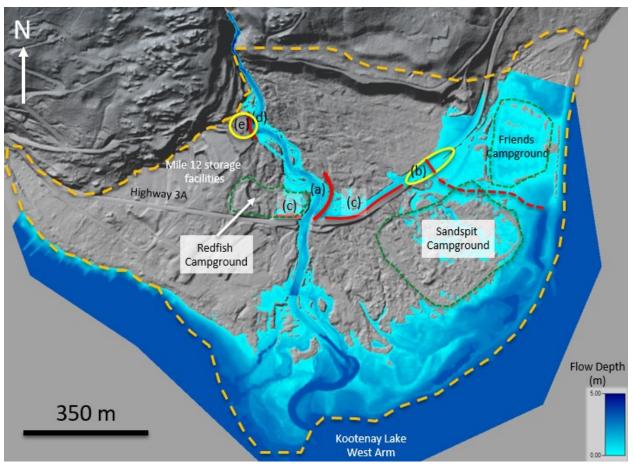
Figure 7-1. Mitigation considerations described in this section for a 500-year return period HEC-RAS model showing inundation depths. Note these are not a complete listing of all mitigation options and serve to illustrate the descriptions above. This figure should not be used for decision making nor design of mitigation works.

In addition to the mitigation options outlined above, development should be actively discouraged on the central and eastern fan portions – those fan segments should be maintained in their natural state. As shown in the composite hazard rating map, the western fan portions are characterized by very low hazard zones that may be suitable for future development upon further study including modelling of highway breach scenarios.

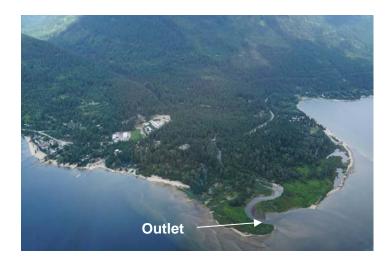
Photo 1.

Overview photo taken during helicopter overflight looking north at Kokanee Creek. The outlet into Kootenay Lake is visible. Photo: BGC, July 6, 2019.

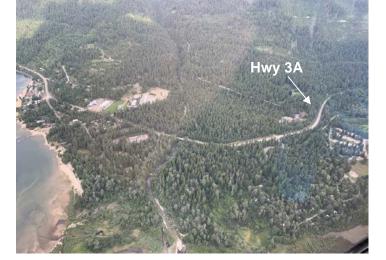
Overview photo taken during helicopter overflight looking north at the Kokanee Creek fan with Hwy 3A (left to right) running across Kokanee Creek. Photo: BGC, July 6, 2019.

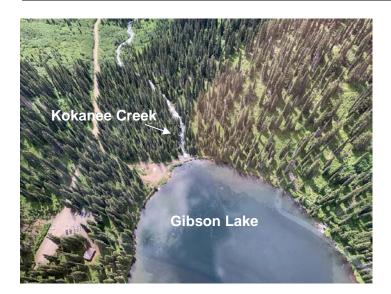
Photo 4.

Overview photo taken during helicopter overflight looking south at Kokanee Creek, approximately 14 km upstream of the outlet to Kootenay Lake. Photo: BGC, July 6, 2019.

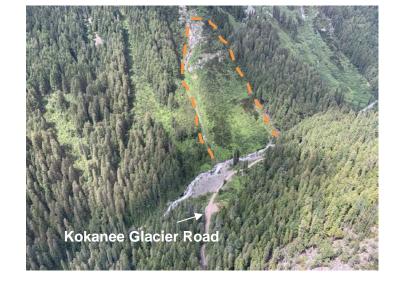
Photo 5.

Overview photo taken during helicopter overflight looking down (west at the top) at the lower Kokanee Creek watershed, approximately 8 km upstream of the fan apex. Kokanee Glacier Road is visible, as well as the site of a potential debris avalanche (orange) to the west of the creek. Photo: BGC, July 6, 2019.

reaches of the watershed are characterized by steep-sided valleys that BGC interprets to contain alpine permafrost environments with frost shattered bedrock based on lidar interpretation. Glacial cirques⁴ can be found on the east facing slopes of the upper watershed that contain erodible sediment in talus slopes derived from the bedrock. The steep valley sides are crossed by numerous snow avalanche paths and debris flow tributaries that feed into the Kokanee Creek mainstem (Drawing 05). From the steep sided slopes, the valley transitions into a wide alluvial channel with lakes (Kokanee Lake and Gibson Lake) in the upper reaches (Photo 4, Appendix B). Throughout the watershed, the main channel has cut through glaciofluvial deposits in the valley bottom and truncated tributary debris flow fans thus supplying sediment to the creek. North-south trending lineaments are noted on the eastern-facing slopes within the mid reaches of the watershed (Drawing 05). An approximately 0.15 km² deposit from a rock avalanche is noted on the eastern-facing slope approximately 9 km upstream of the fan-delta apex (Photo 5, Appendix B).

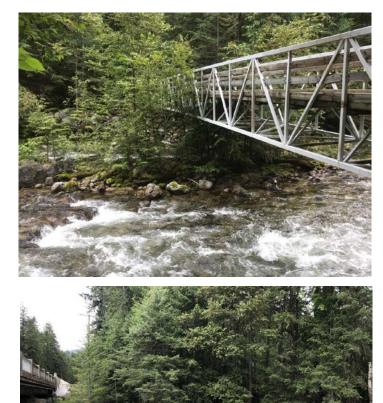
Photo 8.

Upstream of footbridge standing on the left bank of Kokanee Creek looking west. Photo: BGC, July 24. 2019.

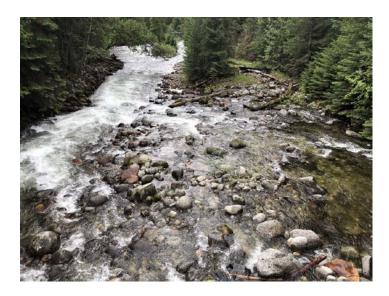
Photo 10.

On the Hwy 3A bridge looking downstream (south) at Kokanee Creek and the flood protection on both banks. Photo: July 24, 2019.

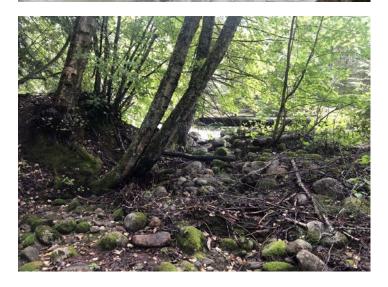
Photo 12.

Standing approximately 50 m downstream of the footbridge looking at a failed dike. Photo: BGC, July 24, 2019.

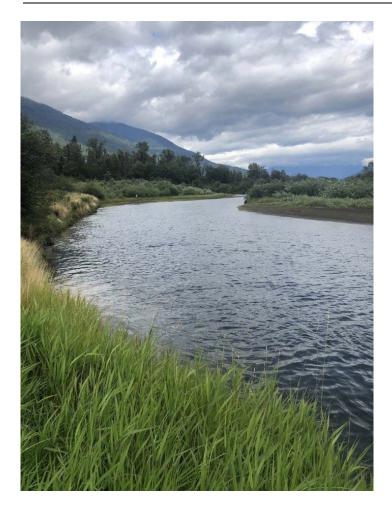
Photo 13.

Standing on the right bank of Kokanee Creek near the outlet into Kootenay Lake looking upstream (north). Kokanee Creek is backwatered by Kootenay Lake. Photo: BGC, July 24, 2019.

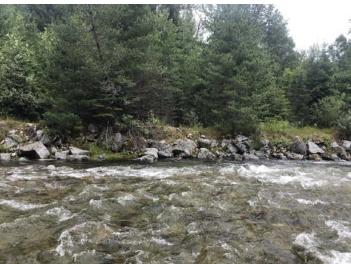
Photo 14.

Standing on the right bank bar looking across (flow is left to right) at the cobble bar and flood protection on the right bank of Kokanee Creek, approximately 800 m upstream of the creek's mouth. Photo: July 24, 2019.

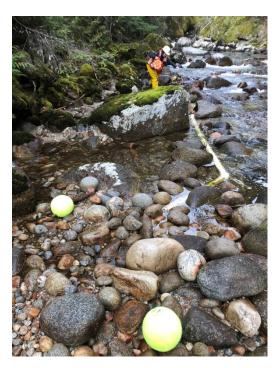
Figure C-2. Photograph taken of Wolman sampling location Kokanee 1. BGC photograph of November 20, 2019.

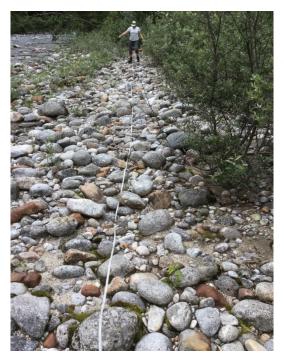
Figure C-4. Photograph taken of Wolman sampling location Kokanee 3. BGC photograph of July 27, 2019.

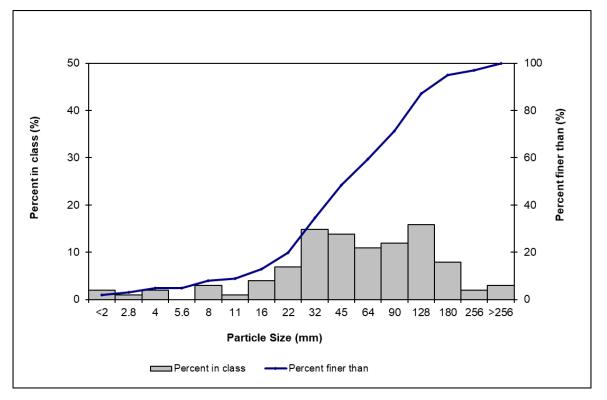
Figure C-5. Kokanee Creek grain size distribution at Kokanee 1 (at fan apex) from Wolman count.

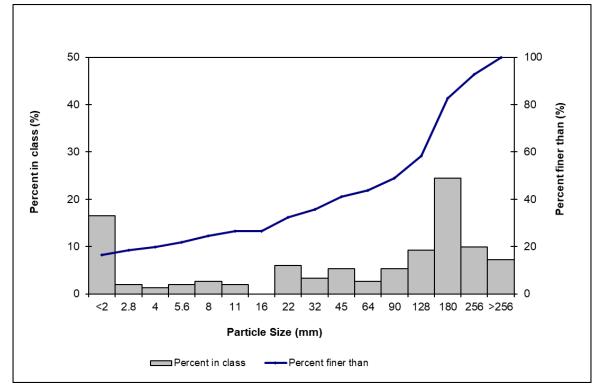
Figure C-6. Kokanee Creek grain size distribution at Kokanee 2 (at Highway 3A bridge) from Wolman count.

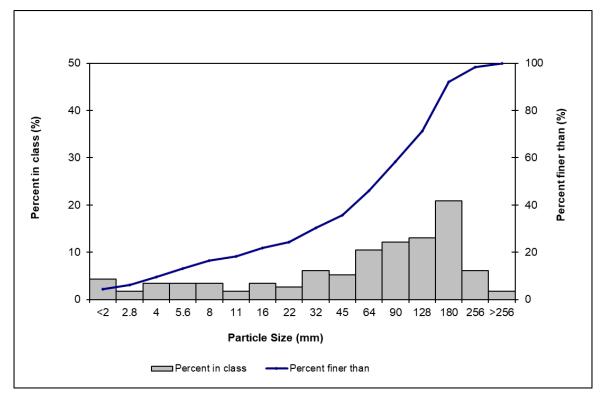
Figure C-7. Kokanee Creek grain size distribution at Kokanee 3 (near outlet to Kootenay Lake) from Wolman count.
