Post-Wildfire Risk Analysis, Fire N70261, 2015, Sitkum-Duhamel

Peter Jordan, P.Geo., MFLNRO, Nelson 22 Sept 2015

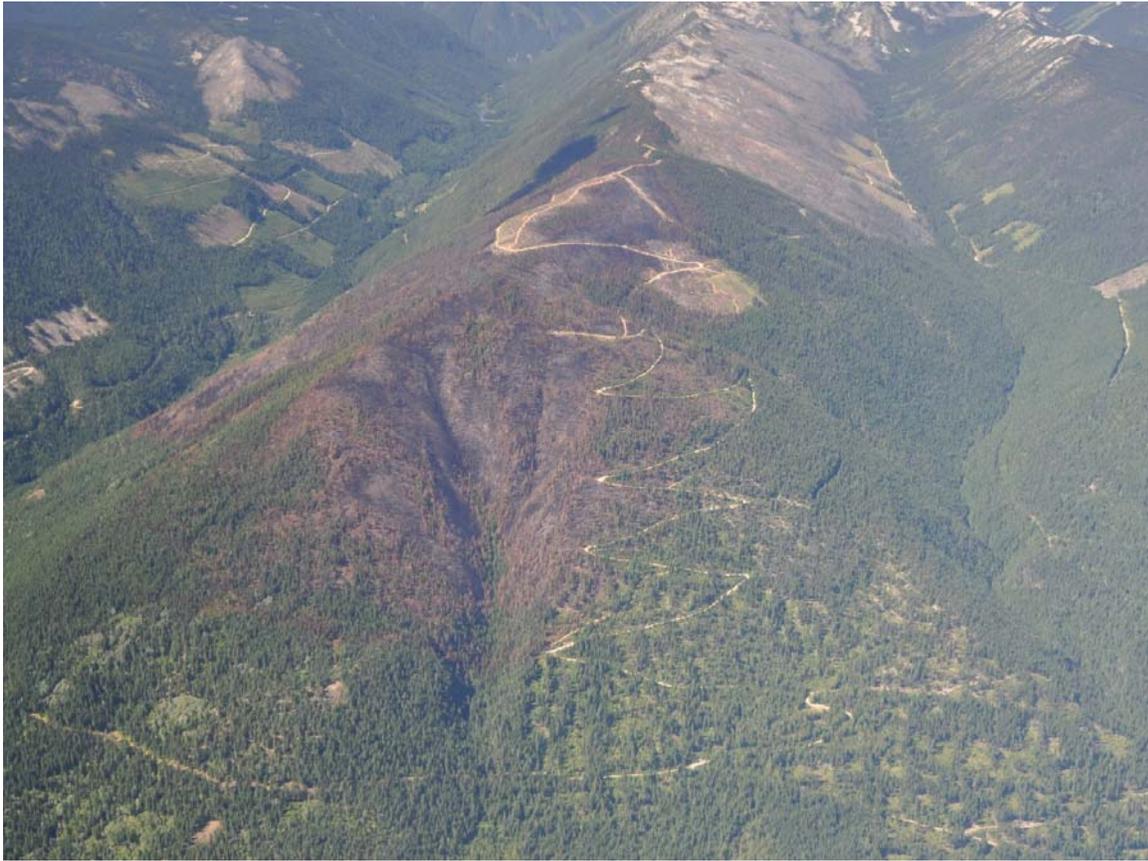
Photo 1. Overview of Fire N70261. Airey Cr watershed in foreground, Sitkum Cr on right.

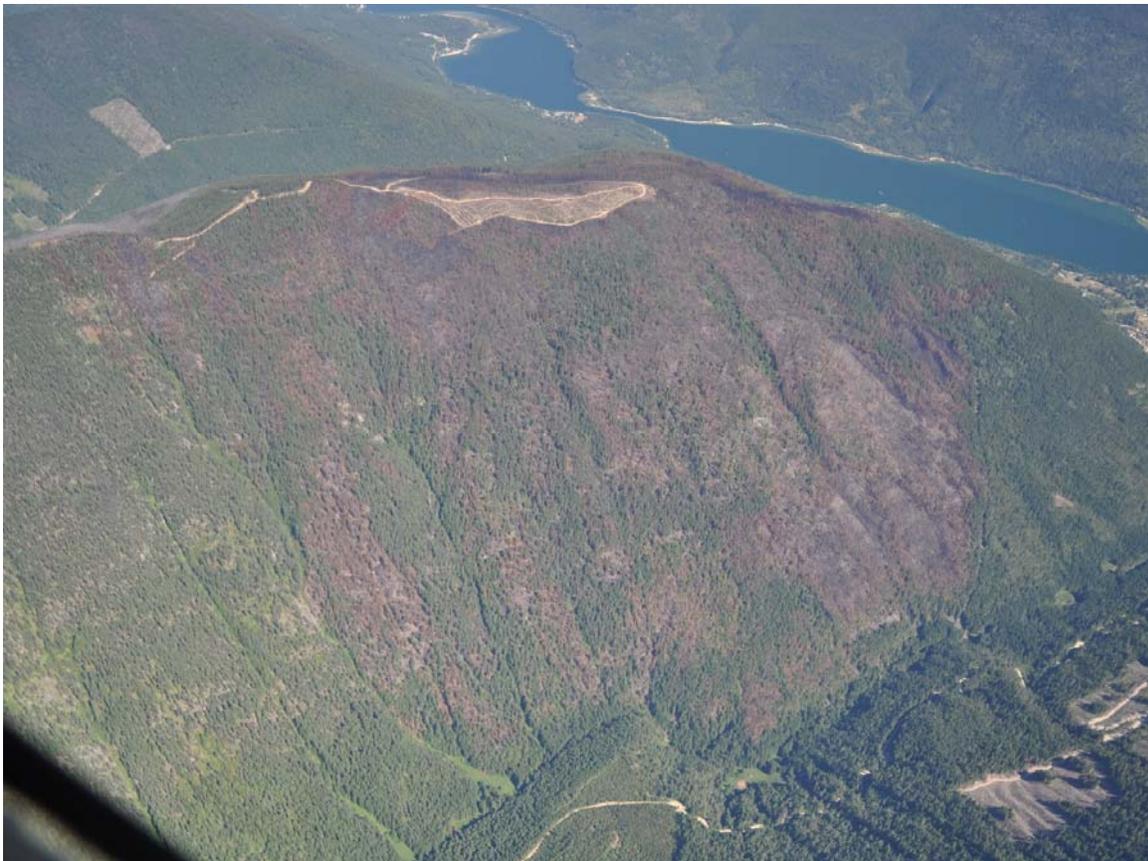
The very steep gullies above Duhamel Creek are subject to frequent, small, rockfall-fed debris flows, which reach the creek occasionally. Some of the gullies are also subject to snow avalanches.

Photo 2. Duhamel Creek gullies.

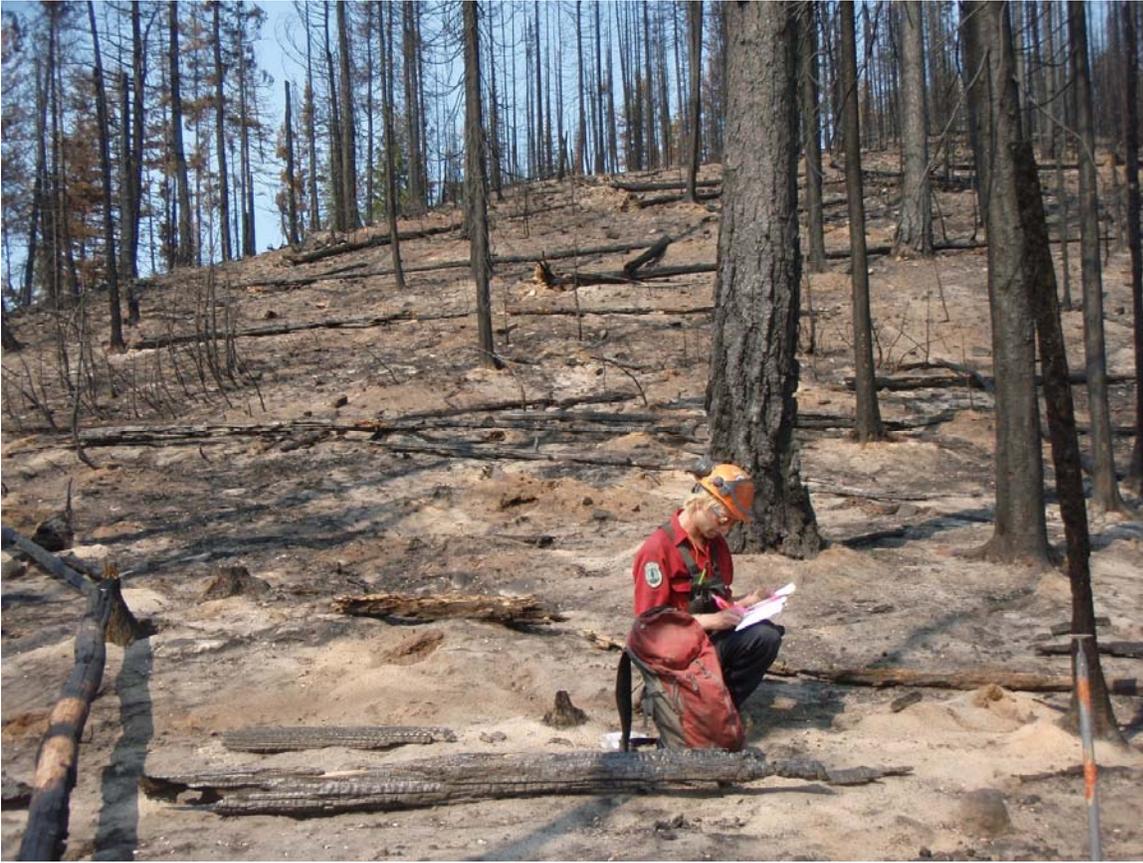
High – trees dead, needles, twigs, and understory consumed

Photo 3. High burn severity site, Airey Creek watershed.

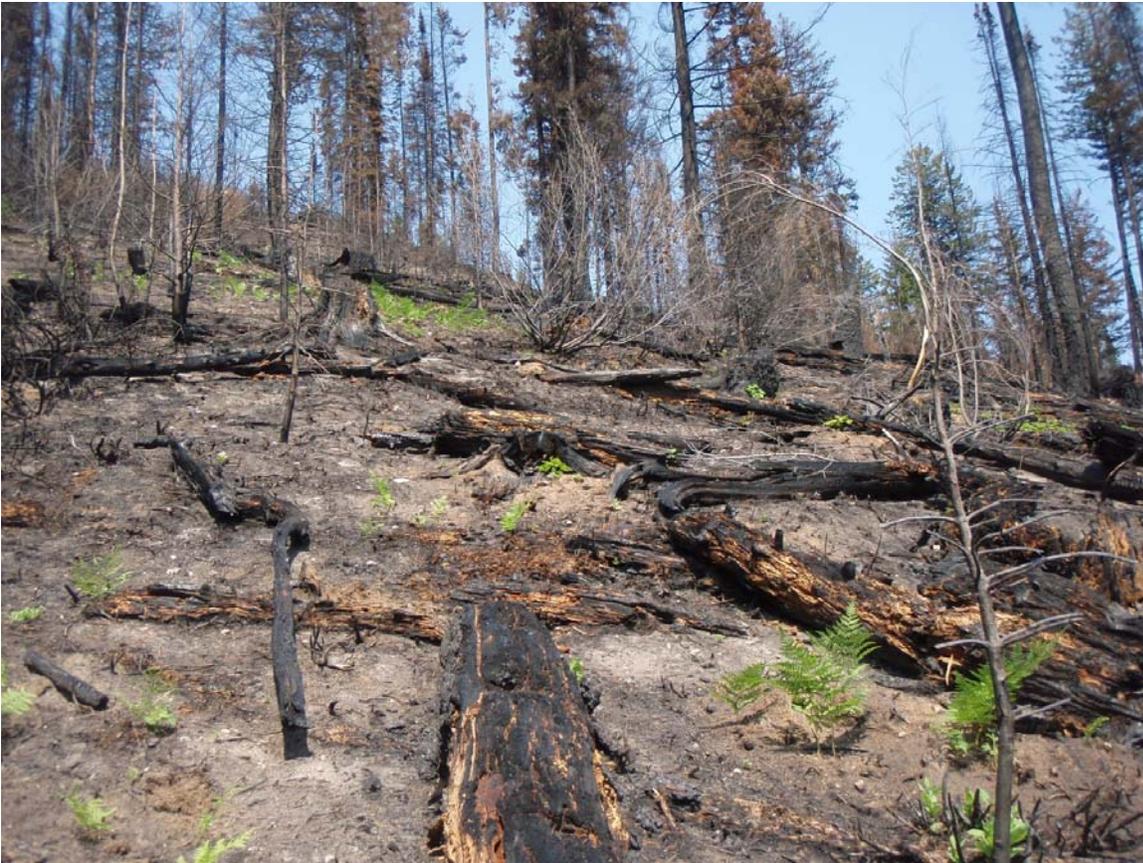
Moderate – trees dead, scorched needles remain on trees, understory burned

Photo 4. Moderate burn severity site, Airey Creek watershed.
