**MINISTRY OF FORESTS: POST-WILDFIRE NATURAL HAZARD RISK ANALYSIS –
RECONNAISSANCE REPORT**

FIRE NUMBER: N72255 Glacier Creek		FIRE YEAR: 2022	DATE OF REPORT: October 11, 2022
AUTHOR: Sarah Crookshanks, P.Geo., Ministry of Forests			
REPORT PREPARED FOR: Southeast Fire Centre, District Manager			
FIRE SIZE, LOCATION, AND LAND OWNERSHIP: 139 ha. Burned Crown and private land 40 km north of Kaslo.			
VALUES AT RISK: Land improvements on private property and Forest Service Road.			
WATERSHEDS AFFECTED	TOTAL AREA	AREA BURNED	BURN SEVERITY (% of <u>burned</u> area)
Glacier Creek	27900 ha	139 ha (0.5%)	0.6 % H, 11% M <i>*See discussion in Comments</i>
SUMMARY OF POST-FIRE HAZARD AND RISK			
<p>1. Hazard = P(H), the probability of occurrence of a hazardous event 2. Probability of spatial impact, P(S:H), the probability of a hazard reaching or affecting an element at risk 3. Partial Risk, the probability of a hazard occurring and affecting an element at risk = P(H) x P(S:H) 4. Location with the highest risk rating given; at other locations the risk may be lower</p>

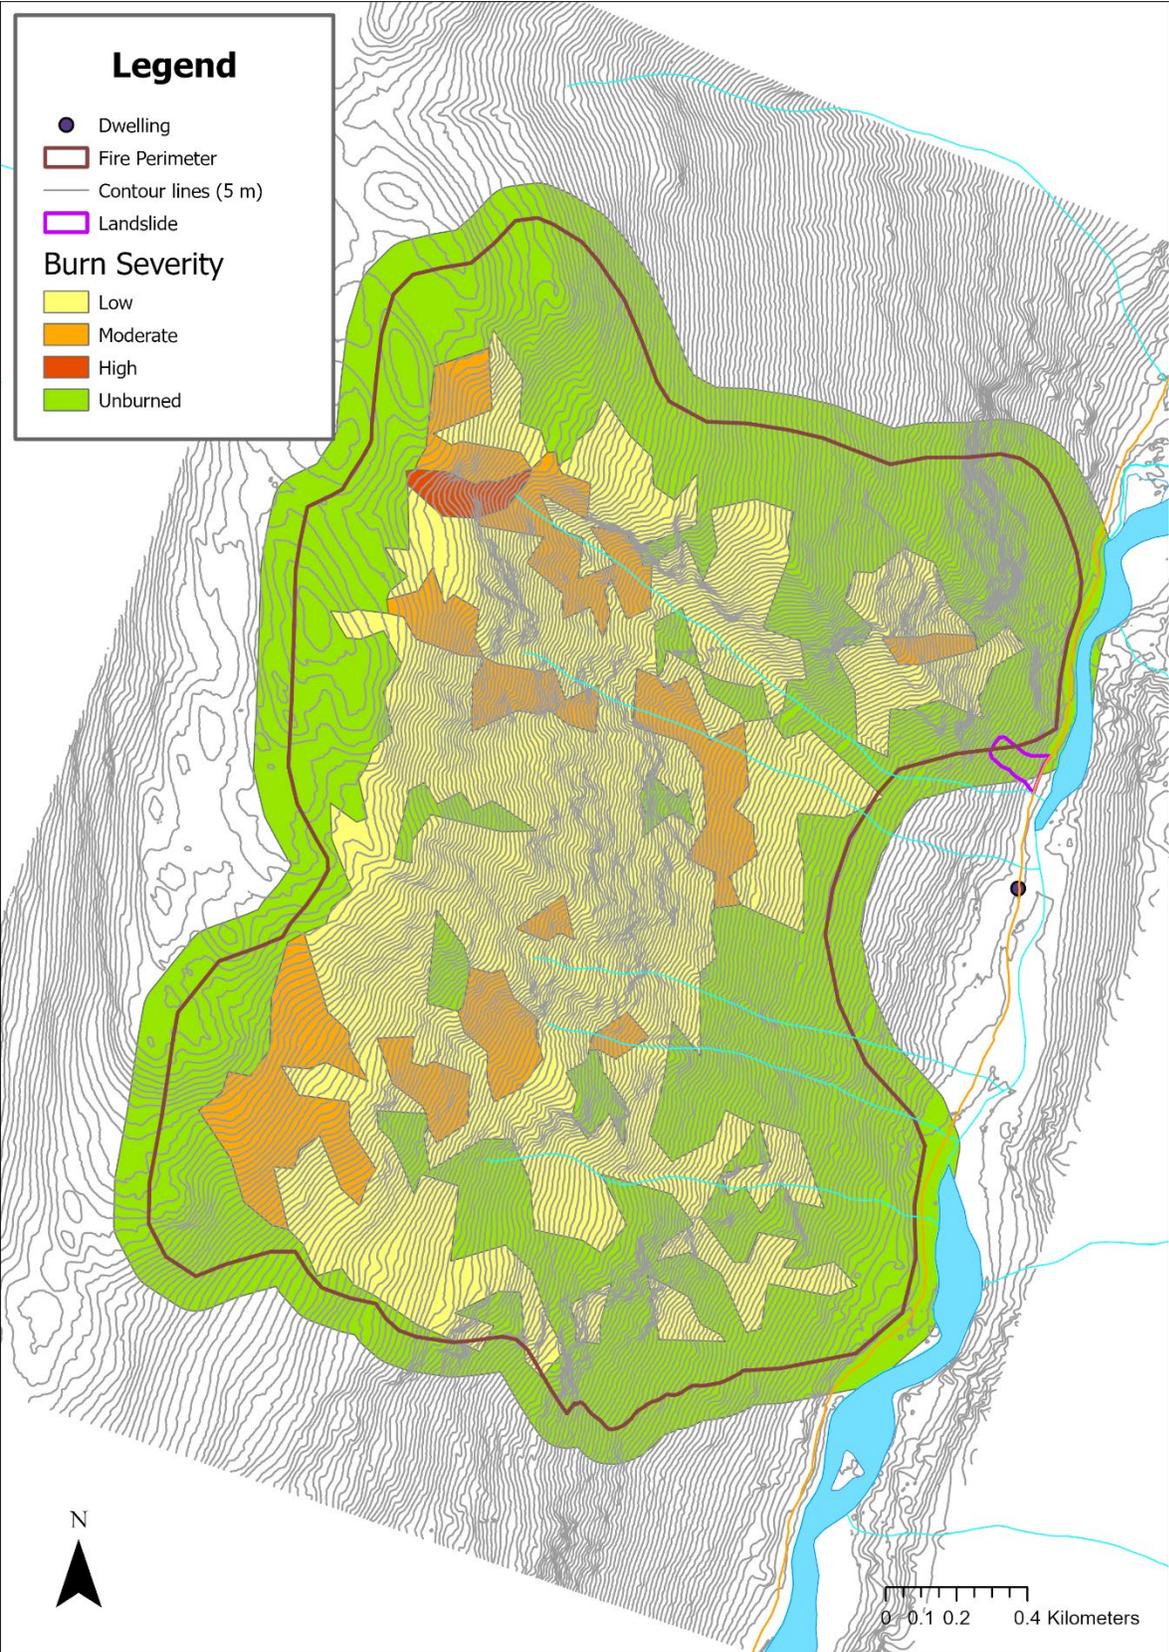
Figure 1 Burn severity map of the Glacier Creek fire showing estimated classes derived from Sentinel-2 imagery (prefire: 2022-08-17, post-fire: 2022-09-21).

Burn severity mapping was produced for this fire in late September by regional geomatics staff using Sentinel-2 satellite imagery. The satellite-derived burn severity within the fire perimeter generally corresponds with the visual determination of vegetation burn severity from aerial photos; however, considerable unburned area was mapped within the BCWS-derived fire perimeter. The field visit in early October verified that along lower slopes of the fire there were patches of moderate soil burn severity with virtually intact vegetation canopy overhead that were showing up as unburned on the satellite-derived map (e.g. Figure 4). BCWS staff confirmed that the fire backed down the slope at night, producing fingers of burned soil and understory extending downslope. The patchiness of this burn may have also made it more difficult for the Sentinel-2 satellite to detect the burned area, as its pixel size is 10 m.

The burn severity numbers reported here are almost certainly underreporting soil and understory burn severity on the lower slopes of the fire. However, more accurate burn severity mapping would require significant field work, which is not warranted given the risks. Considering the information provided by BCWS and field observations by the undersigned, it is likely safe to assume that the unburned area within the fire perimeter on the lower slopes is composed of patchy unburned, low, and moderately burned soil and understory.

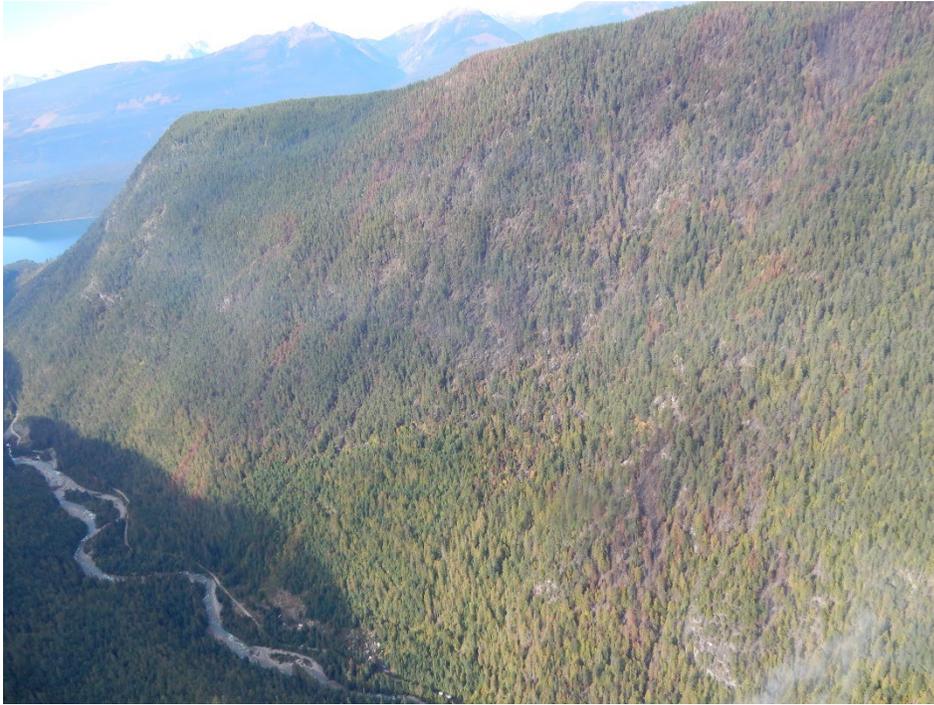
Figure 2 Glacier Creek fire looking downstream along Glacier Creek towards Duncan Lake.

The Glacier Creek fire began on September 3 near ridgetop and burned a face along Glacier Creek (Figures 2 and 3). The fire continued to produce smoke into October, though limited growth was observed after mid-September. An aerial overview of the fire was completed on September 26, and a site visit was undertaken on October 5.

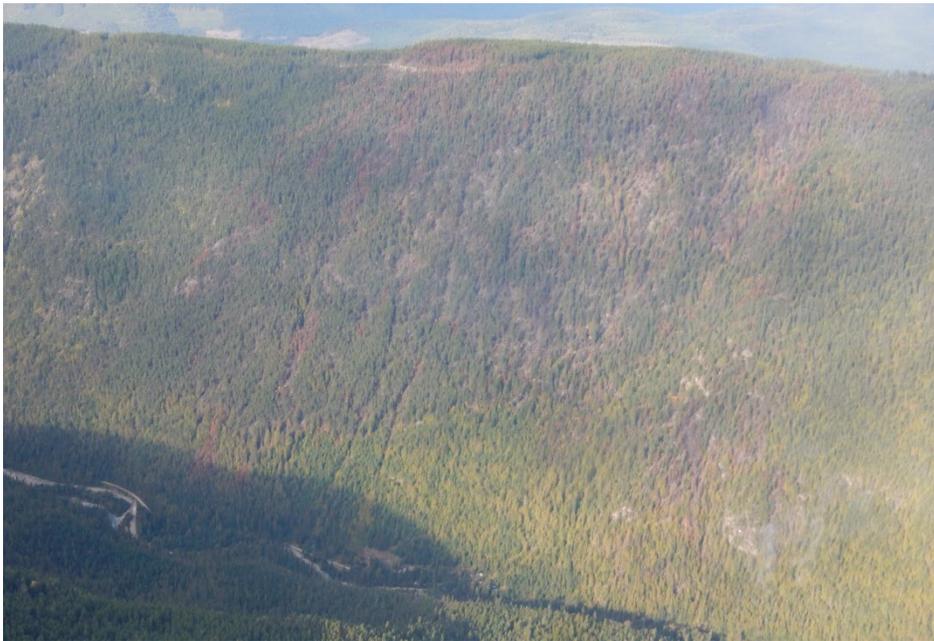
Figure 3 Glacier Creek fire looking west.

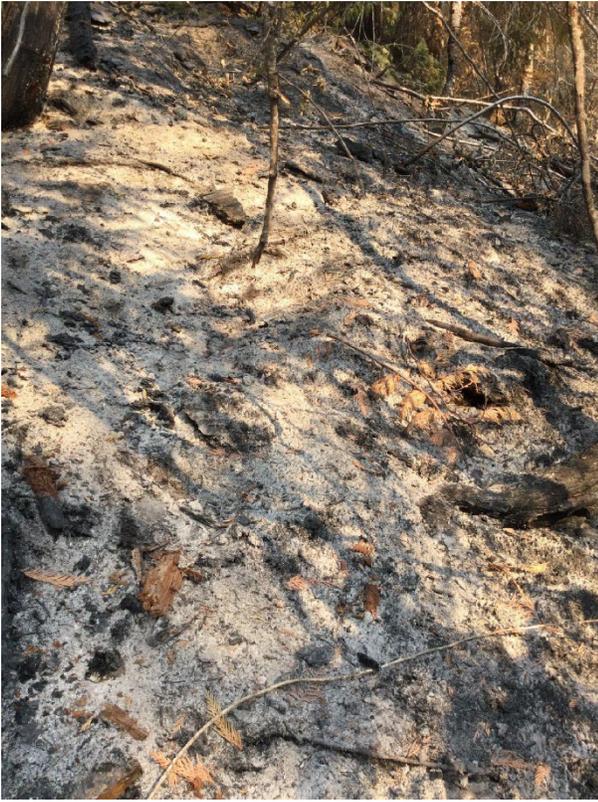
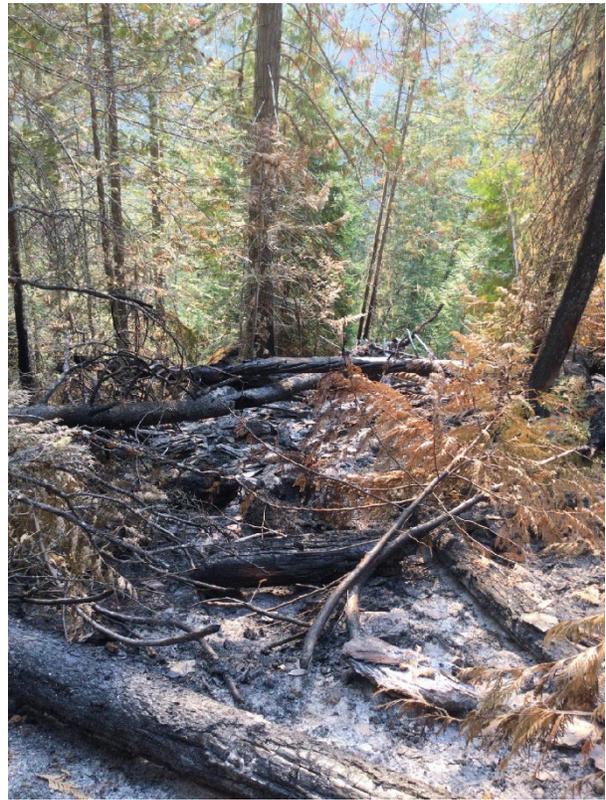
Figure 4 Patches of moderate soil burn severity in an area that is mapped as unburned in Figure 1.
