**MINISTRY OF FORESTS: POST-WILDFIRE NATURAL HAZARD RISK ANALYSIS –
RECONNAISSANCE REPORT**

FIRE NUMBER: N70969 Briggs Creek		FIRE YEAR: 2022	DATE OF REPORT: September 29, 2022
AUTHOR: Sarah Crookshanks, P.Geo., Ministry of Forests			
REPORT PREPARED FOR: Southeast Fire Centre, District Manager			
FIRE SIZE, LOCATION, AND LAND OWNERSHIP: 2160 ha. Fire is located west of Kaslo on Crown land.			
VALUES AT RISK: Private property land improvements, secondary road, municipal water supply, domestic water supply			
WATERSHEDS AFFECTED	TOTAL AREA	AREA BURNED	BURN SEVERITY (% of watershed area)
<i>Kemp Creek</i>	1270 ha	11 ha (1%)	0.05 % H, 0.5% M
<i>Keen Creek</i>	20344 ha	1442 ha (7%)	3% H, 3% M
<i>NE Unnamed Creek</i>	282 ha	76 ha (27%)	3% H, 12% M
SUMMARY OF POST-FIRE HAZARD AND RISK			
<p>1. Hazard = P(H), the probability of occurrence of a hazardous event 2. Probability of spatial impact, P(S:H), the probability of a hazard reaching or affecting an element at risk 3. Partial Risk, the probability of a hazard occurring and affecting an element at risk = P(H) x P(S:H) 4: Location with the highest risk rating given; at other locations the risk may be lower</p>

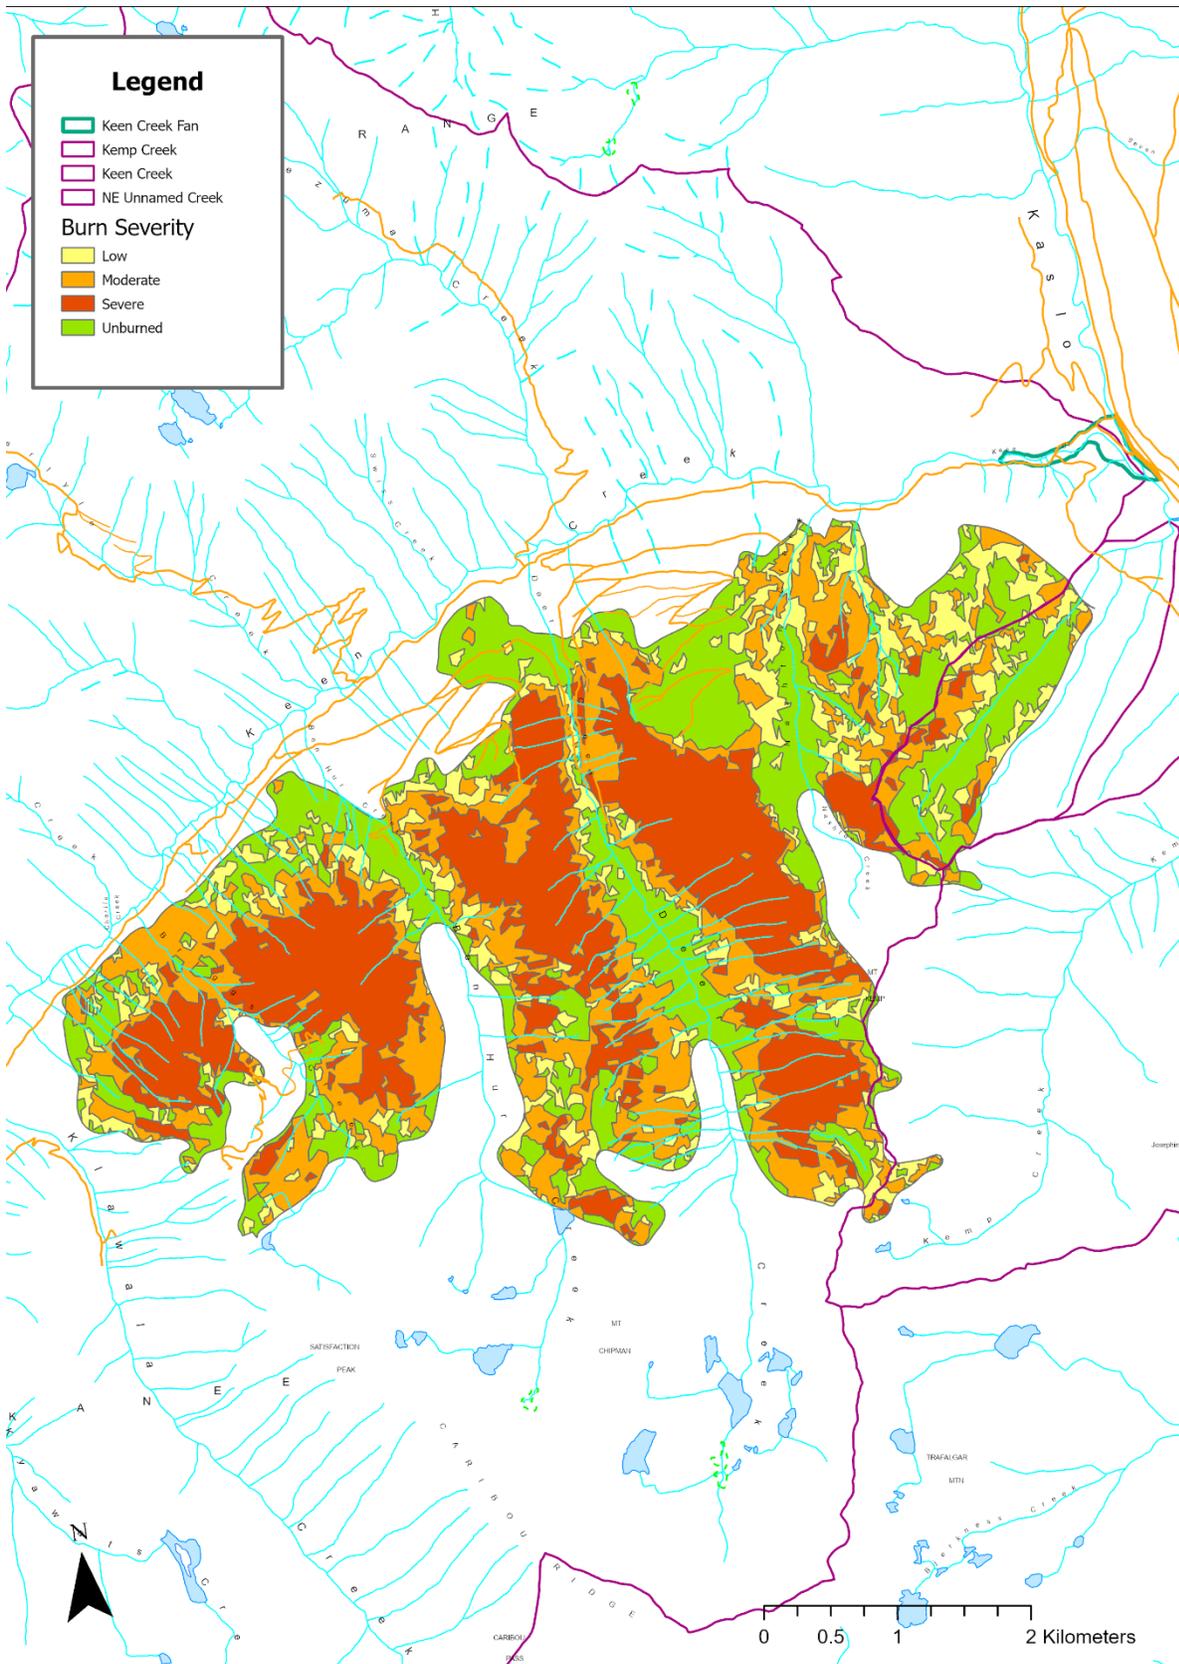
Figure 1 Burn severity map of the Briggs Creek fire showing estimated classes derived using Sentinel-2 imagery (pre-fire: 2021-09-21, post-fire: 2022-09-21).

Burn severity mapping was produced for this fire in late September by regional geomatics staff. The burn severity analysis using Sentinel-2 satellite imagery showed some false positive burned areas outside the fire perimeter, likely due to changes in lighting on rock/talus slopes or vegetation changes in cutblocks. The helicopter overview flight photos confirmed that the fire perimeter was generally accurately drawn. Therefore, the burn severity map was clipped to the perimeter extent. The burned area numbers reported above reflect the clipped burn severity extent. The satellite-derived burn severity within the fire perimeter generally corresponds with the visual determination of burn severity from photos.

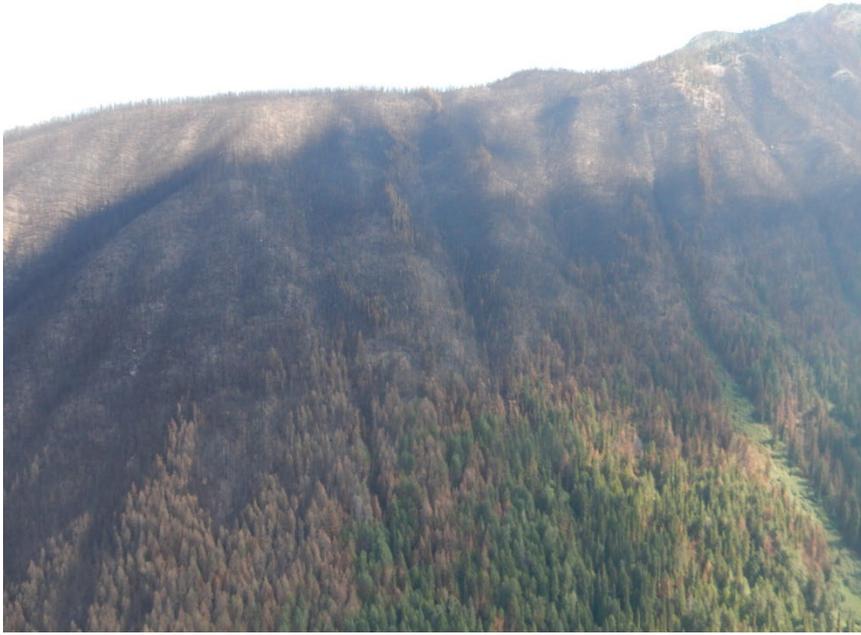
Figure 5 High burn severity in Deer Creek watershed

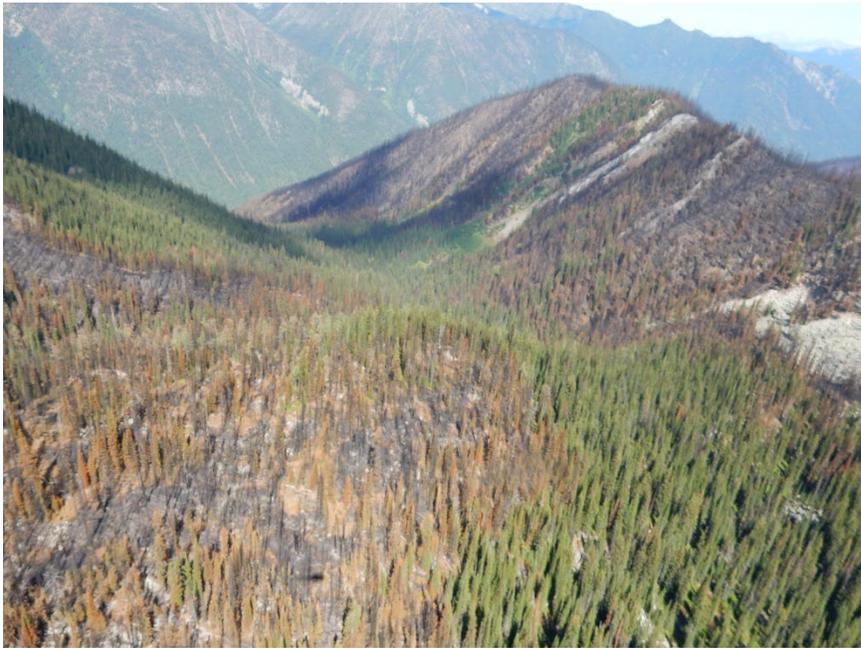
Figure 6 Patchy burn severity in Briggs Creek watershed

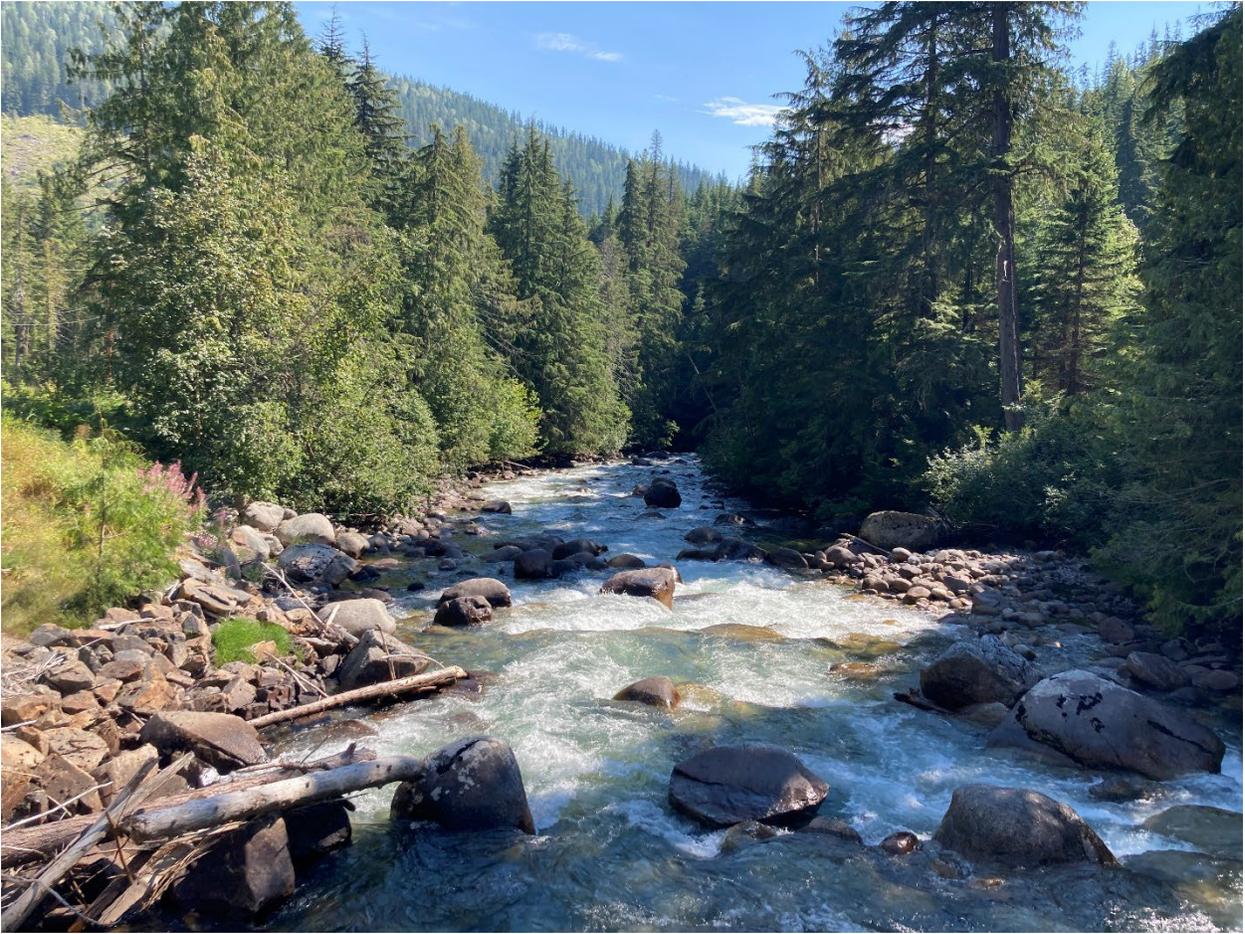
Figure 7 Keen Creek at Kaslo Creek South Fork Road

<i>Keen Creek –flood impacting private property land improvements or Kaslo Creek South Fork Road</i>			
Hazard P(H) ¹ = low Probability of spatial impact P(S:H) ² = moderate Partial Risk ^{3,4} = low			
<p>The steep tributaries that burned in the Keen Creek watershed are susceptible to debris flows and debris floods. However, the Keen Creek channel gradient (3-6%) is not steep enough to transport these events to the fan. A debris flow in one of these steep tributaries would most likely be diluted by the main flow in Keen Creek, and result in turbid water at the mouth of Keen Creek. Furthermore, because only 7% of the watershed burned, the incremental flood risk on Keen Creek is low. Elements at risk on the Keen Creek fan include land improvements on private property and a secondary road.</p>			
<i>Keen Creek - water quality impacts to surface domestic water users</i>			
Hazard P(H) ¹ = moderate Probability of spatial impact P(S:H) ² = high Partial Risk ^{3,4} = high

Domestic water users on Keen Creek may want to consider additional water quality treatment measures.
