Sitkum Creek Fire, 2007, N70347

Post-Wildfire Risk Analysis

**Prepared for BC Ministry of Forests and Range:
Southeast Fire Centre, Southern Interior Forest Region,
and Kootenay Lake Forest District**

17 September, 2007

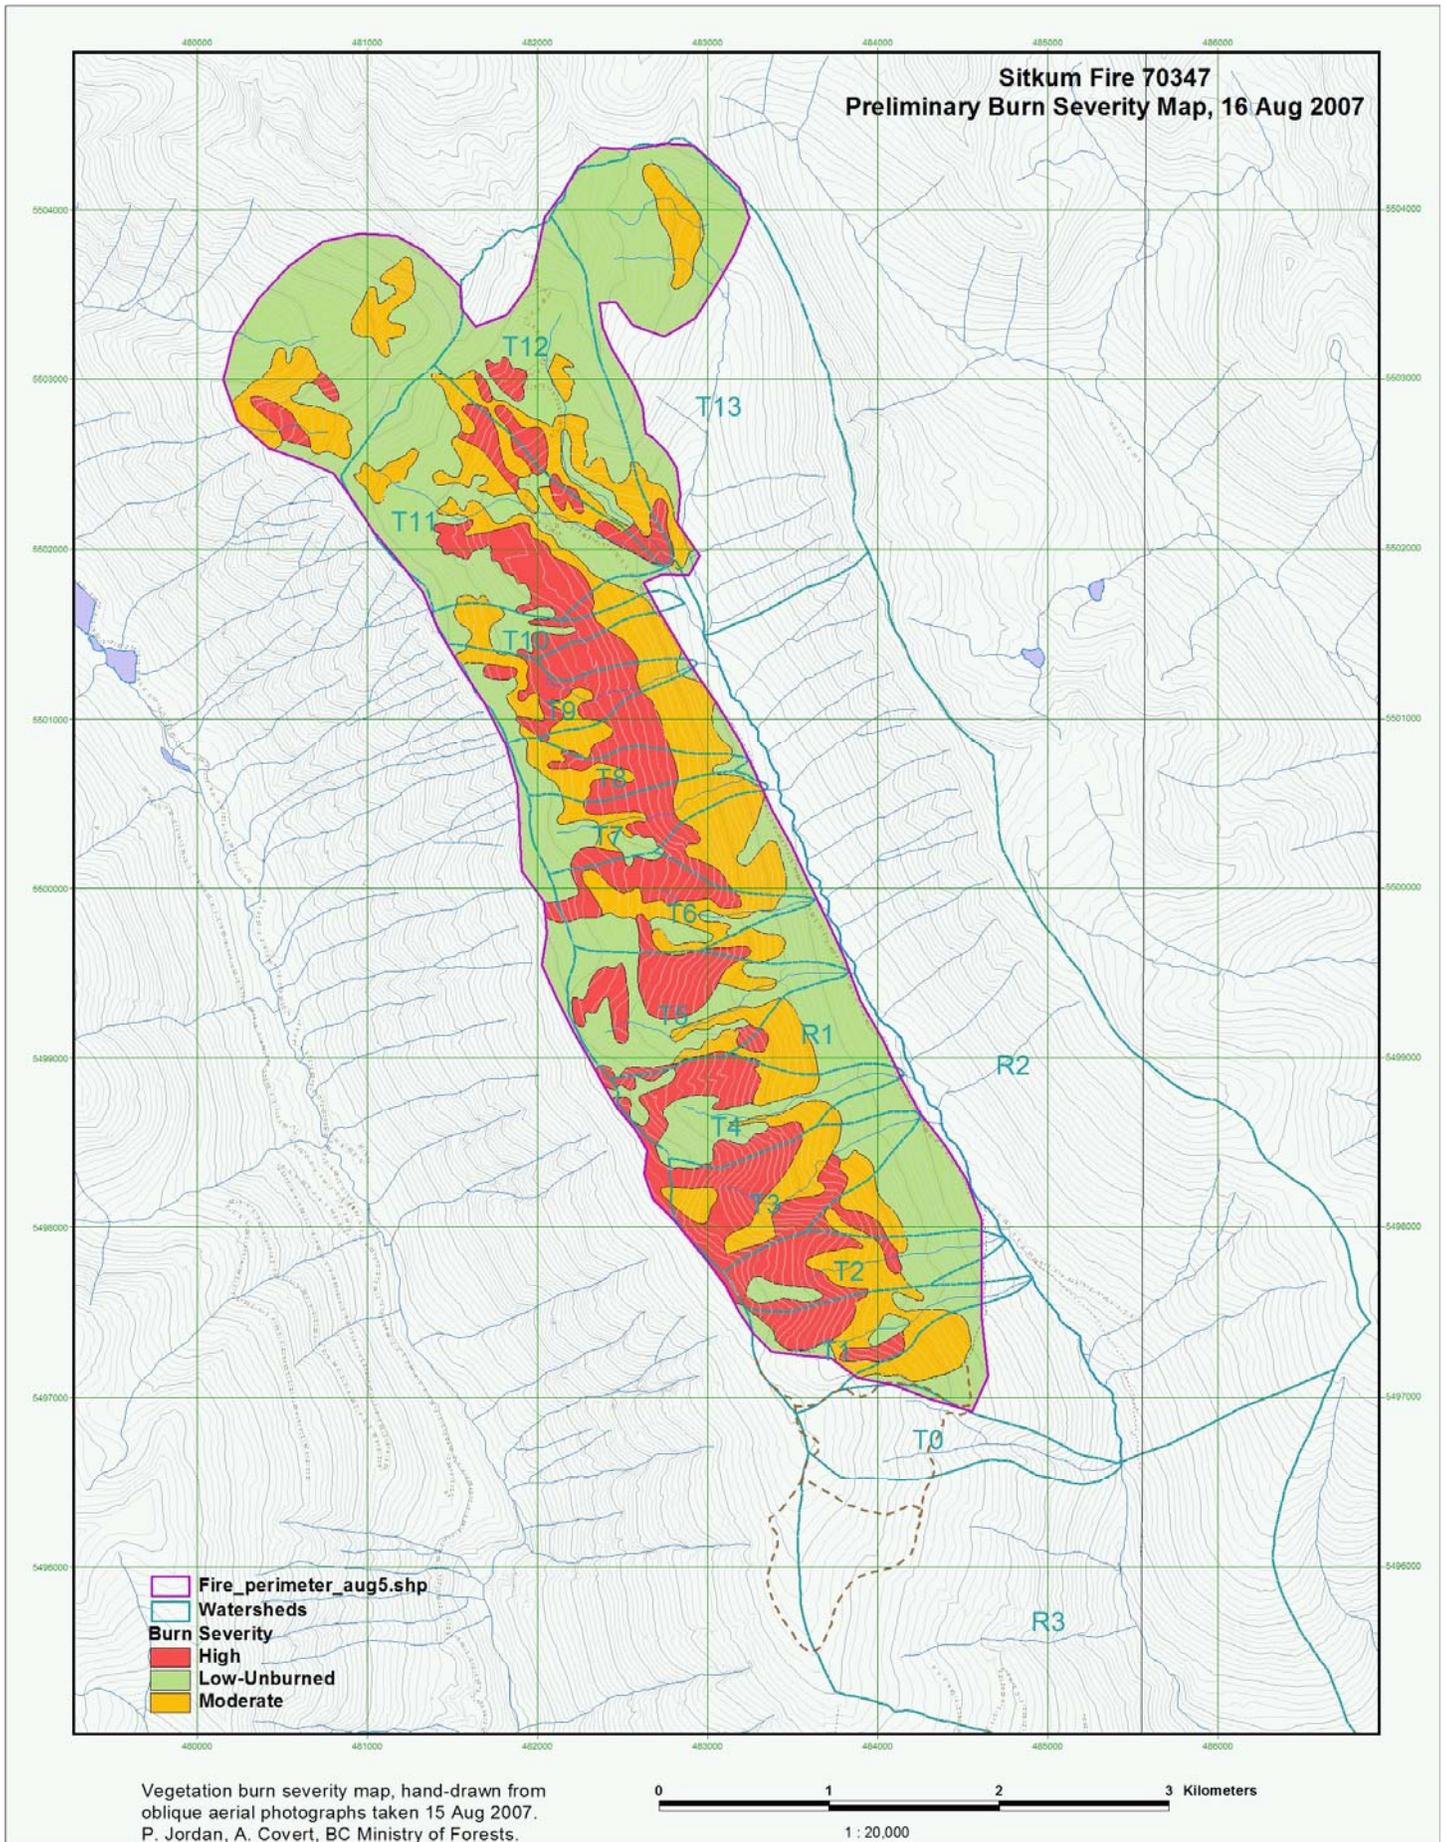
Figure 2. Preliminary burn severity and watershed map (reduced).

The preliminary vegetation burn severity map is shown in Figure 2. (A full-size version in paper or digital form is available on request.) The areas of high, moderate, and low vegetation burn severity are 270, 290, and 504 ha respectively. A summary of the burned areas as percent of watershed area for Sitkum Creek and its tributaries is given in Tables 1 and 2.

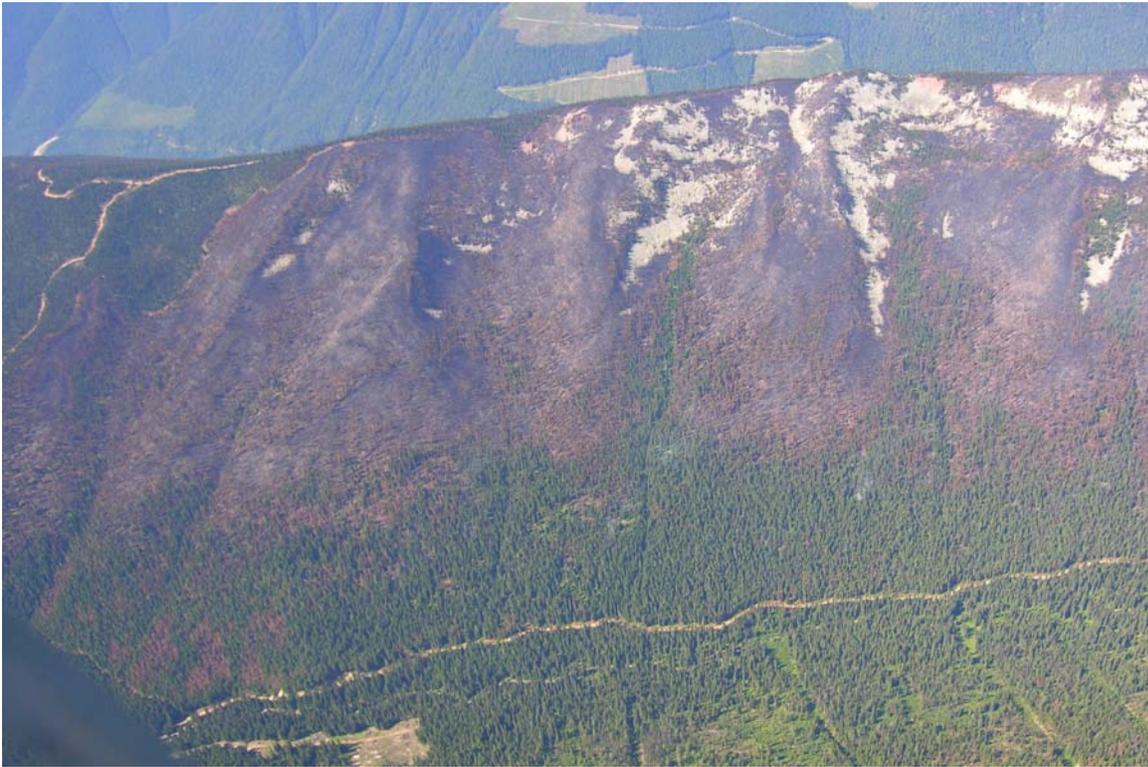
T1 and T2 are both debris flow prone gullies, and appear to have experienced small debris flows (several 100 m³) about every 50 to several hundred years, and larger events (up to a few 1000 m³) at less frequent intervals. Based on observations of the channel condition and debris deposits, it appears that neither gully has experienced a large debris flow in at least the last century. At the mouth of T2 there is a substantial area of old debris deposits, which confine Sitkum Creek against the left valley wall. This area would probably store most of the debris from small events, although a large event could enter the creek. T1 enters Sitkum Creek at a more confined location, and the creek steepens to about 18% for a short distance, immediately below the confluence. It appears that past debris flow events have blocked the creek at this location. There is a possibility that a large event in T1 could temporarily dam Sitkum Creek, causing a

Photo 1. Burned area in tributaries T1 to T5 on the west side of Sitkum Creek.

3. Mitigation treatments, such as aerial mulching, should be considered in the tributary watersheds of T1 and T2, to reduce the debris flow hazard in these drainages.

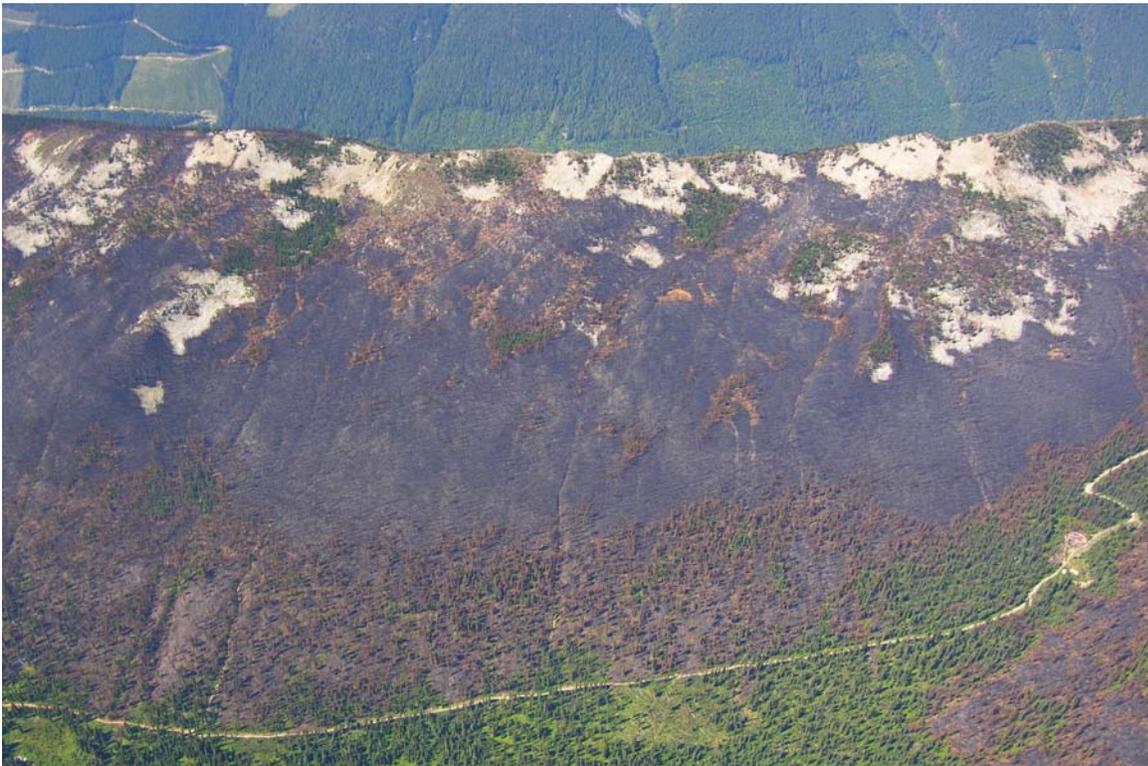
All the streams were inspected at the points where they cross the road, or for the most downstream channels (T1 and T2), at their confluences with Sitkum Creek, and the results are summarized in Table 2. Streams T1, T2, T8, and T9 are considered to be high hazard due to evidence of past debris flows in their lower channels.

Photo 2. Upper Sitkum Creek watershed, showing continuous area of severe burn, and moderate severity area between this and the road. Two recent small debris flows on streams T8 and T9 are visible. The old mill site is on the extreme right.

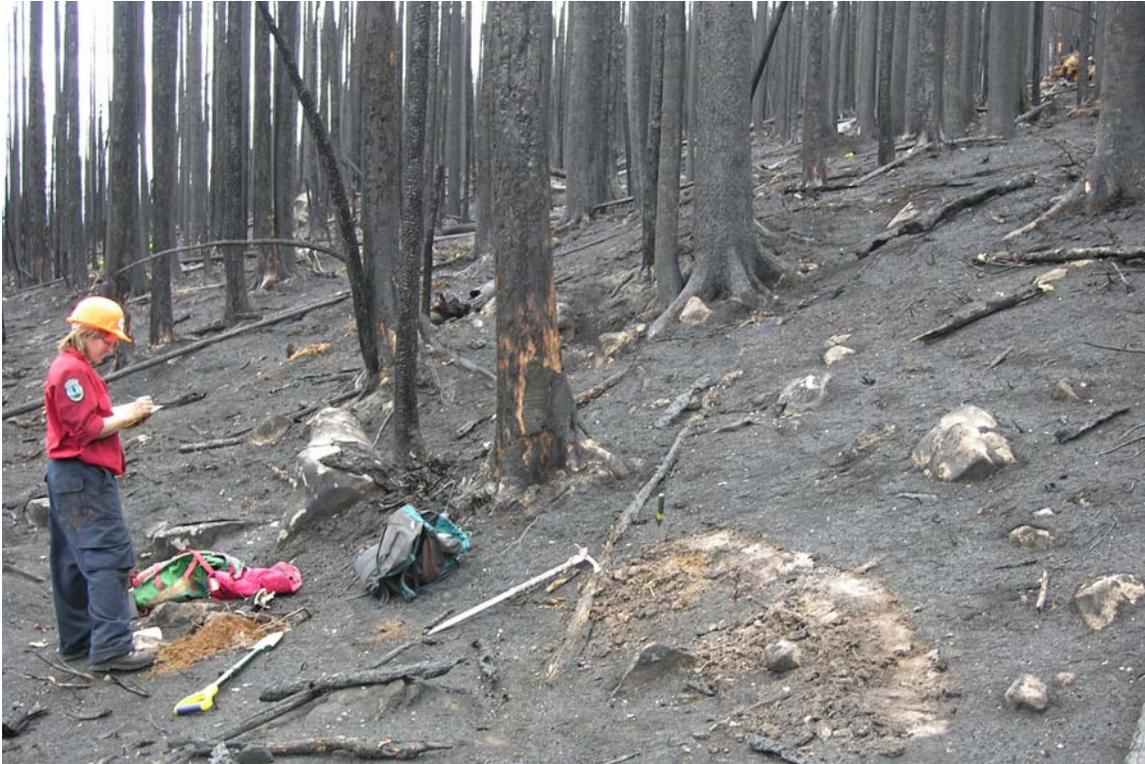
Two traverses were made through the burned area, in the north and south parts of the fire, and a total of 63 plots were measured. In the areas mapped as high vegetation burn severity, about 60% had high soil burn severity, and about 50% of sites had strong water repellency. This is a somewhat lower proportion than other fires we have examined this year (including the Springer Creek fire) and less than some of the 2003 fires (including Kuskonook). However, it is still a significant amount of severe soil burn, and it indicates that about half of the areas mapped as high vegetation burn severity may be subject to producing overland flow in a heavy rainstorm.

Photo 3. Example of a severely burned area, showing a water repellency test plot.

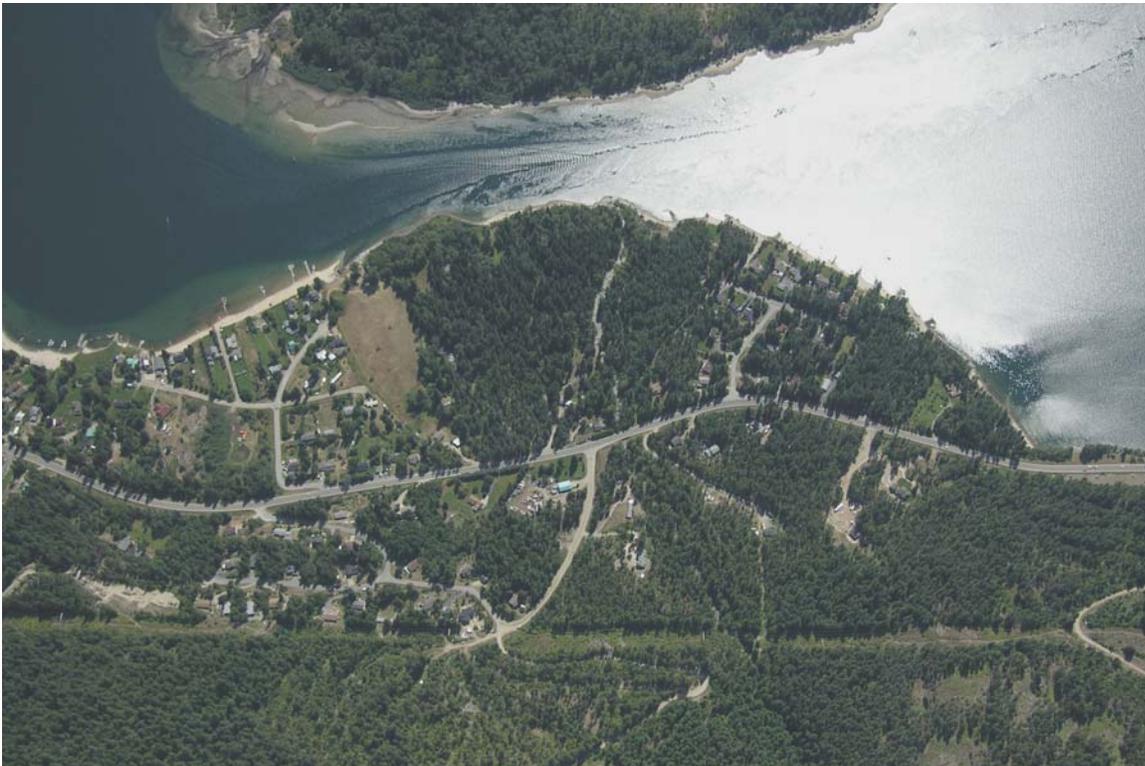
There are approximately 50 houses or similar buildings on the Sitkum Creek fan (from air photos, and the map in Northwest Hydraulic Consultants Ltd, 1990). Many of these houses are near the abandoned channels or points of potential avulsion noted in the above report, and so are considered to be vulnerable in the case of any flood which causes the creek to overflow its channel. Highway 3A crosses the creek by a bridge, at a point where the channel is of limited capacity and is not deeply incised, so this bridge and the adjacent highway are also considered to be vulnerable.

Photo 4. Low-level aerial photo of the Sitkum Creek fan, taken 15 August 2007.
