Funding Water Infrastructure for the Long Term

Regional District of Central Kootenay

Denver Siding

April 11, 2018

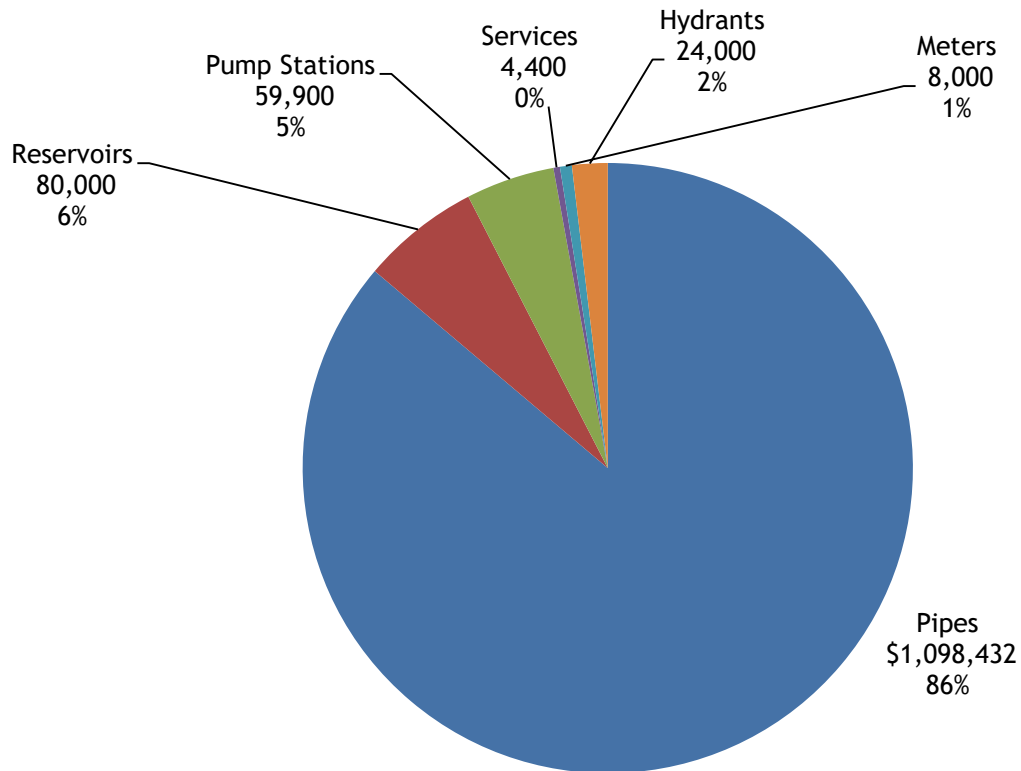
Figure 1: Denver Siding 2017 WATER Assets Replacement Value: \$1,274,732

Denver Siding water infrastructure is summarized here. The total value of the infrastructure and the value of each asset category is shown here in 2017 dollars.

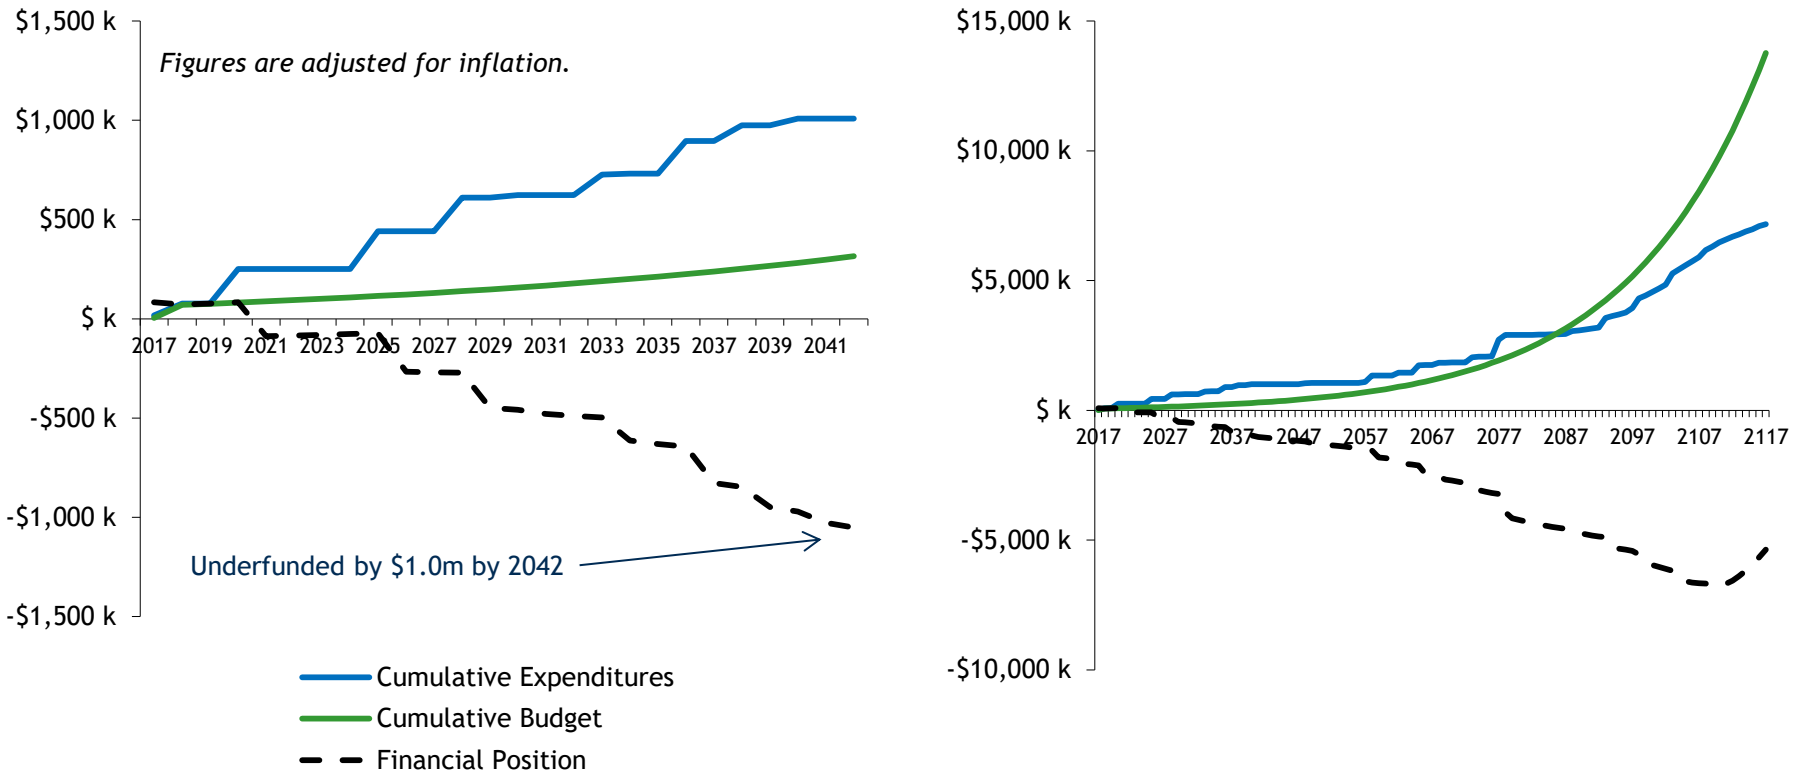
Figure 8: Denver Siding 25 Year and 100 Year Financial Position

This chart compares the expenditures and allocated funds from figure 7. The blue line shows the cumulative expenditures, inflation adjusted, projected over the next 25 years in the asset schedule. The green line shows the cumulative funds allocated towards these projects.

The dash line is the difference between what is projected to be spent and available funds. When this line is above 0, it represents a surplus of funds typically held in an asset reserve fund; when below zero, the dash line represents a shortfall and implies the need for additional funding, or the works need to be delayed or canceled.

3. Make necessary adjustments to rates and fees to bolster the annual contribution for asset replacement (ACFAR) with an aim to have ACFAR meet ACSO and to build up a reserve fund in advance of large future expenditures. The financial position on page 20 can be a guide in determining reserve fund target level; and,
