**AREA E ADVISORY PLANNING AND HERITAGE
COMMISSION
OPEN MEETING AGENDA**

Riparian Assessment and Restoration Plan

Proposed Retaining Wall Removal and Shoreline Bank Restoration

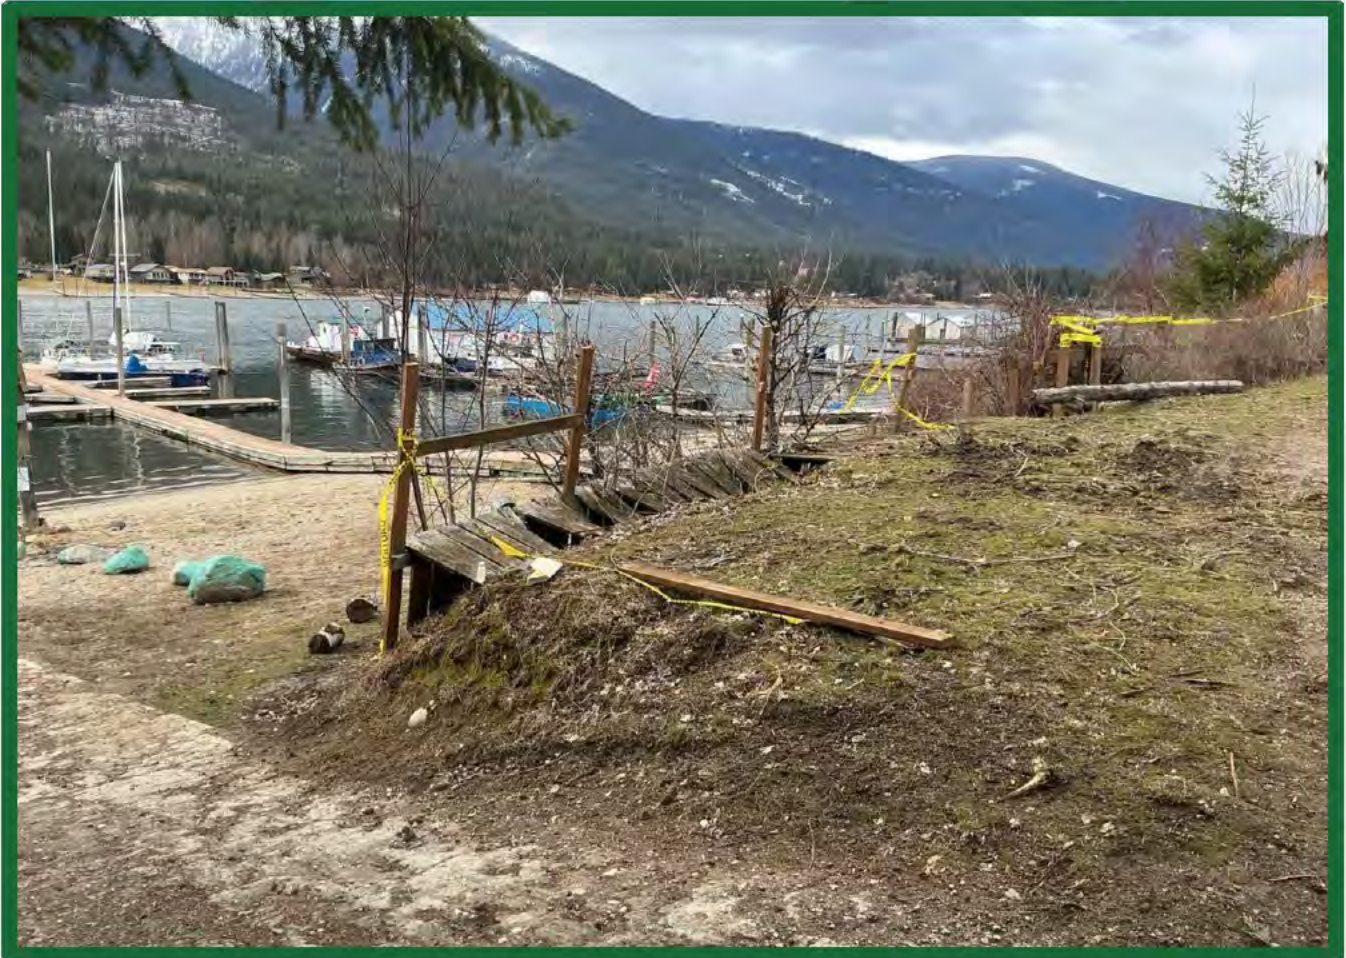
SITE PLAN:
SCALE: 1:300

WEST ARM OF
KOOTENAY
LAKE

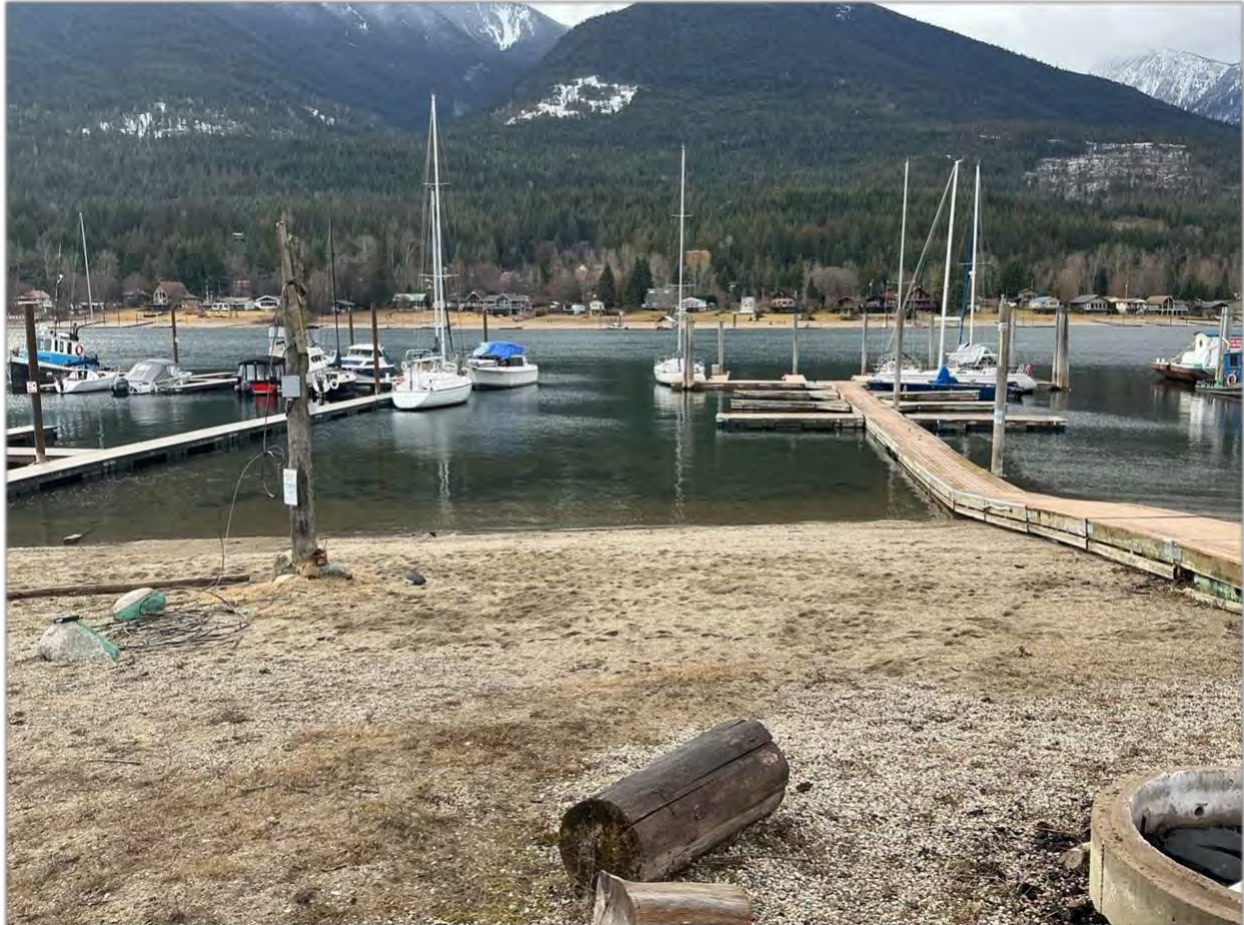
Photo 1. General view of the project shoreline within Balfour Bay showing the modified beach area and surrounding developed shoreline.

The subject property slopes gradually toward the lake and has a modified shoreline influenced by past development. Much of the central portion of the shoreline was previously cleared or altered, resulting in limited riparian vegetation along the immediate water's edge. The ground surface near the shoreline consists largely of exposed sand and gravel typical of developed beach areas in Balfour Bay.

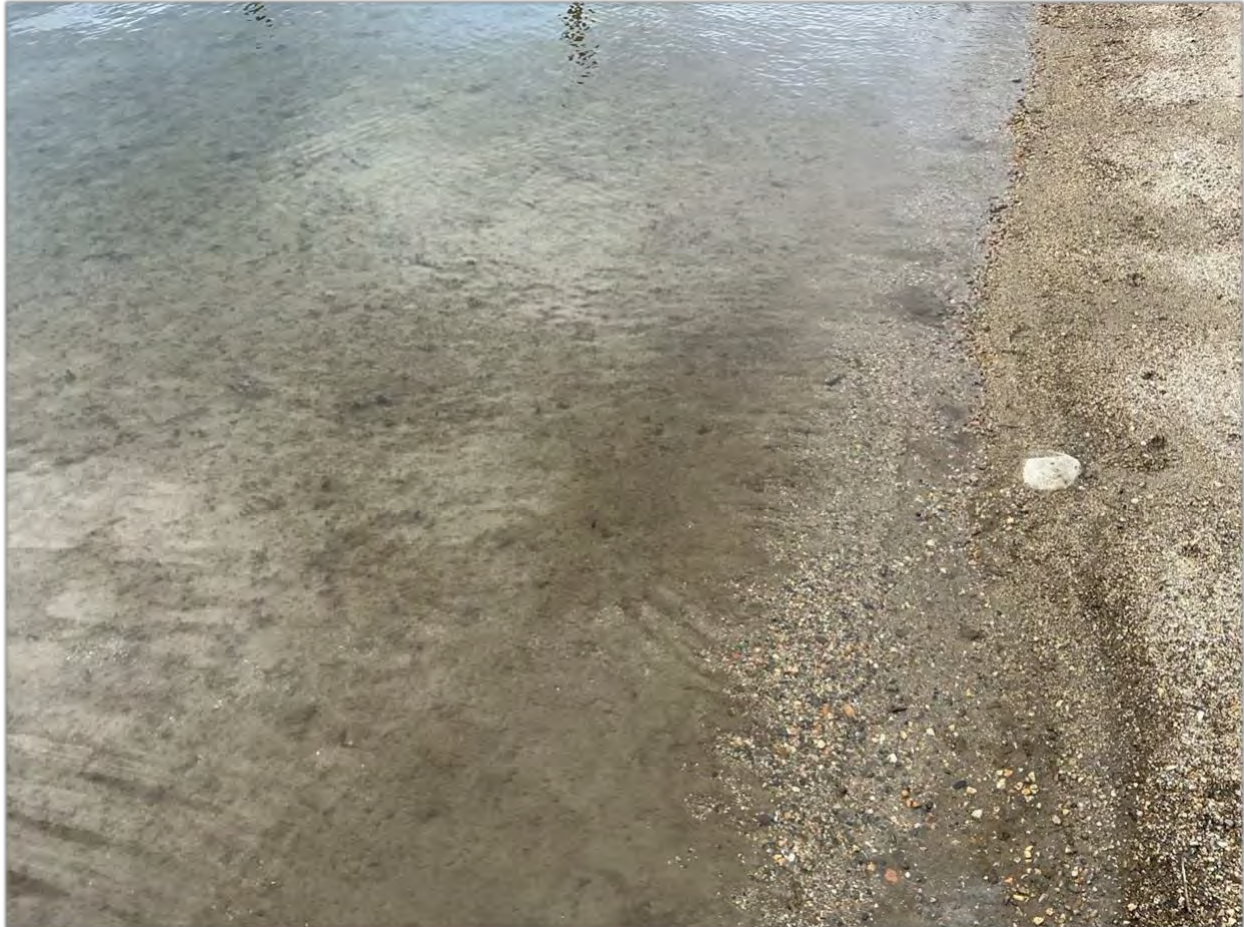
Photo 2. Nearshore substrate at the site showing sand and fine gravel transitioning into shallow water along the shoreline.

Substrate conditions observed at the site are dominated by sand and fine gravel with limited coarse material. Well-sorted spawning gravels were not observed, and structural features commonly associated with fish habitat, such as large woody debris, root wads, or large boulders, were largely absent along the shoreline and nearshore area. As a result, the immediate shoreline provides relatively limited habitat complexity.

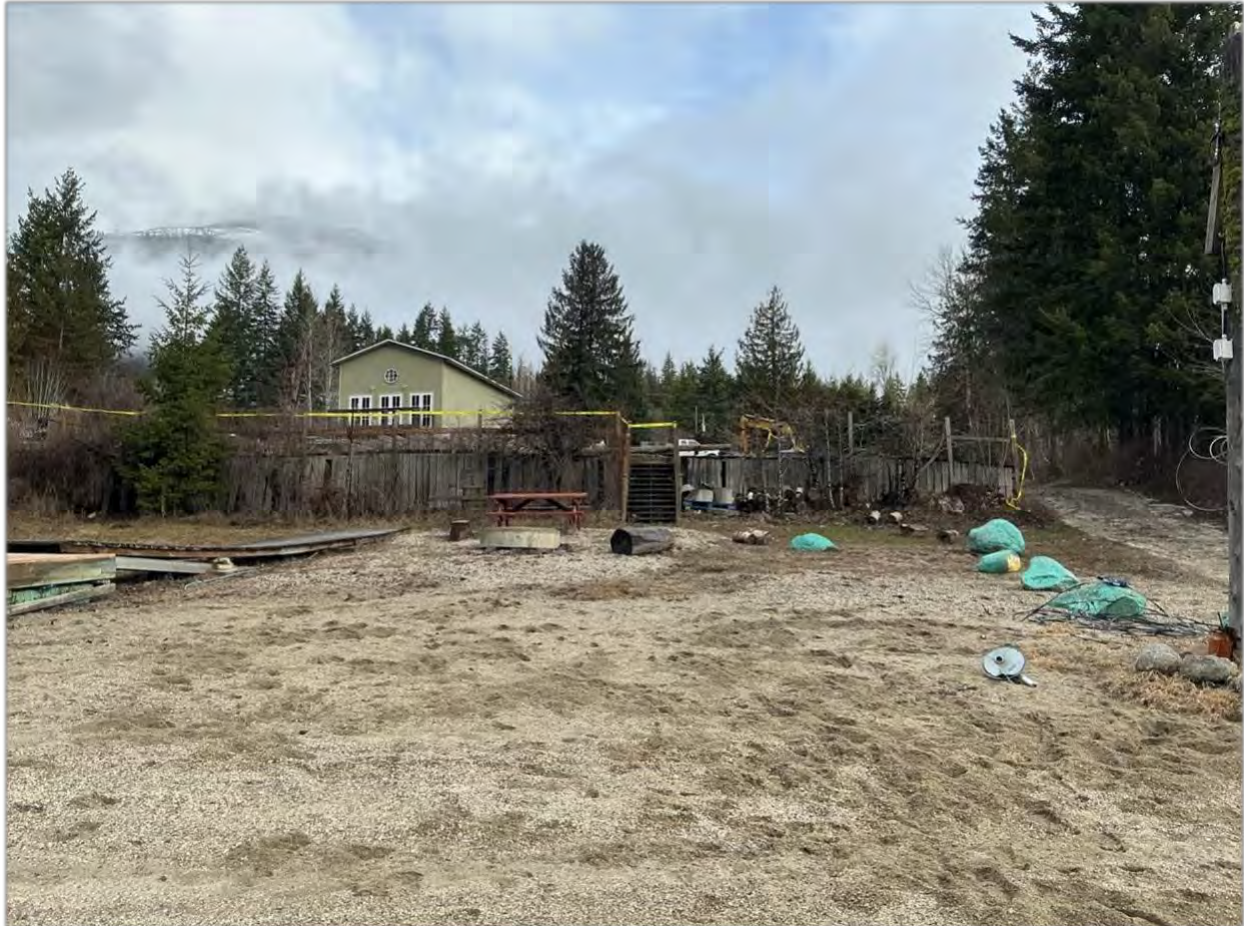
Photo 3. Disturbed shoreline area near the existing timber retaining wall, where riparian vegetation is limited.

The shoreline is currently modified by an existing timber retaining wall near the upper portion of the beach. The wall appears to be deteriorating and is beginning to sag in places. The structure is approximately 28 m long and about 1.9 m high. The area landward of the wall consists largely of sandy and gravelly fill with limited vegetation. The wall and associated disturbance have altered the natural shoreline profile along the central portion of the property. Riparian vegetation in this area is currently limited, likely reflecting past clearing and shoreline modification. The disturbed area associated with the wall and shoreline modification is estimated to be approximately 80–90 m².

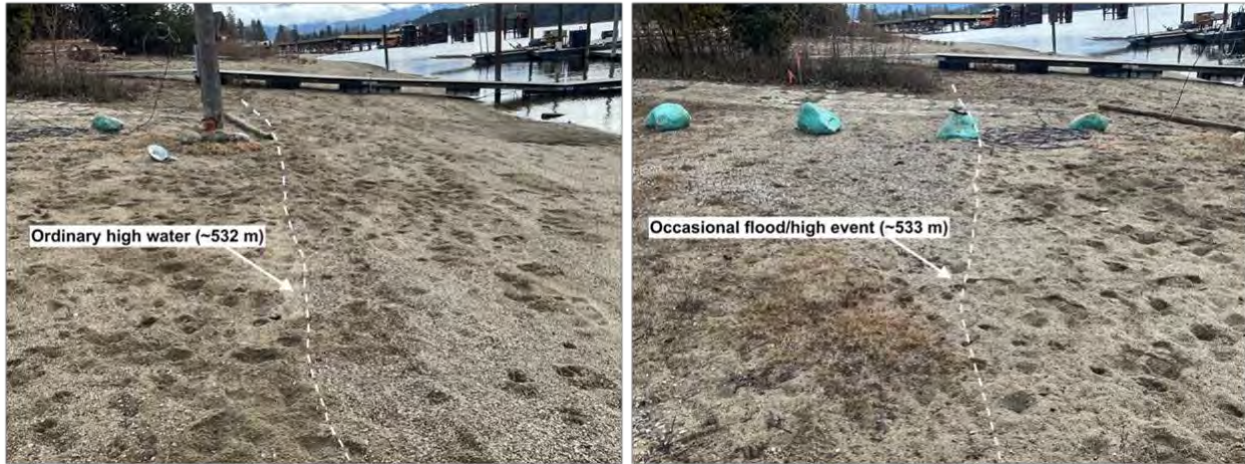
Photos 4-5. Approximate location of natural boundary indicators observed during the field assessment, including the debris and vegetation transition associated with the ordinary high-water level (~532 m; left) and a higher vegetation line (~533 m; right).

Field observations indicated that the primary vegetation, debris, and soil transition associated with the ordinary high-water level occurred at approximately 532 m elevation. A secondary vegetation line was observed higher on the bank at approximately 533 m elevation and was interpreted as indicating a higher episodic water level associated with seasonal high-water or flood events. To ensure a precautionary interpretation of the shoreline boundary for the development permit review, the higher vegetation line was used as the reference point for the riparian setback.

At the time of the site visit, lake levels reported by FortisBC indicated a water level of approximately 530.85 m at the Queen's Bay monitoring station. The natural boundary indicators observed in the field were therefore located approximately 1–2 m above the lake level at the time of the site visit.

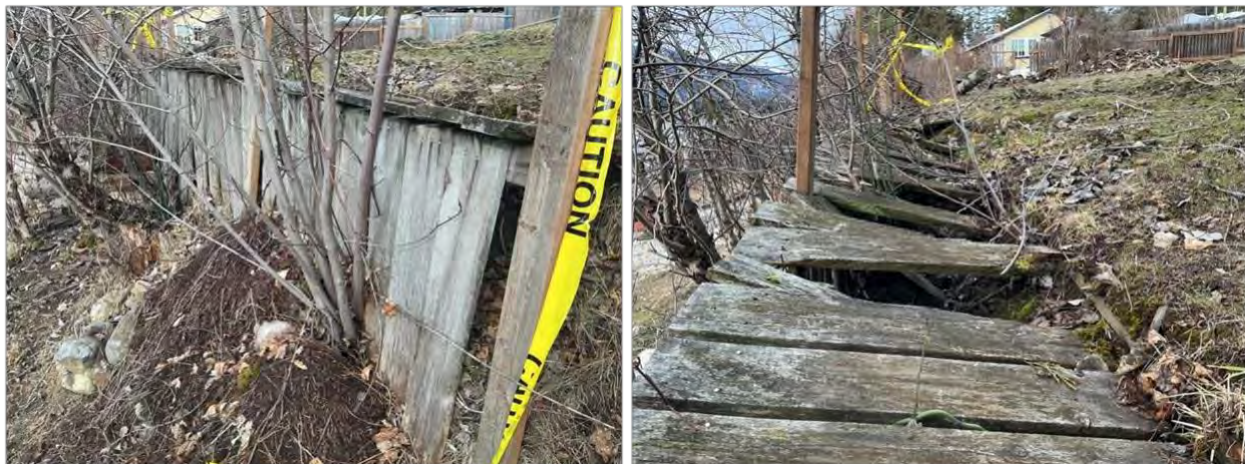
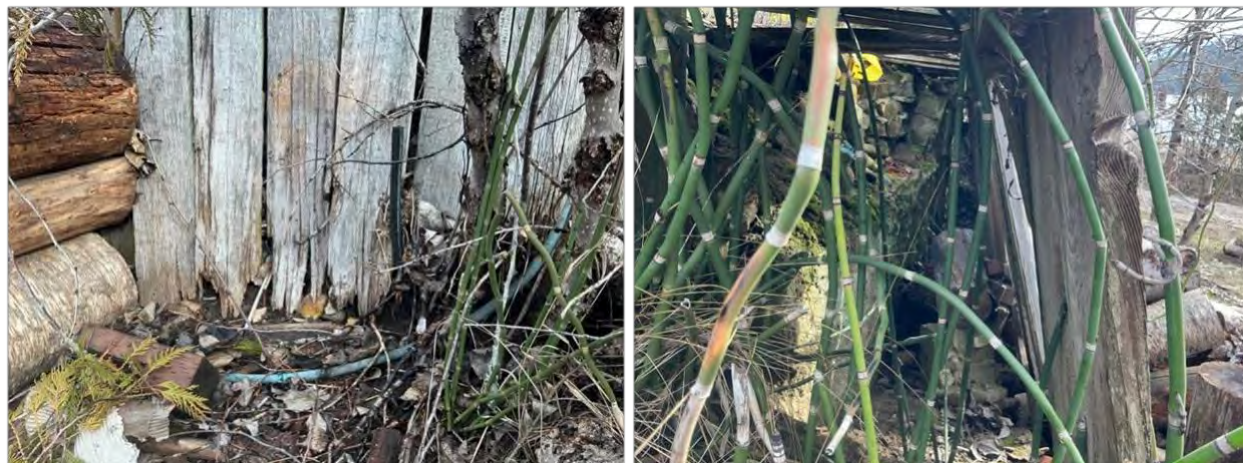
Photos 6-9. Existing timber retaining wall along the shoreline prior to removal.

The proposed work involves removing the existing timber retaining wall and associated concrete barrier elements along the shoreline. The existing wall is approximately 28 m long and about 1.9 m high. Removal of these structures will require excavation of the material currently retained behind the wall.

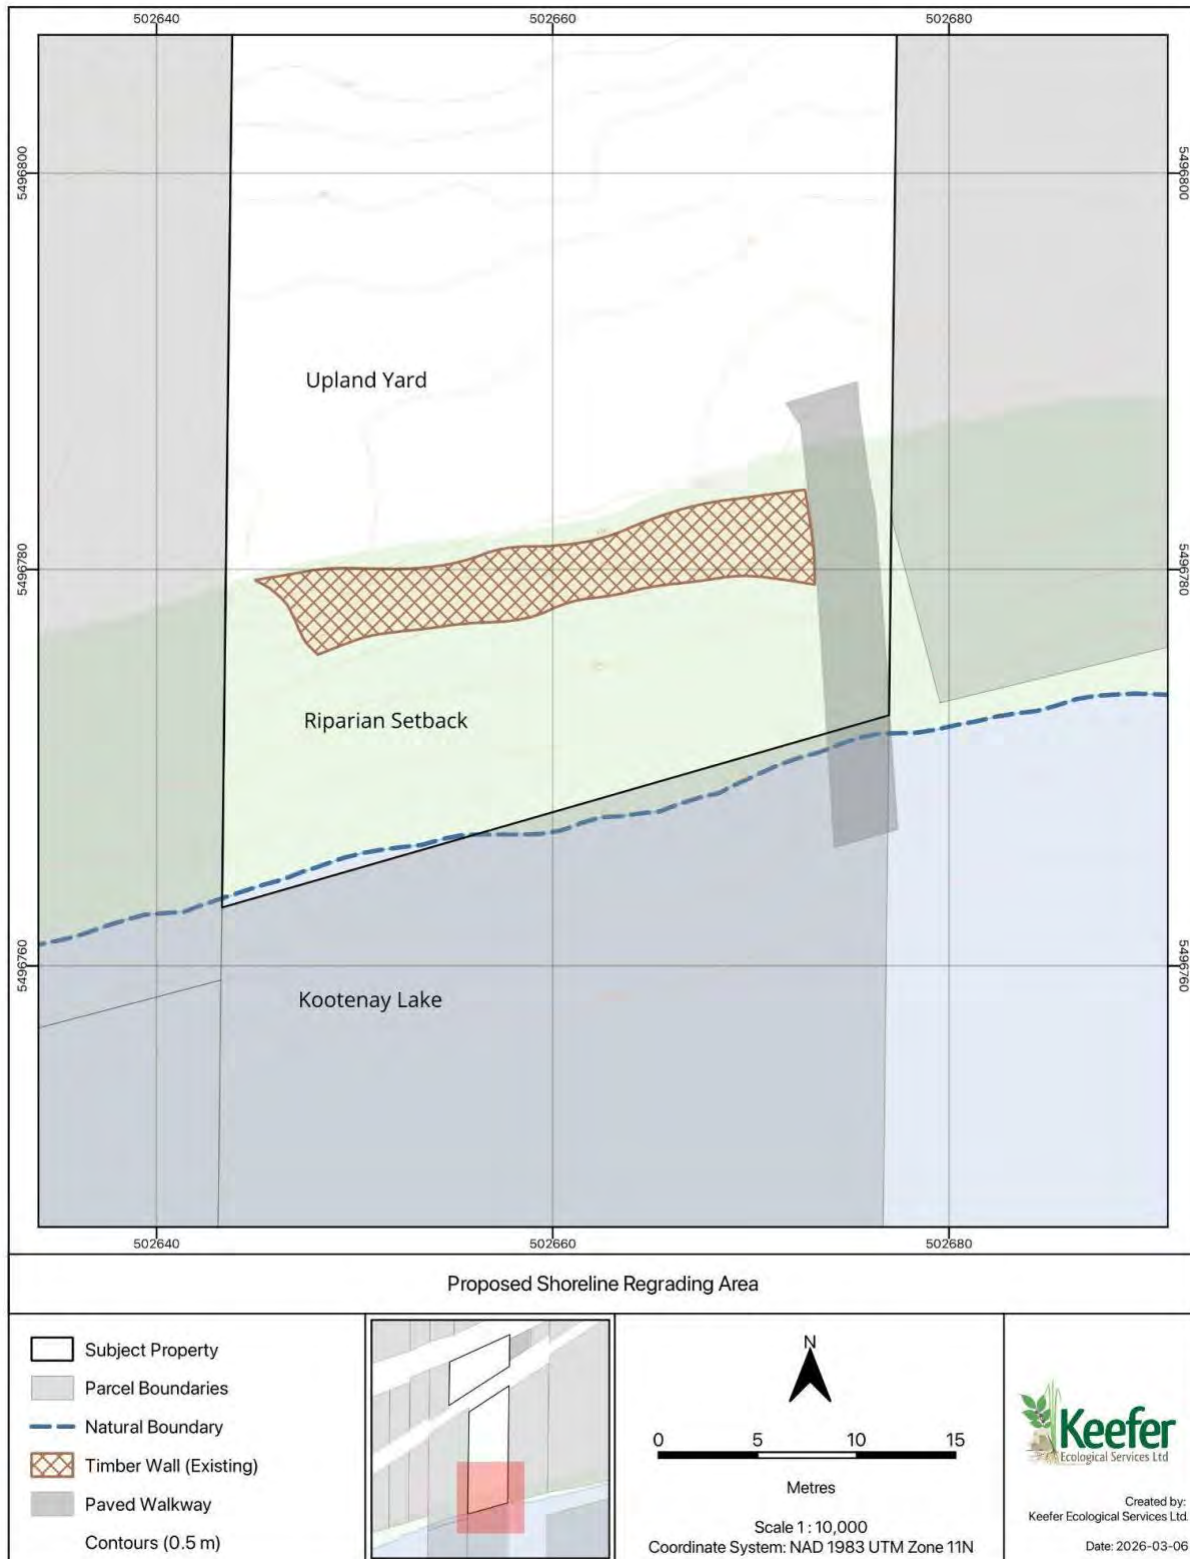
Figure 3. Site plan showing the existing retaining wall, interpreted natural boundary, 15 m setback, and the approximate area of proposed wall removal and shoreline grading.

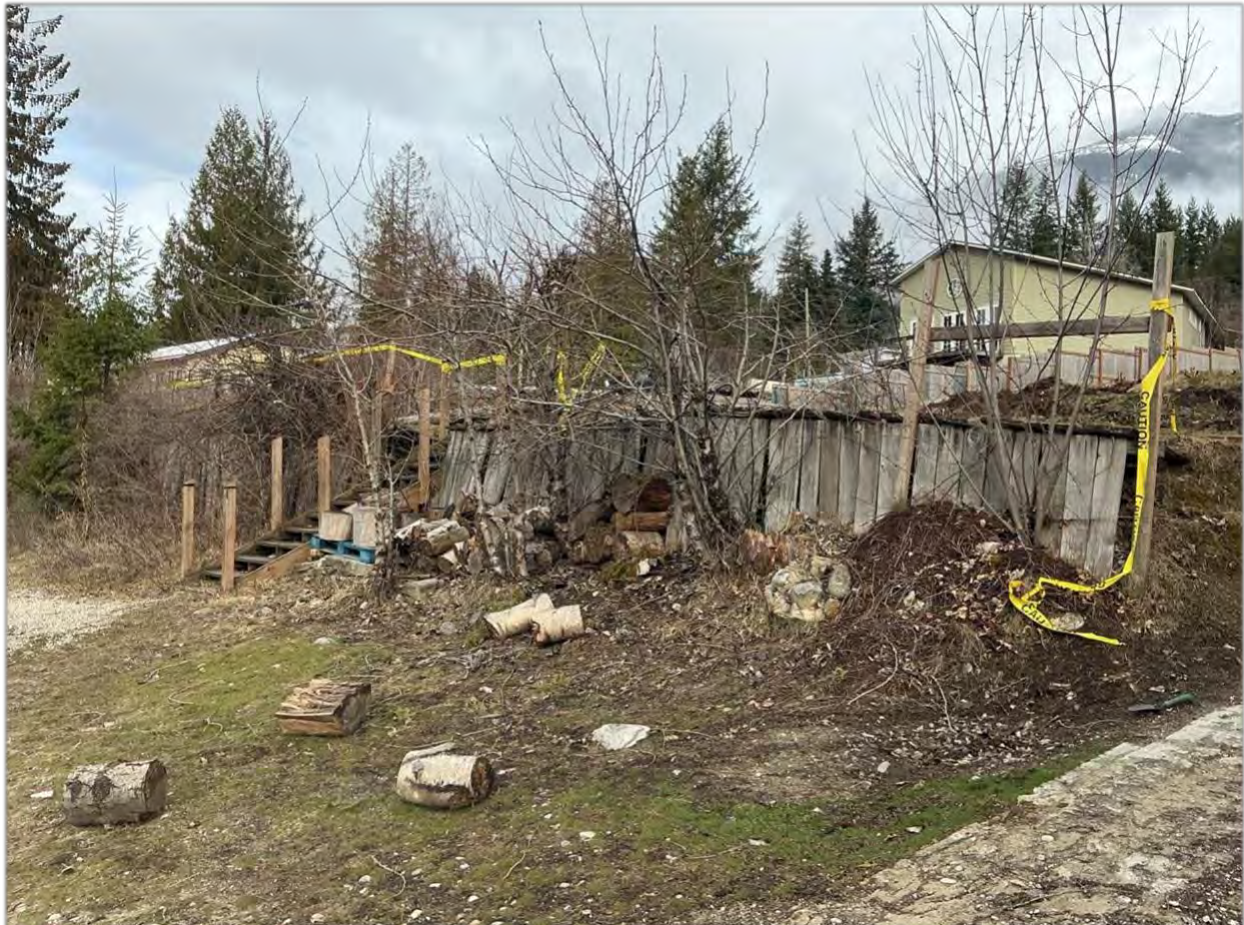
Photo 10. Native vegetation is localized along the base of the retaining wall.

Riparian vegetation within the immediate work area is sparse but includes several native tree, shrub, and herbaceous species occurring along the margins of the disturbed shoreline and near the base of the existing retaining wall. Observed species include black cottonwood, Douglas-fir, Norway maple (*Acer platanoides*), Saskatoon, red-osier dogwood, and horsetail (*Equisetum hyemale*). These plants occur in small patches where soil conditions and moisture allow for localized establishment. Portions of this vegetation occur within the footprint of the proposed grading area and may be removed during retaining wall construction and bank reshaping.

Several native plant species are currently present along the retaining wall, including red-osier dogwood, Saskatoon, horsetail, cottonwood, and a young Douglas-fir. Removal of the retaining wall and grading of the bank will likely require removal of some existing vegetation. Where possible, existing vegetation should be retained or salvaged during construction. Any vegetation removed during construction should be replaced through planting to maintain or improve existing riparian vegetation cover.

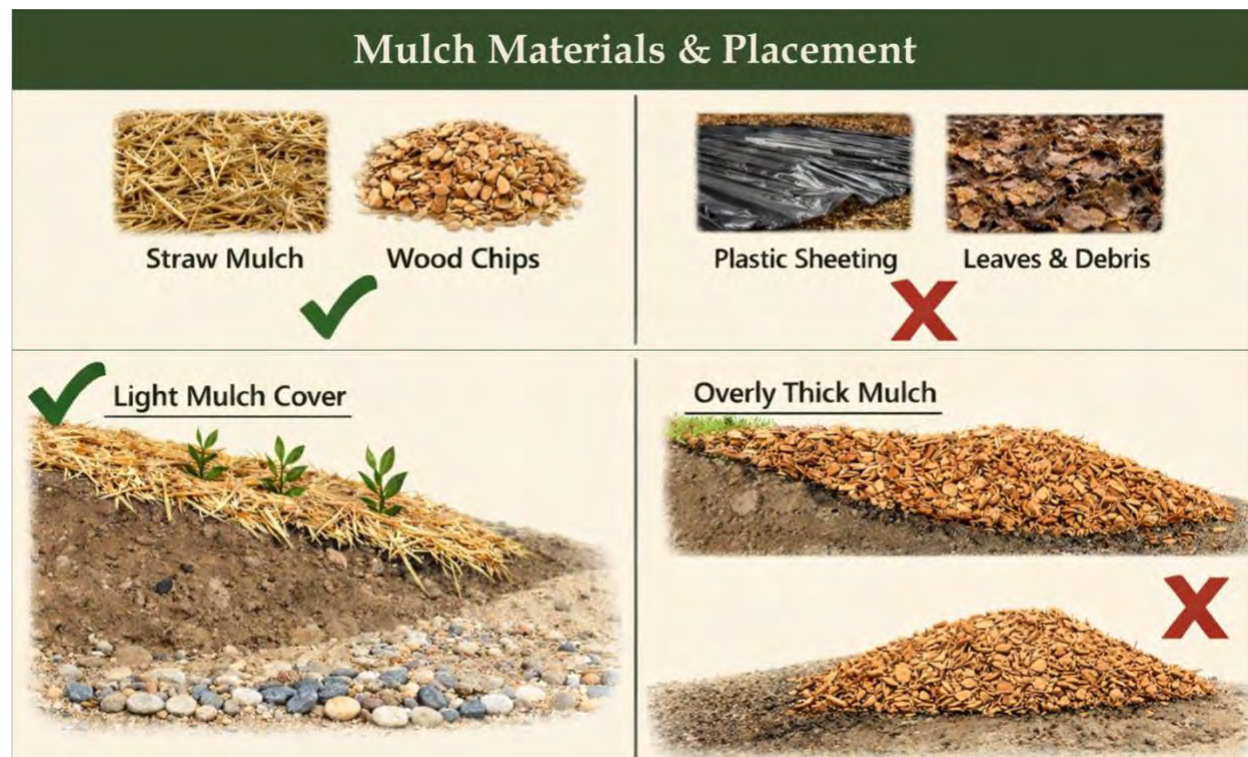
After seeding, the steeper portion of the regraded bank should be covered with a light layer of straw mulch or similar organic mulch. Mulch helps protect the soil surface, retain moisture, and reduce erosion while vegetation establishes. Mulch application should focus on the steep portion of the slope where erosion risk is greatest.

The lower beach area between the toe of the regraded bank and the water's edge will remain unchanged and does not require mulch or erosion control measures. Additional erosion control measures may be implemented if site conditions indicate the need for further stabilization during or after construction.
