# MINISTRY OF FORESTS, LANDS, NATURAL RESOURCE OPERATIONS AND RURAL DEVELOPMENT

## POST-WILDFIRE RISK ANALYSIS – RECONNAISSANCE REPORT

| <b>FIRE:</b> Octopus Creek (N51800) | | <b>FIRE YEAR:</b> 2021 | <b>DATE OF REPORT:</b> November 3, 2021 | |

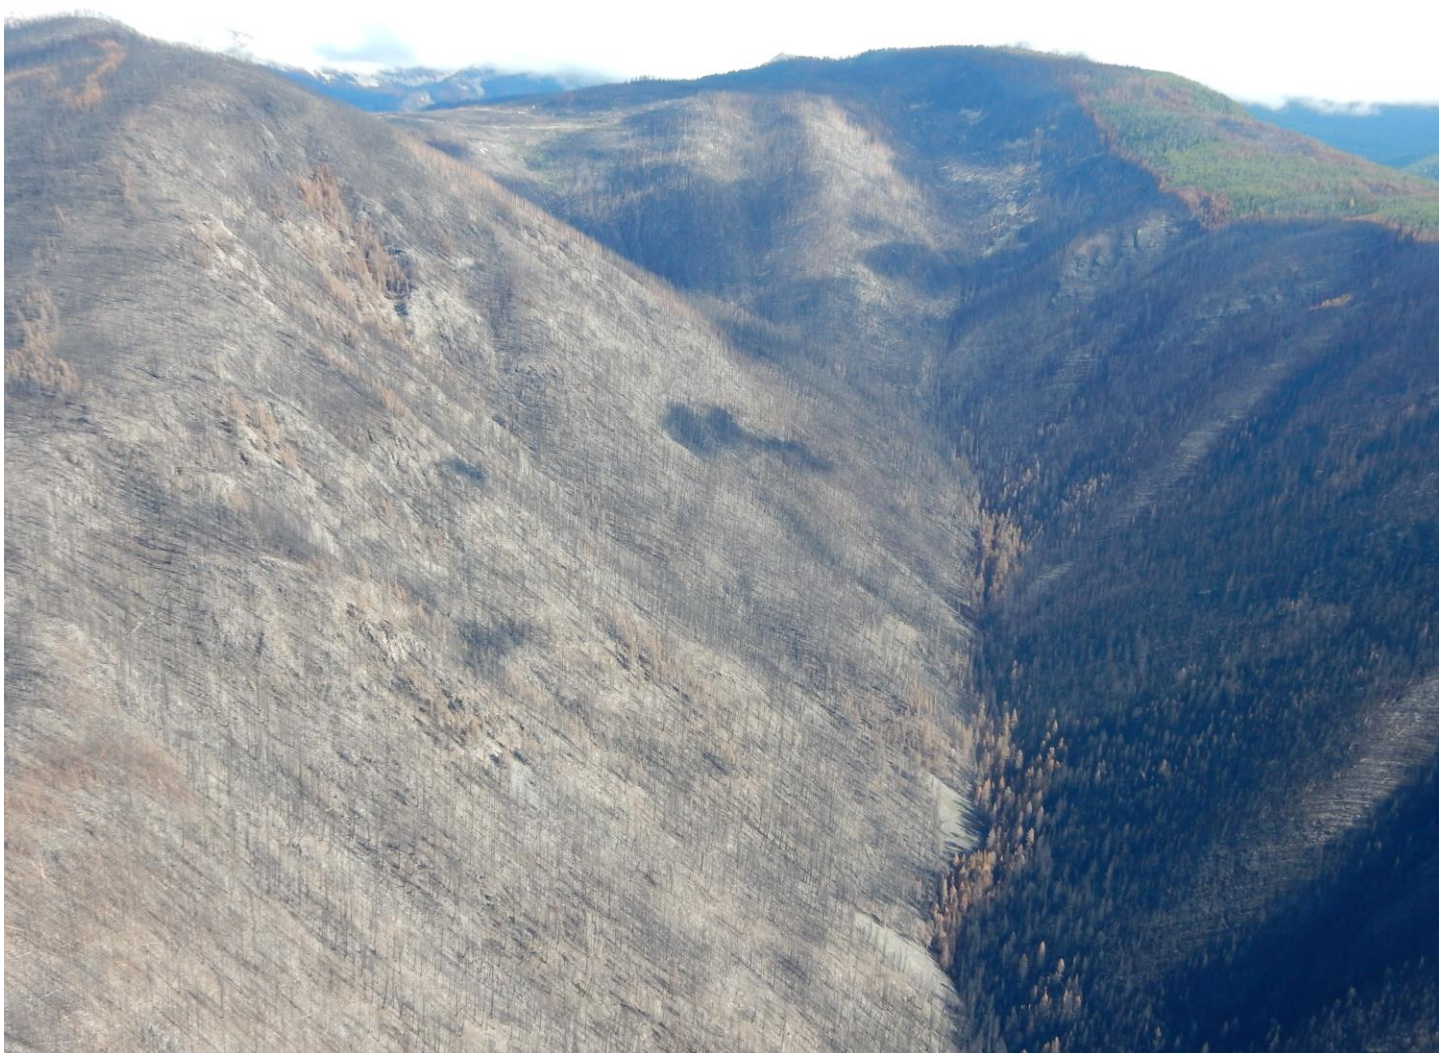
Watershed morphometrics suggest that Octopus, Gladstone, Hutchison and Van Houten Creeks are all potentially susceptible to debris floods, whereas Taite Creek is more likely to be susceptible to clearwater flooding. Because of the large proportion of high burn severity in the Gladstone and Van Houten watersheds, those creeks are considered to have a high debris flood hazard.

Photo 1. High burn severity in Van Houten Creek watershed.

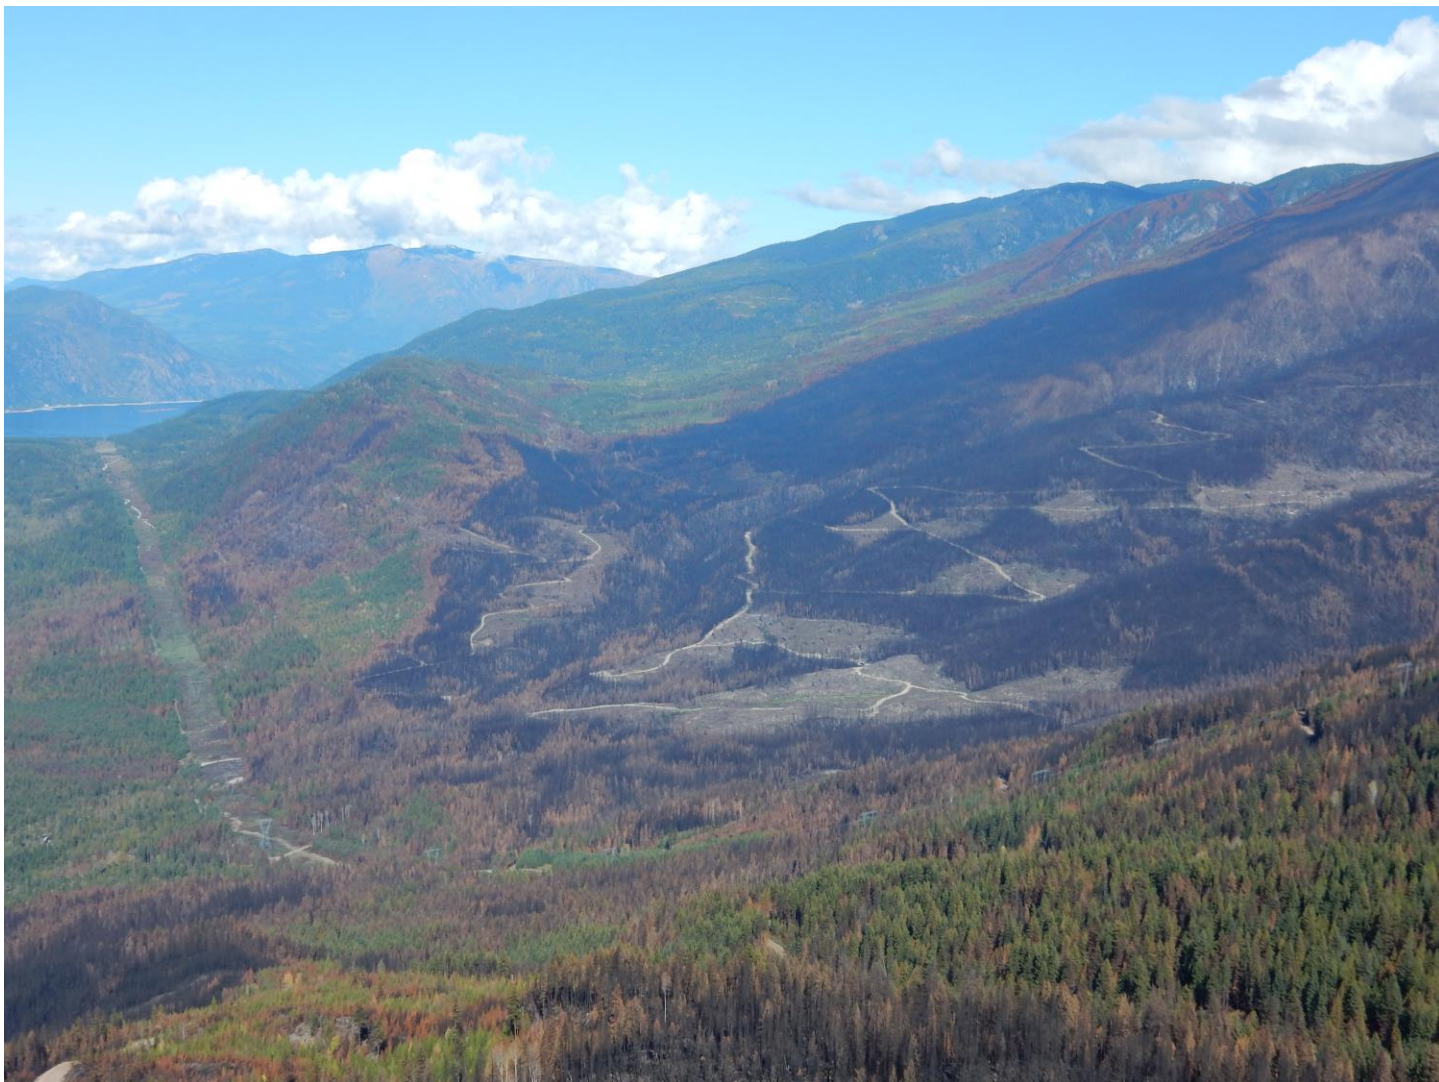
Photo 2. Lower slopes of Taite Creek watershed.

Applegrove Road is susceptible to flood damage where it crosses the Taite Creek and Octopus Creek fans. MFLNRORD should inspect and maintain the bridges regularly at these crossings. Domestic surface water users on creeks that fall within the fire perimeter may want to consider additional water quality treatment measures.

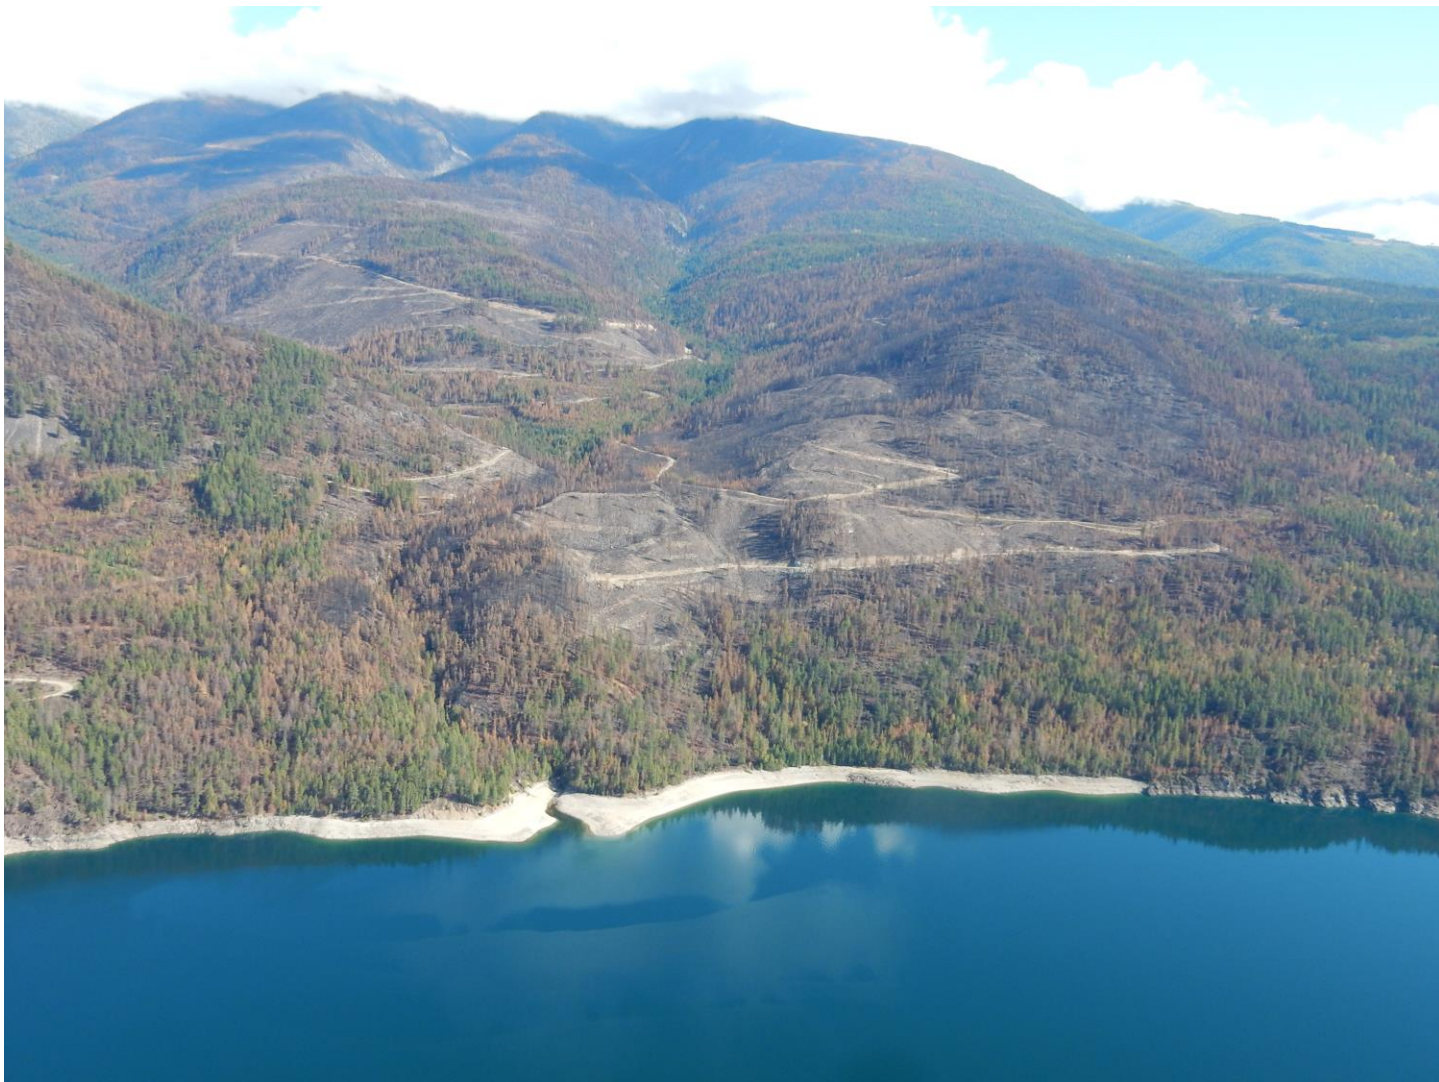
Photo 4. Gladstone Creek.
