**MINISTRY OF FORESTS: POST-WILDFIRE NATURAL HAZARD RISK ANALYSIS**  
**NEMO CREEK - LEVEL 2 RECONNAISSANCE REPORT**

| <b>FIRE NUMBER:</b> N51103 Nemo Creek and N51228 | <b>FIRE YEAR:</b> 2024 | <b>DATE OF REPORT:</b> December 19, 2024 | |
| <b>AUTHOR:</b> Sarah Crookshanks, P.Geo., Ministry of Forests | | | |

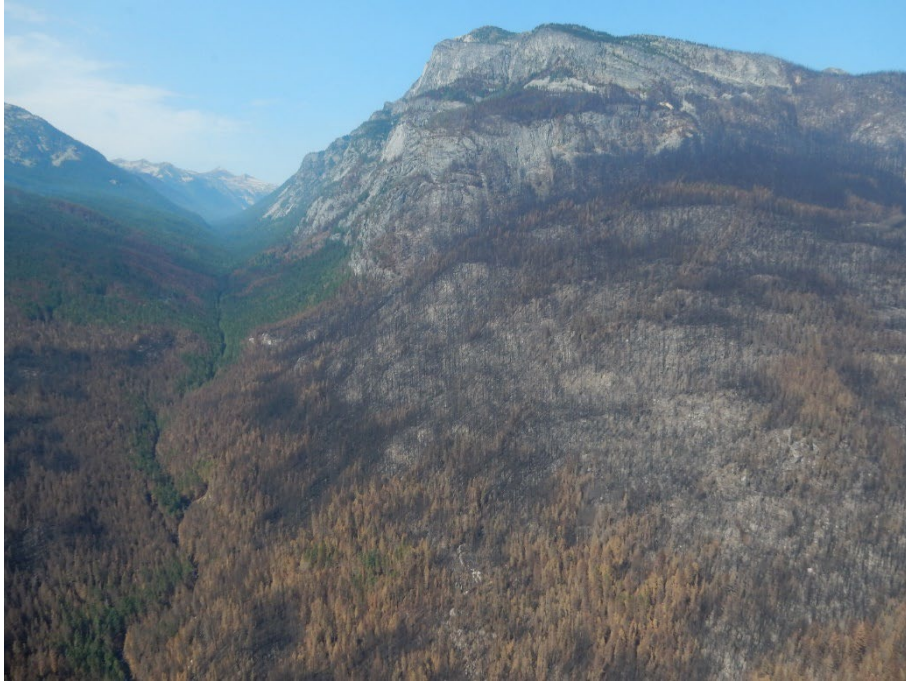
*Figure 2. Looking upstream at the Nemo Creek valley.*

Nemo Creek is a large (>7000 ha) flood-prone creek that drains alpine terrain up to 2600 m. The channel gradient of the mainstem of the creek range from 4-7% until dropping the final 3.5 km to lake level at a gradient of 14%. Only 10% of the watershed area was burned, though the burn is composed mostly of moderate and high burn severity (Figure 2). Given the low proportion of the watershed that was burned, the incremental increase in the likelihood of post wildfire clearwater flooding has been rated as low.

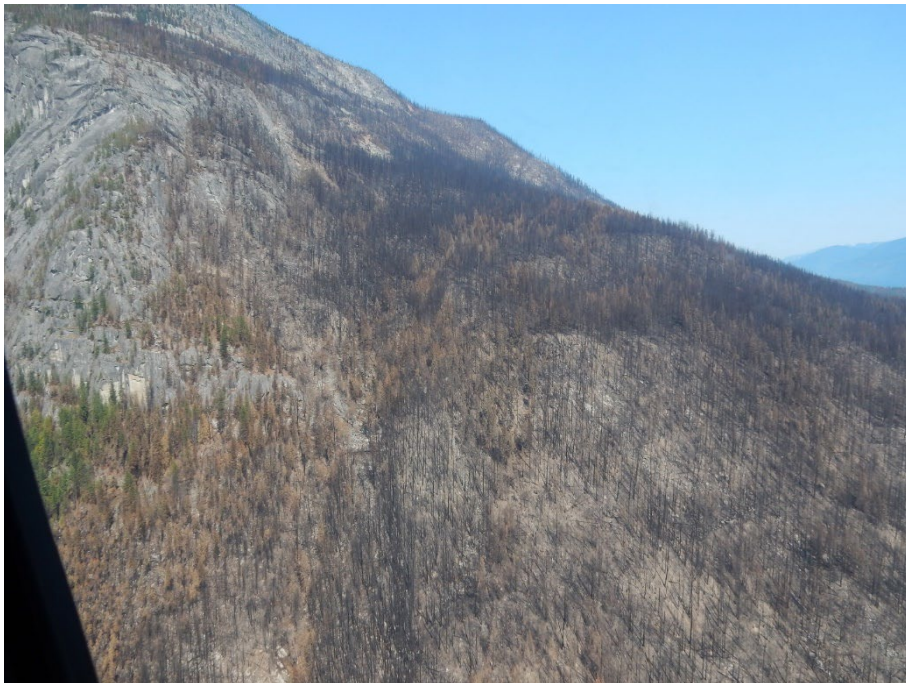
A tributary that could be susceptible to debris-flows drains from the north into Nemo Creek and was burned mostly at high to moderate severity (Figure 3). The distance between where the tributary enters the mainstem and Slocan Lake is 3.5 km. The headwaters of this tributary are composed of unburned bedrock cliffs. If a debris flow were initiated in this drainage, the most likely scenario would be that the flow would be diluted once it converges with Nemo Creek, transitioning to a debris flood. If Nemo Creek discharge was at flood stage near its annual maximum, the debris flow may be further diluted into a clearwater flood. The likelihood of a debris flow event in this tributary has been rated as moderate, because while over 70% of the watershed has been burned at moderate/high severity, the headwaters remain unburned. The likelihood that a debris flow this tributary will be transported as a debris flood down to the Nemo Creek fan has been rated as low; deposition along the mainstem channel is possible and the Nemo Creek drainage area is large enough to allow for significant dilution particularly during periods of high flow.

*Figure 3. Potentially debris-flow prone tributary to Nemo Creek.*

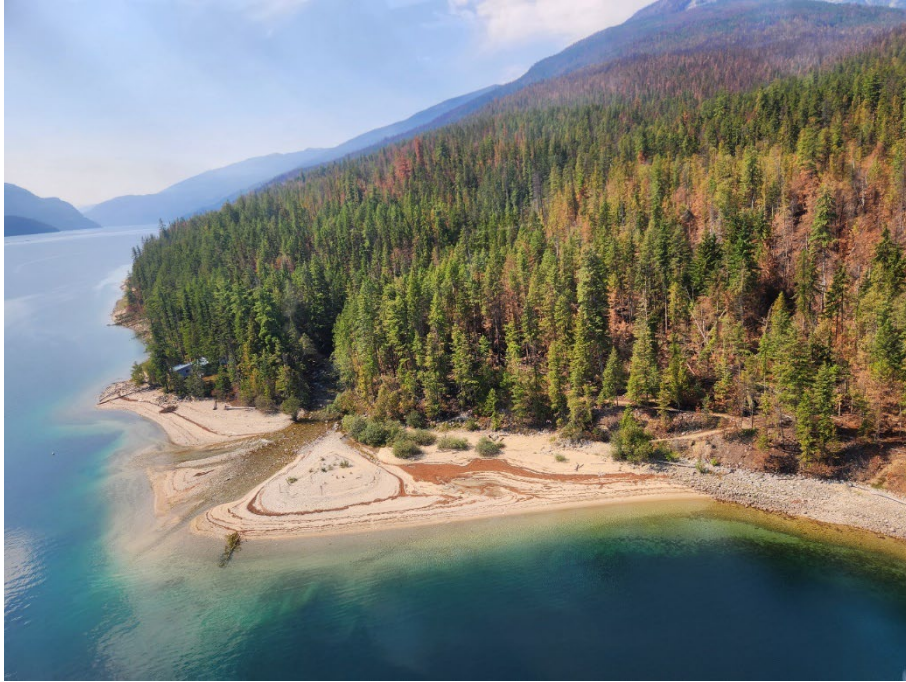
The campsites at Nemo Creek are located to the north of the channel and a cabin on private property is located on the fan to the south of the channel (Figure 4). The channel through the upper portion of the fan is incised, where the bank height to the north is 6.5 m and to the south is 2 m. Therefore, the probability of an event (flood or debris flood) impacting the cabin or the campsites has been rated as moderate and low, respectively.

*Figure 4. Nemo Creek fan (Photo: Ryan Williams, SNT Geotechnical)*

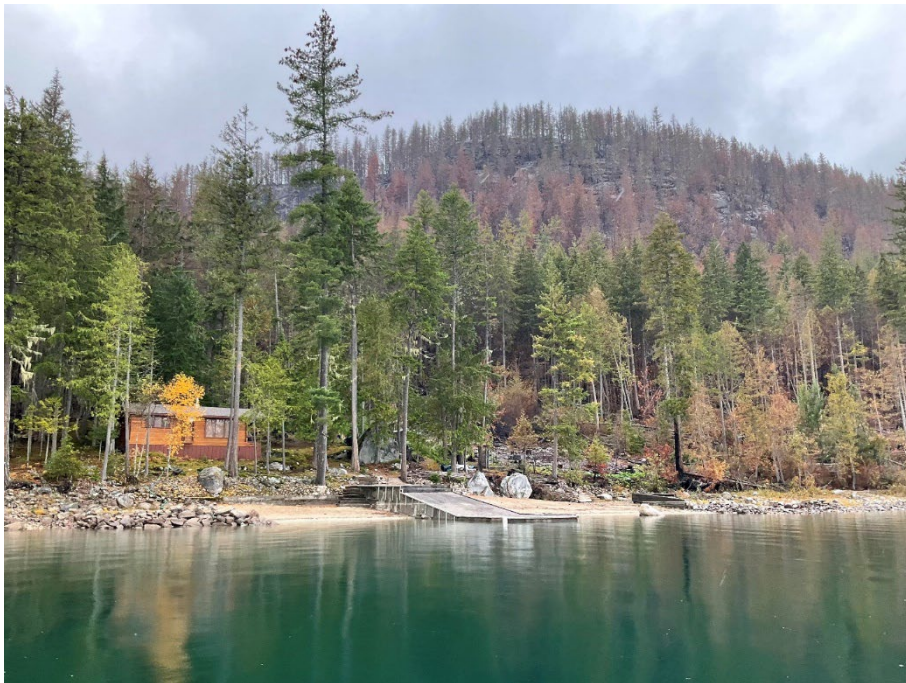
There are approximately eight seasonal cabins on private land that are located north of Hoben Creek and the Sandy Point campground. These cabins are located below a rock bluff area that was burned at moderate severity. Numerous rocks were observed on the land surrounding the two northernmost cabins (one of which was burned in the fire), which indicates that rockfall has historically impacted the area and likely presents an ongoing hazard (Figure 5). Due to private land access restrictions, it was not possible to assess if any recent rockfall has occurred during or since the fire and no detailed assessment of the spatial distribution of the rockfall was undertaken. Additional lots further to the south may also be at risk. Affected residents may wish to hire a technical specialist to undertake a more detailed assessment to better understand the natural hazards which may impact their properties.

The increase in rockfall hazard after wildfire is typically due to the removal of vegetation or fallen logs that were supporting loose rocks. Thermal expansion and exposure can also make rocks more susceptible to detachment and increase the likelihood of rockfall during and after rainfall or freeze-thaw. The highest frequency of rockfall is typically seen during or immediately after the fire, and declines in subsequent years.

*Figure 5. Private cabins below a rock bluff north of Hoben Creek.*
