**REGIONAL DISTRICT OF CENTRAL KOOTENAY**

## **AREA E ADVISORY PLANNING AND HERITAGE COMMISSION OPEN MEETING AGENDA**

##### 5.1 Development Permit Application (DP2605E) – Suki Stinson

## Unauthorized works in Kootenay Lake on Crown Land Foreshore - Riparian Assessment V1.0

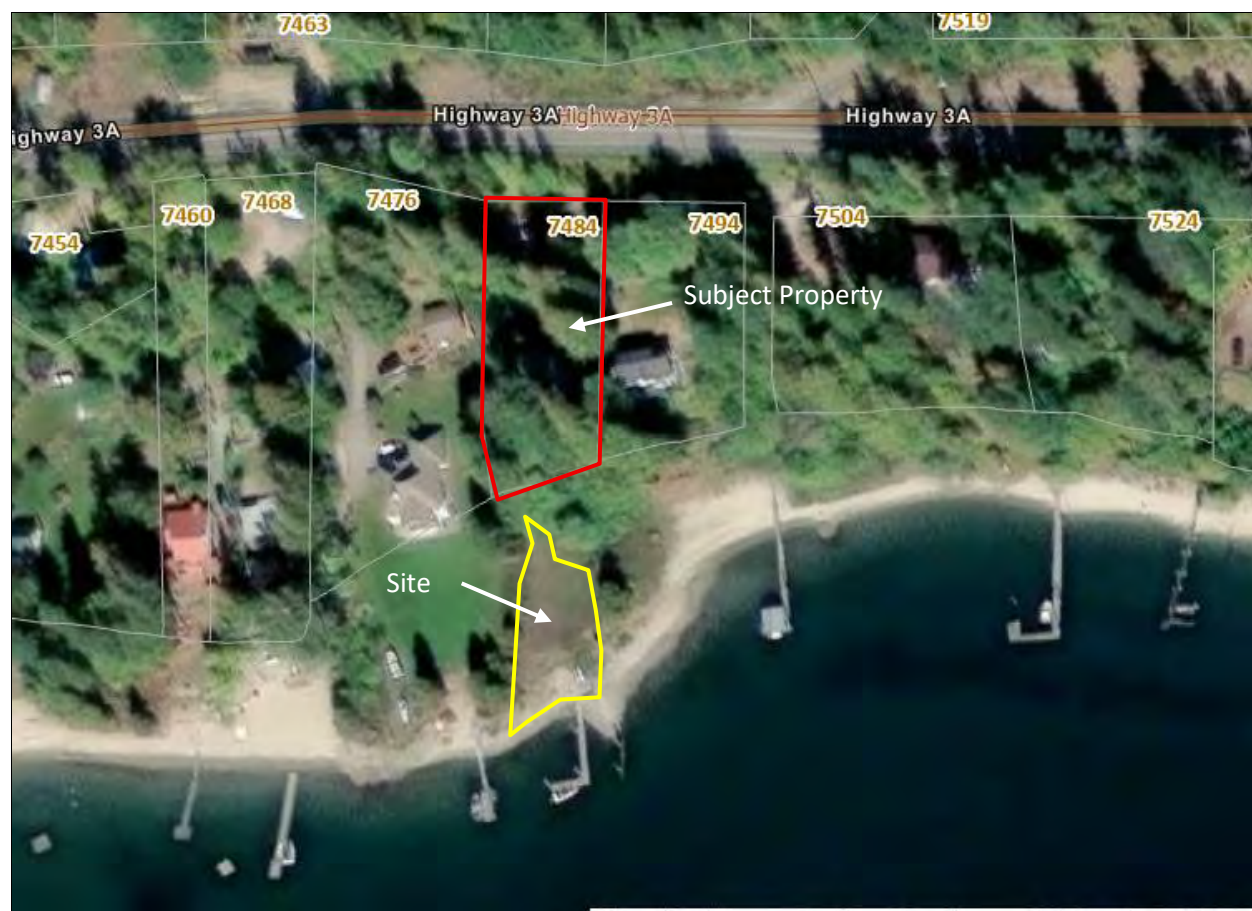
Figure 1. Location map of Subject Property (delineated in red) and approximate location and extent of the unauthorized works on Crown Land (delineated in yellow).

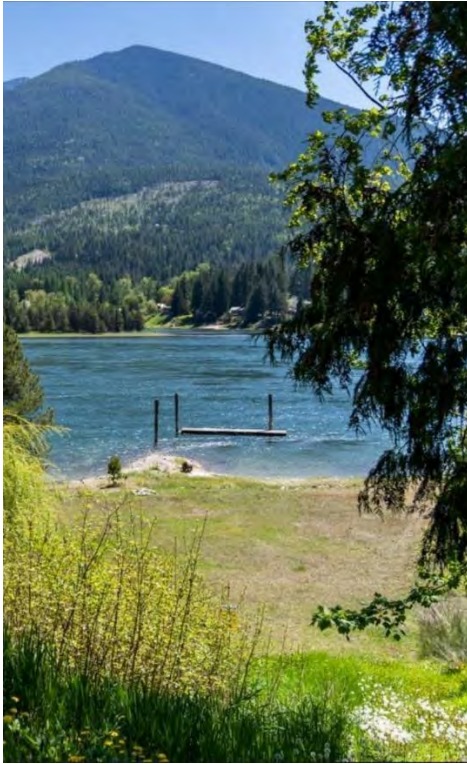
Photo 1. View of Site on Crown Land adjacent to Subject Property prior to unauthorized works. Note herbaceous cover present on foreshore. Photo provided by Allan Tite. May 2025.

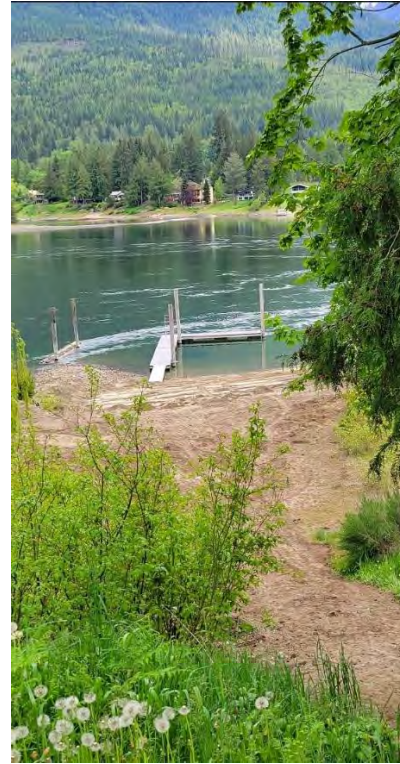
Photo 2. View of Site on Crown Land adjacent to Subject Property post unauthorized works. Photo provided by Alan Tite. May 2025.

The unauthorized works were conducted on the beach and lawn area resulting in the removal of herbaceous cover. The trees and shrubs that are located on either side of the property were not affected by the works (Photo 2, pers comm Allan Tite). Most of the area above the HWM was reseeded and irrigated, and had reestablished grass cover (Photo 13) at the time of the site visit on August 13, 2025, restoring the site similarly to previous conditions prior to the works being completed.

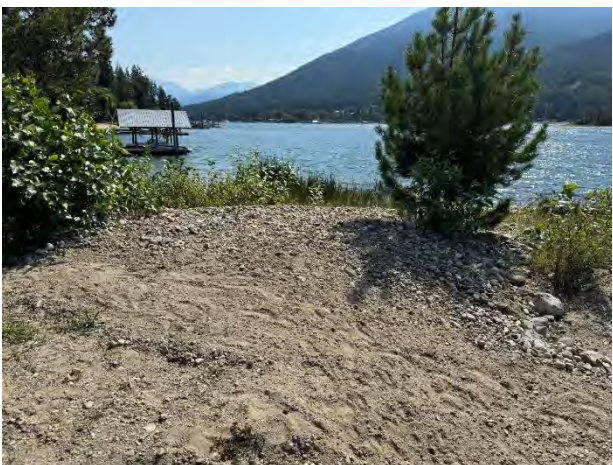
The unauthorized works consisted of beach cleaning, which resulted in the mechanical removal of the herbaceous cover (of unknown composition) and sorting of the substrate to create a more sandy beach (Photo 1 and Photo 2). A mixture of gravel and cobbles were removed from the foreshore and were mostly placed along and onto an existing groyne on Crown Land east of the property (Photo 3 to 5).

Photo 3. Mixture of cobbles and gravel placed at the upper end of existing east groyne. Aug. 13, 2025.

- To help restore aquatic habitat complexity along the shoreline, we recommend that the substrate which was removed and placed on the groynes (including gravels and cobbles) be respread along the area that was affected by the unauthorized works. This work can be completed by hand and should be done in the dry during the Kootenay Lake low water period between Feb 1-Apr 30. The owner has chosen to do the works by hand to reduce impacts from machinery access onto the foreshore. Any additional disturbance to soils within the foreshore and riparian area shall be avoided.
- Allow native vegetation to naturally regenerate on the beach area and foreshore. At this time, no additional planting is recommended. This natural method of restoration has been found to be effective for foreshore restoration, as long as plants are not pulled or cut.

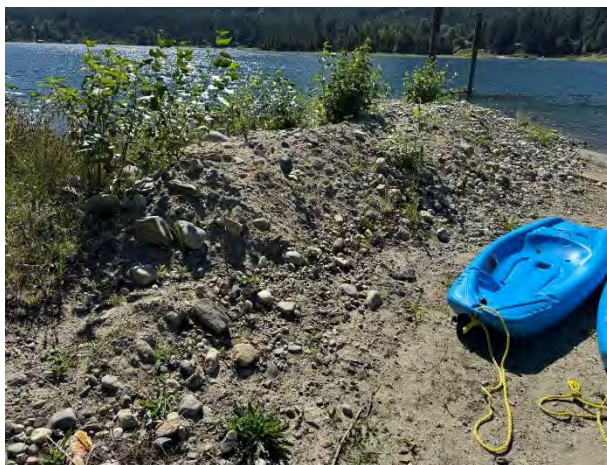
Photo 4. Mixture of cobbles, gravels and fines placed against existing east groyne. Aug. 13, 2025.

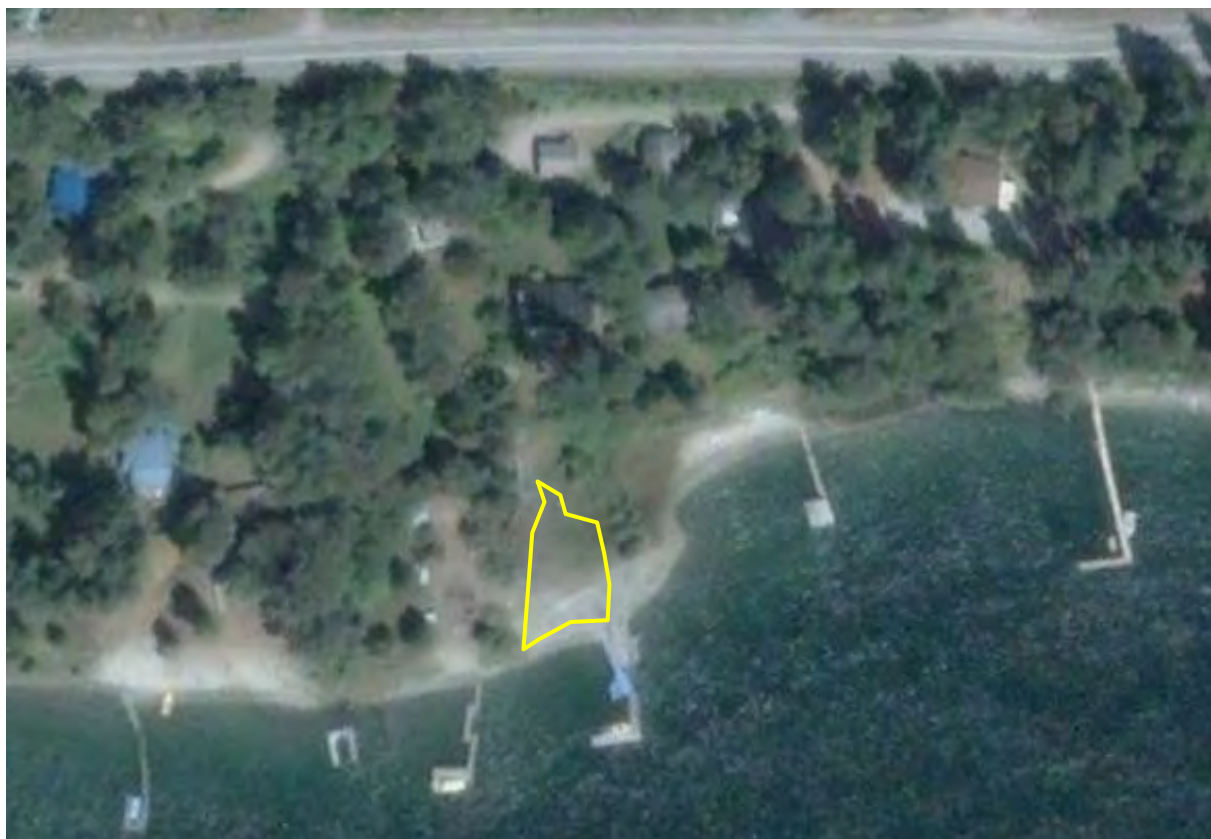
A review of historical photos prior to the purchase of the property by the current owners in 2023, indicates that a substantial portion of the property had previously been cleared at least as early as 2004 (Figure 2) and that the property remained in similar condition since then.

Figure 2. Area of disturbance depicted on aerial photo circa 2004 showing low herbaceous vegetation cover.

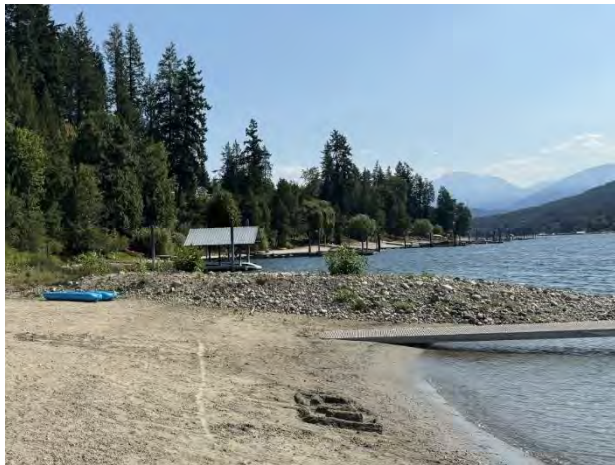
Photo 6. Existing groyne within Crown Land foreshore on the east side. Aug. 13, 2025.

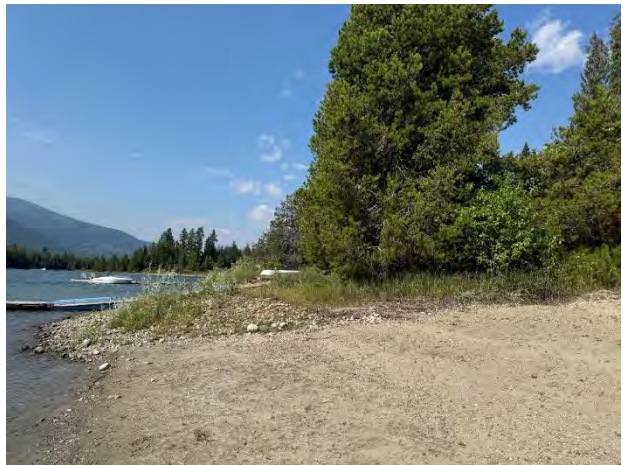
Photo 7. Existing groyne within Crown Land foreshore on the west side. Aug. 13, 2025.

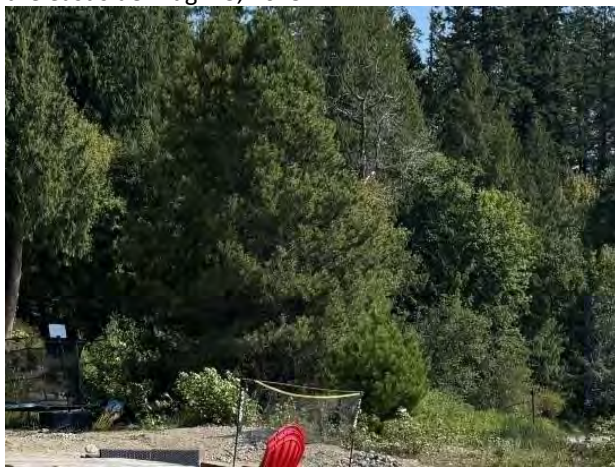
Photo 8. Riparian vegetation within Crown Land on east side. Aug. 13, 2025.

The riparian vegetation was limited to a narrow strip on either side of the area with a mix of young native trees, shrubs and herbaceous species. Tree cover consisted mostly of young lodgepole pine (Photo 8 and Photo 9). A few shrubs were present including red-osier dogwood (*Cornus sericea*) and cottonwood regen (*Populus trichocarpa*). The herb layer included scouring rush (*Equisetum hyemale*), vetch (*Vicia sp*), and grasses. Sparse herbaceous vegetation was present below the high water mark along the groynes and included western willow aster (*Symphyotrichum lanceolatum*), brown-eyed susan (*Gaillardia arisfata*), selfheal (*Prunella vulgaris*), pasture sage (*Artemisia frigida*), lodgepole pine regen, cottonwood regen, narrowleaf willow (*Salix exigua*) and grasses (Photo 10 and Photo 11). One individual curly dock (*Rumex crispus*) was observed in this area and is considered an invasive species (Central Kootenay Invasive Species Society (CKISS)).

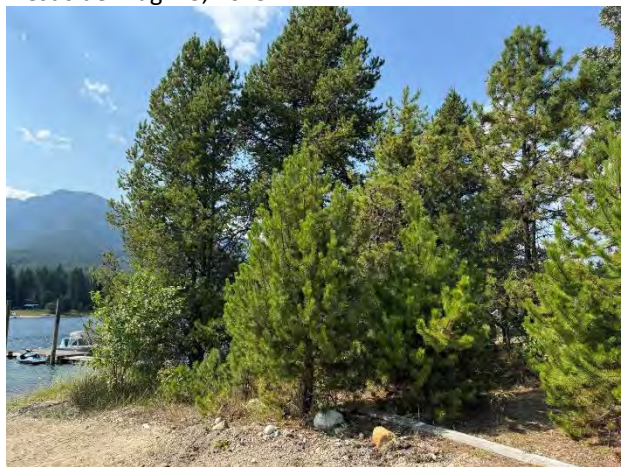
Photo 9. Riparian vegetation within Crown Land on west side. Aug. 13, 2025

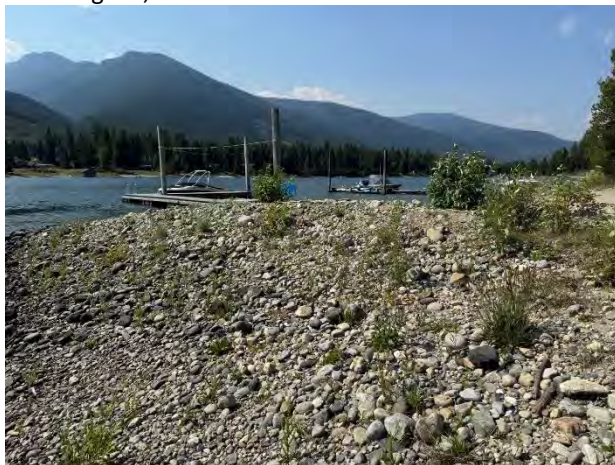
Photo 10. Sparse vegetation along eastern groyne. Aug. 13, 2025.

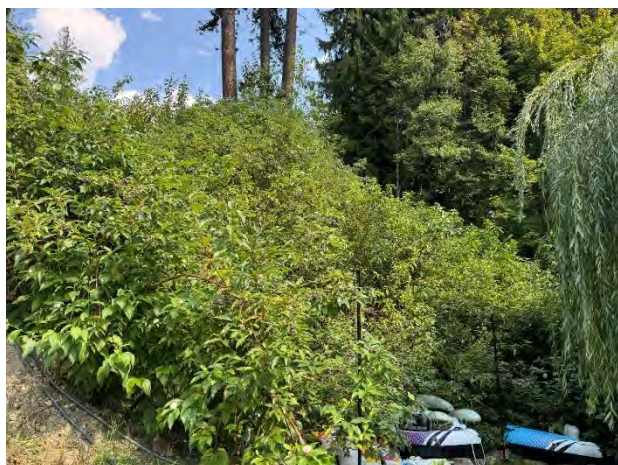
Photo 12. Dense shrub cover on steep slope. Aug. 13, 2025.

Dense shrub cover is present on the steep slope (above the disturbed area and outside of the WDP area) consisting mainly of red-osier dogwood and elderberry (*Sambucus caerulea*; Photo 12). A weeping willow (*Salix babylonica*) is featured at the base of the slope (Photo 13). Of note, a patch of scotch broom was observed on the west side of the pathway at the base of the slope and is considered a Priority invasive species (CKISS; Photo 13). A portion of the Crown Land impacted by the unauthorized works was reestablished with grass cover (Photo 13).

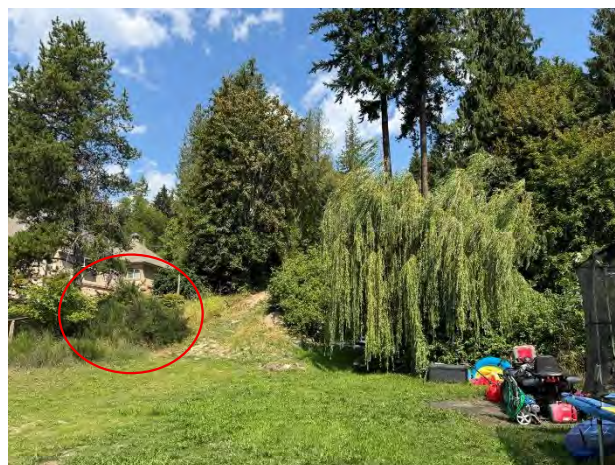
Photo 13. View of steep bank and path towards the house with weeping willow at base of slope. Aug. 13, 2025. Note patch of scotch broom on the west side of property and grass/herbs reestablished in foreground.

Central Kootenay Invasive Species Society (CKISS) manages invasive species using a prioritized approach. The management strategy for a specific species is based on a number of factors including the phase of invasion and the potential impacts of the species (CKISS 2023). Priority species lists can be found at <https://ckiss.ca/species/invasive-plant-priority-lists/>. It is recommended that species identified for Prevention (1), Eradication (2) and Containment (3) as per the Priority List developed by CKISS be managed accordingly. Based on the CKISS 2025 Priority List, curly dock and scotch broom are identified as priority invasive species. Even though outside of the disturbance area, we recommend that the patch of scotch broom at the base of the slope be removed.

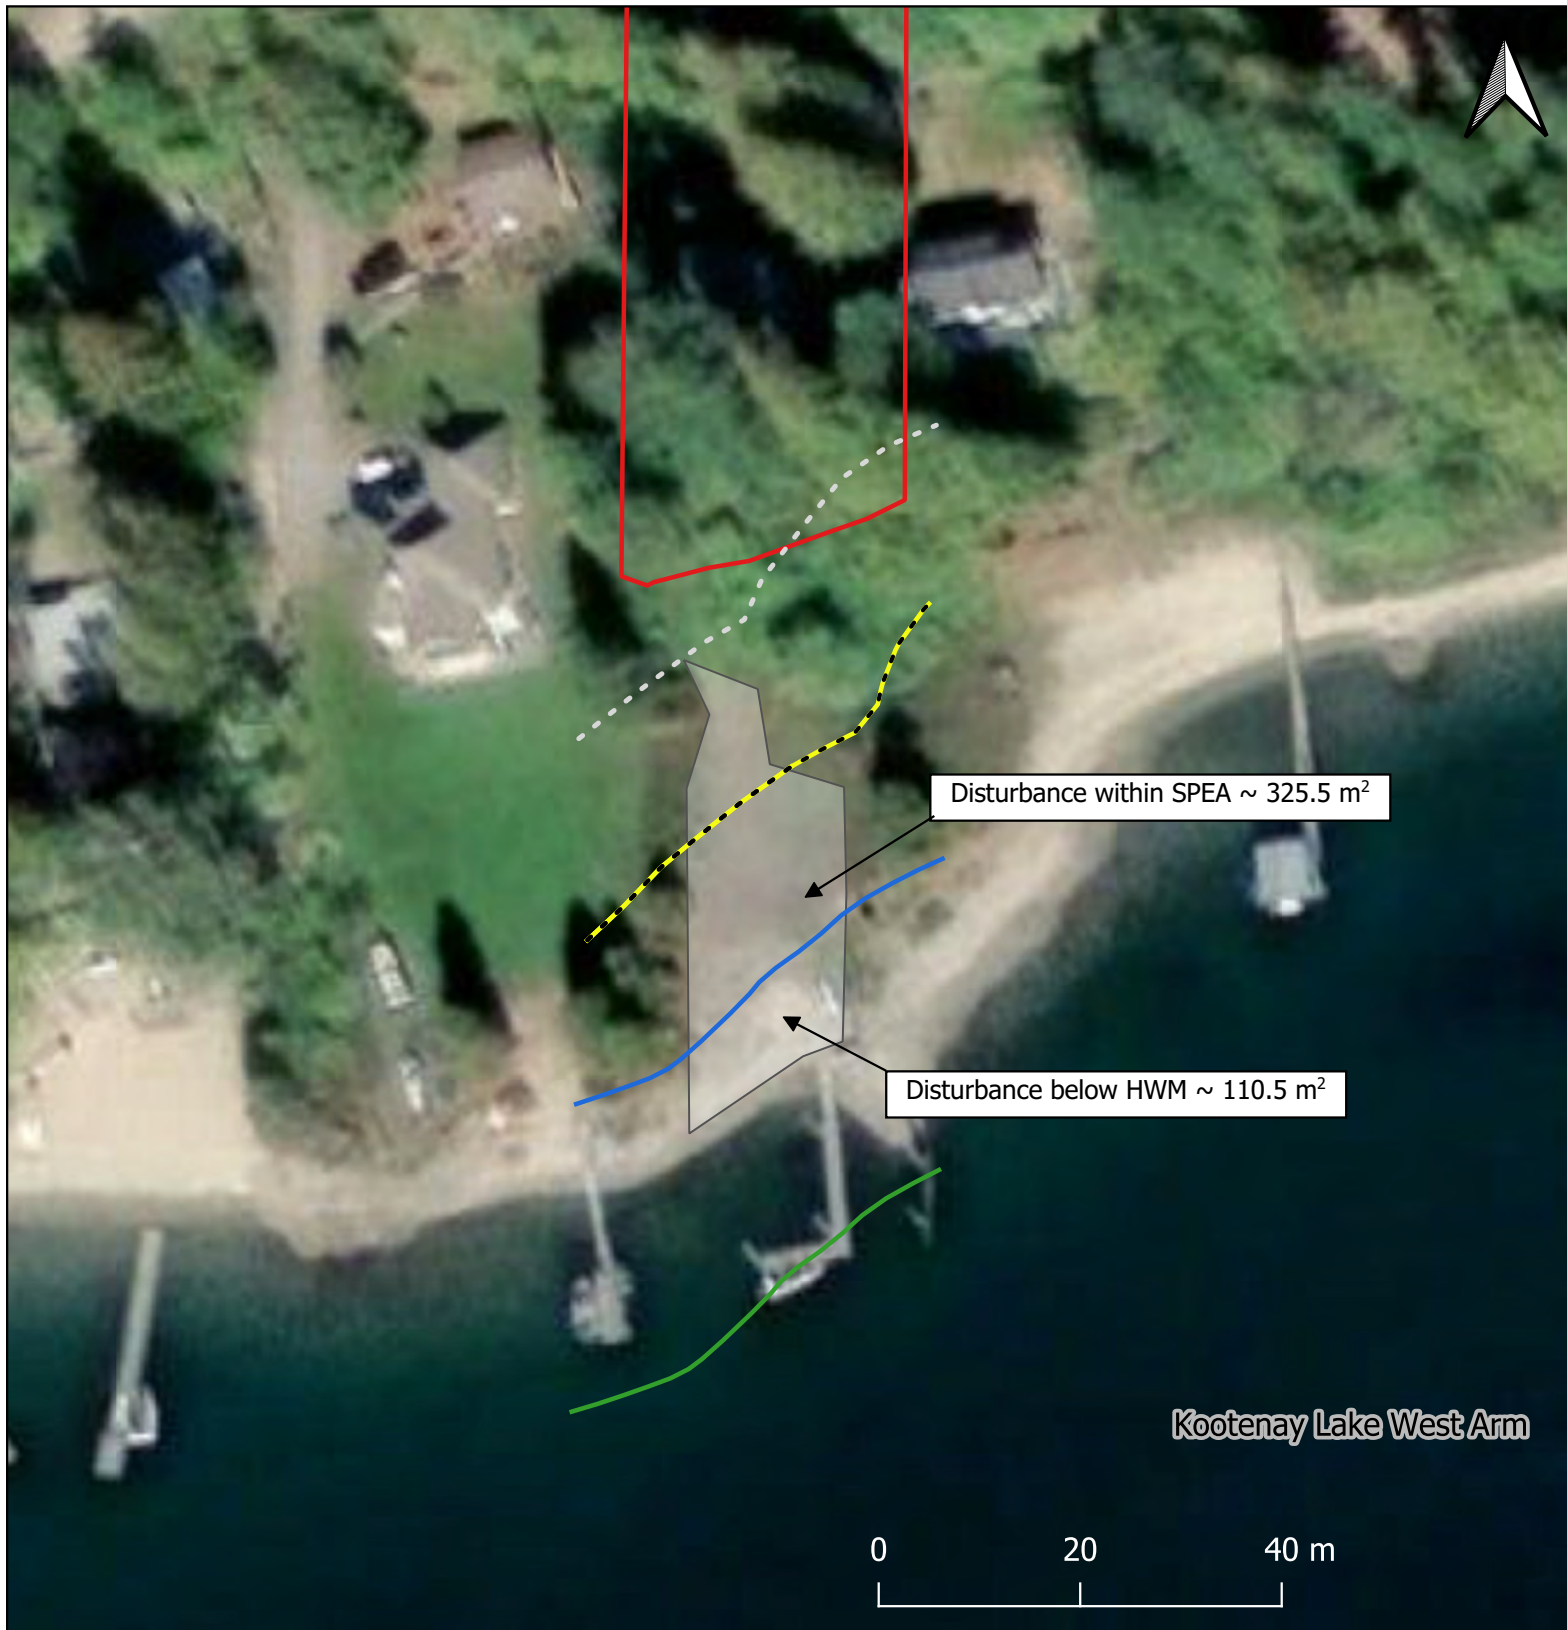
**APPENDIX 1. STREAMSIDE PROTECTION AND ENHANCEMENT AREA (SPEA) MAP**

### 7484 Hwy 3A Waterfront Development Permit Assessment Area

portion of the impacted area was flooded prior to our site visit. This led to the resorting and compaction of shoreline substrate after the unauthorized works and concomitant loosening of the substrate. The total area of disturbance was estimated at 535 m<sup>2</sup>, with ~110.5 m<sup>2</sup> below the HWM and ~325 m<sup>2</sup> above the HWM within the SPEA (Appendix 1).

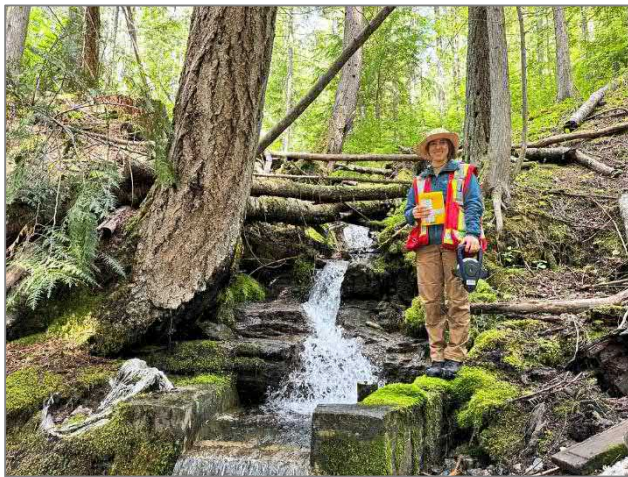
- 9101 Fisher Avenue- A water intake structure was observed within Ross Creek (Photo 1).
- 9201 Fisher Avenue - Pumphouse structure located along the south side of Ross Creek on the north side of the Fortis RoW (Photo 2)
- 2237 Hamilton Drive – Existing old fence along top of bank of Alymer Creek on the south side of the creek.
- 2271 Hamilton Drive – No existing development observed within the study area of Madden Creek.
- 2295 Hamilton Drive - No existing development observed within the study area of Madden Creek.

Photo 1. Water intake structure within 9201 Fisher Avenue on Ross Creek (June 2, 2026).

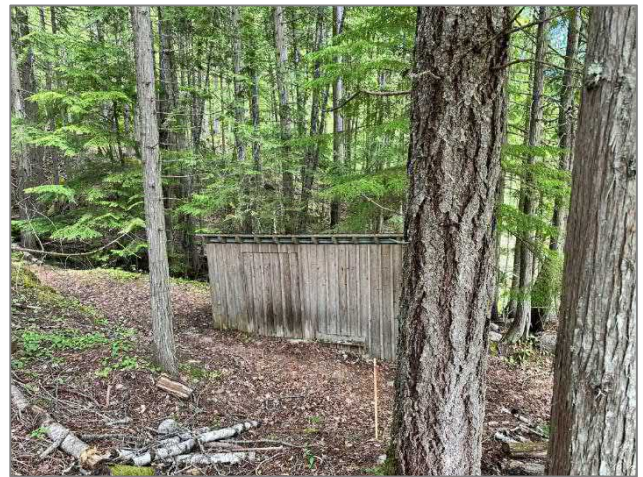
Photo 2. Existing pumphouse within 9201 Fisher Avenue south of Ross Creek (June 2, 2026).

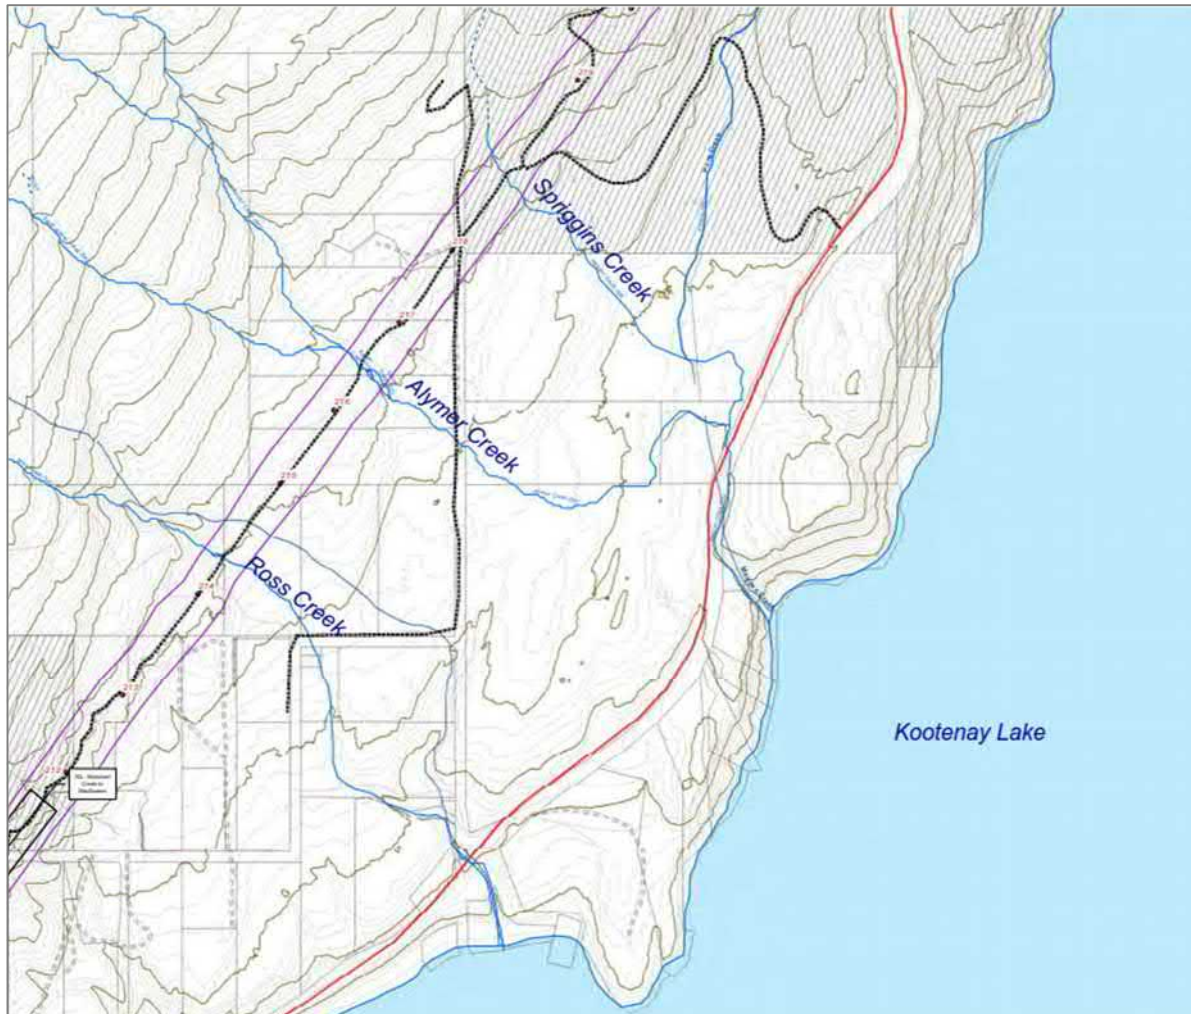
The project area has three aquatic features including Ross Creek, Alymer Creek and Spriggins Creek (Figure 2).

Figure 2. Watercourse Map.

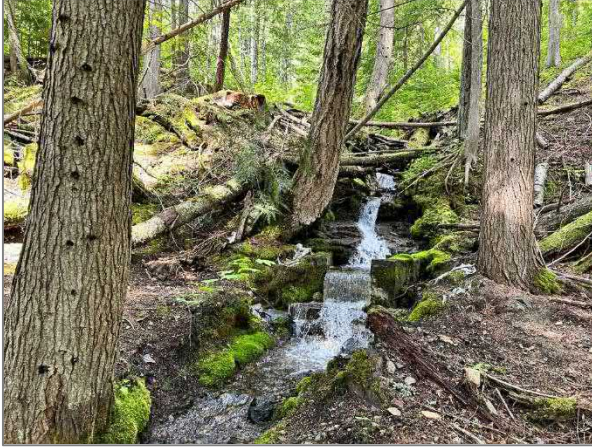
Photo 3. Ross Creek looking upstream (June 2, 2026).

Ross Creek is 2.7 km long and flows in a southeast direction into Kootenay Lake. It has a watershed area of ~1.3 km<sup>2</sup> upstream of the project site based on Fortis BC lidar and stream map. The reach of Ross Creek that runs through the property is well defined, with an average channel width of 1.6 m, an average bed depth of 0.25 m, and an average gradient of ~14%. The creek is characterized by cascade pool morphology with dominant gravel and sand substrate with some cobble (Photo 3 and Photo 4). The creek is perennial (flows >6 months per year) and has no recorded fish (Habitat Wizard 2026).

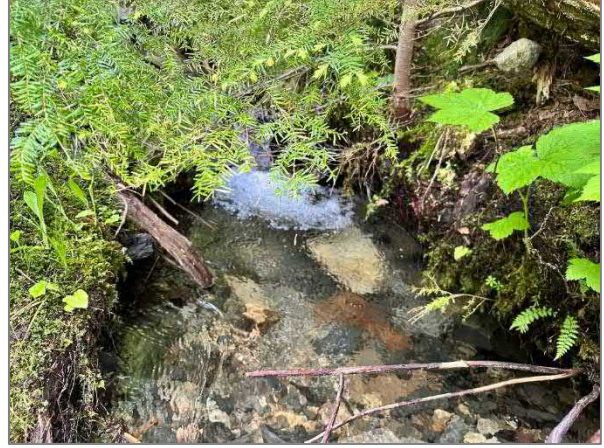
Photo 4. Ross Creek - well defined channel with gravel and cobble substrate (June 2, 2026).

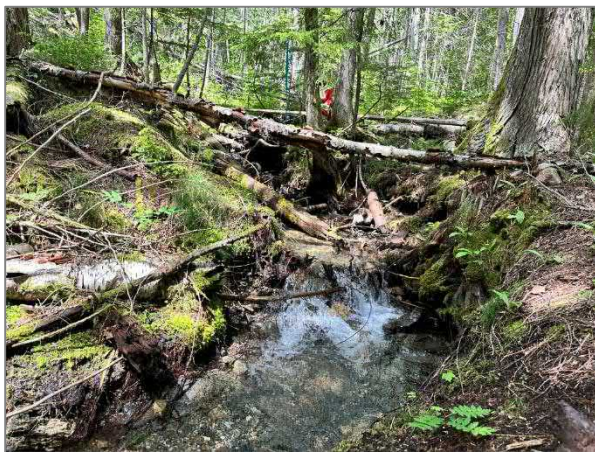
Photo 5. Alymer Creek looking upstream (June 2, 2026).

Alymer Creek is 4 km long and flows in a southeast direction into Kootenay Lake. It has a watershed area of ~2.5 km<sup>2</sup> upstream of the project site based on Fortis BC lidar and stream map. The reach of Alymer Creek that runs through the property is well defined, with an average channel width of 3.3 m, an average bed depth of 0.35 m, and an average gradient of ~10 %. The creek is characterized by cascade pool morphology with dominant gravel and sand substrate with some cobble (Photo 4 and Photo 5). The creek is perennial (flows >6 months per year) and has no recorded fish (Habitat Wizard 2026).

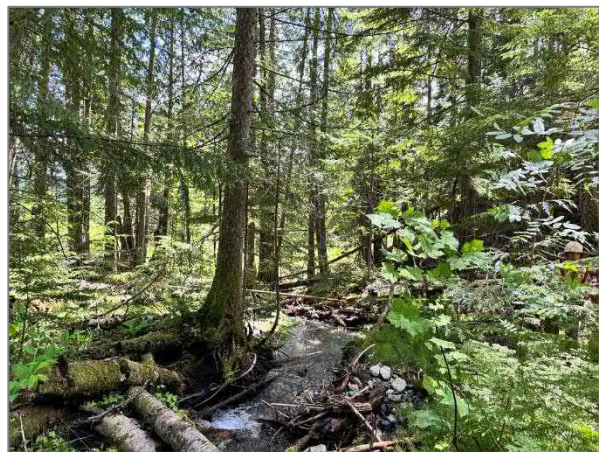
Photo 6. Alymer Creek looking downstream (June 2, 2026).

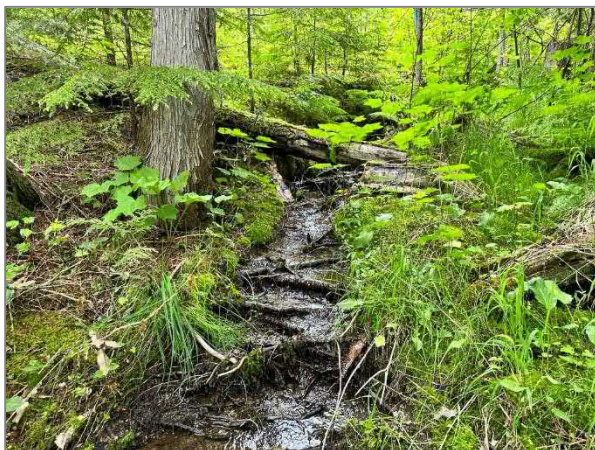
Photo 7. Spriggins Creek looking upstream (June 2, 2026).

Spriggins Creek is 2.2 km long and flows in a southeast direction merges with Madden Creek and then flows into Kootenay Lake. It has a watershed area of  $\sim 0.4 \text{ km}^2$  upstream of the project site based on Fortis BC lidar and stream map. The reach of Spriggins Creek that runs through the site is somewhat defined, with an average channel width of 0.6 m, an average bed depth of 0.08 m, and an average gradient of  $\sim 15\%$ . The creek is characterized by cascade pool morphology with dominant gravel and sand substrate with some cobble (Photo 7 and Photo 8). The creek had low flows in early June during the site visit and has no recorded fish (Habitat Wizard 2026). Due to the size of the stream, low flows during the site visit in June and low bed depth, it is presumed that the creek does not flow  $>$  six months a year, however this could not be confirmed as only one site visit was conducted.

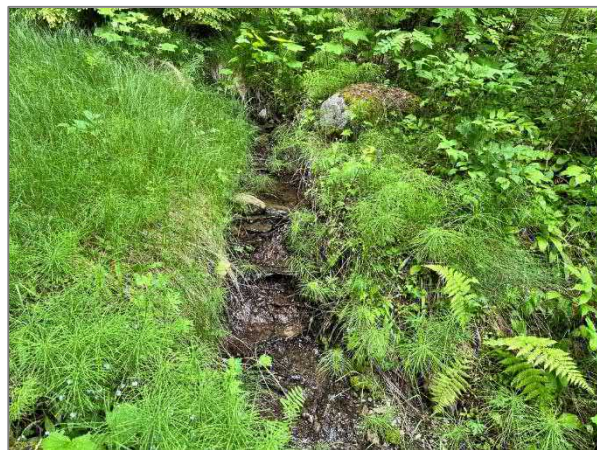
Photo 8. Spriggins Creek looking upstream (June 2, 2026).

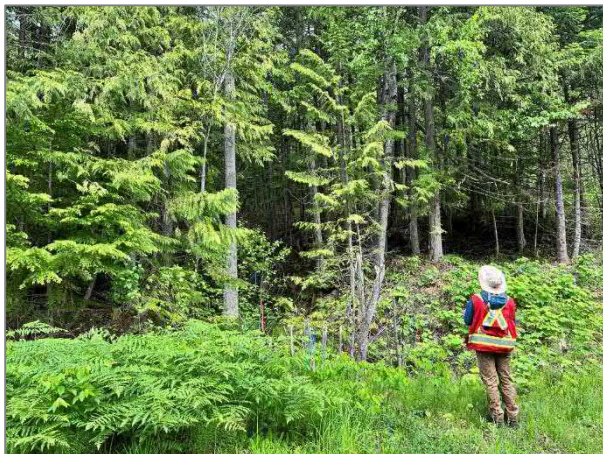
Photo 9. View of typical riparian vegetation along Ross Creek from RoW (June 2, 2026).

The riparian vegetation along all three creeks is relatively consistent. These areas are largely undeveloped, with evidence of historical logging. The riparian zone is characterized by a young mixed forest with scattered mature trees throughout (Photo 9 and Photo 10).

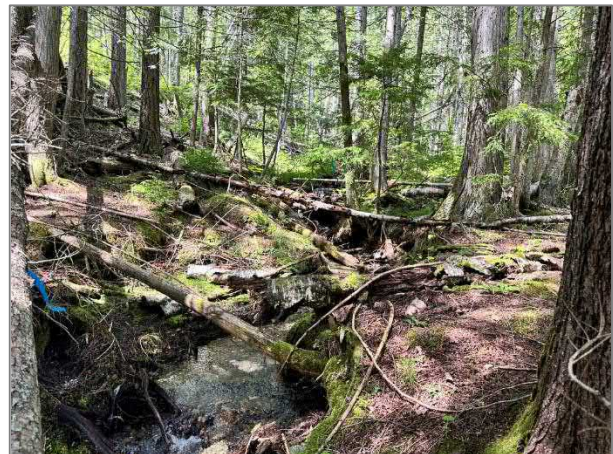
Photo 10. Riparian vegetation along Alymer Creek (June 2, 2026).

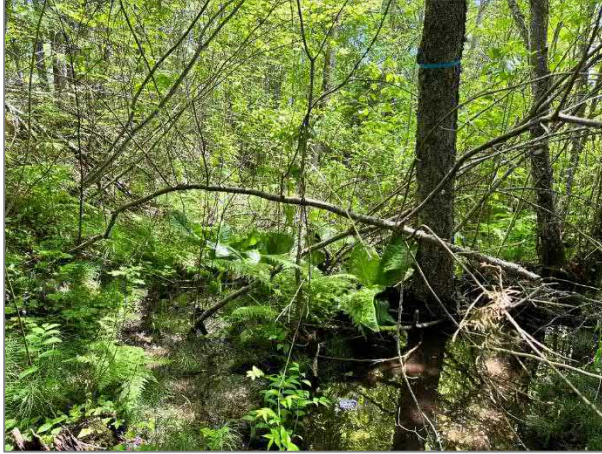
Photo 11. Horsetail and skunk cabbage along Ross Creek (June 2, 2026).

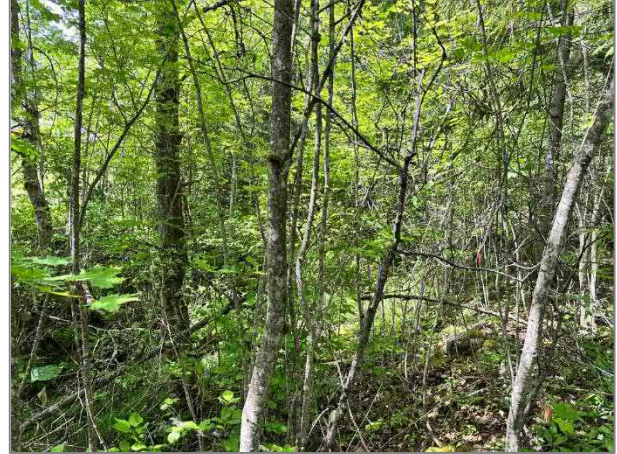
Photo 12. Mature maple stand along Ross Creek lower area (June 2, 2026).
