Regional District of Central Kootenay (RDCK)

Johnsons Landing Landslide Hazard and Risk Assessment

May 16th 2013

Doug Nicol¹, P.Eng., Peter Jordan², P.Geo., Dwain Boyer², P.Eng., Daryn Yonin³, P.Eng.

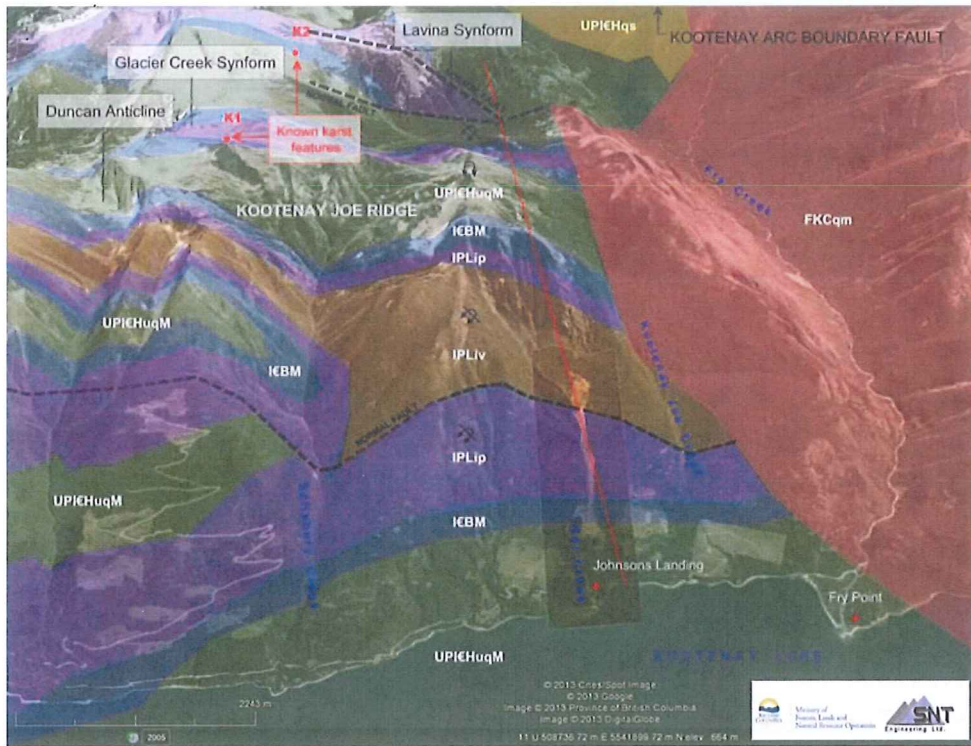
Figure 8: Bedrock geology overlay and known karst features (same legend as next Figure)

Figure 8 and Figure 9 illustrate the bedrock geology and representative cross section through the Gar Creek drainage. The location of known karst features are shown on Figure 8 and are discussed in Section 5.

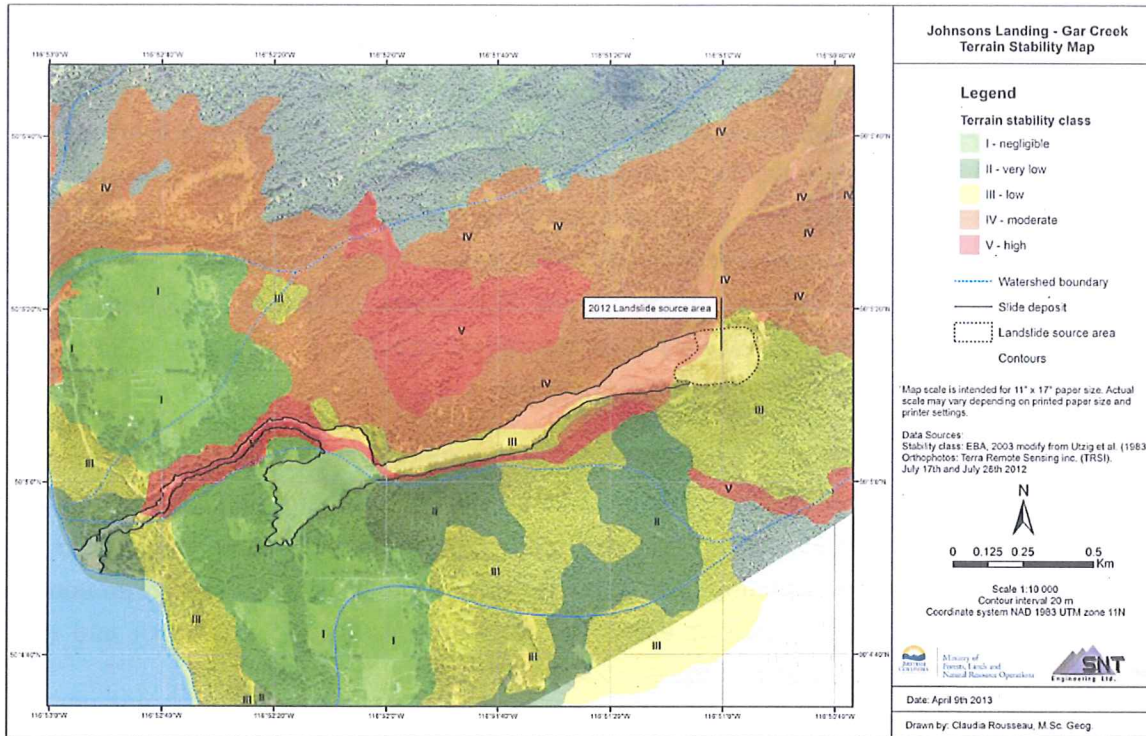
Figure 10: Landslide location relative to terrain stability polygons (polygons from Nature Investigations Ltd. 1983) digitalize by EBA (2003)

Terrain interpretations for mass wasting, surface erosion, and sediment delivery used a Low-Moderate-High classification system, as the class I to V system for terrain stability was not yet in use in the BC Interior. In 1998, Kutenai Nature Investigations Ltd. re-interpreted the mapping to conform to the classification in the Forest Practices Code "Mapping and Interpreting Terrain Stability" guidebook (BC Ministry of Forests, 1999). Class III, IV, and V terrain is typically defined as having a low, moderate, and high likelihood of post harvesting landslide initiation. As noted in Figure 10 the landslide source area was almost entirely within a polygon mapped as Class III or low likelihood of landslide.

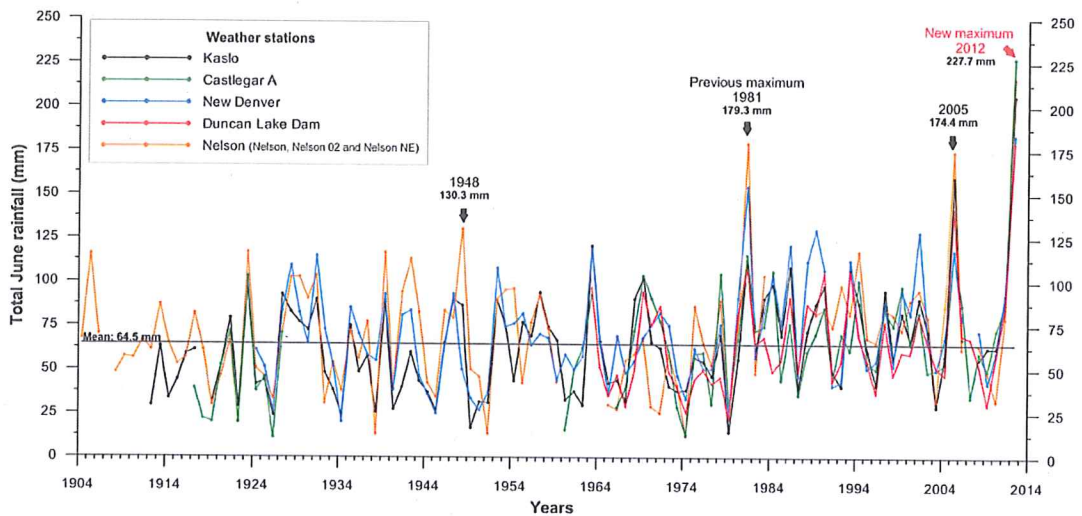
Figure 12: Total June rainfall recorded at weather stations near Johnsons Landing

Figure 12 shows the local rainfall during June 2012 compared with historical June rainfall data. Recorded 2012 June rainfall was 3.5 times the average (average of Castlegar, Kaslo, Nelson, New Denver and Duncan Lake stations). All five local stations recorded June rainfall over 180 mm with Castlegar at 227 mm (Environment Canada Climate Data).

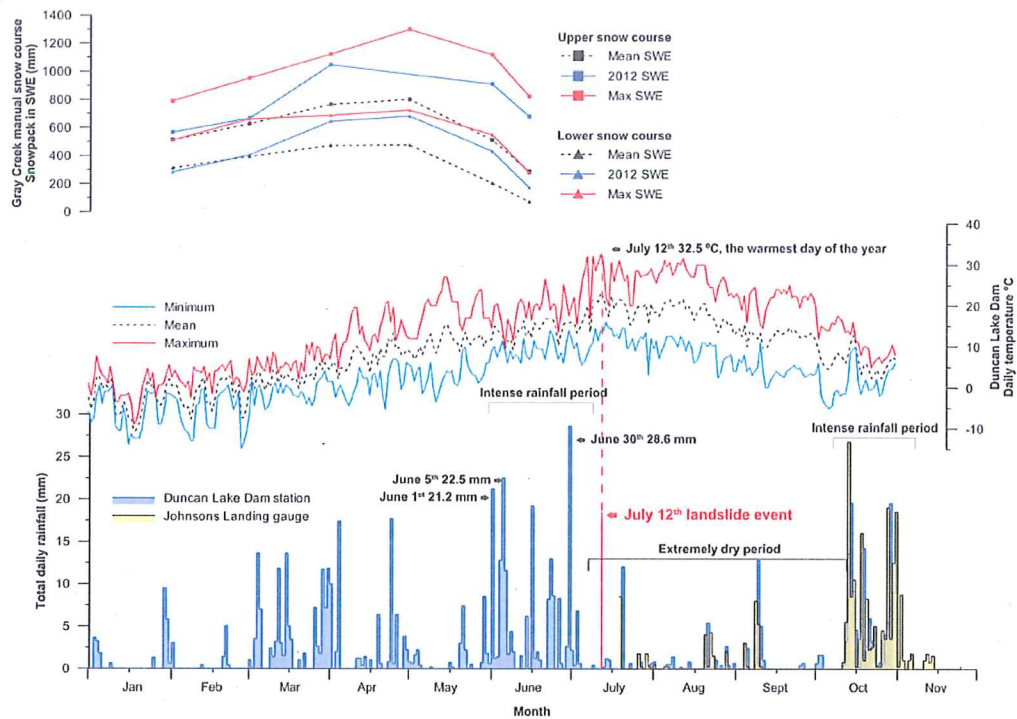
Figure 13: Summary of 2012 daily rainfall and temperatures from Duncan Lake Dam weather station and monthly snow pillow in snow water equivalent (SWE) from Gray Creek manual snow courses (Lower and Upper)

An early summer intense rainfall period occurred between May 28th and July 3rd. Four days in June (June 1st, 5th, 16th and 30th) recorded rainfall between 19 mm to 29 mm (Figure 13). This unusual wet period was followed by an extremely warm and dry period during which the landslide occurred. The nine days preceding the landslide event were dry with cumulative rainfall of only 1 mm. Moreover, according to the temperature records from Duncan Lake Dam weather station (20 km north of Johnsons Landing), the three days preceding and including July 12th were the warmest days of the year with a maximum of 32.5°C on the day of the landslide (see Figure 13).

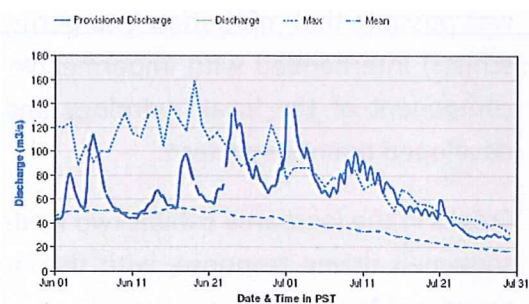
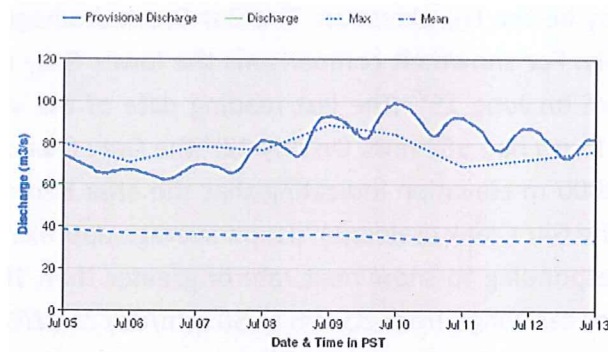
The Kaslo River discharge shows a series of peaks during the month of June (Figure 15 and Figure 16), three of which are over 100 m³/sec that correspond to rainfall events. Peaks on June 24th and July 2nd formed new discharge records for flows after June 20th. A fourth more gradual ascending peak occurred on July 10th as a result of warming temperatures and snow melt. The diurnal pattern of daytime heating and snowmelt is evident between July 8th and July 12th. The snowmelt related peaks produced record river discharges for the days of July 8th to July 13th.

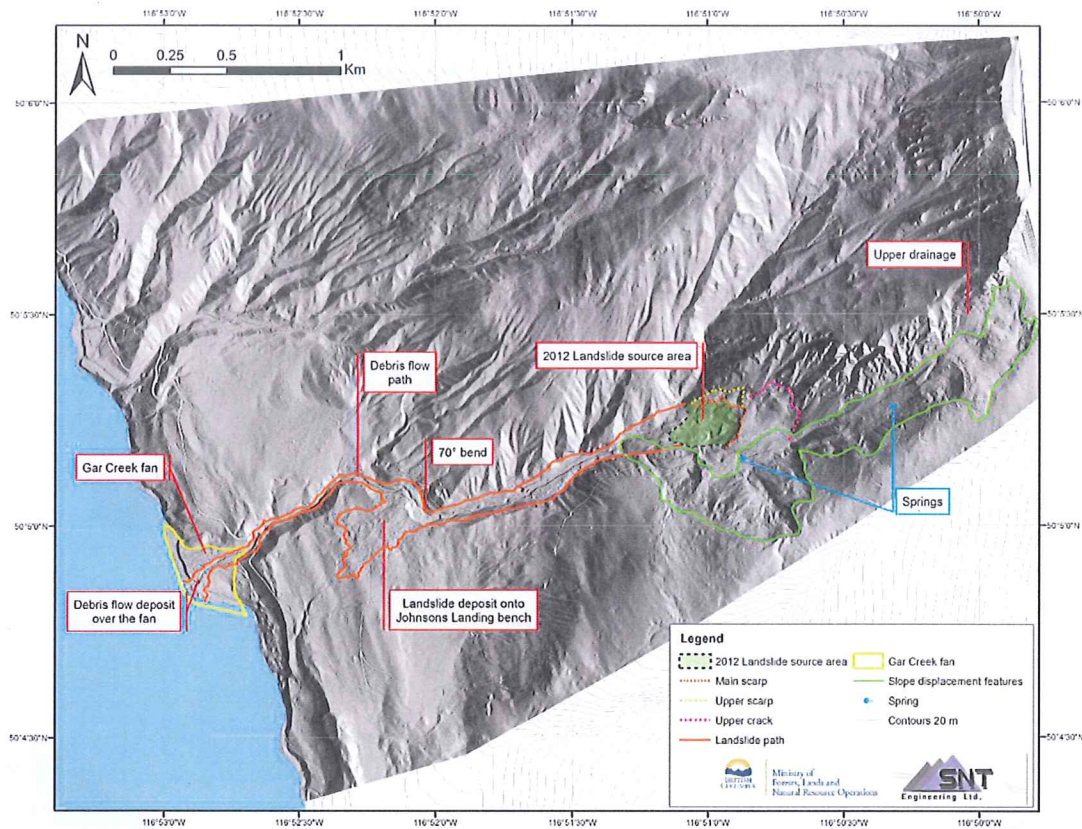
Figure 17: Gar Creek drainage (LIDAR image)

During the field reviews (2012) no surface water was observed in the Gar Creek north tributary while two springs were observed (see Figure 17), originating from the southeast portion of the drainage, supplying a significant volume of water to Gar Creek. These two springs are likely responsible for much of the dampened flow volumes observed in Gar Creek. Significant subsurface and surface flows immediately post landslide were observed primarily on the north and east portions of the landslide main scarp. The subsurface flows near the landslide in all cases appeared to emerge from till and colluvium units at/ above the bedrock contact.

The two upper most springs contributing to Gar Creek emerge at discrete locations at the 1150 m and 1500 m elevation (as shown on Figure 17).

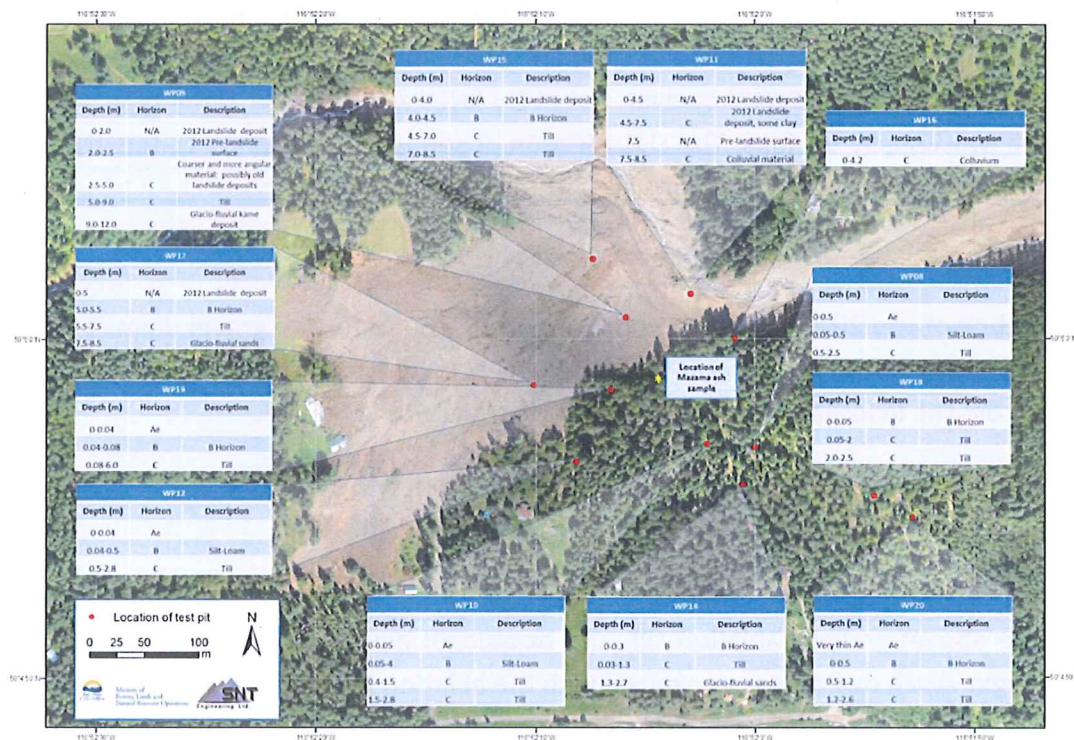
Figure 19: Classification of test pit stratigraphy

The locations of test pits are shown in Figure 19 and grain size testing of selected samples is shown in Figure 20. The test pits were named corresponding to their location waypoint. Other locations are shown at which surface samples were collected. Samples were collected from selected layers in each test pit; however, not every layer was sampled, if the type of material in that layer was visually obvious. The classification of soil layers observed, cumulative grain-size distribution curves, and full test results are included in Appendix D.

At one location immediately adjacent to the upper part of the landslide deposit, on the surface of the Johnsons Landing bench at a 20 cm depth, a layer of Mazama ash was uncovered (Figure 19, and Photos 34 and 35 Appendix A). Mount Mazama is a volcano in Oregon which spread a layer of ash across southern BC approximately 7700 years ago. A sample of the ash was sent to and tested by the Washington State University, who confirmed its origin. The observation of the ash layer at a shallow depth provides additional confirmation that a large landslide has not deposited debris onto the Johnsons Landing bench in at least the last 7700 years.

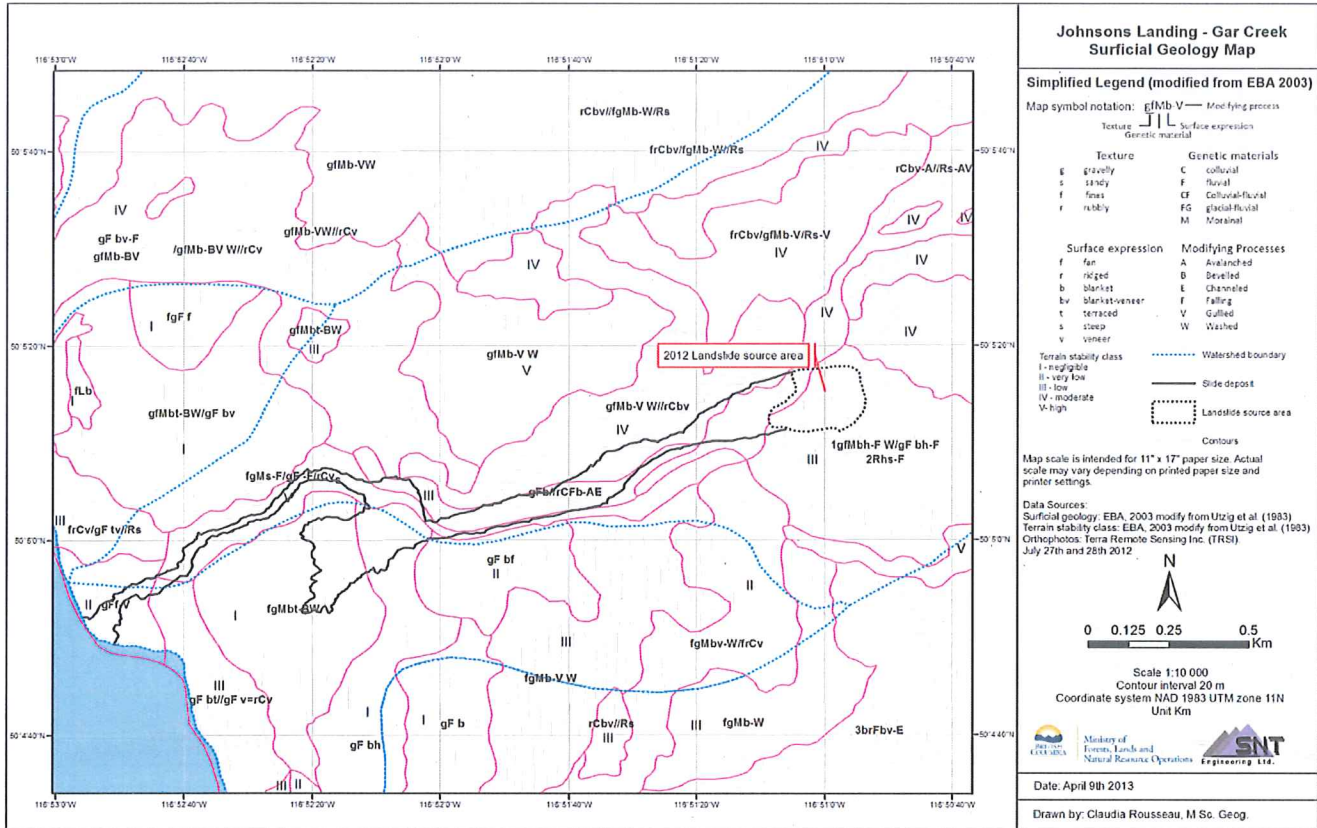
Figure 21: Gar Creek surficial geology map (modified from EBA 2003 and Kutenai Nature Investigations Ltd., 1983)

Terrain mapping by Kutenai Nature Investigations Ltd. (1983) has mapped the area of the Johnsons Landing bench (Figure 21) now covered by landslide debris as fgMbt (gravelly fines morainal terraced blanket) and gF^Gbh (gravelly glacial fluvial hummocky blanket) consistent with our field observations and test pits, which showed a lack of previous landslide debris.

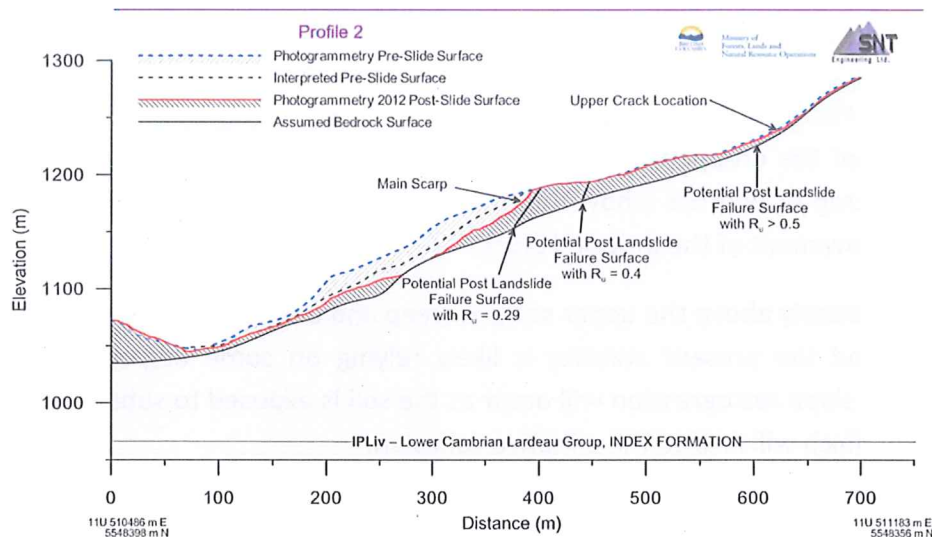
Figure 22: Profile 2 slope stability analyses

Profiles 1 through 3 are located through the north side and the south side of the main scarp respectively (Profile 2 trends almost due East/West). Profiles 1 and 2 extend upslope beyond the upper crack. The upper crack is actually a small scarp (4 m of displacement) at its northern extent (Profile 1) with progressively less shear towards the south. At a location between Profile 2 and Profile 3 the upper crack was not present (could not be traced). Profile 5 is located at the northern side of the main scarp (trends NE to SW). Profile 5 includes the dropped block and upper scarp.

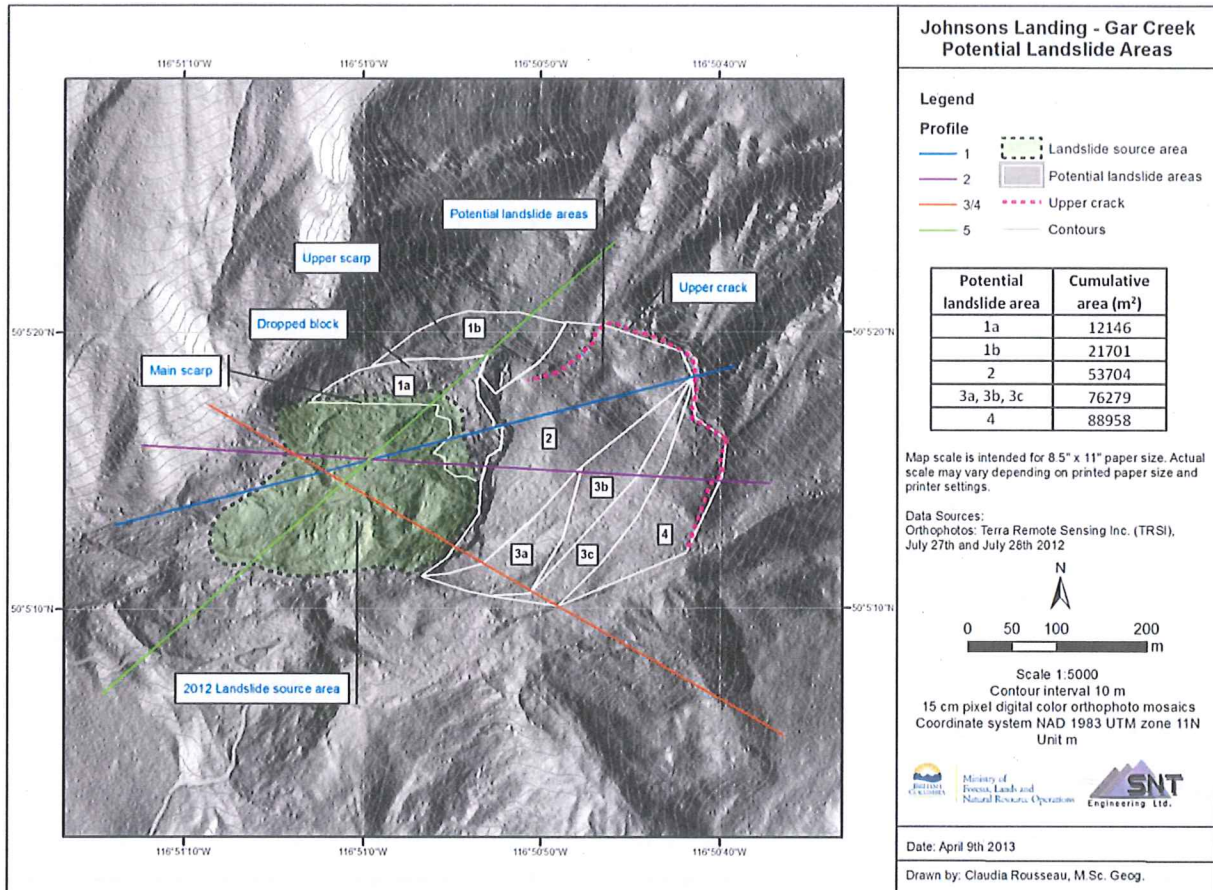
Figure 23: Slope stability cases map

Based on field observations and supported by the limit equilibrium analyses a total of four primary landslide scenarios as shown in Figure 23 were selected for further consideration for potential landslide magnitude and run-out analyses.

0.00001 (1:100,000)	889,000	Representative of Cases 1 through 4 of Figure 23. Represents factor of safety assuming Ru of 0.5 or failure to bedrock with an average landslide thickness of 9 m. Failure extends to the upper crack.

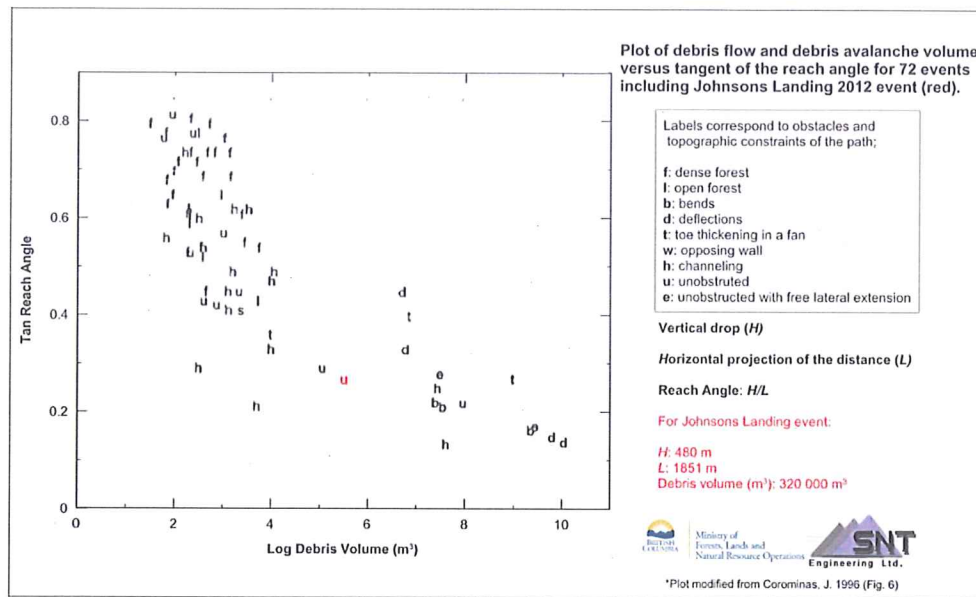
Figure 28: Plot of Debris flow and debris avalanche volume versus tangent of the reach angle for 72 events including Johnsons Landing 2012 event (modified from Corominas 1996)

The landslide run-out distance was compared with other recorded large landslides. The run-out distance, L , is defined as the horizontal distance between the crown of the landslide source and the toe of the deposit. It can also be calculated from the height of the slope, H , divided by the tangent of the angle between the deposit elevation and source elevation, called "reach angle". The reach angle can be estimated empirically as a function of the volume of the landslide, from a correlation developed by Corominas (1996) for debris flows and debris avalanche events (see Figure 28 and Appendix F).

The July 12th event falls in the middle of data collected for 72 debris flow and debris avalanche events and 101 “unobstructed” landslides. Additional correlations are shown in Appendix F.

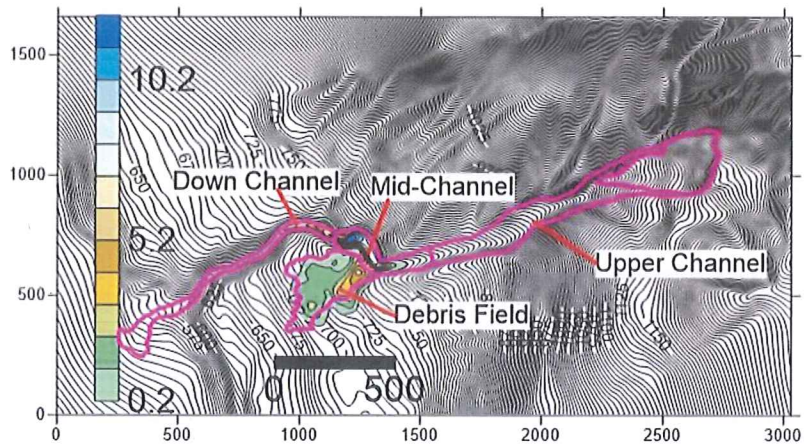
Figure 32: DAN-W run-out for the 2 Rheology Case

Based on this back analysis a forward analysis was conducted with DAN-W for both sets of parameters. The forward analysis evaluated the run-out and overtopping volume for potential landslide magnitudes. The forward analysis determined that the two rheology set of parameters provided more conservative results. It was found that landslides of 50,000 m³ (1:50 per year event) and 100,000 m³ (1:100 per year event) were confined to the Gar Creek channel (did not flow onto the Johnsons Landing bench) while landslides of volume 200,000m³ to 400,000m³ travelled to a location near the end of the Johnsons Landing bench. Landslides greater than 400,000m³ (1:5,000 per year event) travelled all the way to the beach and Kootenay Lake. DAN-W run-out distances for various landslide magnitudes are shown on Figure 32.

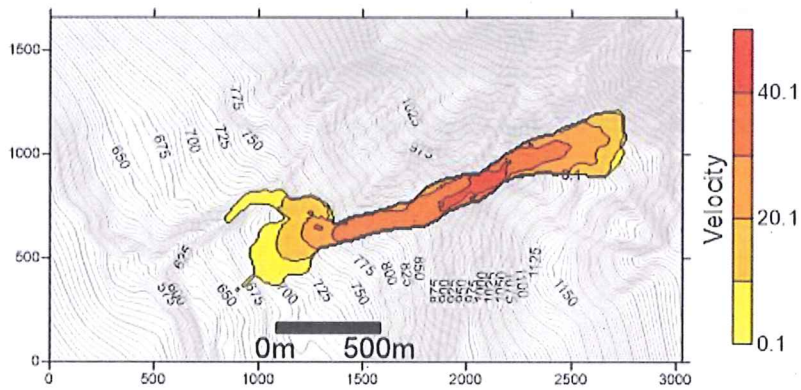
Figure 33: DAN 3D back analysis with estimated deposit thickness.

close to that determined in the site investigation. The duration, velocities and 3-D debris deposit shape of the event were well predicted. Figure 33 shows the DAN-3D back analyzed deposit shape and Figure 34 shows the back analysed landslide velocities.

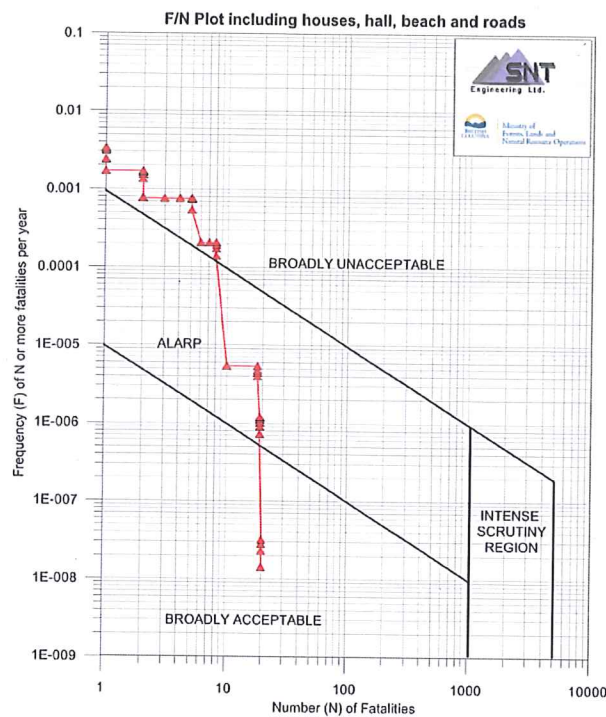
Figure 38: F/N plot considering houses, community hall, road users and beach users (criteria modified from Hong Kong Government Planning Department (1994), Morgan (1991) and Fell (1997))

For the Johnsons Landing area an individual occasionally occupying the Johnsons Landing Community Hall is exposed to a relatively low risk (PDI less than 1:100,000 per year). However the societal risk of a larger group exposure plots above the broadly acceptable criteria as shown on Figures 38 to 40. The societal risk is also above the broadly acceptable criteria when considering the combined population of exposed residents, which is to be expected considering the results of the individual risk analysis.

While an individual user of the Argenta-Johnsons Landing Road, Houston Road and the Beach is exposed to relatively low risks (less than 1:10,000 per year) the societal risk plots in the broadly unacceptable range due to the number of different vehicles and individuals traveling the road and using the beach.

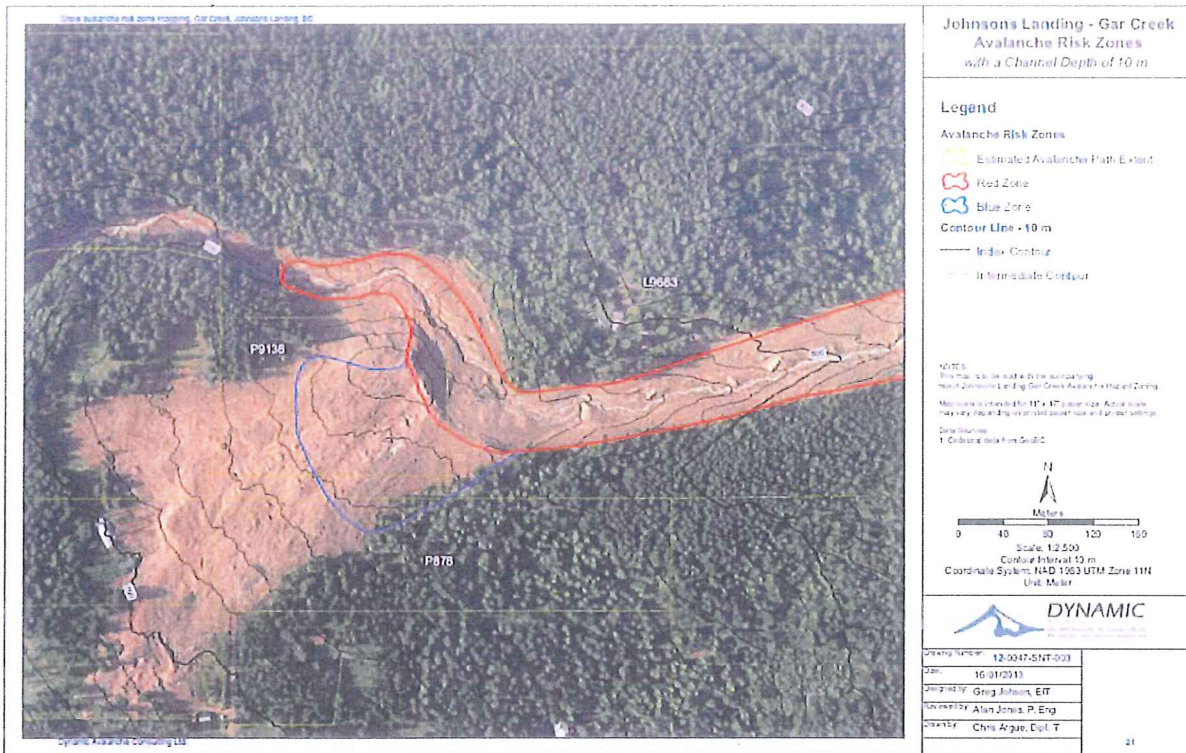
Figure 43: Avalanche risk zones with a channel depth of 10 m (from Dynamic Avalanche Consulting Ltd's report, Appendix K)

Figure 43 and Figure 44 show the results of the avalanche assessment in terms of the run-out of the Red Zone and Blue Zone. The Red Zone is a high risk area where construction of permanently occupied structures is not permitted according to the Guidelines for Snow Avalanche Risk Determination and Mapping (CAA 2002). The Blue Zone is a moderate risk area where construction of permanently occupied structures is normally not permitted according to the Guidelines for Snow Avalanche Risk Determination and Mapping (CAA 2002).

While the landslide hazard and risk extends beyond the snow avalanche run-out area and therefore controls potential areas for development the landslide hazard exposure window is typically in the spring during or after snow melt. During the winter months the snow avalanche hazard is greater in those areas shown on the map (Red and Blue zones).
