MINISTRY OF FORESTS, LANDS AND NATURAL RESOURCE OPERATIONS, POST-WILDFIRE RISK ANALYSIS – PRELIMINARY REPORT

FIRE: N71691 Morley Creek		FIRE YEAR: 2017	DATE OF REPORT: 28 August 2017
AUTHOR: Sarah Crookshanks			
REPORT PREPARED FOR: Selkirk Resource District (Kootenay Lake FD), and Southeast Fire Centre			
FIRE SIZE, LOCATION, AND LAND STATUS: 76 ha. Fire is located on the face between Sitkum and Kokanee Creeks, 16 km NE of Nelson. Crown land.			
VALUES AT RISK: Houses on Morley Creek fan; water intakes on Morley Creek (35 water licences); Highway 3A			
WATERSHEDS AFFECTED:	TOTAL AREA	AREA BURNED	BURN SEVERITY (% of burned area)
Morley Creek	108 ha	46 ha (43%)	38% H, 62% M
Morley-Sitkum Face	110 ha	8.9 ha (8%)	Moderate
Morley-Kokanee Face	252 ha	6.1 ha (2%)	33% H, 67% M
Kokanee Creek	9500 ha	14.5 ha (<1%)	35% H, 65% M
Sitkum Creek tributary (Bourke Creek)	132 ha	0.4 ha (<1%)	Moderate
<small>**Note: All burn severity calculations are approximate until better data is available</small>			
SUMMARY OF HAZARDS AND RISKS:			HAZARD¹

Post-Wildfire Natural Hazards Risk Analysis, Fire N71691, Morley Creek

Sarah Crookshanks, MFLNRO, 28 August 2017

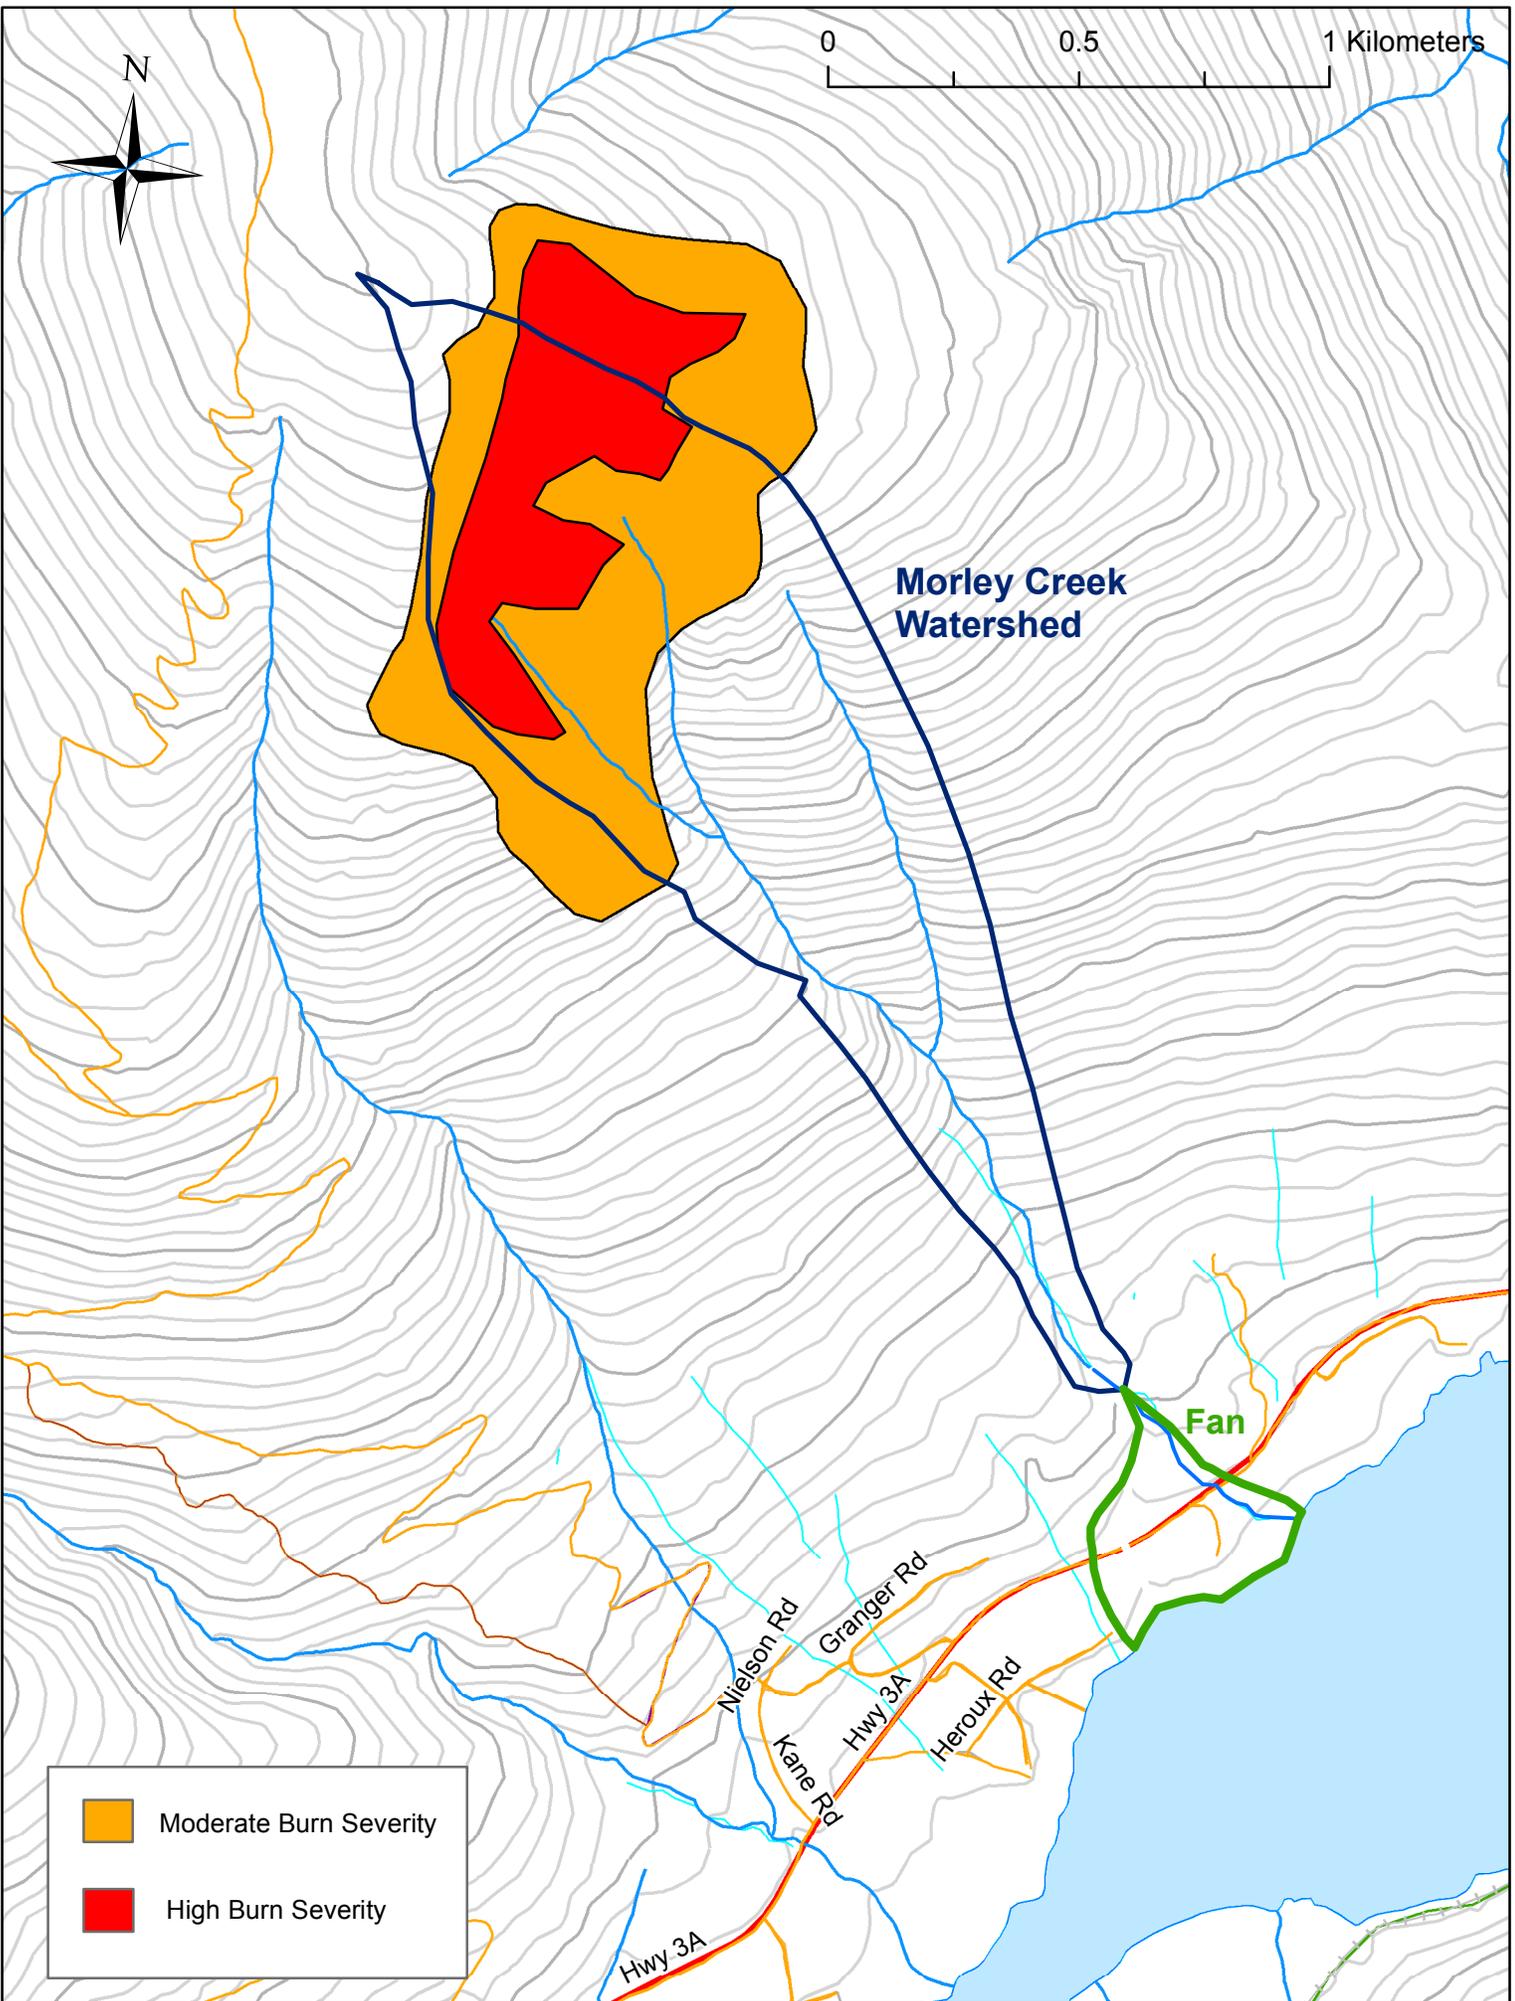
Figure 1 is a map of the Morley Creek watershed and of the fire showing the burn severity mapped from photographs taken from a helicopter (e.g. Figure 2) and ground data. The fire occupies 43% of the watershed area. Of the burned area, 38% is high burn severity. ***The burn severity areas are very approximate and subject to review once satellite imagery is obtained.*** The burn area is located in the headwater area of the watershed. The gullies that form the headwaters of Morley Creek steepen downslope away from the fire. The table below summarizes some of the watershed statistics for Morley Creek.

Figure 1. Map of fire, showing preliminary burn severity (on next page). Scale 1:15,000. Burn severity polygons were drawn manually from photos taken from the air on 22 August 2017. A more accurate burn severity map will be prepared from satellite imagery when this is available.
