# **RDCK FLOODPLAIN AND STEEP CREEK STUDY**

# **Harrop Creek**

Final March 31, 2020

Prepared by BGC Engineering Inc. for: Regional District of Central Kootenay

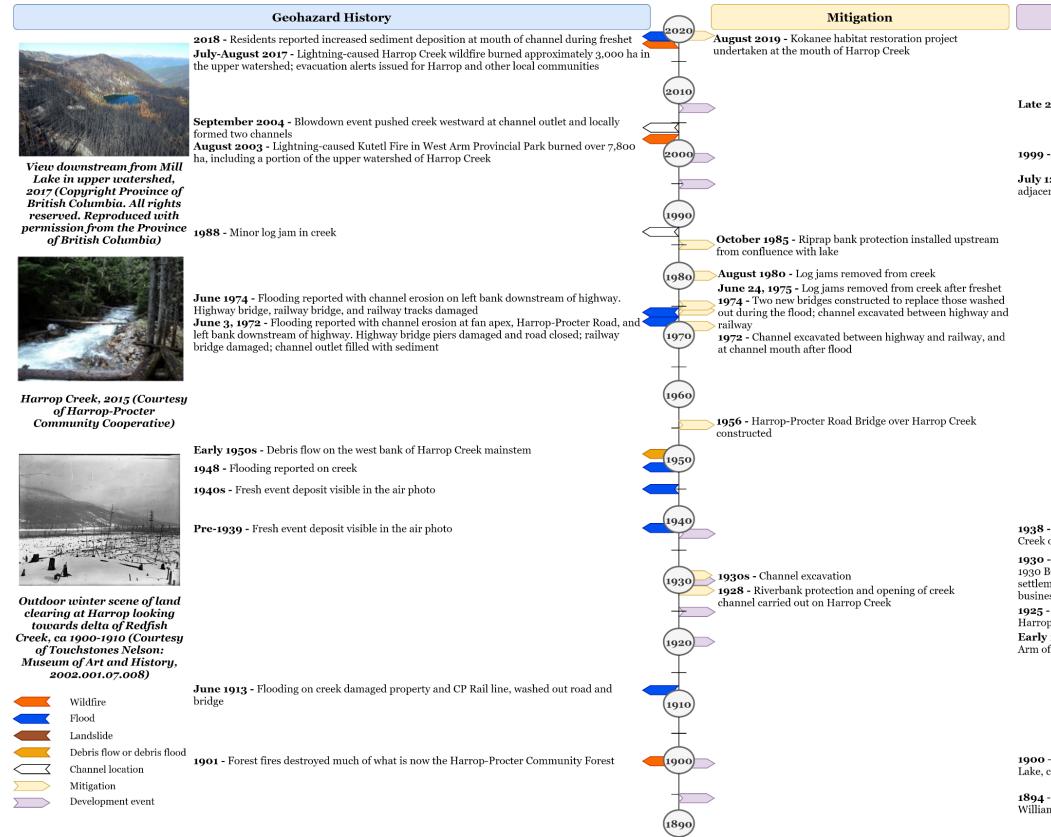
- The channel has been dredged (i.e., cleared with equipment) several times, typically following debris flood events or freshet floods.
- A forest fire burned a large portion of the upper watershed in 2017. Since the fire, residents have noted increased sediment deposition at the mouth of the channel.

Figure 4-1. Summary of recorded geohazard, mitigation, and development history at Harrop Creek.

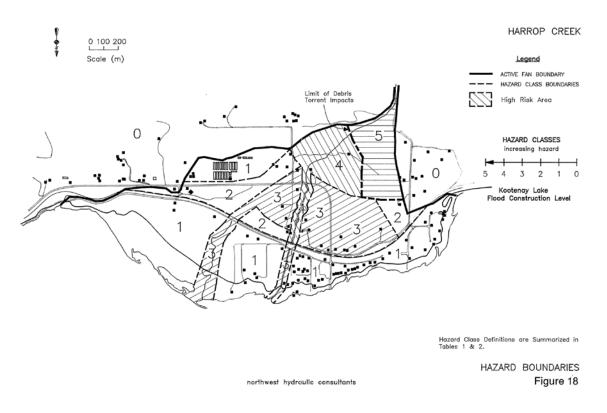
The NHC/Thurber (1990) assessment considered debris torrents<sup>5</sup>, avulsions or channel shifts, and inundation. For each fan-delta investigated, hazard areas were codified between 0 (lowest hazard) and 5 (highest hazard). However, since NHC/Thurber (1990) also included loss of life consequences as a second dimension in their hazard mapping, their hazard maps provided information on relative levels of risk. Specific risk zones were defined as those where individual life loss risk exceeds or falls below specified values. Areas with a hazard (risk) code of 3 or higher were interpreted to have a significant threat to loss of life defined as the annual probability of death of a select individual of > 1:20,000. Figure 6-3 shows the NHC/Thurber risk map for Harrop Creek.

## Figure 6-3. NHC/Thurber's (1990) Harrop Creek individual life risk map. Class 4 and 5 imply individual life loss risk values exceeding 1:10,000. Class 3 1:10,000 to 1:20,000. Class 0, 1 and 2 < 1:20,000.

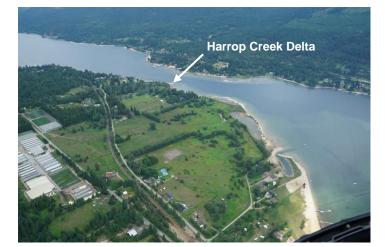
#### Photo 2.

Overview photo taken during helicopter overflight looking northwest at the Harrop Creek fan and the community of Harrop. Erindale Road (bottom to top) is running across the fan. Photo: BGC, July 6, 2019.

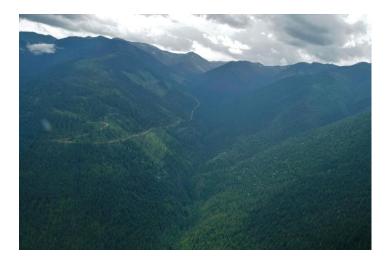
#### Photo 3.

Overview photo taken during helicopter overflight looking south along Harrop Creek. Tributary A joins Harrop Creek from the southeast (i.e., right side of photo). Photo: BGC, July 6, 2019.

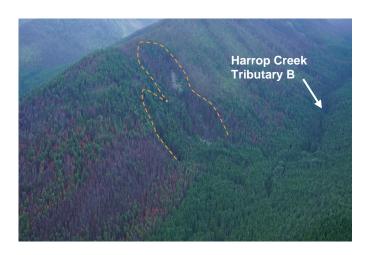
#### Photo 4.

The creek channel throughout the watershed is deeply incised into thick glacial deposits at the valley bottom forming prominent edges of till terrace incision that are visible in the lidar imagery (Drawing 05). Along Tributary B, two large landslides are evident in the lidar (Figure 3-2). BGC estimates the landslide deposit areas are in the order of 70,000 m<sup>2</sup> for the lower landslide and 180,000 m<sup>2</sup> for the upper landslide. The upper landslide has pushed the channel to a new configuration while the lower landslide may have temporarily blocked the channel and was subsequently dissected by the creek. BGC visually assessed both landslides from a helicopter. Photo 4 in Appendix B shows the lower landslide and Photo 5 is looking down, along the upper landslide. The landslides are covered with mature forest suggesting that they are at least hundreds of years old. As these were the only deep-seated landslides identified by BGC in the watershed, the occurrence of two landslides during the Holocene implies an approximate frequency of 5,000 years.

Overview photo taken during helicopter overflight looking southeast at old landslide scarp (orange dashed line) east of the Harrop Creek Tributary B, located approximately 7.5 km upstream of the outlet to Kootenay Lake (see Drawing 05 for location). Photo: BGC, July 6, 2019.

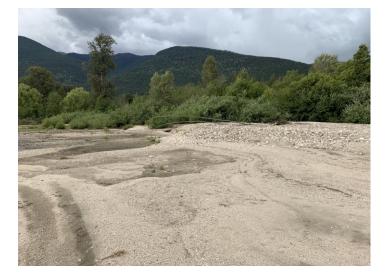
Photo 12. Harrop Creek fan at Harrop Creek outlet to Kootenay Lake. Photo: BGC, July 5, 2019.

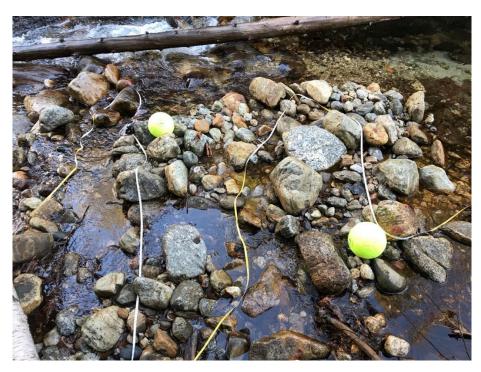
Figure C-2. Photograph taken of Wolman sampling location Harrop 1. BGC photograph of November 20, 2019.

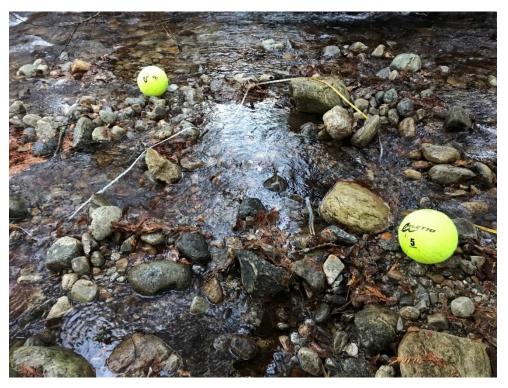
Figure C-3. Photograph taken of Wolman sampling location Harrop 2. BGC photograph of November 20, 2019.
