BC Ministry of Forests, Lands, and Natural Resource Operations
and Rural Development

POST-WILDFIRE NATURAL HAZARDS RISK ANALYSIS
SYRINGA COMPLEX FIRES
(N52497, N52489, N52548 – 2018)

December 13, 2018

Report Number: 511.18.26

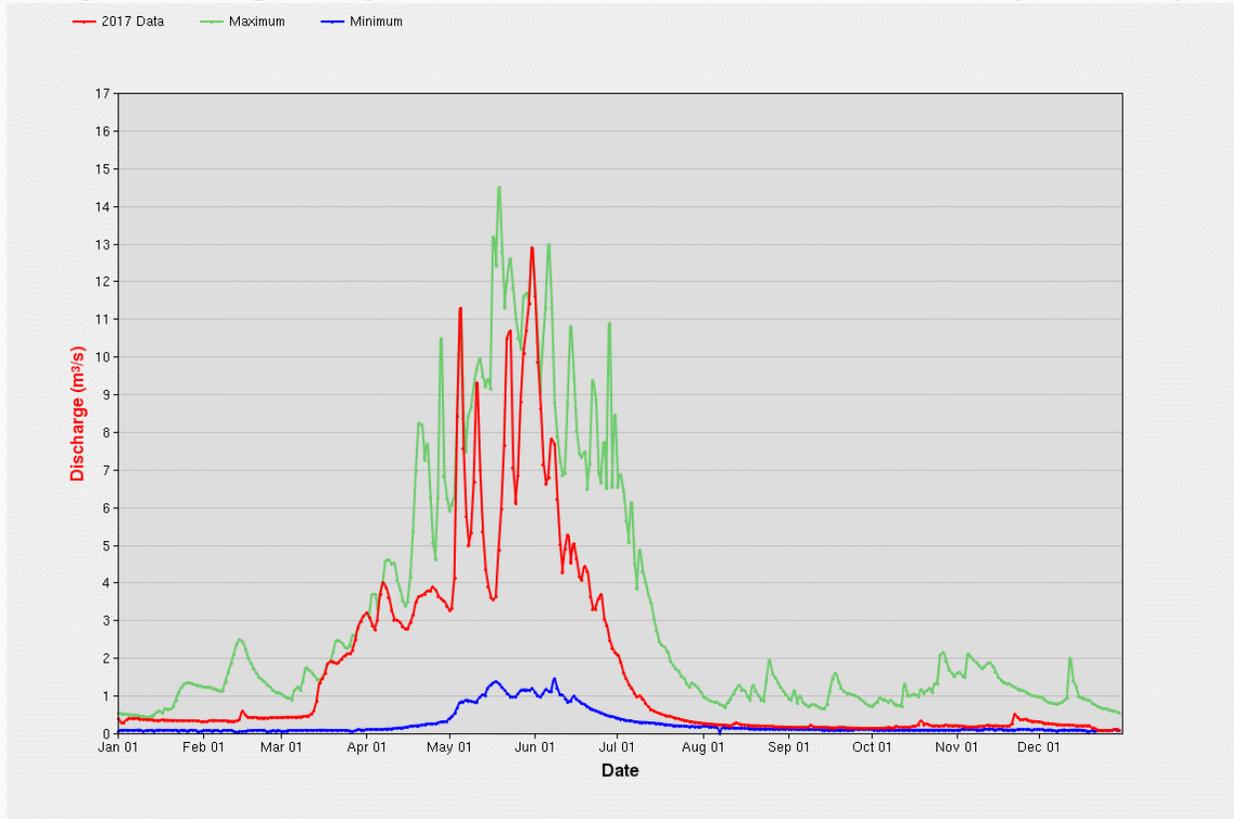
Streamflow is dominated by spring runoff. On larger streams which include subalpine areas, such as Deer Creek, summer and fall rains seldom or never cause flows as high as typical spring peaks. However, on small, lower-elevation streams, summer or fall rainstorms can cause localized floods. Deer Creek is the only gauged stream in the area; its hydrograph is shown below (Figure 2).

Figure 2. Summary annual hydrograph for Deer Creek, with 2017 data shown as an example. Drainage area is 81.6 km².

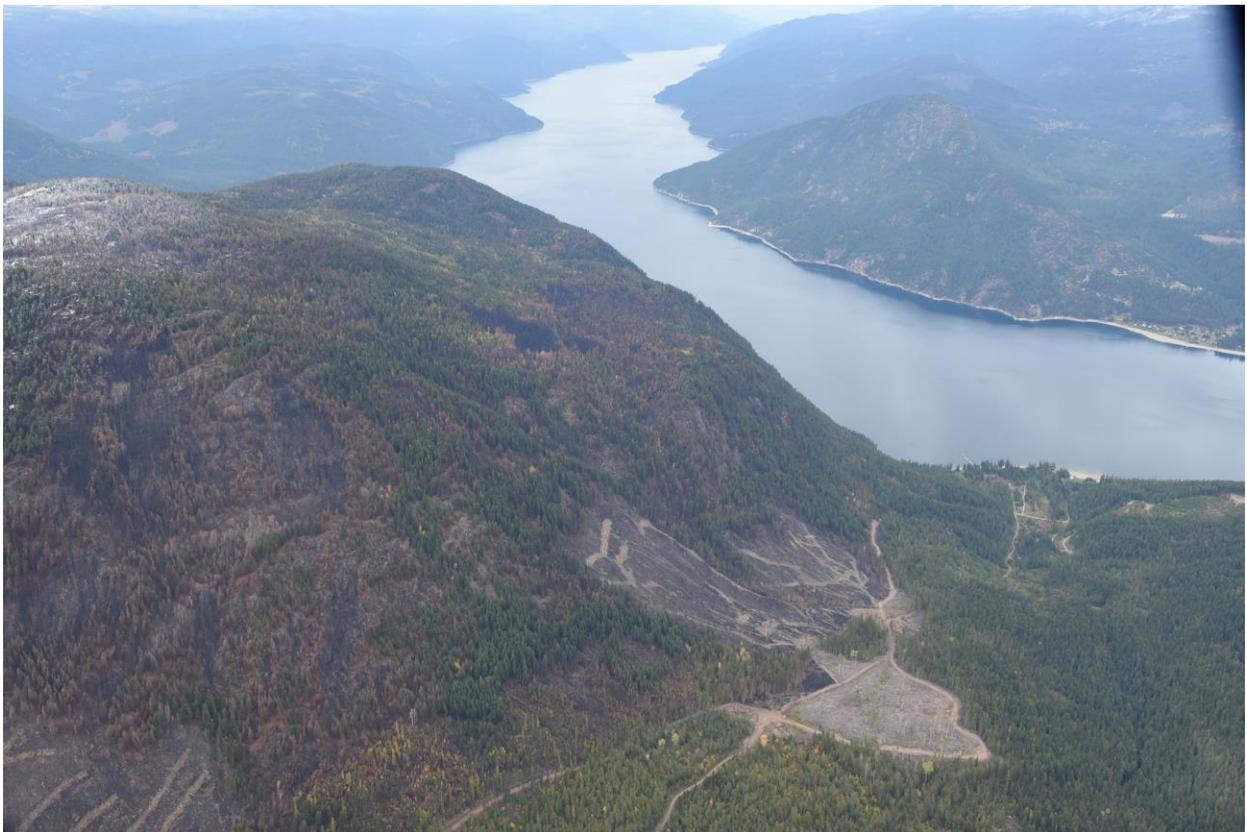
4.3.4 Recreation sites and trails: The Bulldog Tunnel is a significant historical feature on the Columbia & Western rail trail. Small areas of mostly moderate burn severity are above the tunnel entrances on both sides, but the incremental hazard of landslides that could affect the rail grade are considered low. A landslide several years ago from the logging road on the slope above came close to the tunnel entrance (Photo 11).

Photo 11. Bulldog Mountain fire. Looking west up Brooklyn Creek. Rail grade and entrance to Bulldog Tunnel are visible at left. Note landslide from road just above tunnel entrance. Cutblocks were logged in 2015 to 2016, and have unusually severe burn (mapped as “moderate” on BARC map).

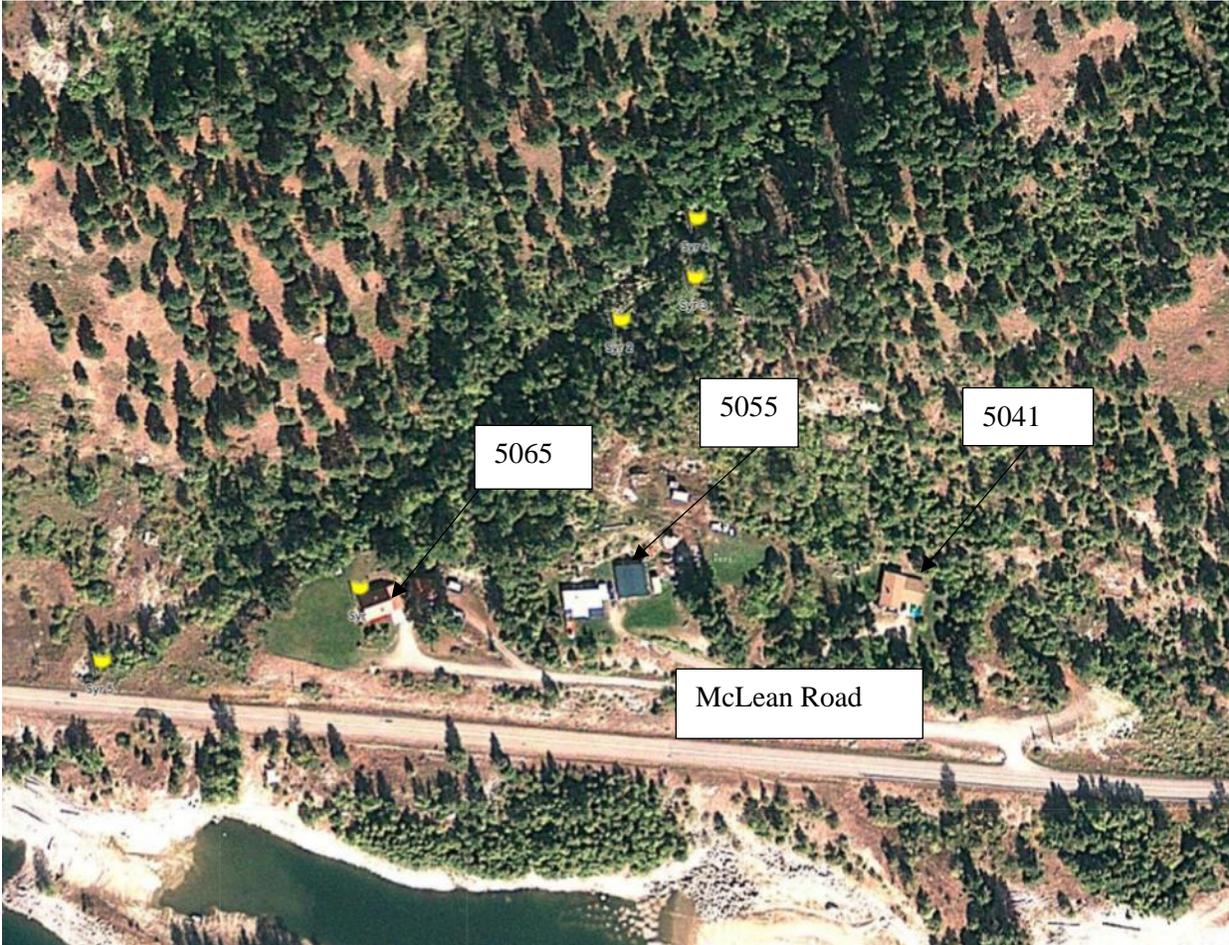
Figure 1. Irwin Creek fan

The drainage area is approximately 1156 Hectares with only 5% burned at Low and Moderate burn severity (none at High).

Conclusions: Given low fire burn severity, incremental hazard is low and partial risk is very low (houses). There is a higher partial risk (moderate) to the water intake system. Culvert at Broadwater Road appears to have excess capacity for creek flow volumes. Even though the water intake system is spatially exposed the hazard is low and no additional works (as a result of the fire) are warranted.

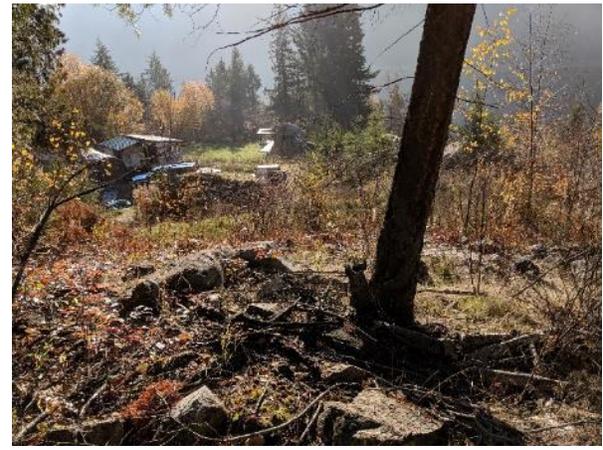
Photo 4. 5055 McLean Road from fan apex

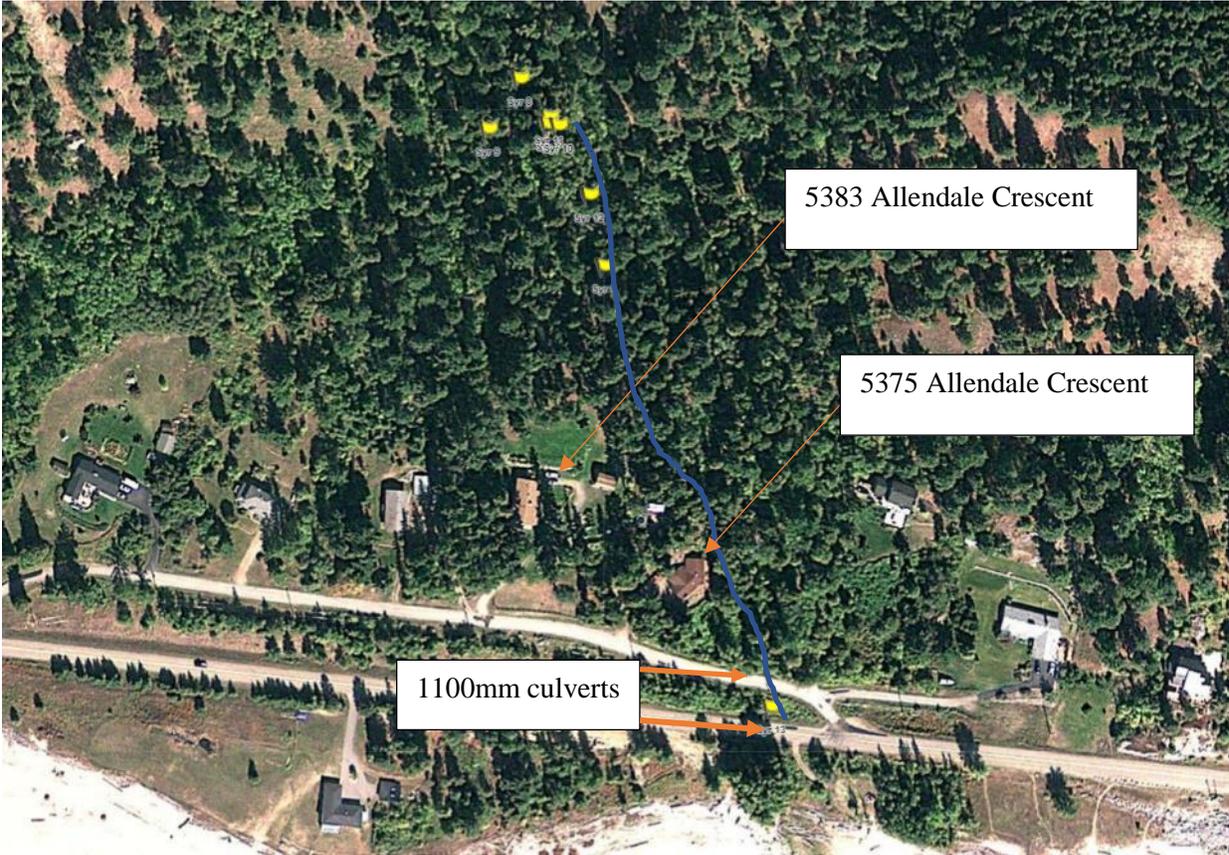
Figure 1. Allendale Creek fan

The Allandale Creek drainage area is 350 hectares with approximately 20% having a moderate burn severity with most of this at high elevation.

Consideration should be given to replacing the apparently undersized culverts across Allendale Crescent and Broadwater Road; however, there are no houses directly downslope of roads, so consequence low as long as culvert overflow can't flow longitudinally down the Broadwater Road.

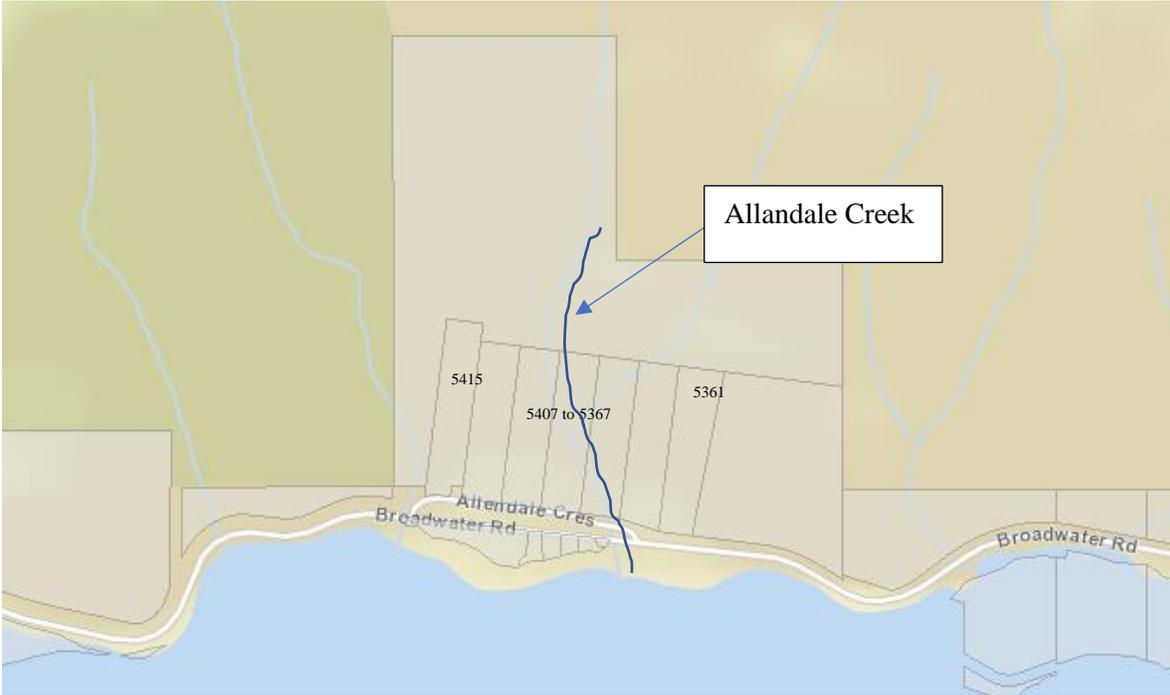
Figure 2. Allandale Creek fan showing property boundaries (RDCK web map)

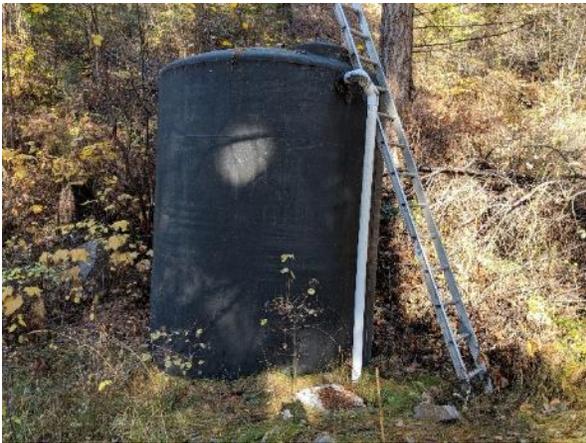
Photo 1. Allandale Creek reservoir (near fan apex)

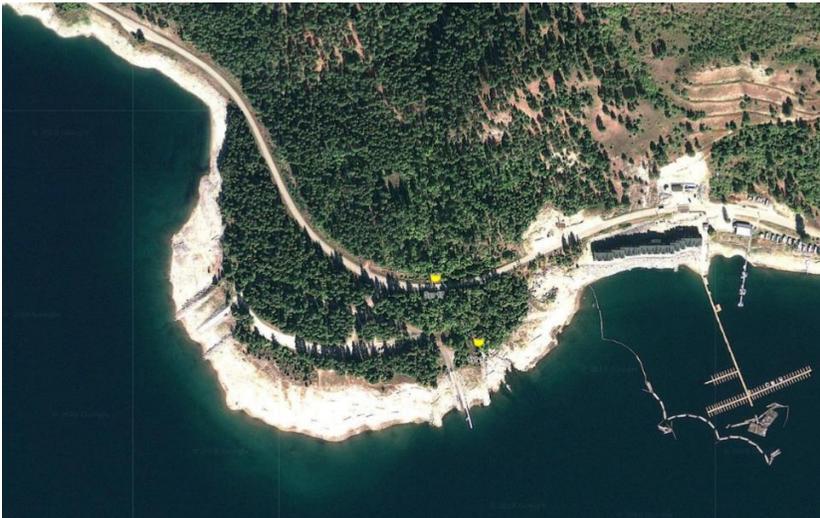
Figure 1. Syringa Creek fan and Broadwater Road

The hazard (flooding) due to the burned area is considered low and the partial risk (Broadwater Road and fan infrastructure) is also low. The culvert appears to have excess capacity to convey some increase in flow volumes.

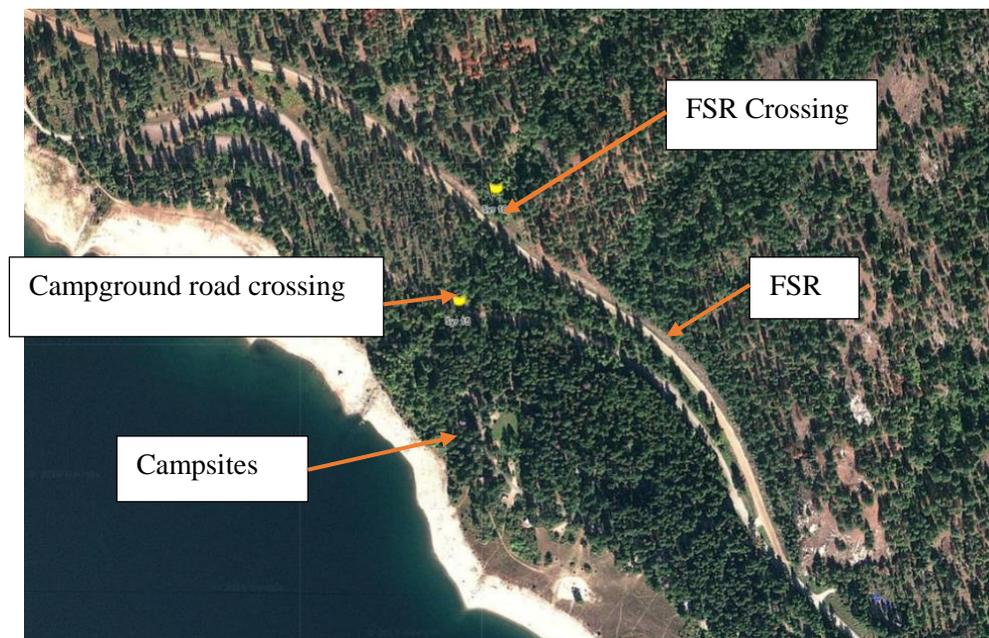
Figure 1. Campground Creek 2

4.1.2 Campground watersheds and adjacent faces: The headwaters of “Campground Creek 2” has been partly burned (59% total) at low and moderate severity (Photo 2). It has a forested alluvial fan which was probably formed by debris flows, but has no evidence of recent activity. The creek is incised about 3.5 m in a stable channel, and crosses both the campground access road (old highway) and the Deer Creek FSR in 900 mm culverts. Campground facilities are located east and west of the fan. Debris flow and flood hazards due to the fire are considered to be low and partial risk to the campground is low.

The post wildfire hazard of debris flow and flooding is considered low (L). The culverts may be undersized for a Q_{100} flood event; however, they are located 3.5m below local ground grade and so there is potential for increased culvert capacity with the excess head. A debris flow would likely block the culvert at the upper FSR crossing location - potentially redirecting stream flows; however, the nearest campsites are located 200m away at the left distal edge of the fan. The temporal and spatial hazard is considered moderate (M) and partial risk is low (L).

Even though the partial risk is considered low, the cost/effort to reduce the risk further is minimal and involves not having the campsites at the distal edge of the fan occupied until the hazard is reduced (2 to 3 years). If BC Parks requires a reduction in the risk, then the limits of potential debris flow runout should be mapped in the field so that the campsites at risk can be identified and use restricted.
