# 2024 Dam Safety Review

## HB Tailings Facility

Salmo, BC

MAY 26, 2025  
ISSUED FOR USE (REVISION 01)  
704-ENG.DAMS03004-01

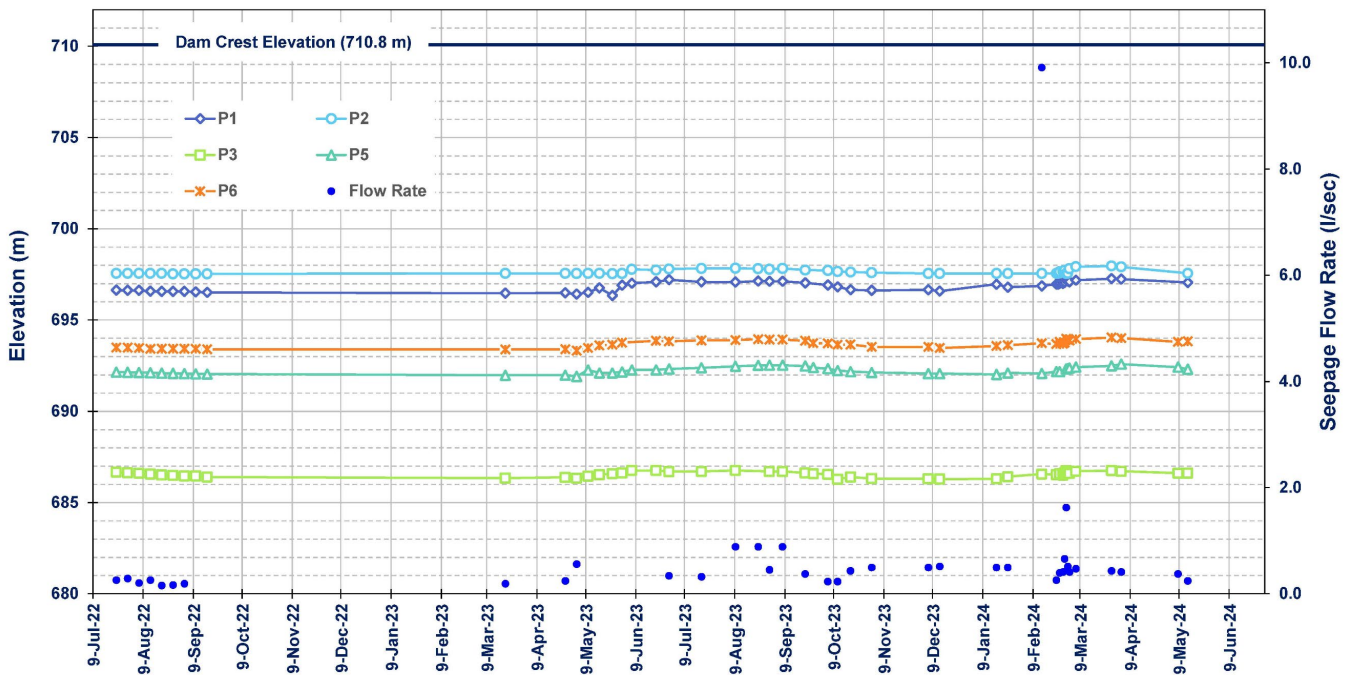
**Figure 6: Water Level Fluctuations in Standpipe Piezometers (July 2022 – June 2024)**

Monitoring data collected from the standpipe piezometers and seepage weir over the past two years (July 2022 to June 2024) are presented in Figure 6. Based on the data recorded over the past two years, it appears that there is a direct relationship between the piezometric levels, and the flow rates recorded at the seepage weir. During this period, the highest flow rate was recorded on February 14, 2024, due to high precipitation event (53 mm in 24 hours). The water level fluctuations of piezometers together with the trigger level for each piezometer during the past two years are also provided in Appendix G, Figures E.1 to E.5. Based on the historical piezometric data during this period, Piezometer P1 was the only one to exceed its trigger level of 697.2 m in late July 2023, as well as in late March and early April 2024.

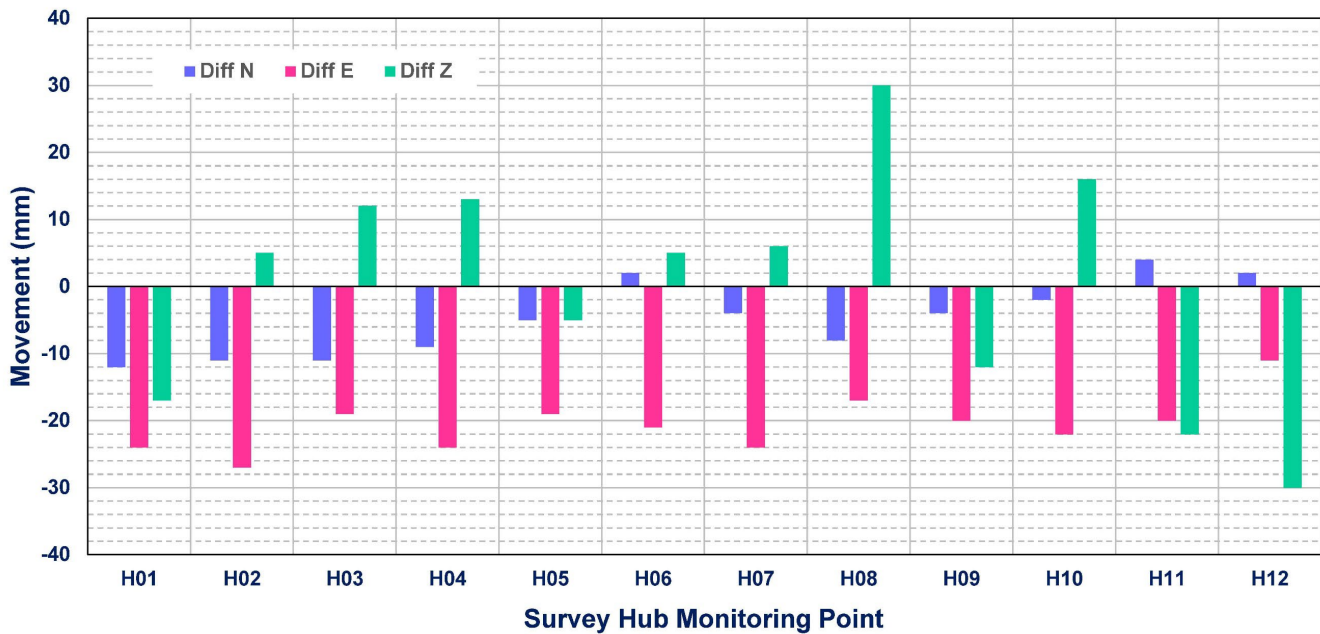
**Figure 7: Movements Recorded in Survey Hub Monitoring Points (2021-2022)**

The movements of the survey hub monitoring points were measured in 2021 and 2022, and the results were reported in the 2023 annual DSI (SRK, 2024). The recorded data is graphically presented in Figure 7. According to SRK (2024), movements within  $\pm 100$  mm are considered normal. The highest movements were observed at survey hub H08 (+30 mm in the vertical direction) and H12 (-30 mm in the vertical direction). Figure A.4 in Appendix A illustrates the location of the survey hub monitoring points.

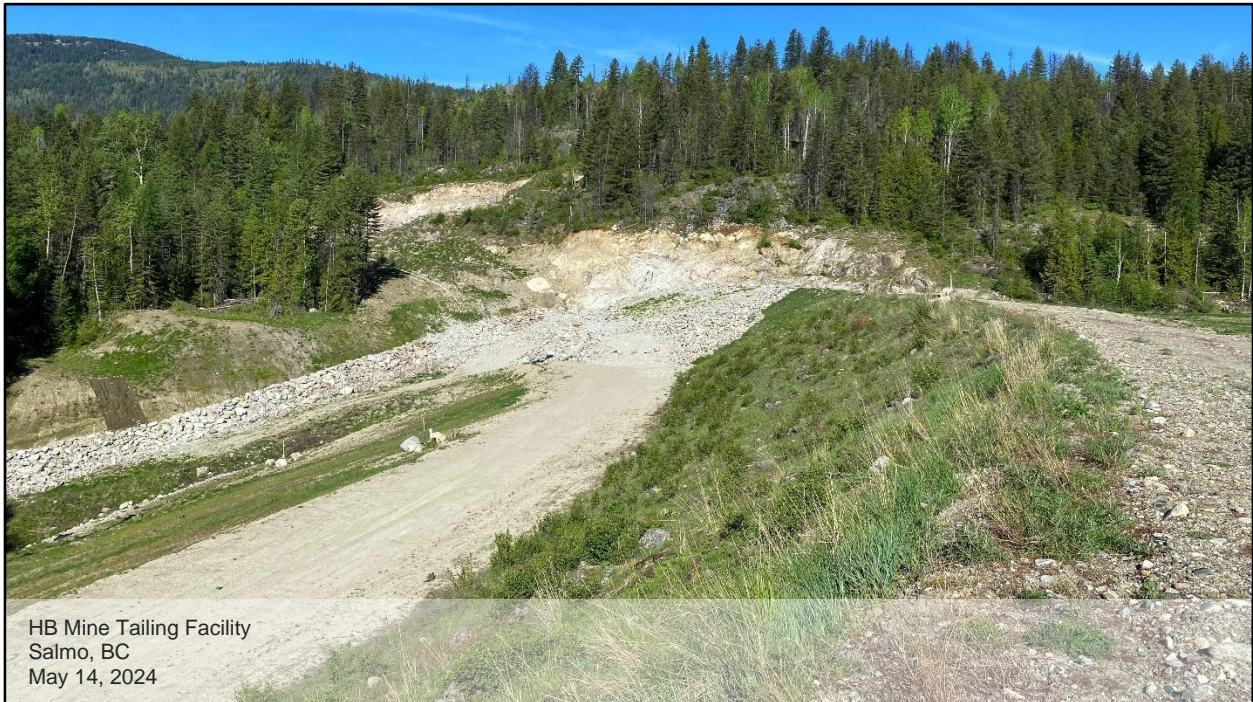
**Photo D.5: View of downstream slope face of the dam and the crest of expanded toe berm, looking from the dam crest to west. Well established vegetation was found throughout the downstream slope face.**

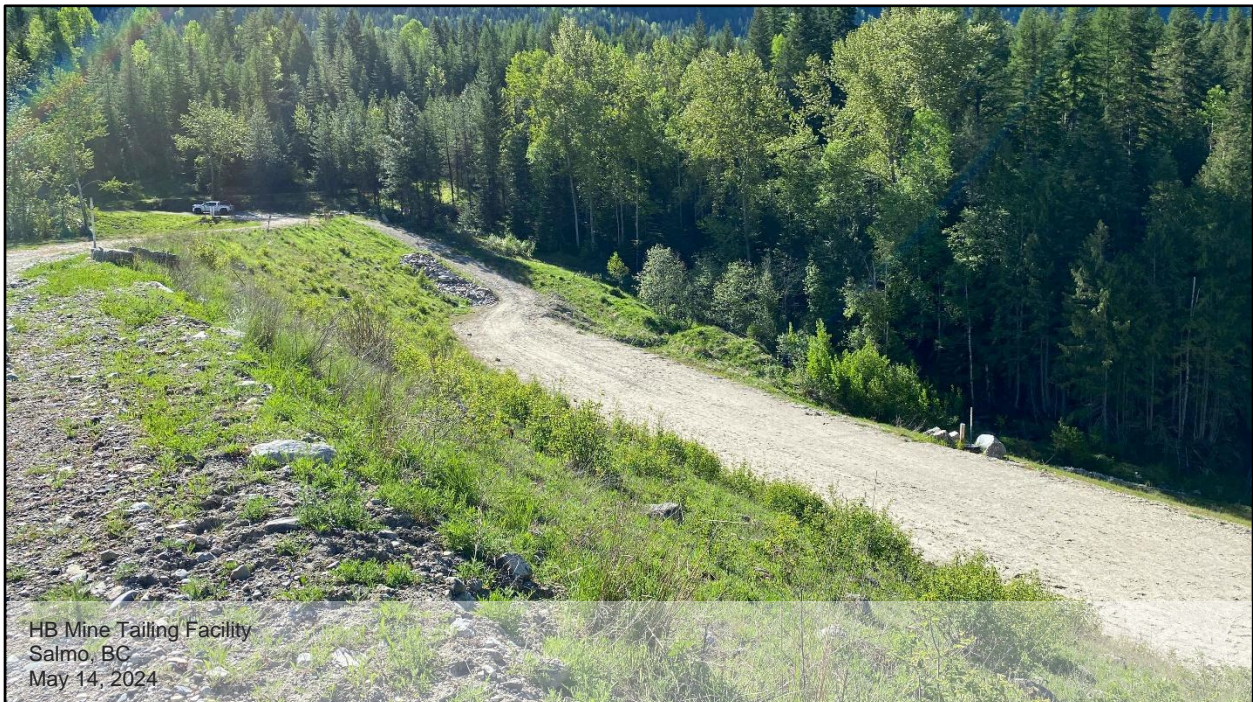
**Photo D.6: View of downstream slope face of the dam and the crest of expanded toe berm, looking from the dam crest to east. The downstream slope of the dam appears to be in general good condition.**

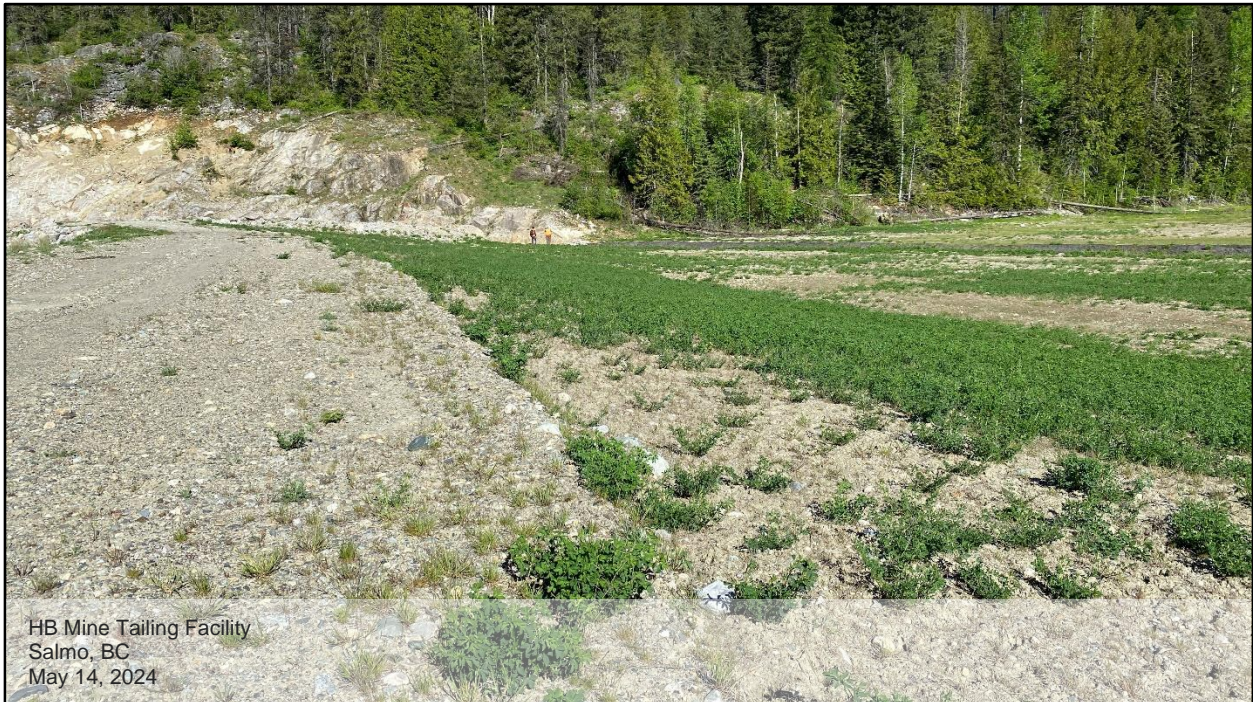
**Photo D.7: General view of the tailing impoundment area, looking west. No sign/evidence of depression or sinkhole was noted along the interface with the tailing impoundment area.**

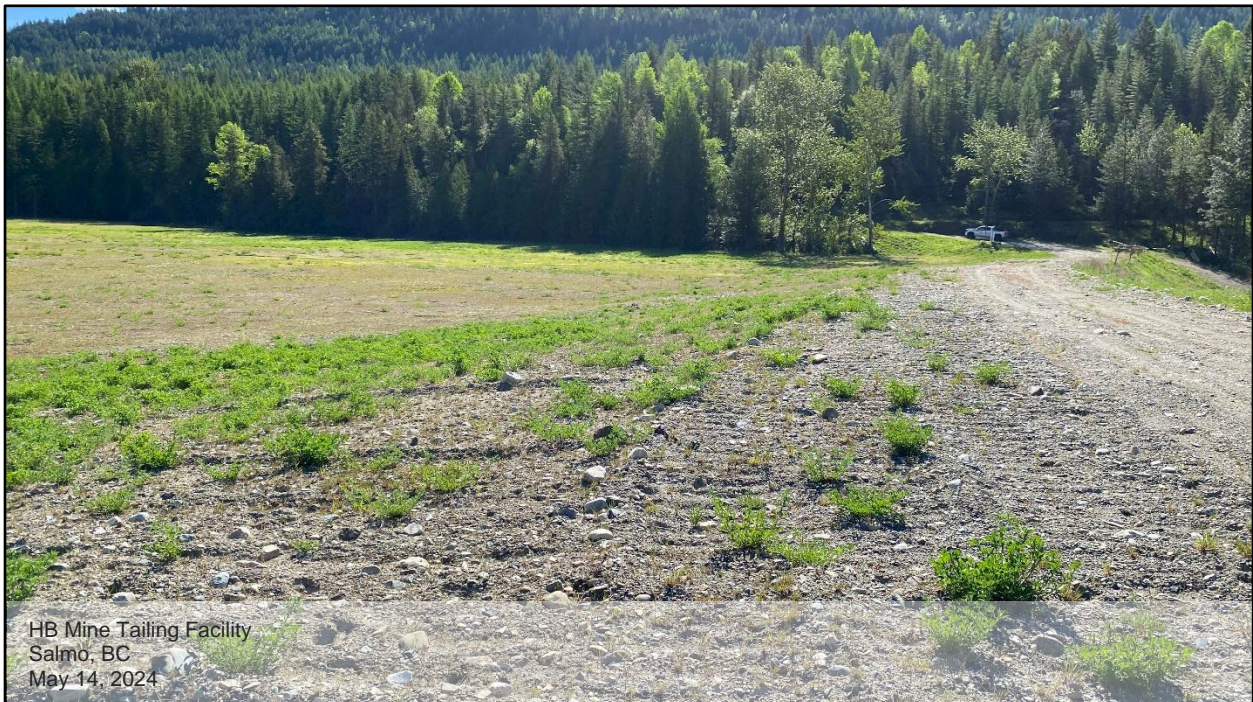
**Photo D.8: General view of the tailing impoundment area, looking east. Vegetation is growing throughout the area; however, sparse vegetation was found in some areas.**

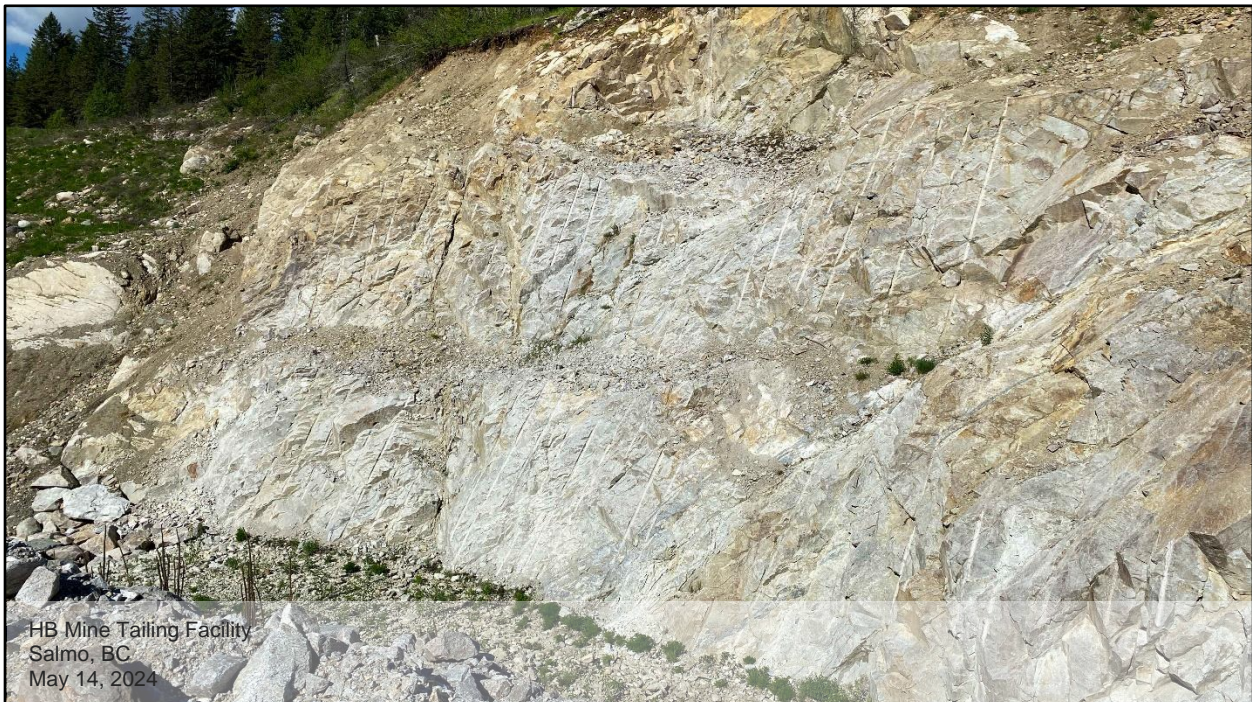
**Photo D.12: View of the western slope of bedrock spillway. This area is visually inspected during the routine site inspections for any potential instability.**

2024-DSR-14	Emergency levels have not been developed in the current version of EPRP.	7.4	–	Update the EPRP to incorporate the Five-Step Dam Emergency Plan (DEP) Process including the steps as outlined in the Instructions, Guide, and Templates for Preparing a Dam Emergency Plan in British Columbia (updated April 2024).	High
2024-DSR-03	No rock slope study/assessment was conducted along the western slope of the bedrock spillway. Major failure of the rock slope may fully/partially block the bedrock spillway and decrease its discharge capacity.	5.2.3	–	Perform a rock slope stability study/assessment of the western slope of the bedrock spillway.	Medium

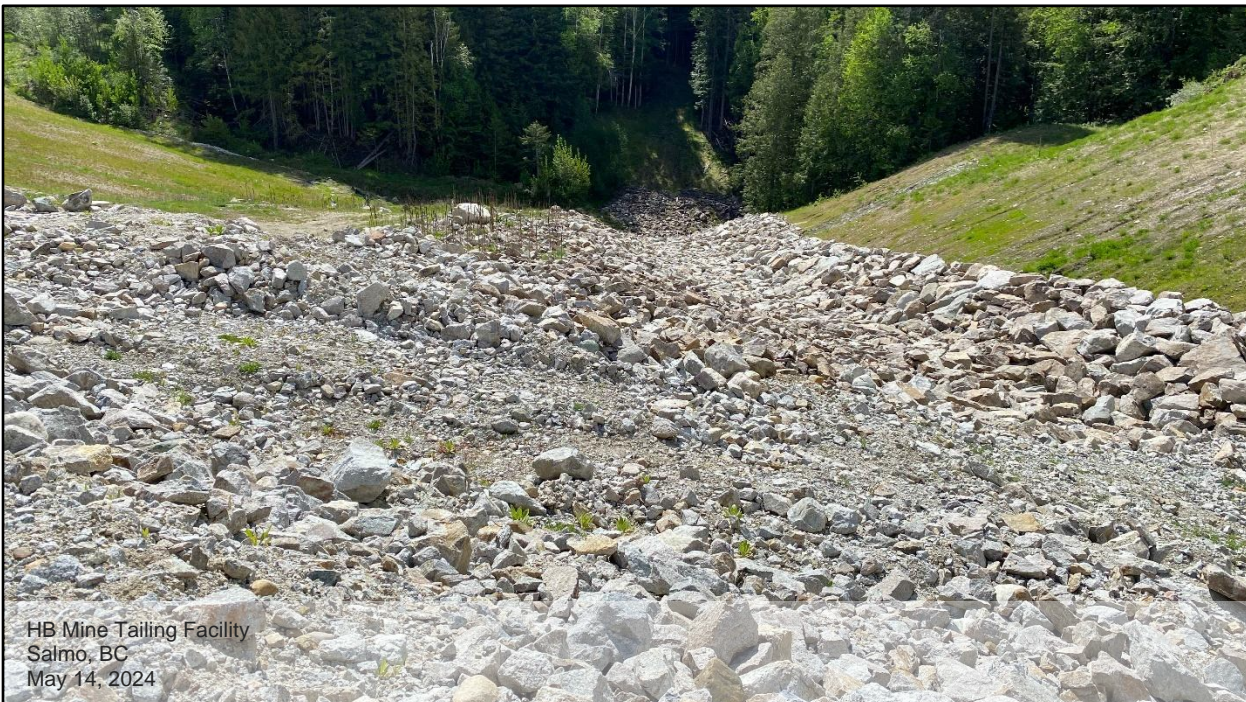
**Photo D.14: View of the spillway outlet channel, looking south. The spillway channel appears to be in general good condition.**

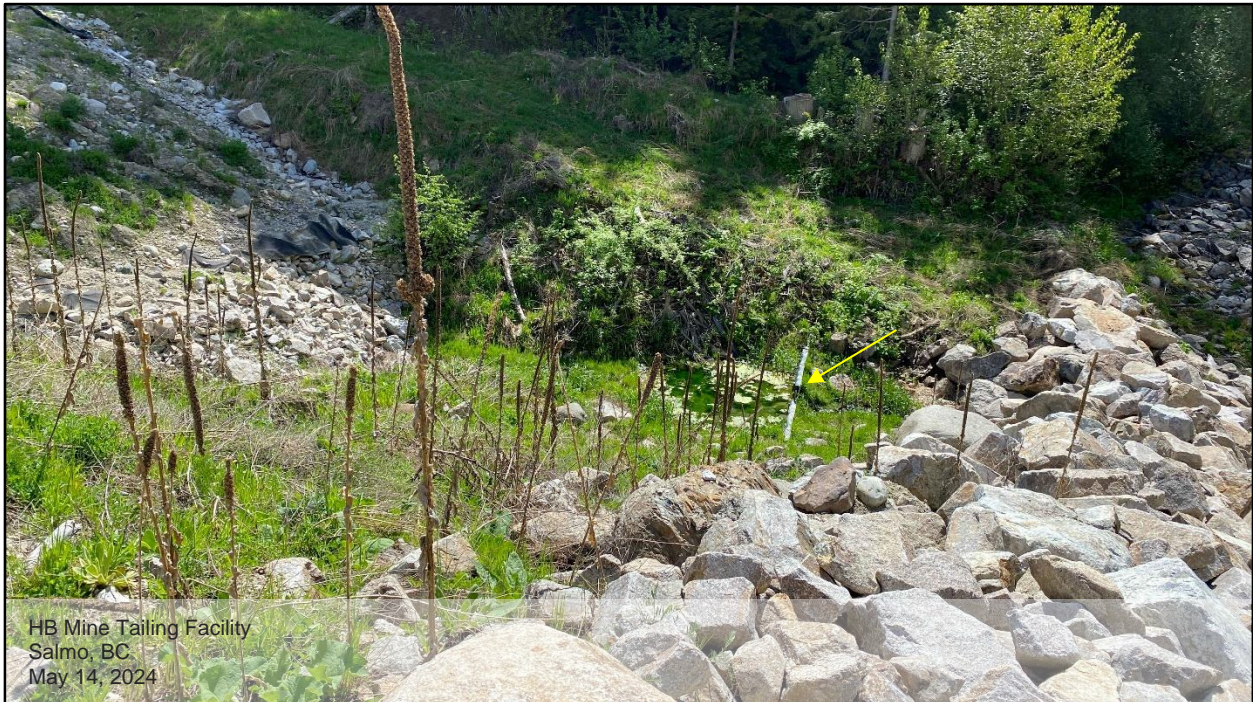
**Photo D.17: View of the downstream toe, looking east. A seepage V-notch weir (yellow arrow) situated at the downstream toe of the expended berm measures the dam seepage flow rate manually. The seepage water at the downstream toe was clear with no turbidity.**

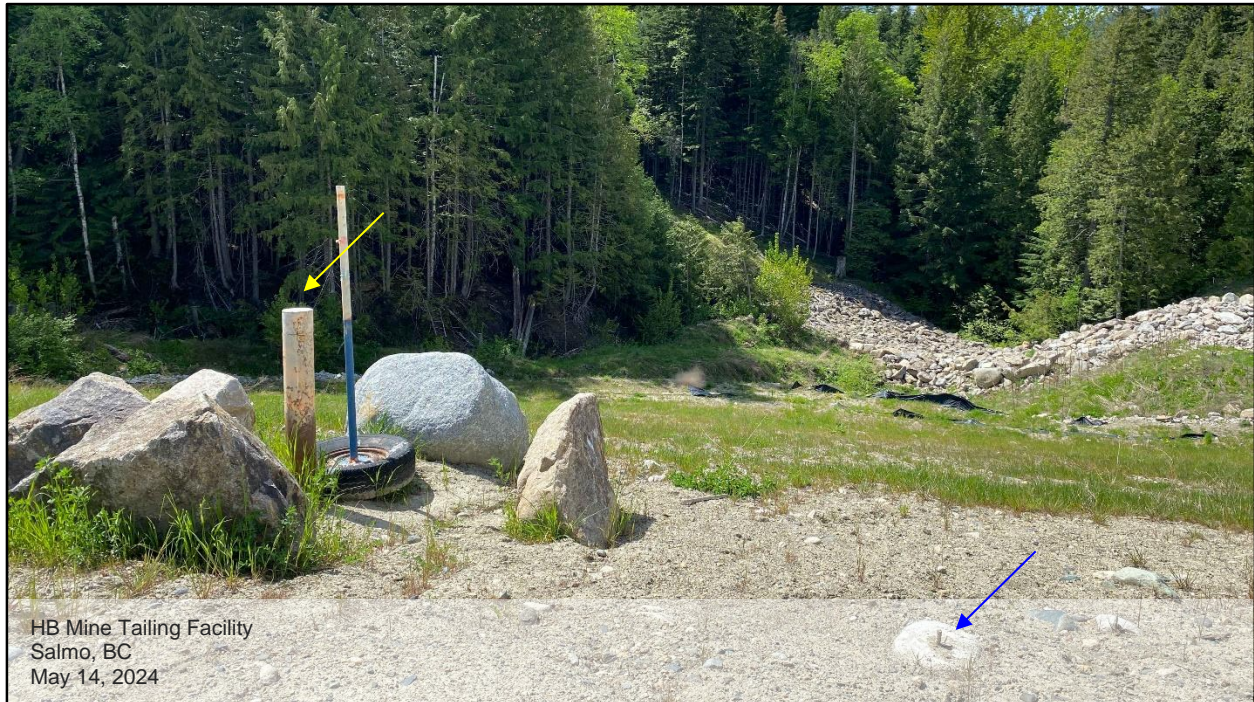
**Photo D.20: A close view of the survey hub H11, located at the downstream slope of the expanded berm.**

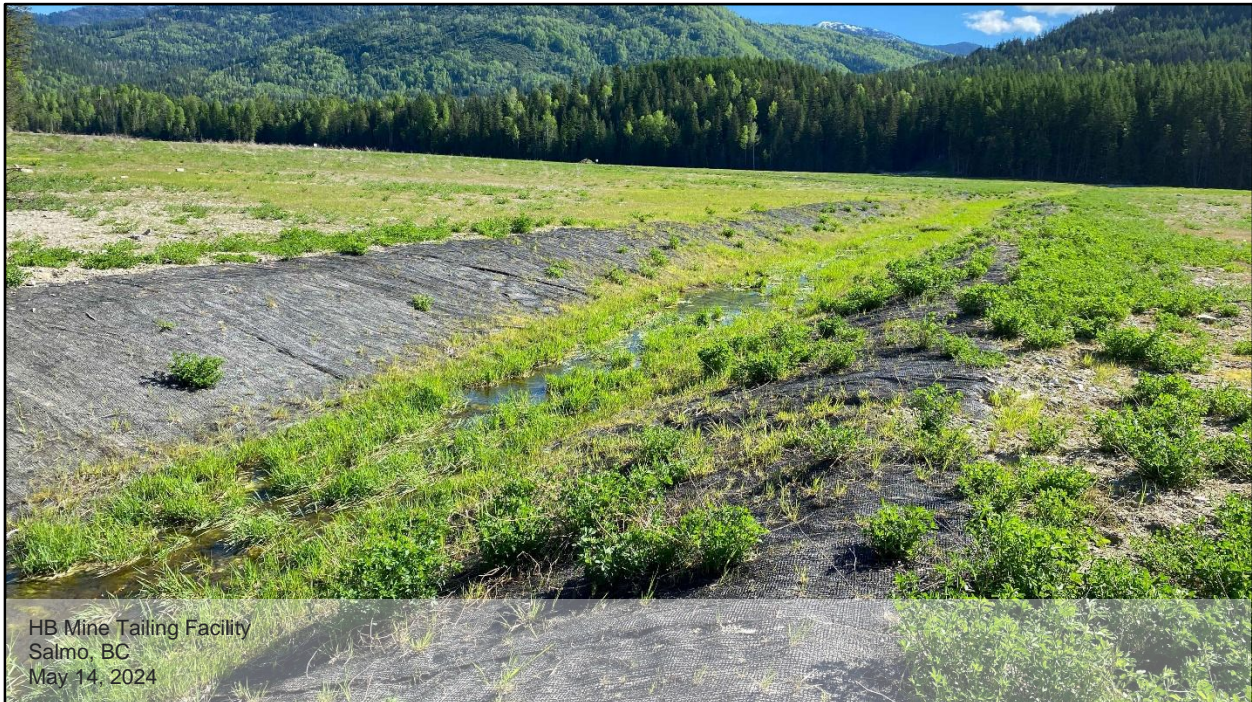
**Photo D.25: General view of the tailing impoundment area and Main Channel, looking northeast. An erosion control blanket has been placed throughout the bottom and slope of the channels.**

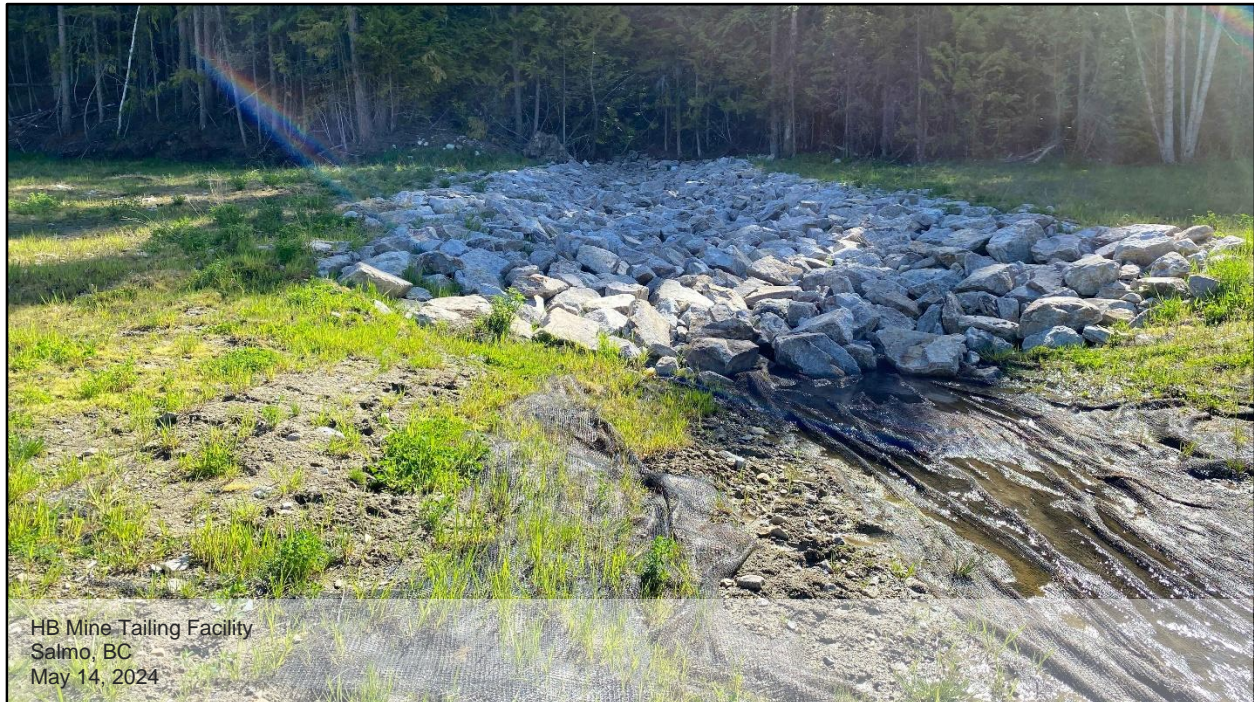
**Photo D.29: View of the South Spur Channel inlet and Energy Dissipation Structure (SSCED), looking east.**

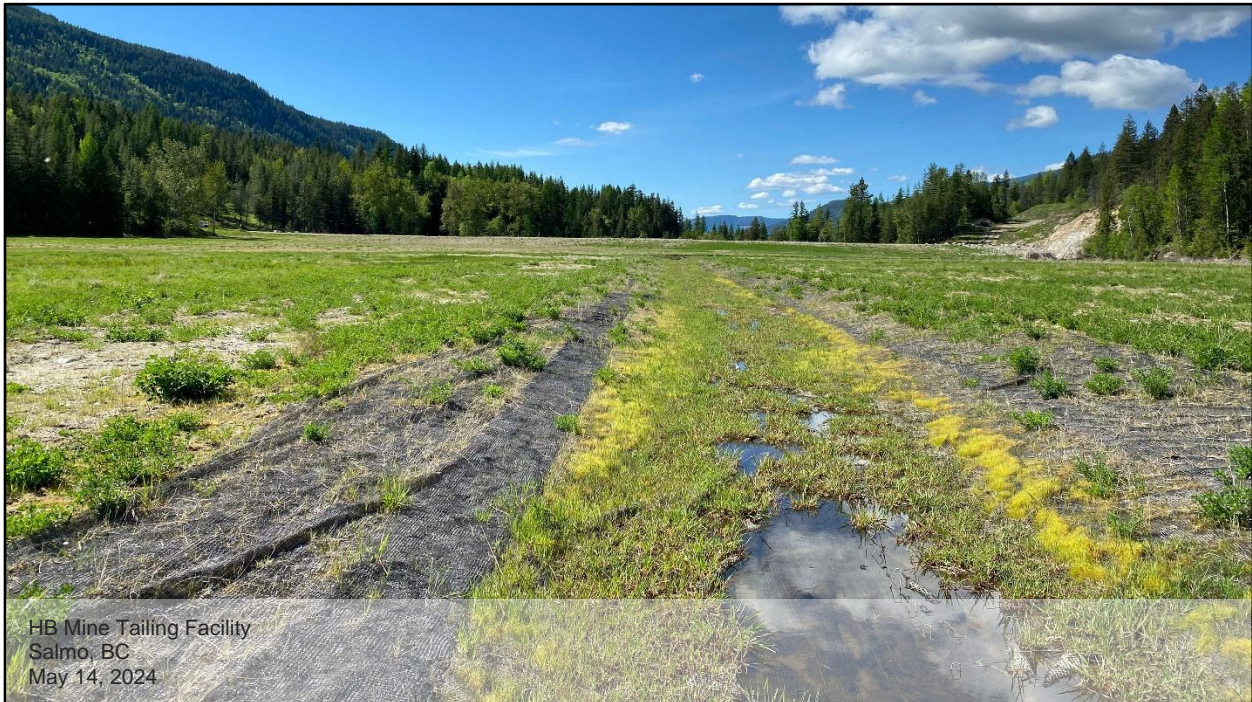
**Photo D.33: General view of the upstream side of the dam, tailing impoundment area, and Tailings Surface Drainage Channel (Main Channel), looking south. Grassy vegetation is growing along most areas of the channels that needs to be monitored and removed.**
