2025 Annual Facility Performance Report – HB Mine Tailings Facility

Salmo, BC

SRK Consulting (Canada) Inc. ■ CAPR003603 ■ February 2026

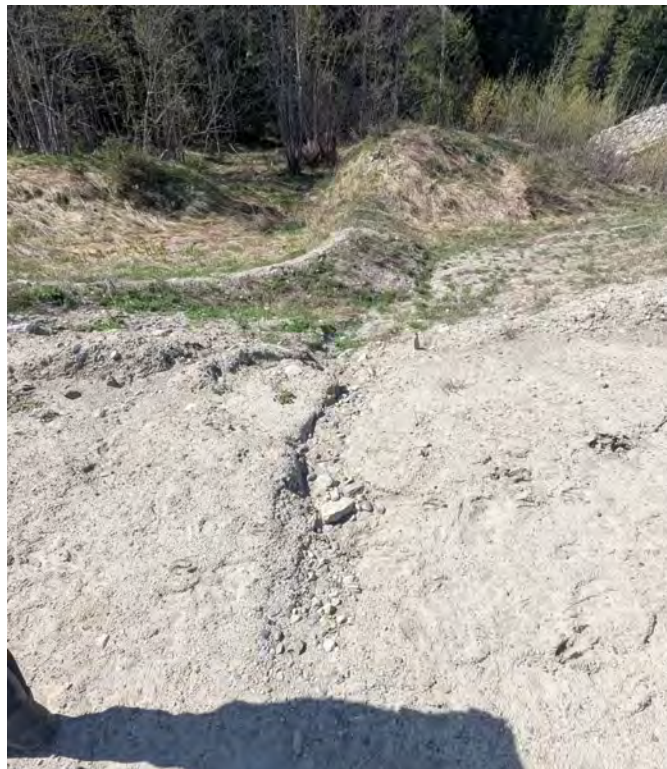
Photo 27: Erosion gully in the toe berm crest near the east abutment. Due to concentrated flow from the toe berm crest.

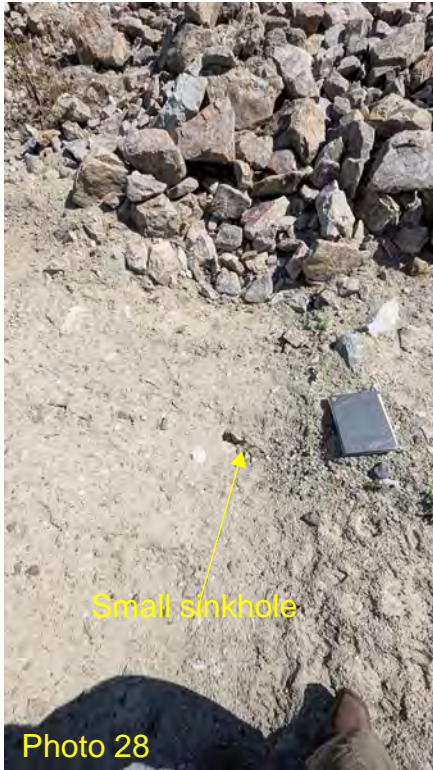
Photo 28 and 29: Small sinkhole on the toe berm crest near the east abutment caused by settlement of till into the underlying weighted filter. Approx 10 cm diameter; 15 cm deep.

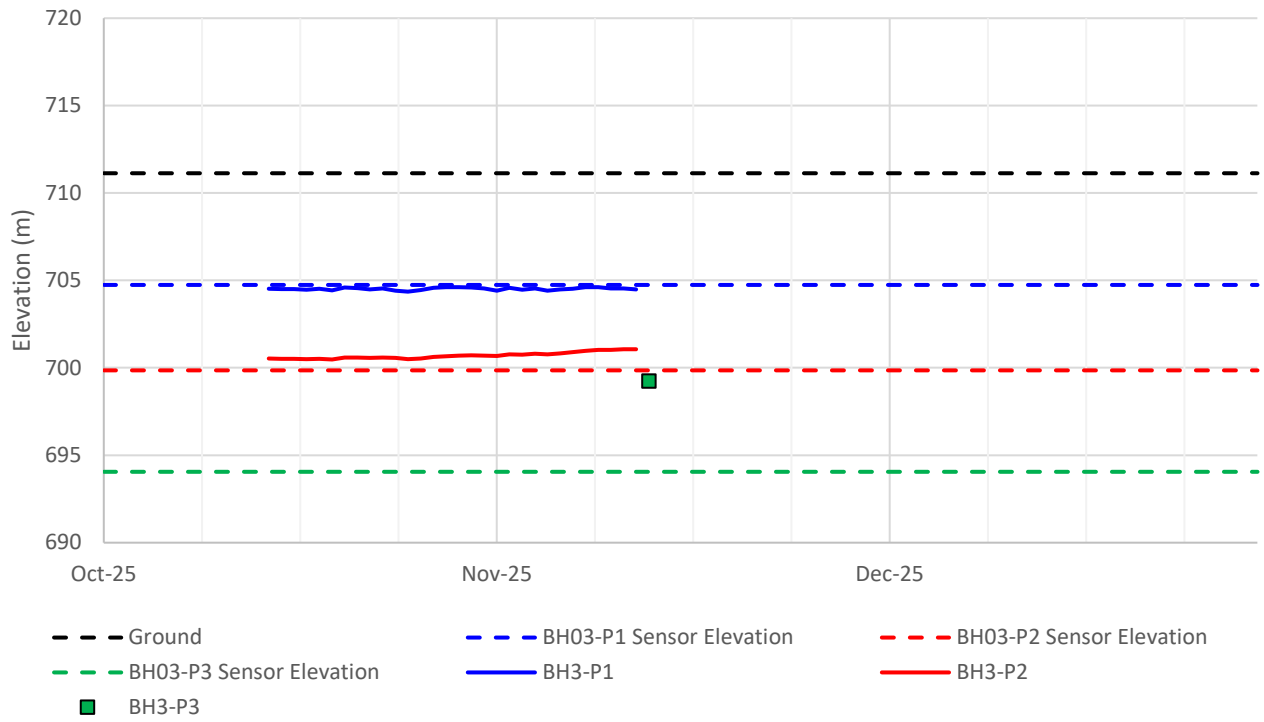
SRK25-BH03 Vibrating Wire Piezometers

1. There is an issue with one of the datalogger channels that results in the BH-P3 data not being recorded. The single BH3-P3 reading on November 13 , 2025 was manually recorded.

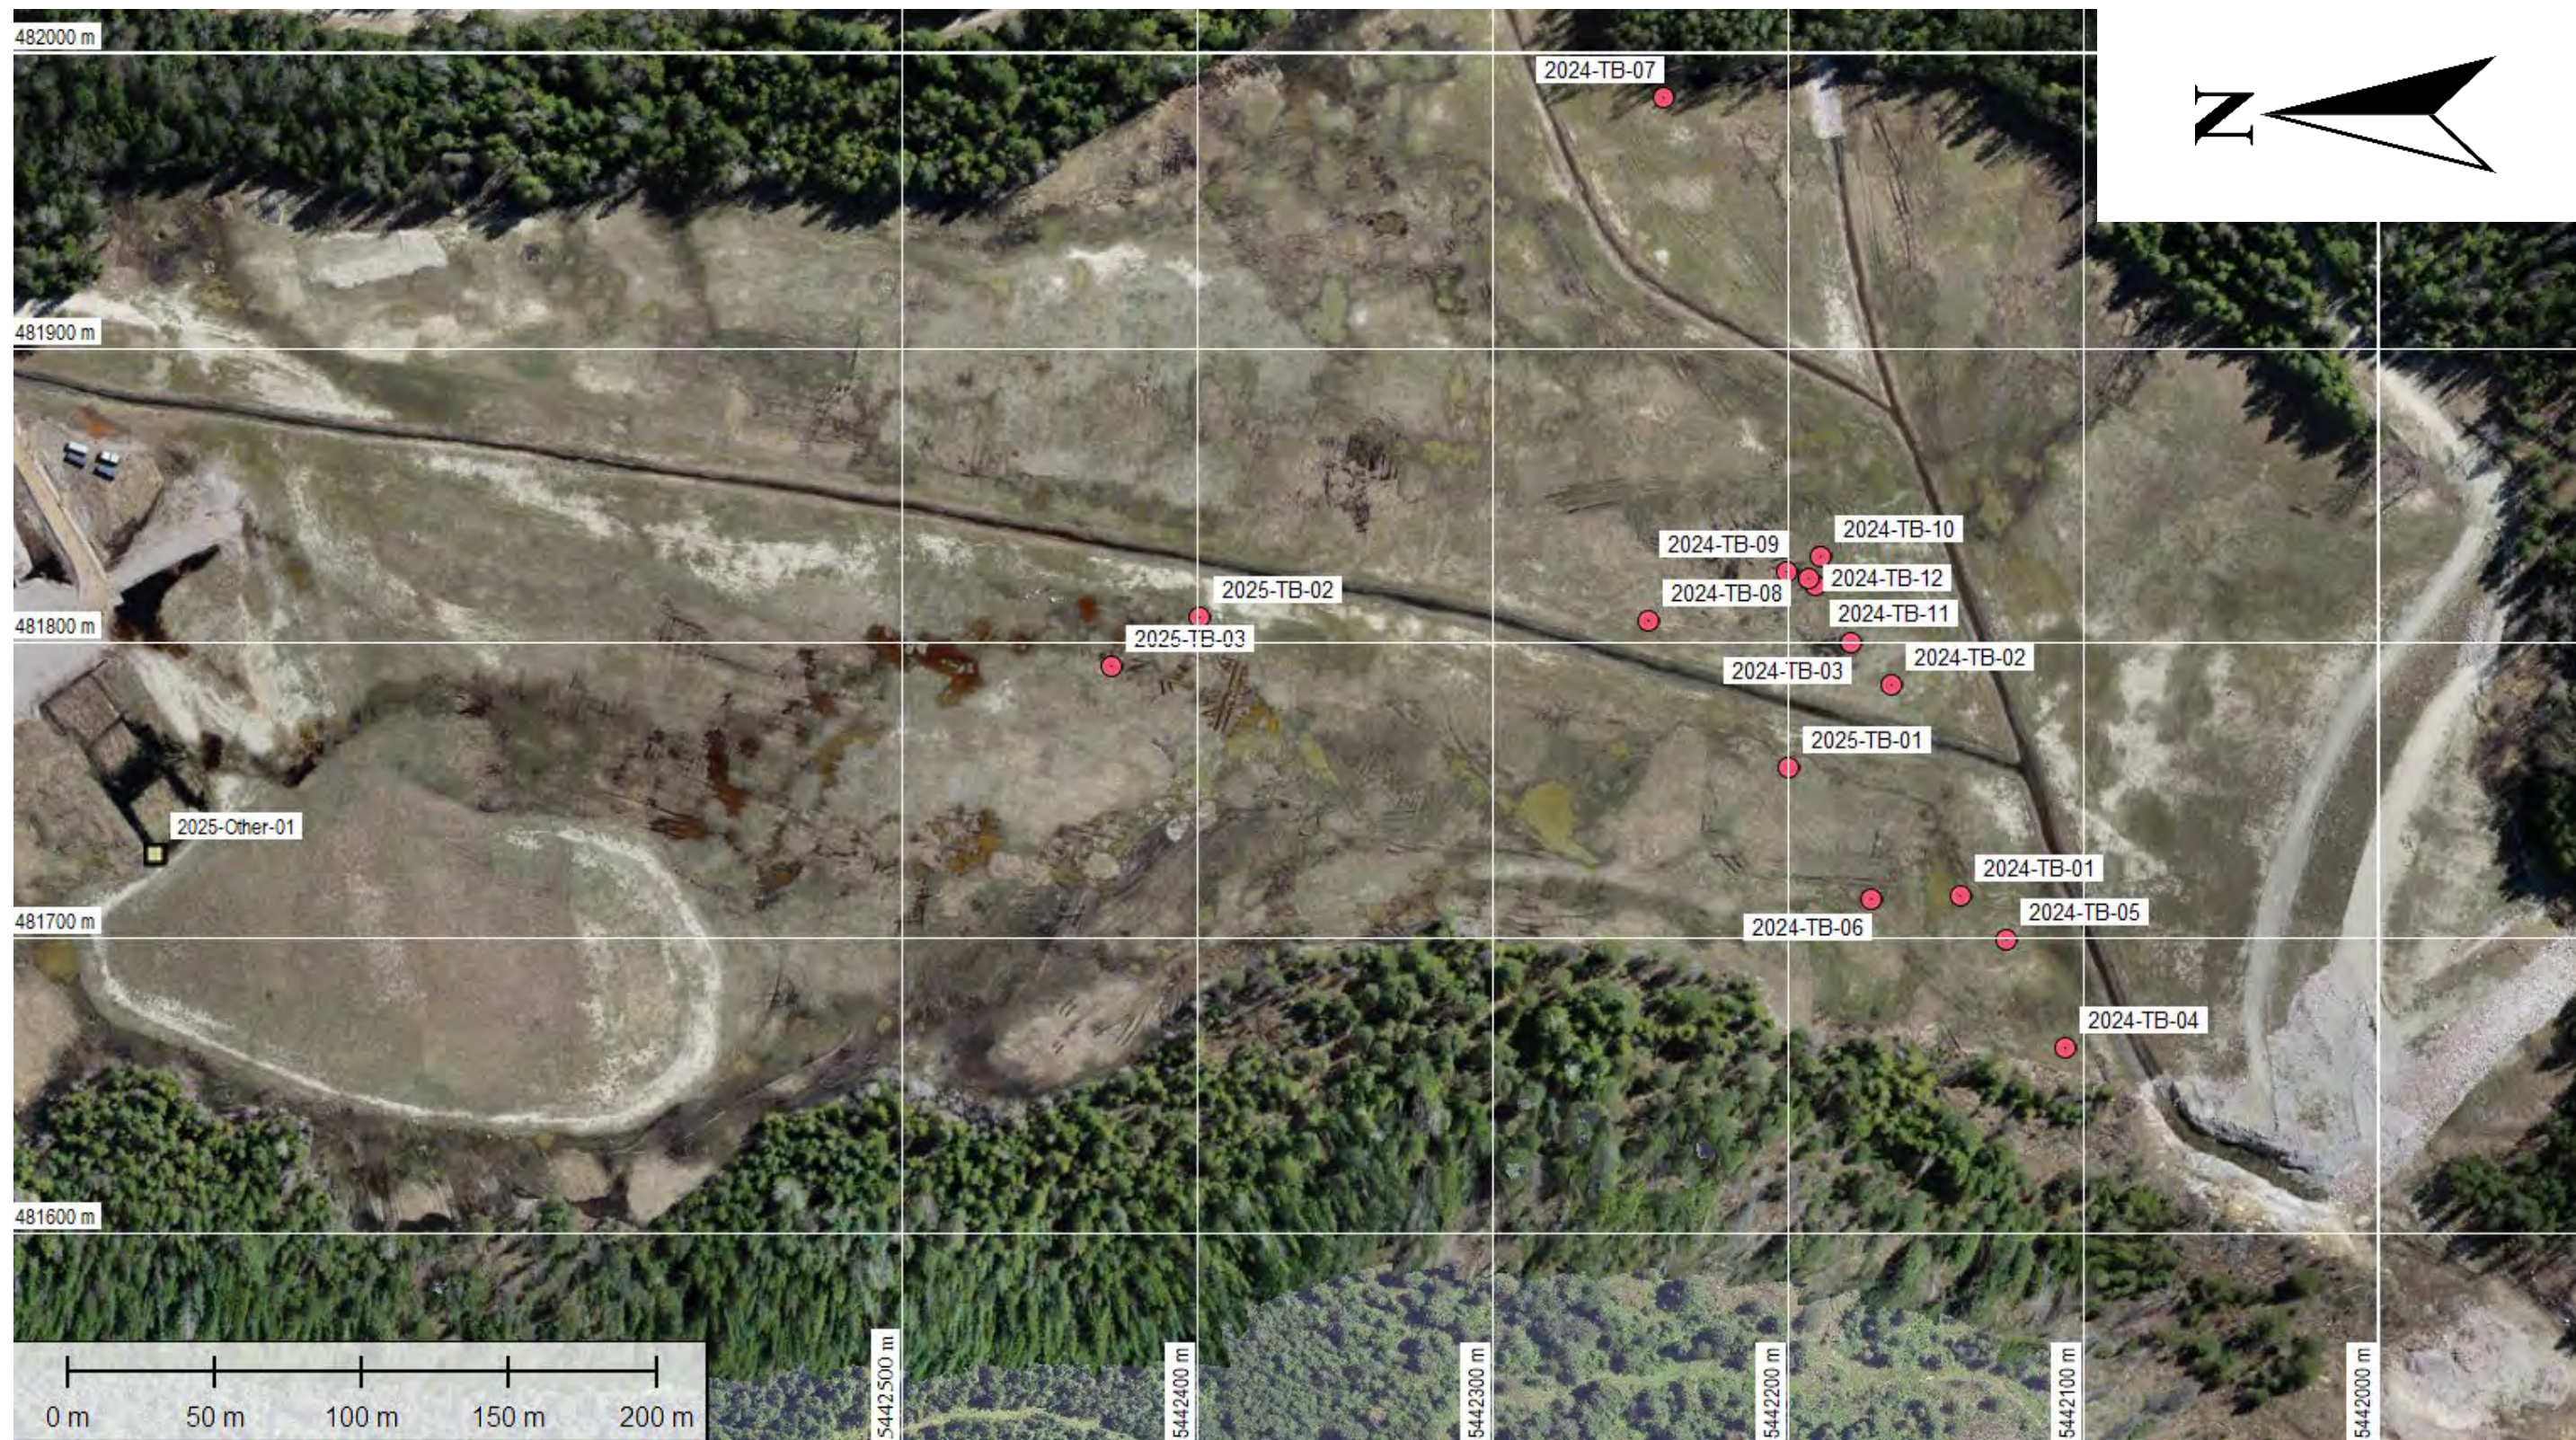
HB Mine Tailings Facility	2025 Cover Inspection		
		Tailings Exposure Locations		
		Date: Dec 2025	Approved: P. Mikes	Figure: 1

On July 29, 2025, all identified tailings exposures were excavated using hand-shovels and 5-gallon buckets and placed in a low-lying area adjacent to the Ross Landform. The area was then covered with the adjacent stockpile from the Central Landfill operations. The disposal location is identified as “2025-Other-01) in Figure 1 – Attachment 2.

1. Drone orthophoto of the tailings area taken on April 16, 2025
2. Tailings Exposures observed on site inspections on May 14, 2024, and April 28, 2025.
3. All tailings exposures were remediated on July 29, 2025. Tailings were buried adjacent to the Ross Landform near the north end of the tailings area on July 29, 2025.

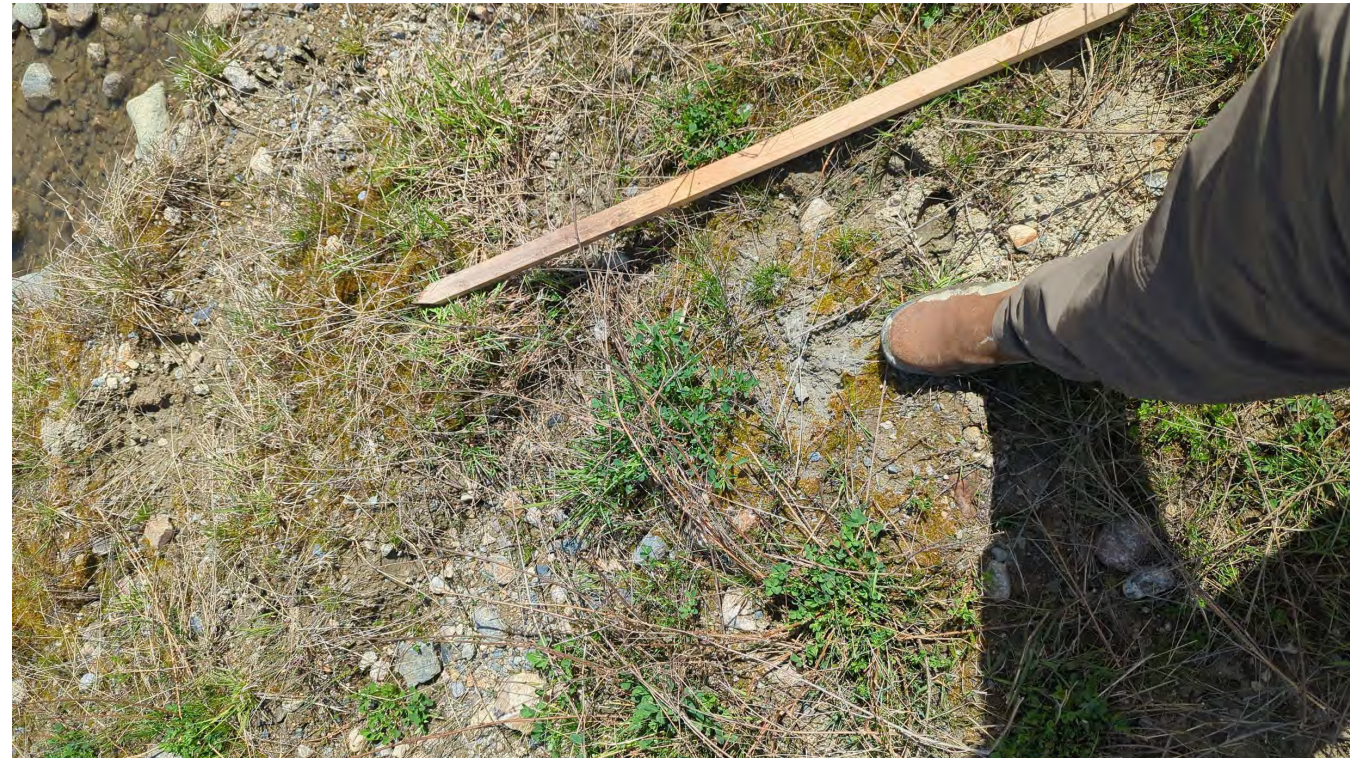
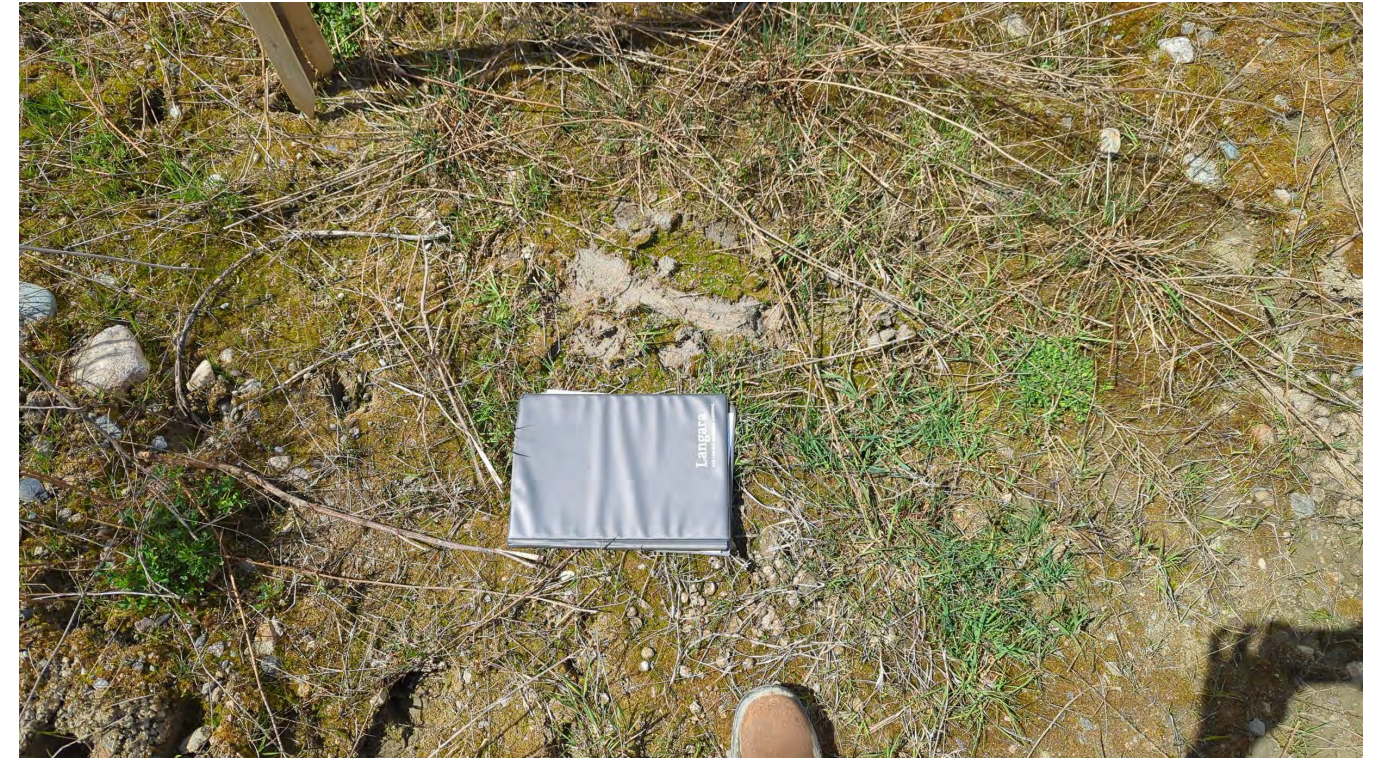
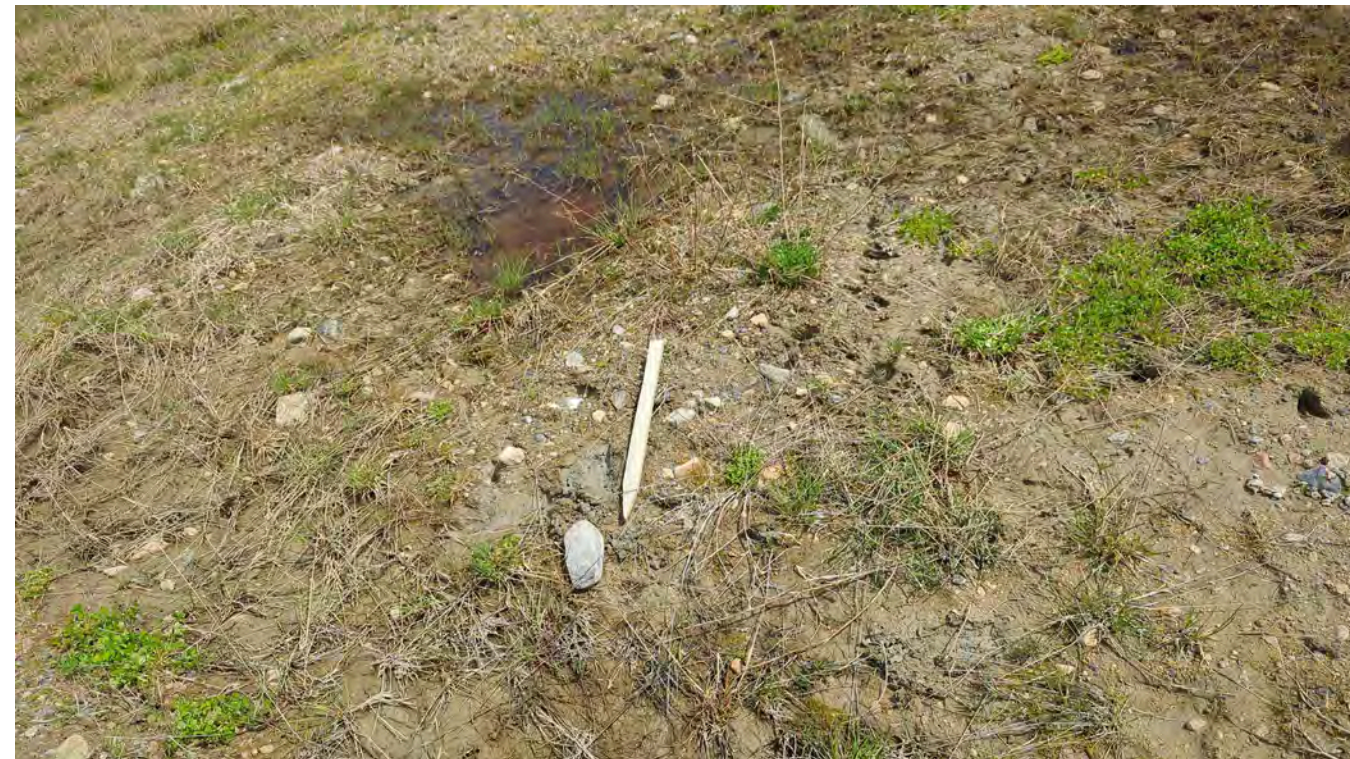
2025 Cover Inspection		
		2025 Tailings Exposure Photographs		
Job No: CAPR003603 Filename: HBTf_2025_CoverInspection_PhotoLog.pptx	HB Mine Tailings Facility	Date: Dec 2025	Approved: P. Mikes	Figure: 2

All three tailings exposures are believed to be remnants from the 2021-2022 cover construction due to the presence of mossy vegetation on the tailings (Figure 2 – Attachment 2). The mossy vegetation was also present on the exposures observed in 2023 and 2024. No changes in condition were observed to the previously identified features.

1. Tailings Exposures observed on a site inspection on April 28, 2025.

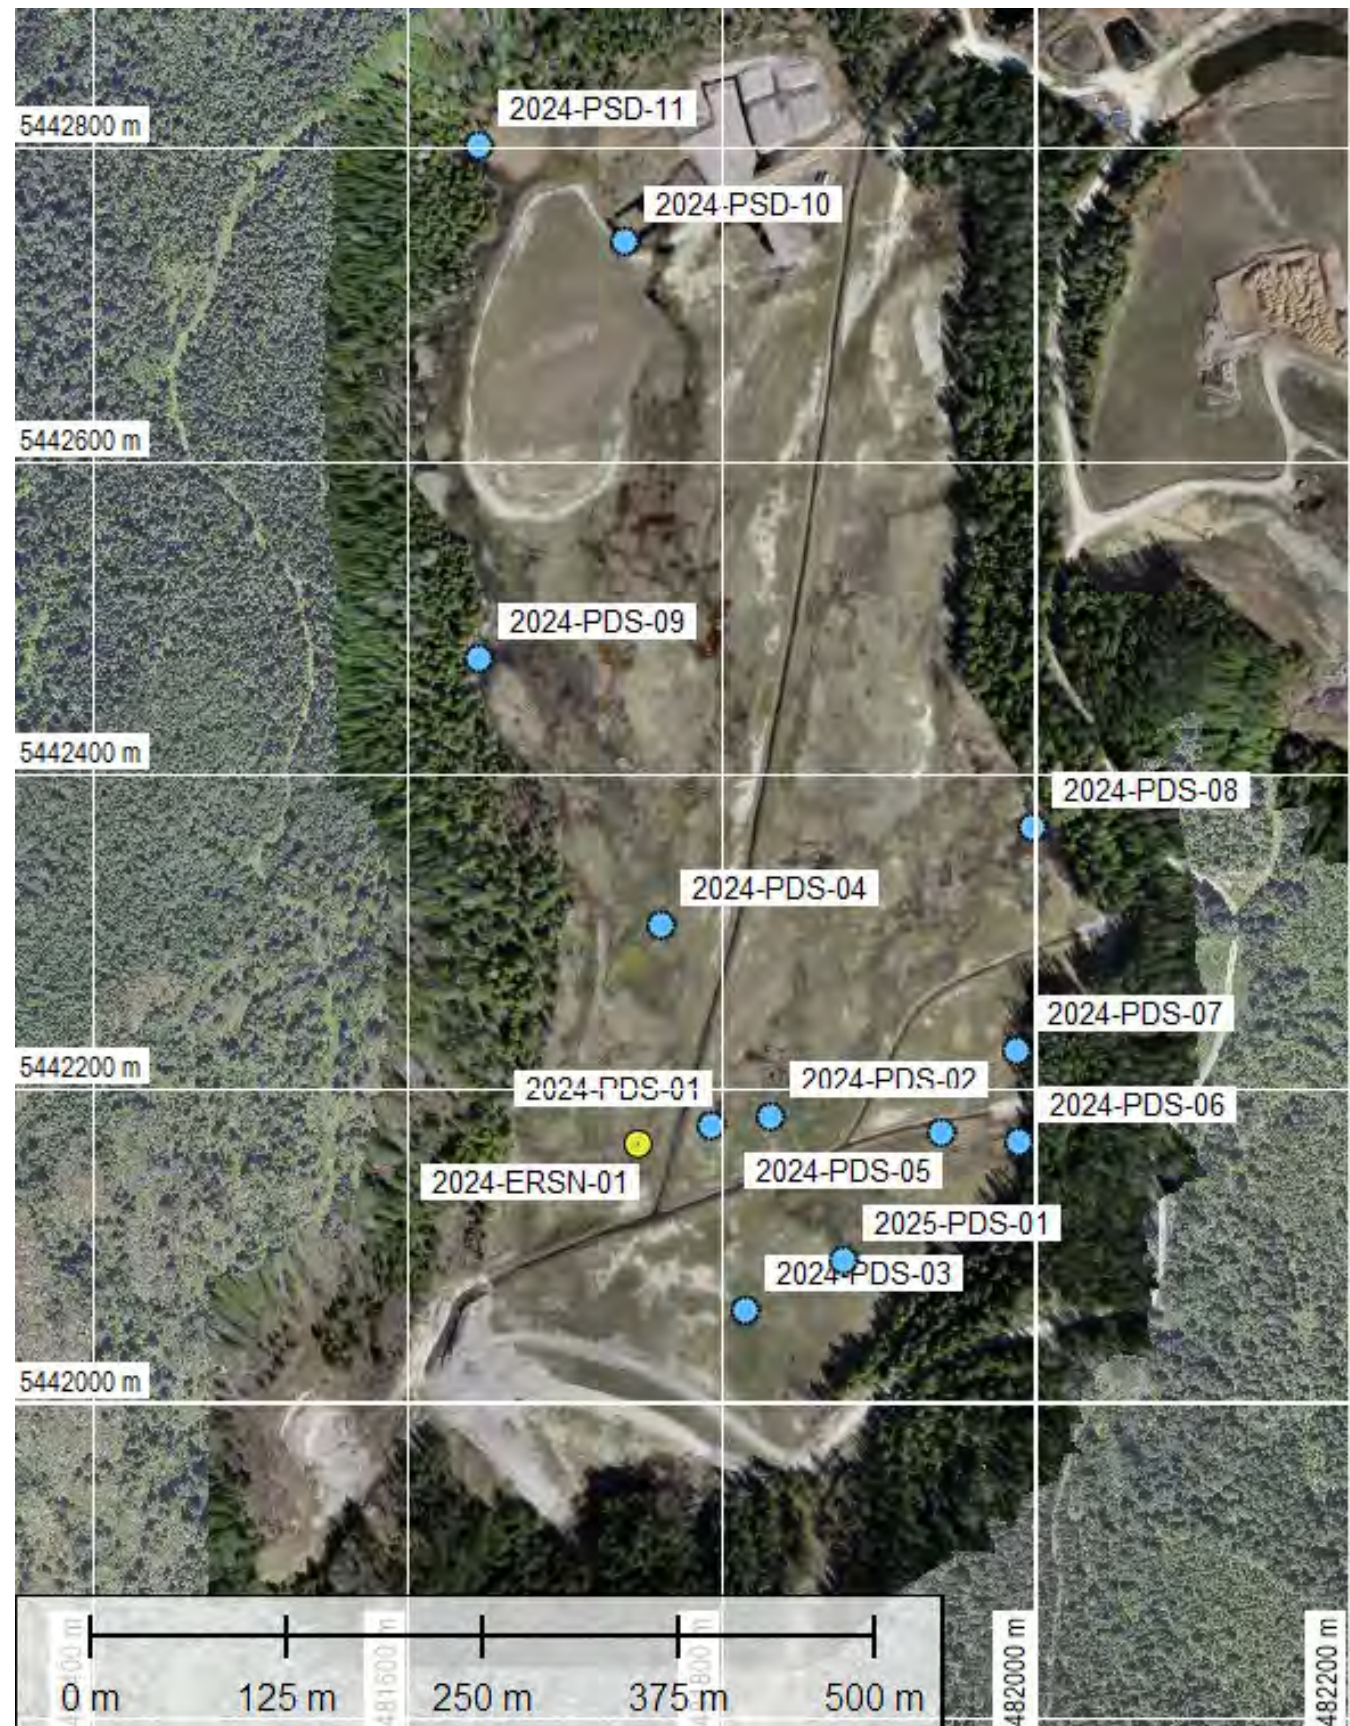
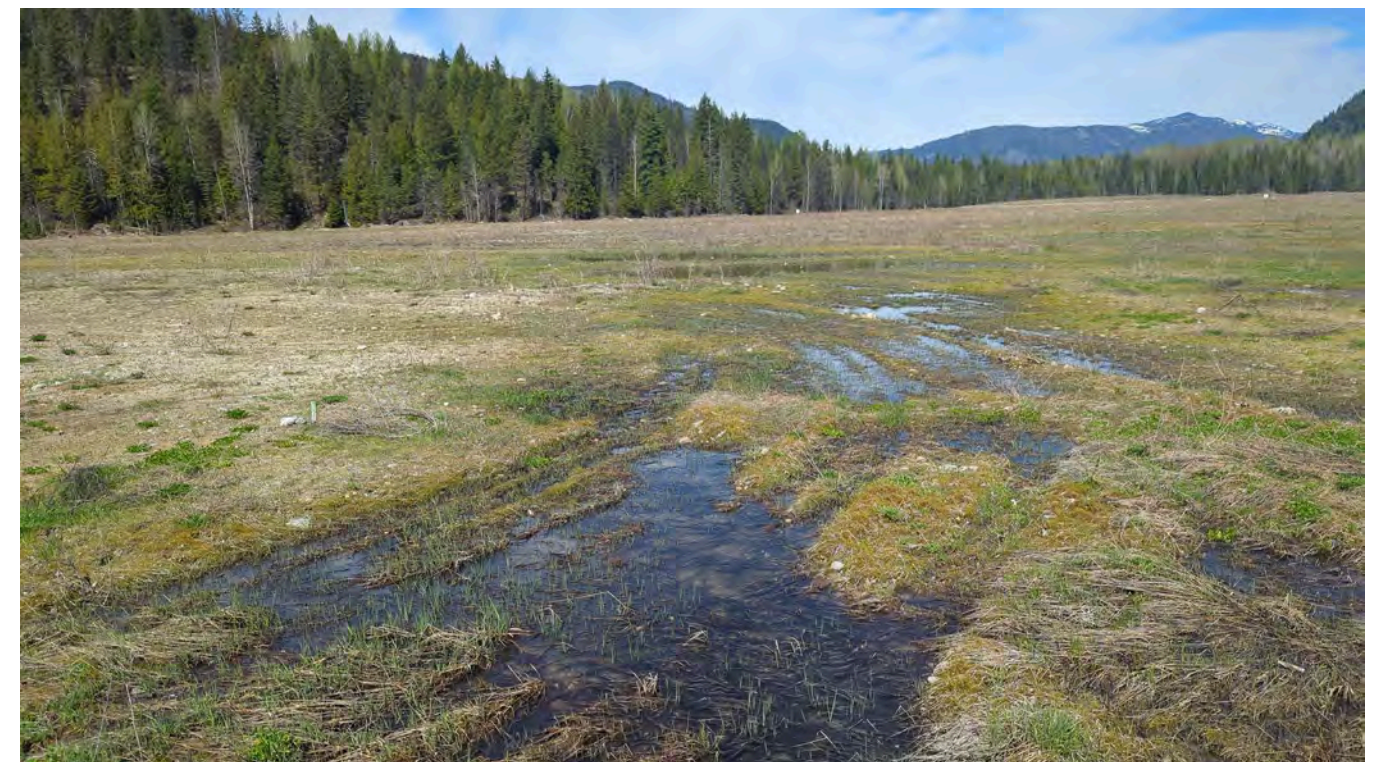
2025 Cover Inspection		
		2025 Erosion and Ponding Observations		
Job No: CAPR003603 Filename: HBTF_2025_CoverInspection_PhotoLog.pptx	HB Mine Tailings Facility	Date: Dec 2025	Approved: P. Mikes	Figure: 3

1. Site inspection on April 28, 2025

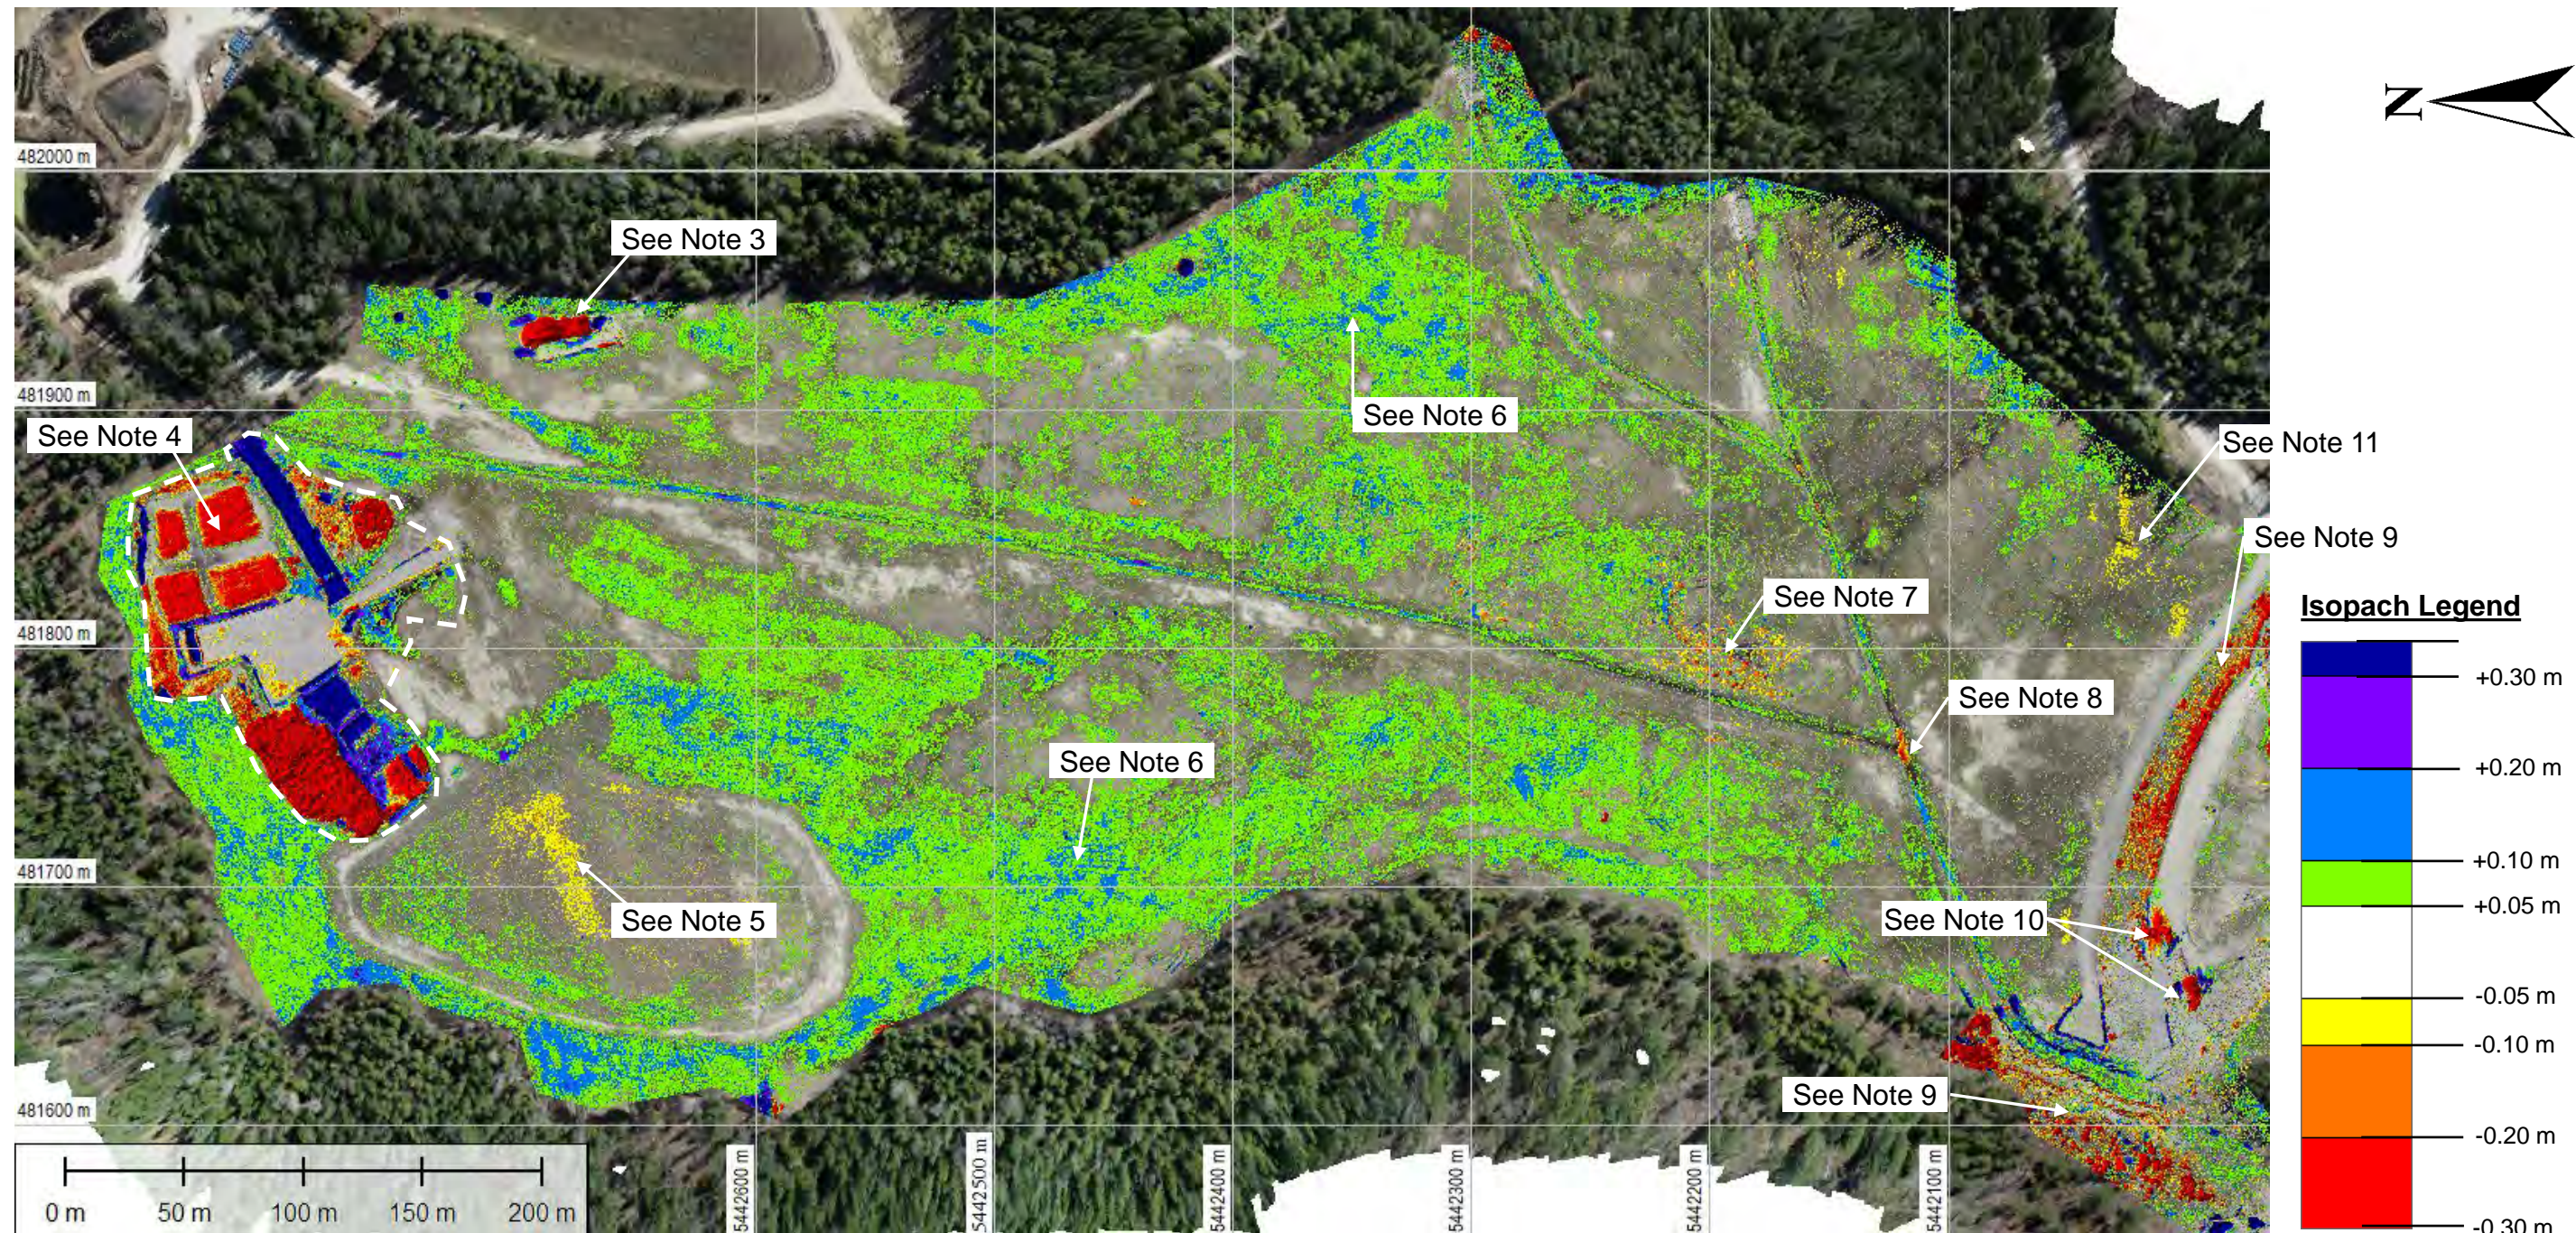
2025 Cover Inspection		
		Cover Differential Settlement Review		
Job No: CAPR003603 Filename: HBTf_2025_CoverInspection_PhotoLog.pptx	HB Mine Tailings Facility	Date: Dec 2025	Approved: P. Mikes	Figure: 4

Figure 4 in Attachment 2 presents an isopach 2025 drone cover surface (April 16, 2025) minus the 2022 construction asbuilt survey (September 13, 2022). The survey data indicates that minimal differential settlement of the tailings cover has occurred generally less than 10 cm.

1. Isopach is a comparison of the April 16 2025 drone cover survey to the 2022 construction asbuilt survey.
2. The 2025 was adjusted downward by 0.405 m to match the 2022 survey using control points near the HB Dam. The accuracy of the isopach may decrease to the north.

10. Two red areas on the 2012 HB Dam Repair Zone is due to material excavated from these areas in 2023 for spillway maintenance. Excess riprap material from the 2021-22 construction was stockpiled in this area. The removal of this material is not a dam safety concern.

11. Area of differential settlement. The amount of settlement observed is within the predicted settlement range and does not impact drainage.

Additional details of the survey cover review are provided in Figure 4 in Attachment 2. No actions are required to address settlement.

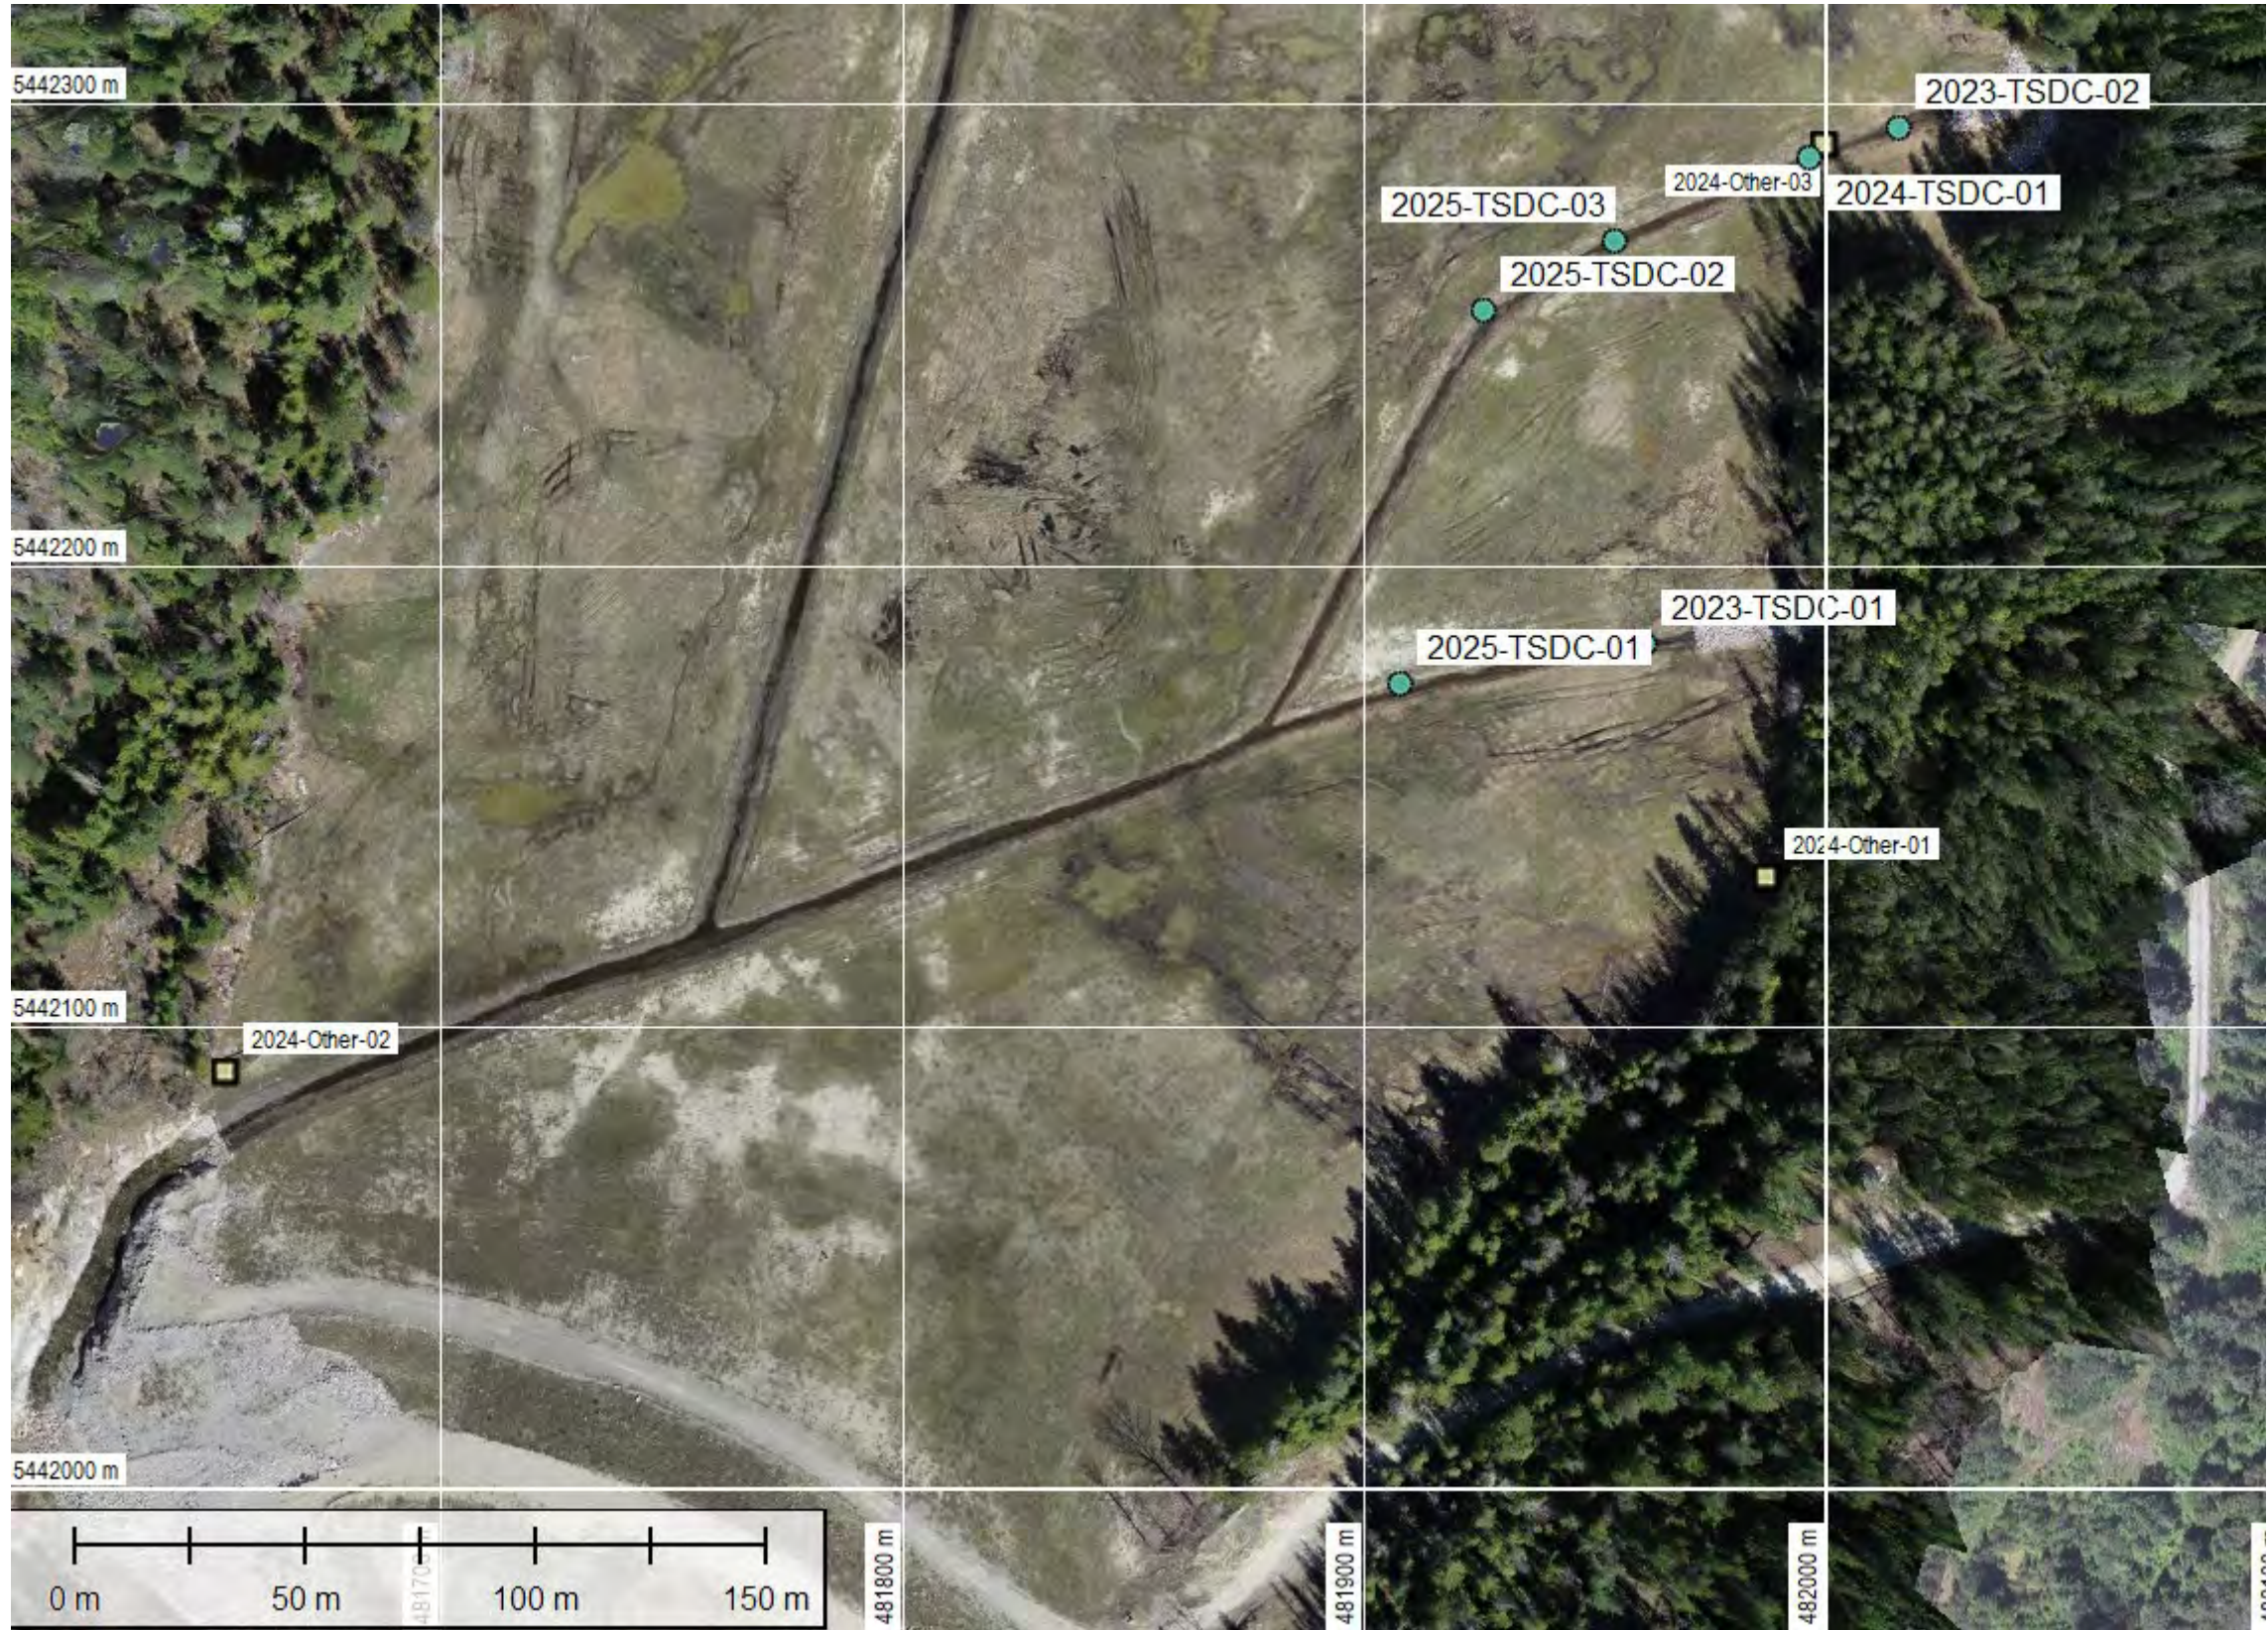
2025 Cover Inspection		
		2025 Tailings Surface Drainage Channel and Other Observations		
Job No: CAPR003603 Filename: HBTF_2025_CoverInspection_PhotoLog.pptx	HB Mine Tailings Facility	Date: Dec 2025	Approved: P. Mikes	Figure: 5

Three additional features were noted in the 2025 inspection (Figures 5 to 7 in Attachment 2. These features should continue to be monitored with no action required at this time.

1. Drone orthophoto of the tailings area taken on April 16, 2025
2. Location of 2025-Other-01 can be found on Figure 1.
