2025 Annual Facility Performance Report – HB Mine Tailings Facility

Salmo, BC

SRK Consulting (Canada) Inc. ■ CAPR003603 ■ February 2026

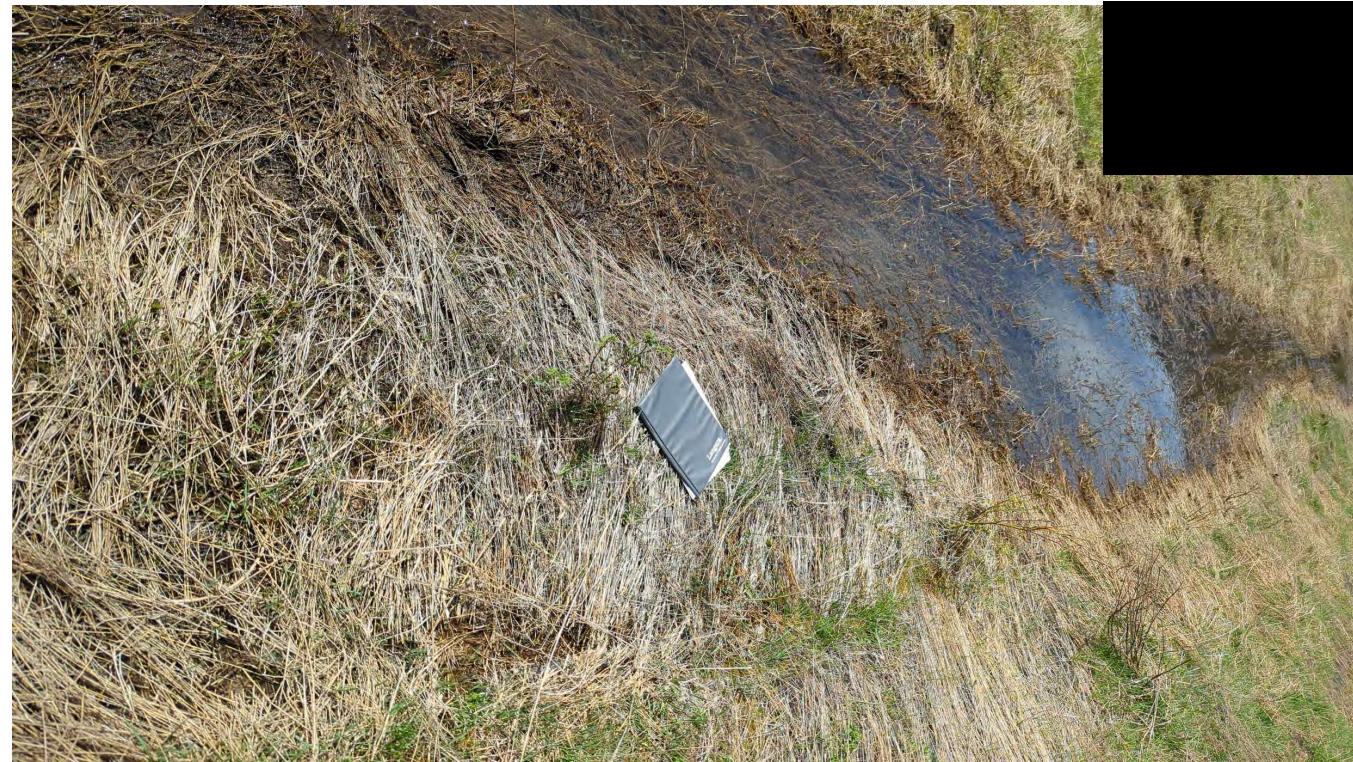
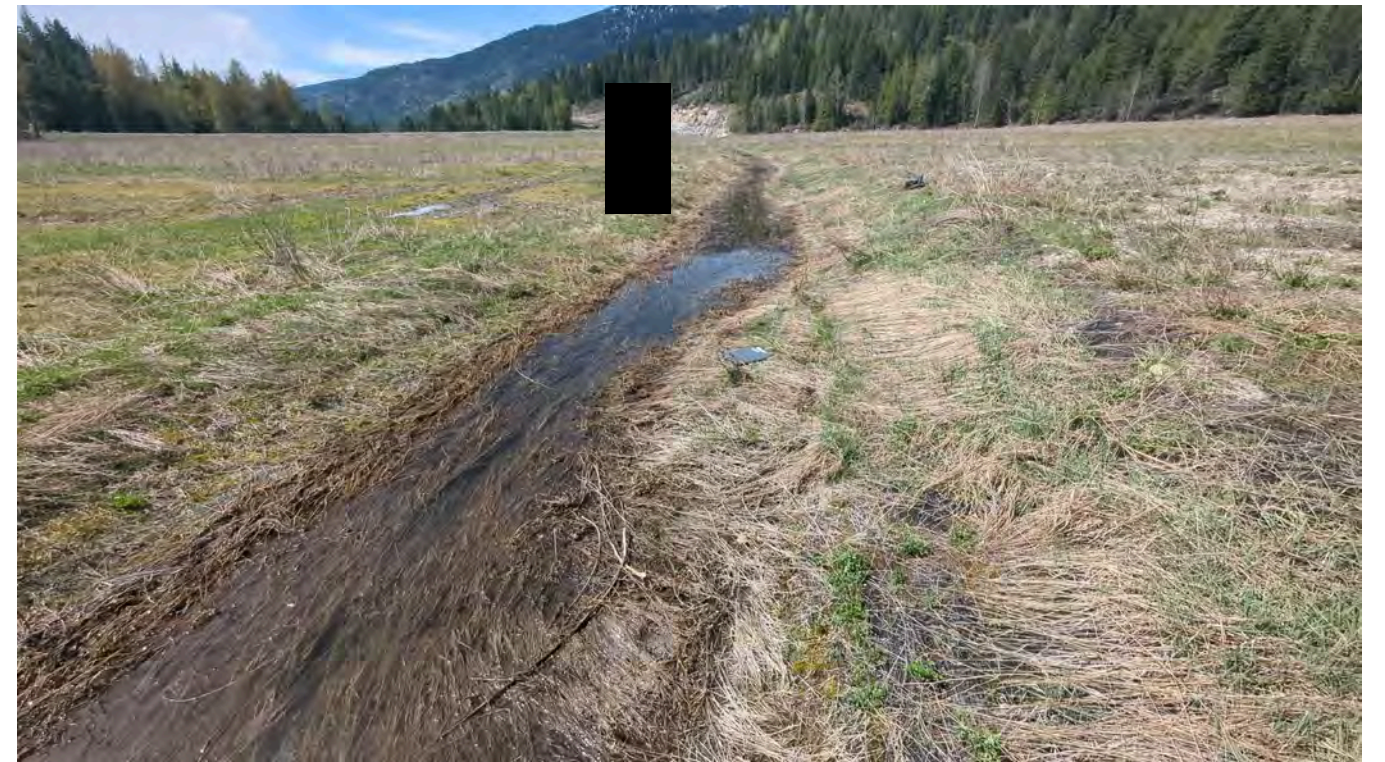
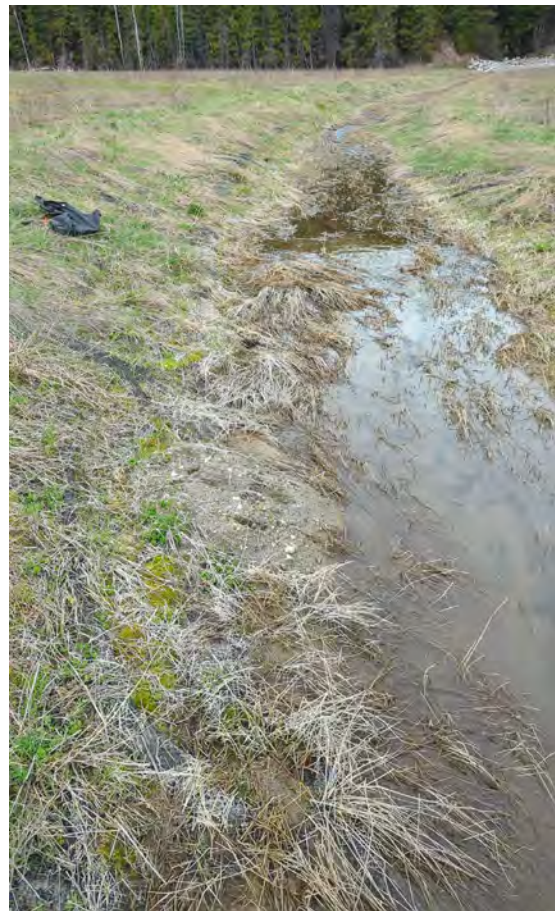
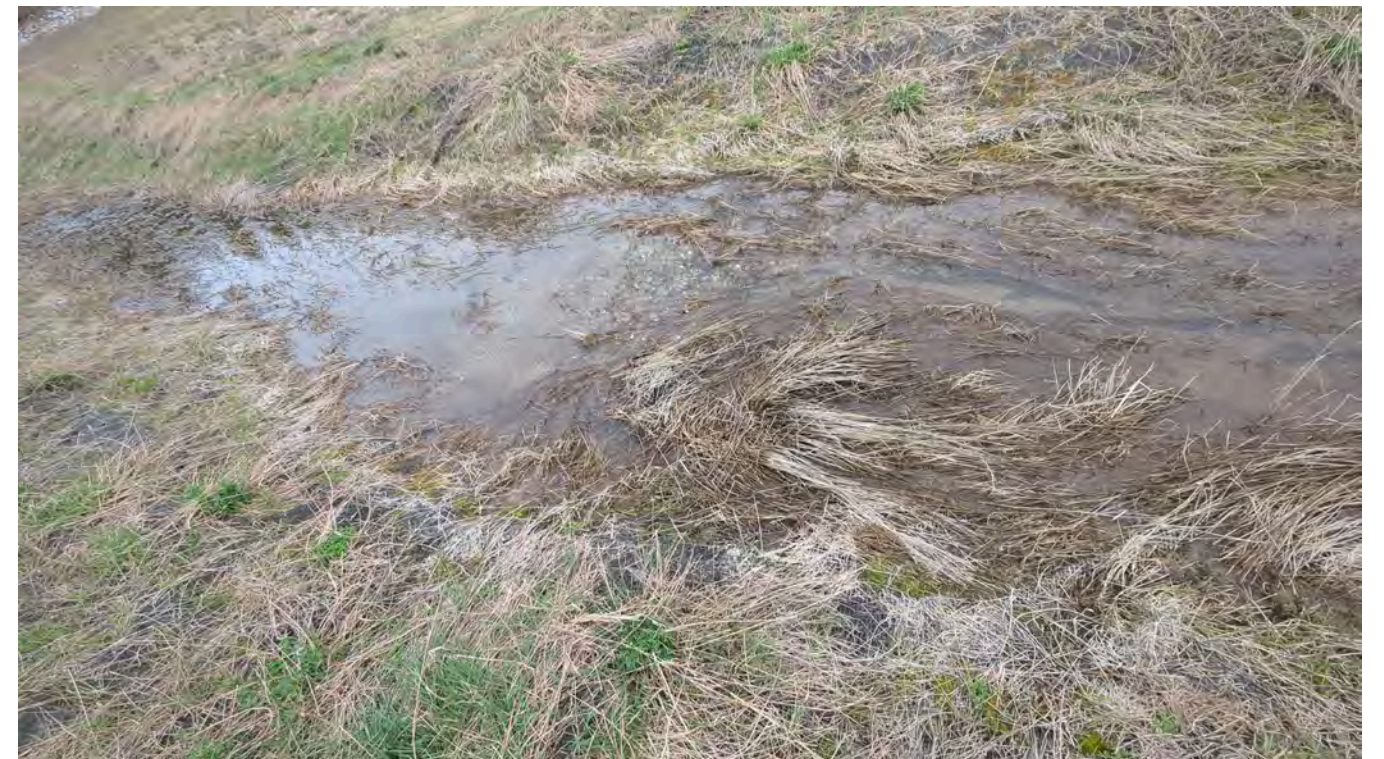
2025 Cover Inspection		
		2025 Tailings Surface Drainage Channel and Other Observations		
Job No: CAPR003603 Filename: HBTf_2025_CoverInspection_PhotoLog.pptx	HB Mine Tailings Facility	Date: Dec 2025	Approved: P. Mikes	Figure: 6

Three additional features were noted in the 2025 inspection (Figures 5 to 7 in Attachment 2. These features should continue to be monitored with no action required at this time.

1. Site inspection on April 28, 2025
