BC Ministry of Forests

# POST-WILDFIRE NATURAL HAZARDS RISK ANALYSIS KOMONKO CREEK FIRE (N51210)

November 29, 2024

Report Number: 24.540.21

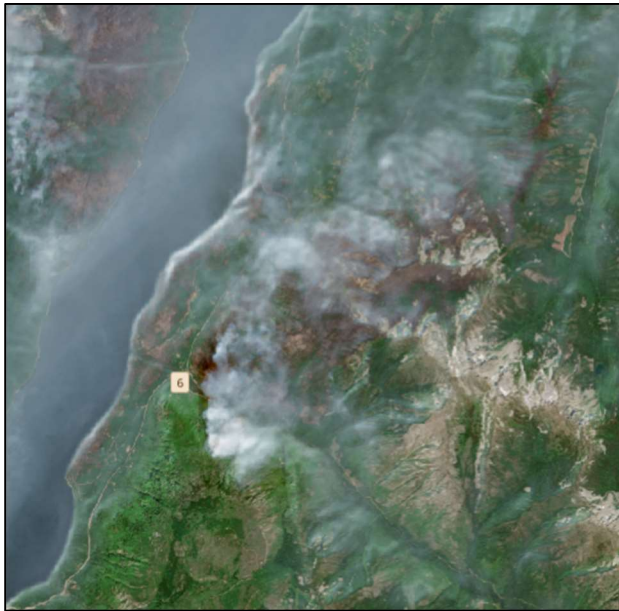
**Photo 1:** Sentinel-2 L2A Satellite imagery from August 1; the Fire is crossing the Enterprise Creek valley.

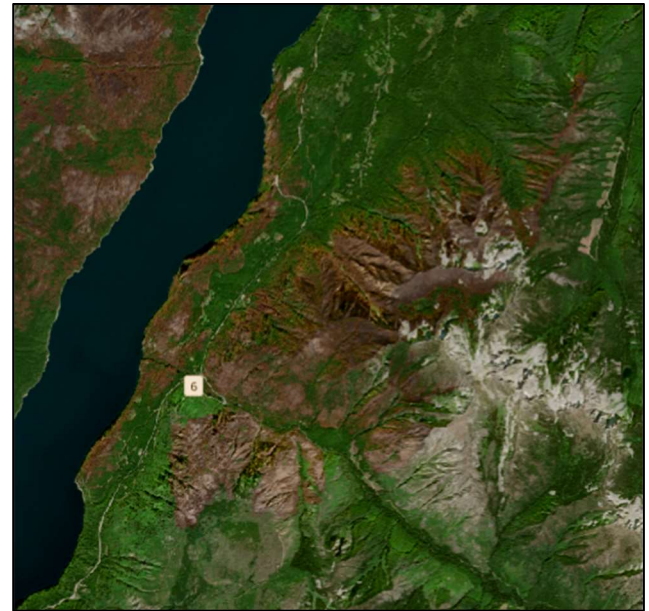
**Photo 2:** Sentinel-2 L2A Satellite imagery from August 31; the Fire appears to be out.

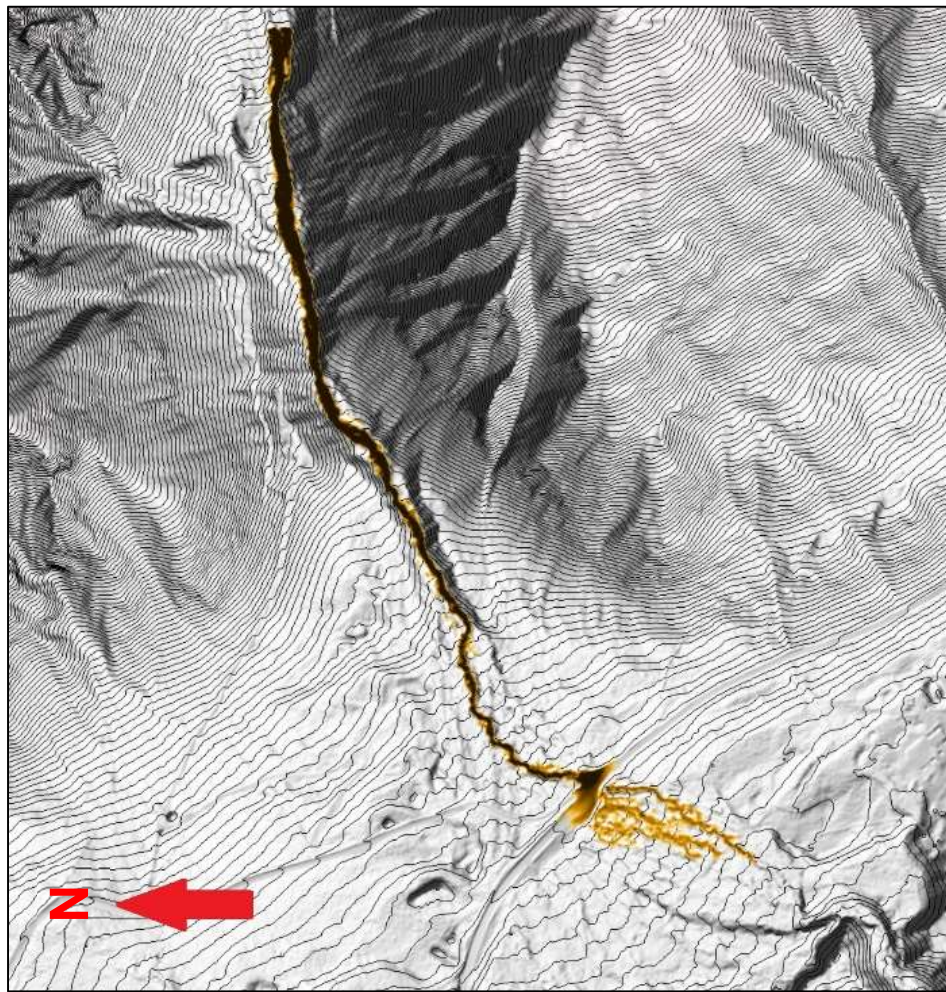
A representative model output of the Aylwin Upper Creek is shown in Figure 2. The Aylwin Upper model illustrates the dispersion plume of water and sediment. The debris crosses most of the fan in a well-confined channel and spreads out as the gradient drops near the Highway. At the Highway, the debris overflows in both directions along the road, with the majority of the flow across the RMR junction and the southbound pullout further north. Below the road, the flow finds several old channels but would likely return to the main channel relatively quickly. It is noted that debris flow events of greater volumes, or that behave differently than assumed (based on model input parameters), may runout further or into different areas. The model use was primarily as a check of field observations.

**Figure 2:** Modelled flows on Aylwin Upper Creek above the Highway. North is to the left of image.

The flow path modelling of Aylwin Upper Creek (shown in Figure 2) suggests that water and debris can reach the Highway crossing.

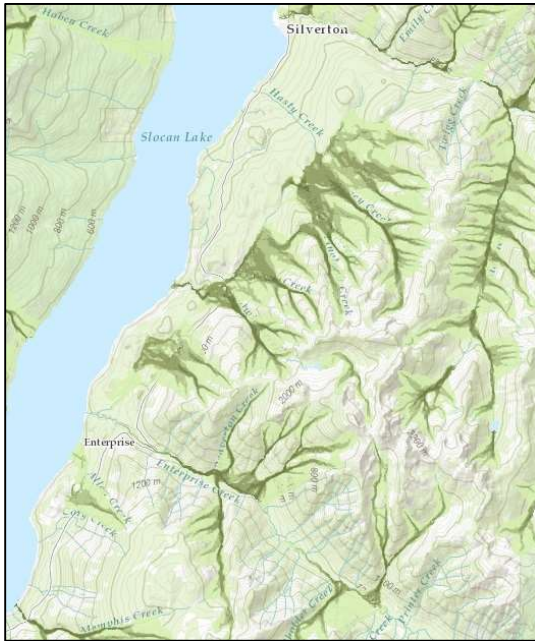
**Figure 3:** Excerpt from the Debris Flood Susceptibility Mapping (Source RDCK Cambio Communities Map). The darker the green coloration the higher the likelihood of debris flood occurrence.

Debris floods and debris flows are quite similar hydrogeomorphic<sup>21</sup> processes and these maps tend to be quite similar in their output. The majority of the creeks within the fire show on both maps as having some potential for hydrogeomorphic events. It is interesting to note that Allen Creek, on which no visible channels or active streamflow on the lower slopes above the Highway were identified during fieldwork, shows as being prone to debris floods in one channel and debris flows in another. Cory Creek, which has at least 3 channels appears to only be prone to debris flows. This lack of consistency of output suggests that these maps are limited by the level of topographic data input to their modelling.

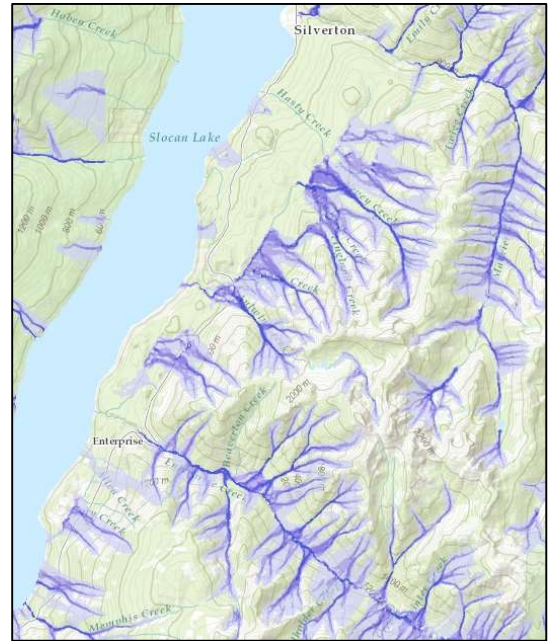
**Figure 4:** Excerpt from the Debris Flow Susceptibility Mapping (Source RDCK Cambio Communities Map). The darker the blue coloration the higher the likelihood of debris flow occurrence.

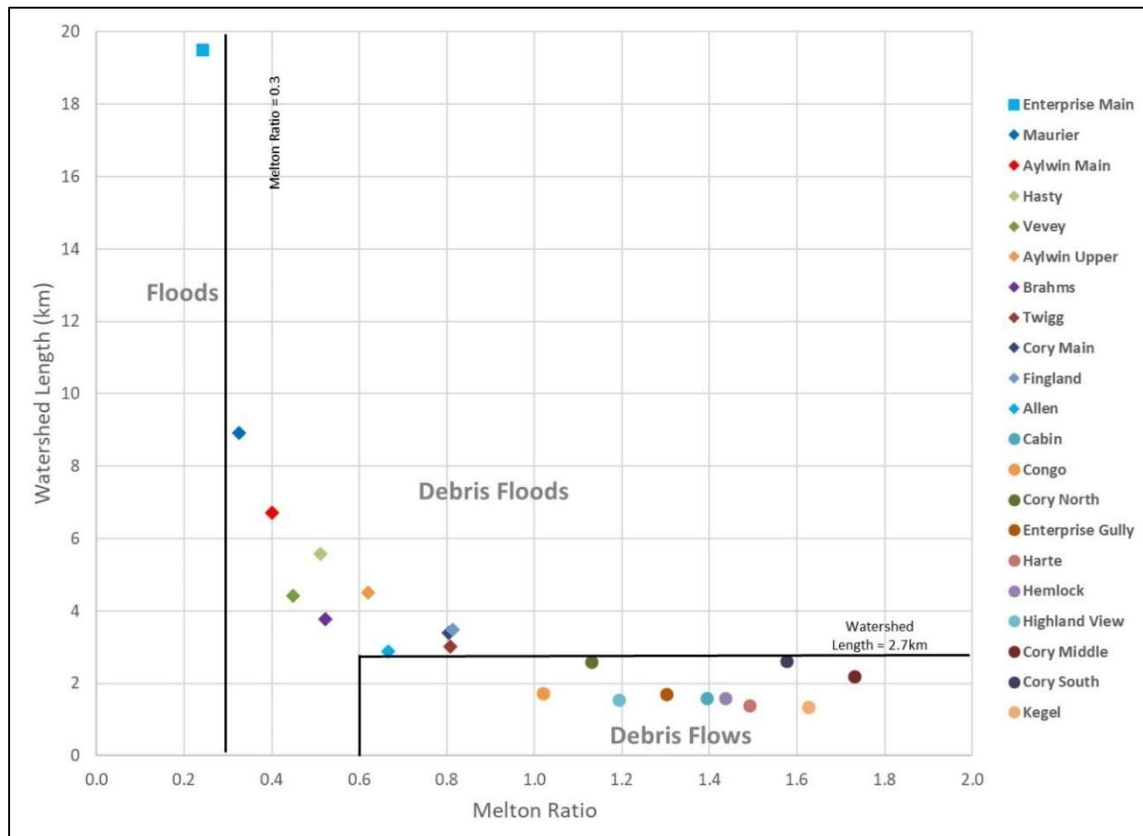
**Figure 5:** The hydrogeomorphic processes of creeks in the Fire plotted as a function of the Melton ratio and watershed length (Wilford et al. 2004).

Enterprise Creek is a large watershed in which flooding is the expected hydrogeomorphic process. All of the mid-sized watersheds between 2 and 25 km<sup>2</sup> in area and 2.7 and 10 km in watershed length (Maurier, Aylwin (Main), Hasty, Vevey, Aylwin (Upper), Brahms, Twigg, Cory (Main), Fingland and Allen), plot within the region where a debris flood is the expected hydrogeomorphic process. All of the small watersheds are short and steep and plot within the region where debris flows are the expected hydrogeomorphic process.

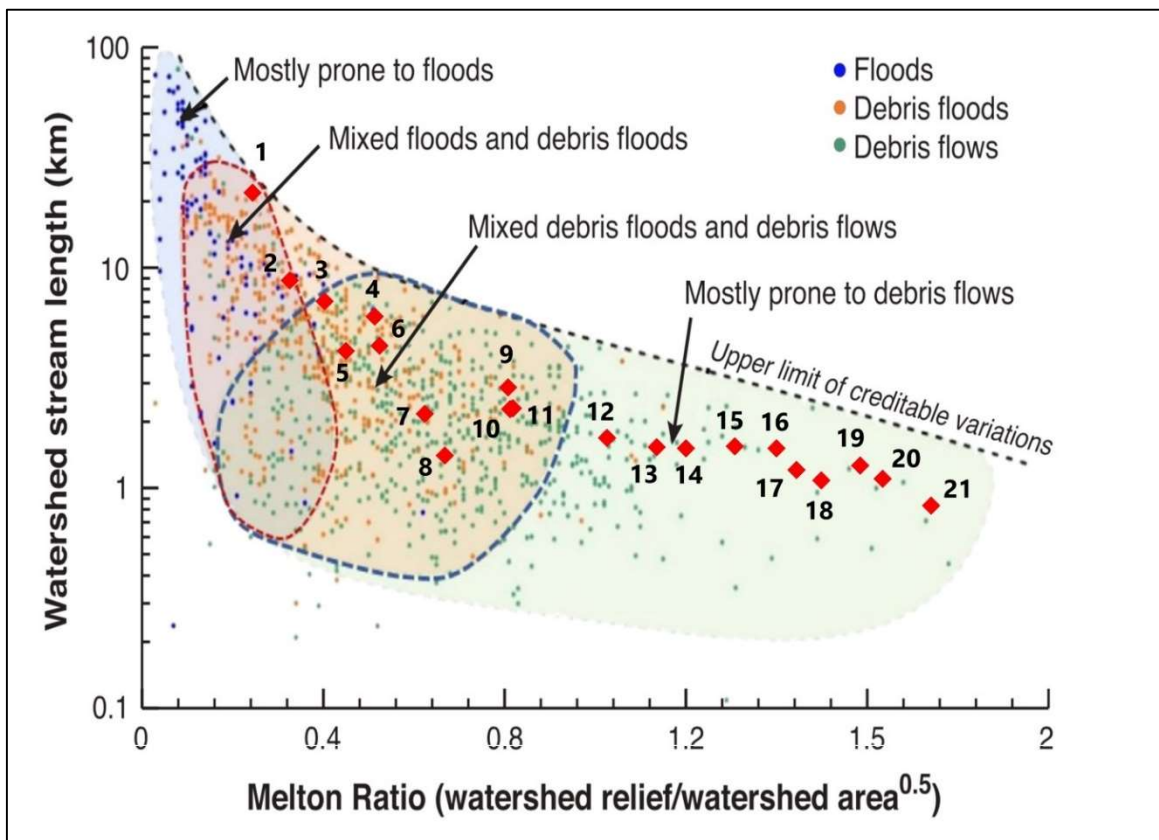
Church and Jakob (2020) use a different metric to differentiate between hydrogeomorphic processes; they plotted the Melton ratio versus stream length for a large dataset from watersheds across BC and Alberta (Figure 6). Due to greater relief along shorter streams, the Melton ratios in steep face unit streams have higher Melton ratios; these are shaded in green in Table 6. All of the small face unit streams plot in the “*Mostly prone to debris flows*” zone. The mid-sized watersheds, shaded orange in Table 6, have lower Melton ratios and plot in the “*Mixed debris floods and debris flows*” zone. Enterprise and Maurier Creeks have large watersheds with long moderate-gradient streams that plot in the “*Mixed floods and debris*” zone. None of the creeks in the Fire plot in the “*Mostly prone to floods*” zone as the physiography of the region is typically mountainous with steep slopes.

**Figure 6:** The Fire creeks plotted on a figure of the steep creek processes as a function of the Melton ratio and stream length, from Church and Jakob (2020<sup>25</sup>). The numbers refer to the watersheds in Table 6.

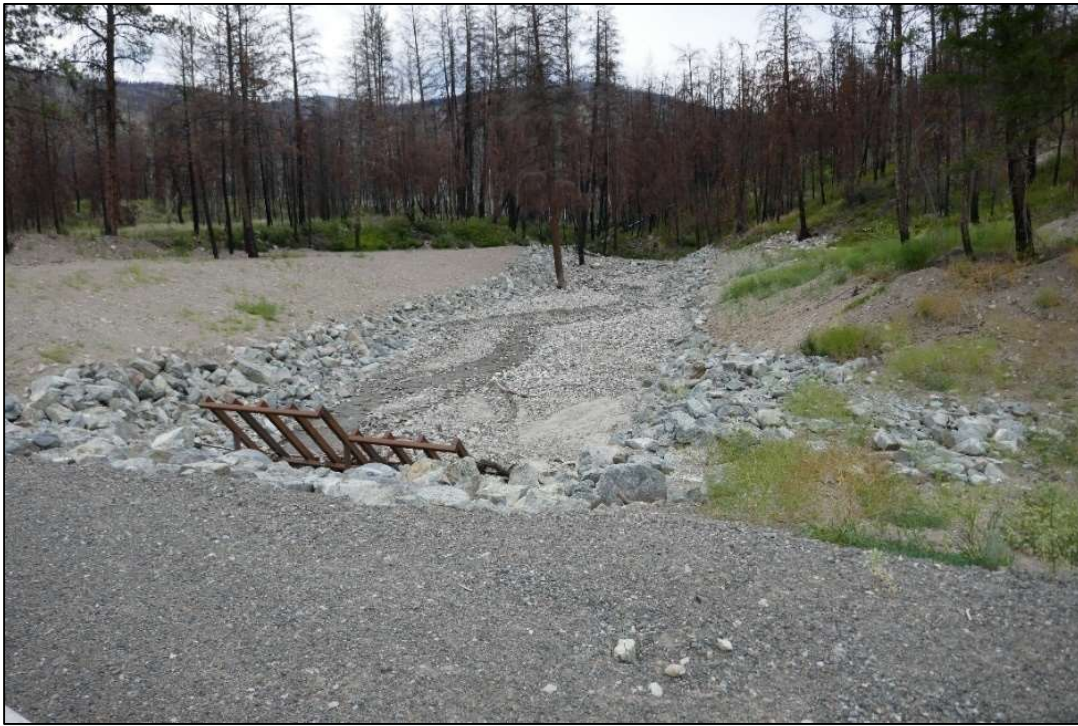
The culvert carrying Aylwin Creek under the Highway appears to be well sized for elevated clearwater flows, but the potential for increased sedimentary and woody debris movement could reduce the capacity of the culvert by plugging the culvert inlet. Development of a wide channel through a broad armoured catch basin with a trash rack (example shown in Photo 26) above the Highway may be a suitable solution to reduce the channel gradient at the culvert inlet and provide space for debris aggradation.

**It is recommended that the MoTT review the lower alluvial fan and determine where there is potential for channel avulsion.** Construction of a berm on the east side of RMR and the Highway to control the flow and incorporated sediment and woody debris might be required to maintain the direction of flow into the existing culvert and prevent channel migration onto RMR or the Highway.

**Photo 26:** Construction of a wide channel through an armoured catch basin with a trash rack at the culvert inlet, such as shown in this image, may be a suitable solution at the highway crossing of Aylwin Creek.

Note that the above recommendations are conceptual in nature and implementation of a berm structure, culvert catch basin, and trash rack will require detailed study and design by an appropriately qualified registered professional (QRP) and may require authorization under the Water Sustainability Act.

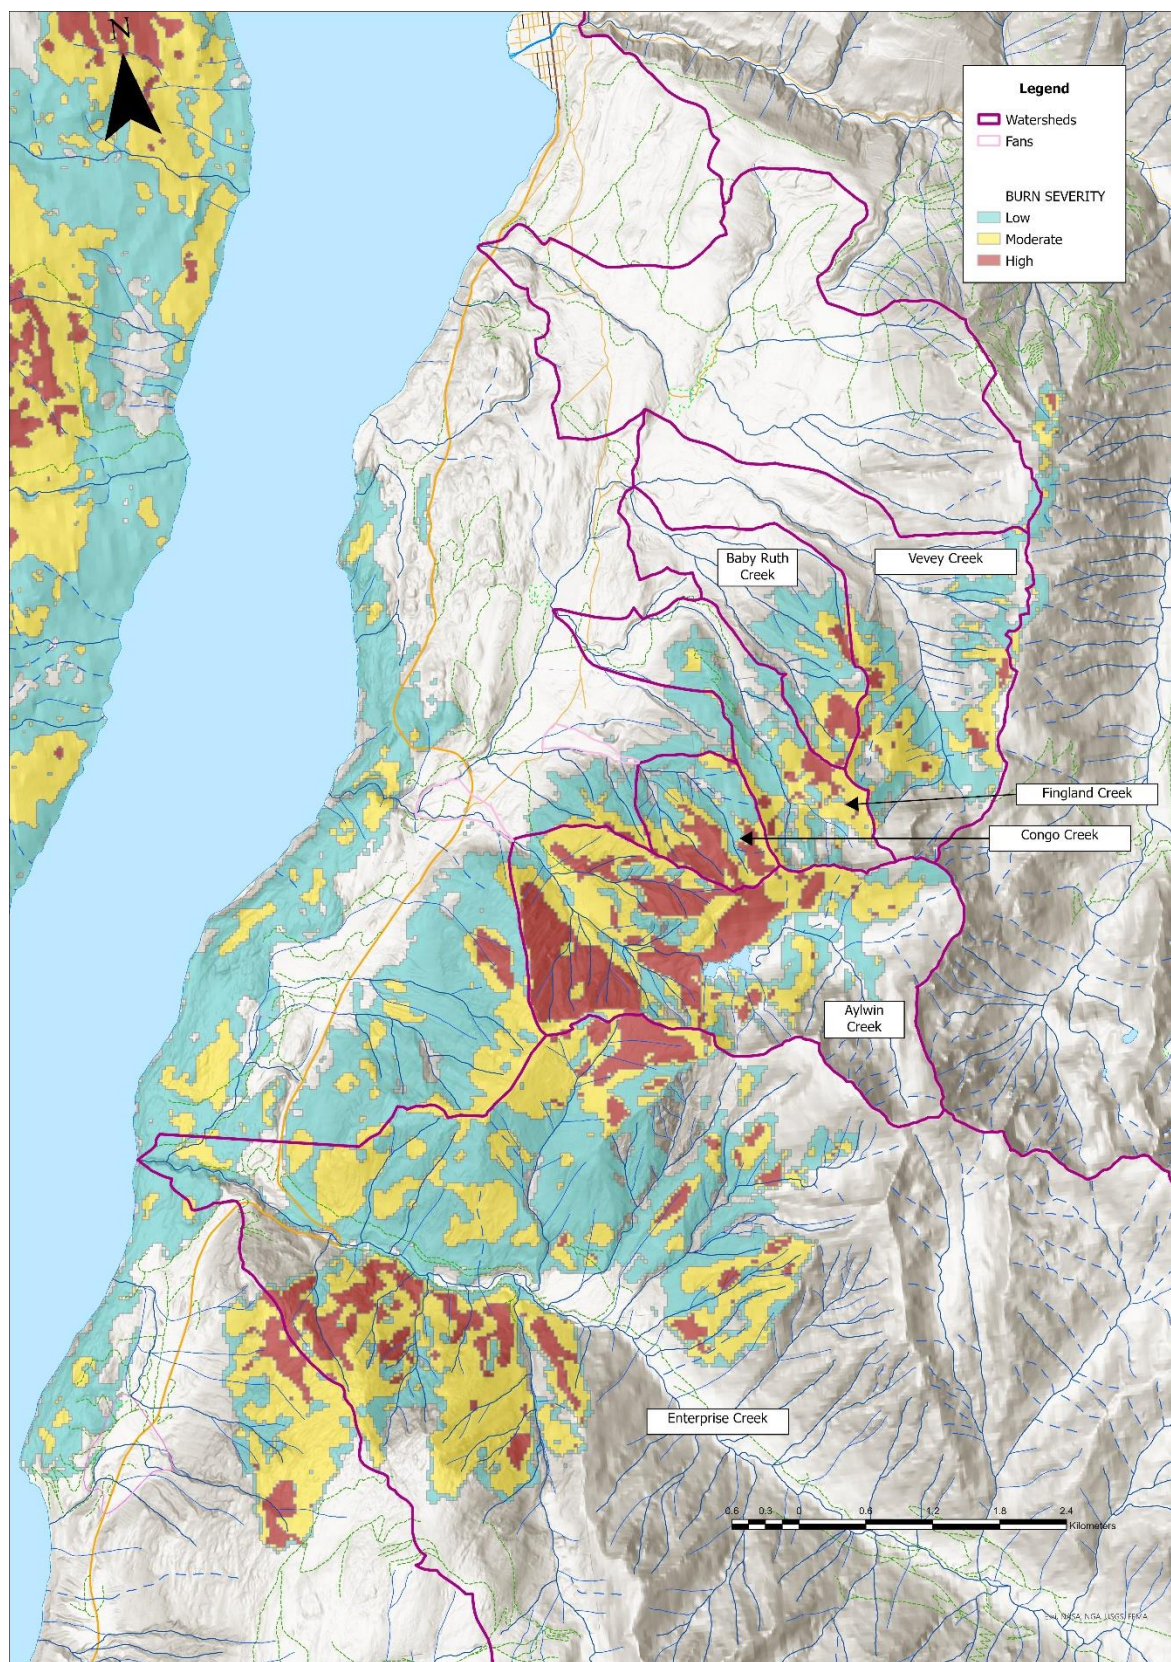
Figure 1. Burn severity map of the Komonko Creek fire showing estimated classes derived from Sentinel-2 imagery (prefire: July 11, 2024; post-fire: August 20, 2024). Further work may alter the estimated burn severity classes.

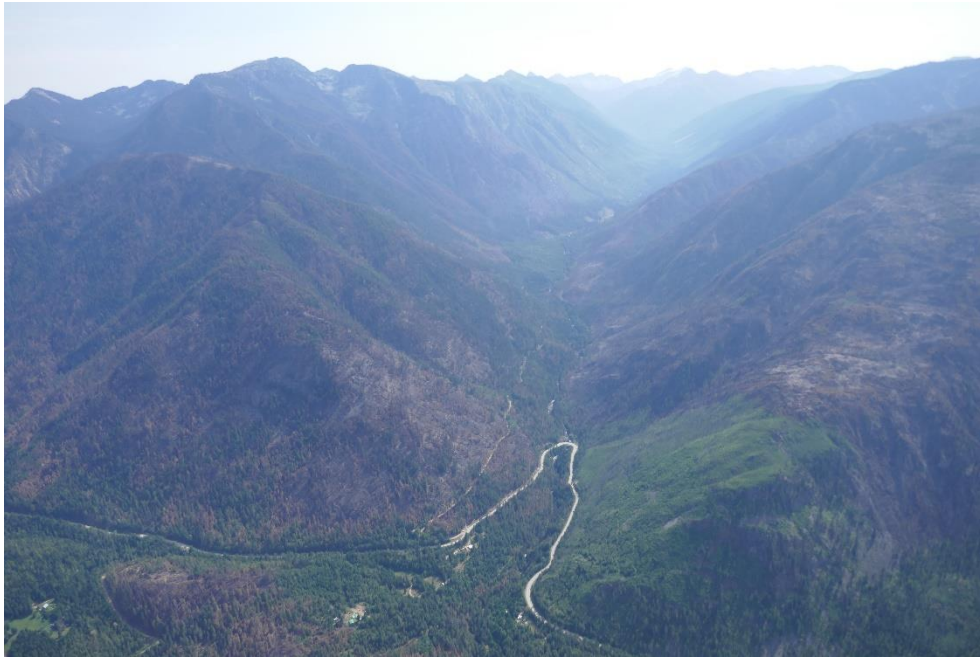
*Figure 2. Enterprise Creek (Photo: T. Giles, SNT Geotechnical).*

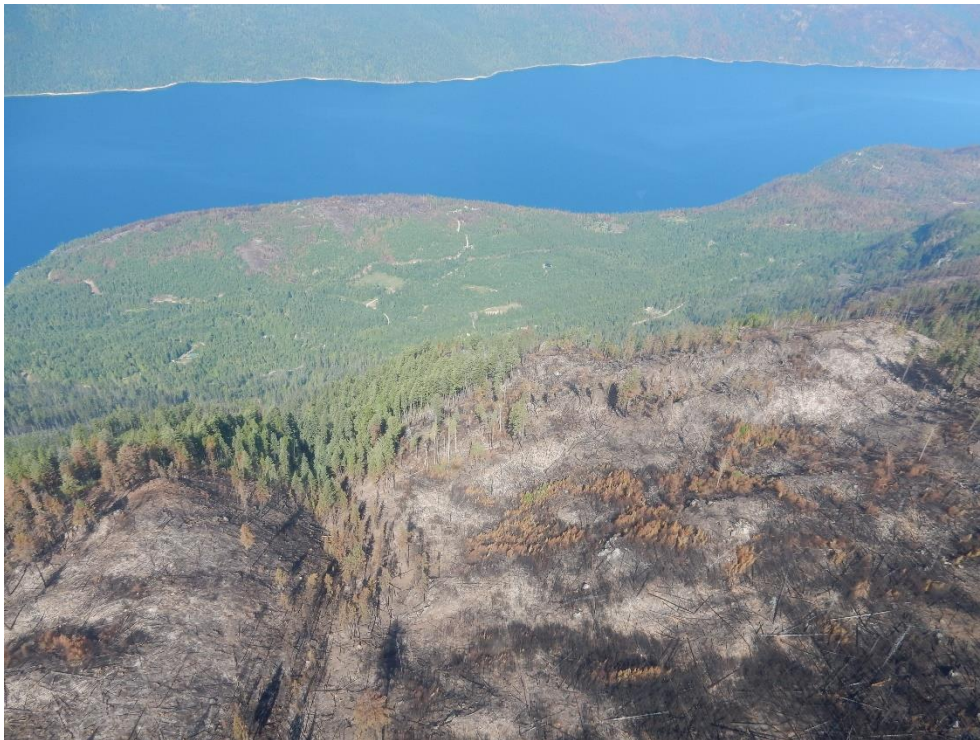
*Figure 3. Headwaters of Cory Creek.*
