BC Ministry of Forests

# POST-WILDFIRE NATURAL HAZARDS RISK ANALYSIS PONDEROSA FSR FIRE (N51069)

December 18, 2024

Report Number: 24.510.01.03.01.04

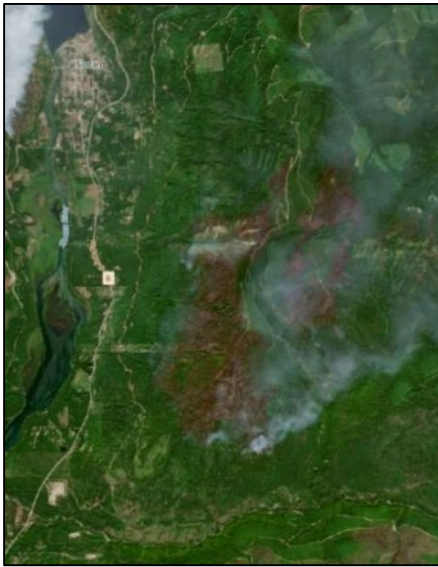
**Photo 1:** Sentinel-2 L2A Satellite imagery from August 1; the Fire is burning south of O'Shea Creek and has spotted to the ridge top. Smoke from the Mulvey Creek Fire (N51117) can be seen west of Slovan.

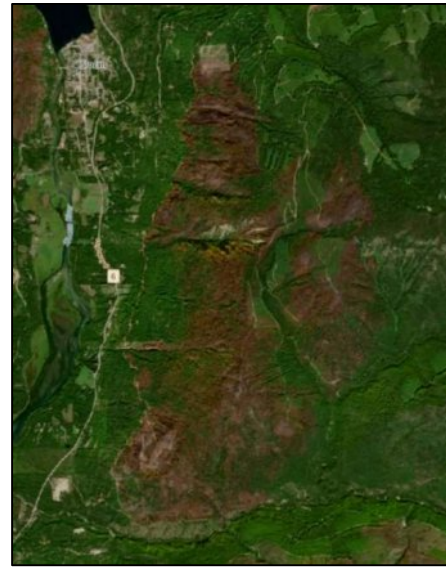
**Photo 2:** Sentinel-2 L2A Satellite imagery from August 31; the Fire appears to have reached its full extent and is out.

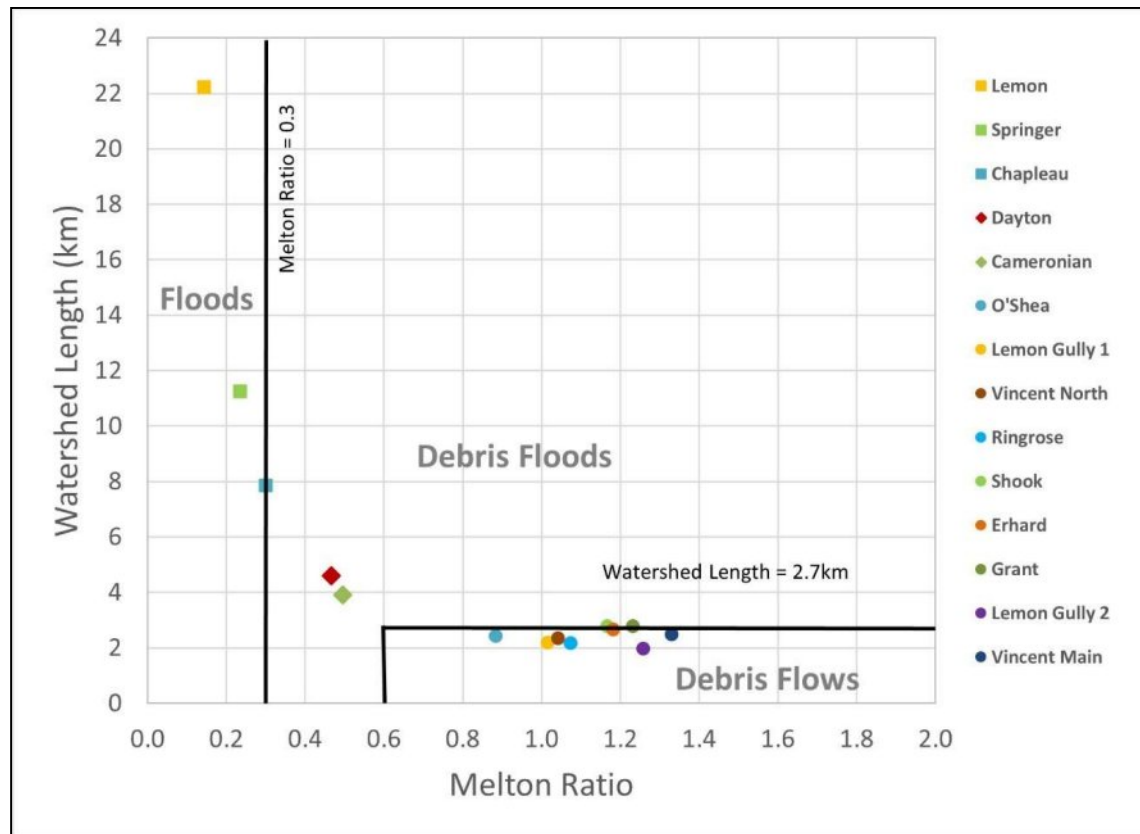
**Figure 5:** The hydrogeomorphic processes of creeks in the Fire plotted as a function of the Melton ratio and watershed length (Wilford et al. 2004).

Lemon Creek is a very large watershed in which flooding is the expected hydrogeomorphic process; Springer Creek also plots in the flood zone (Figure 5). Chapleau Creek is on the border between flood and debris floods. Dayton and Cameronian Creeks are mid-sized watersheds (6.51 and 4.66 km<sup>2</sup>, respectively) that plot within the region where a debris flood is the expected hydrogeomorphic process. The remainder of the watersheds are short and steep and plot within the region where debris flows are the expected hydrogeomorphic process.

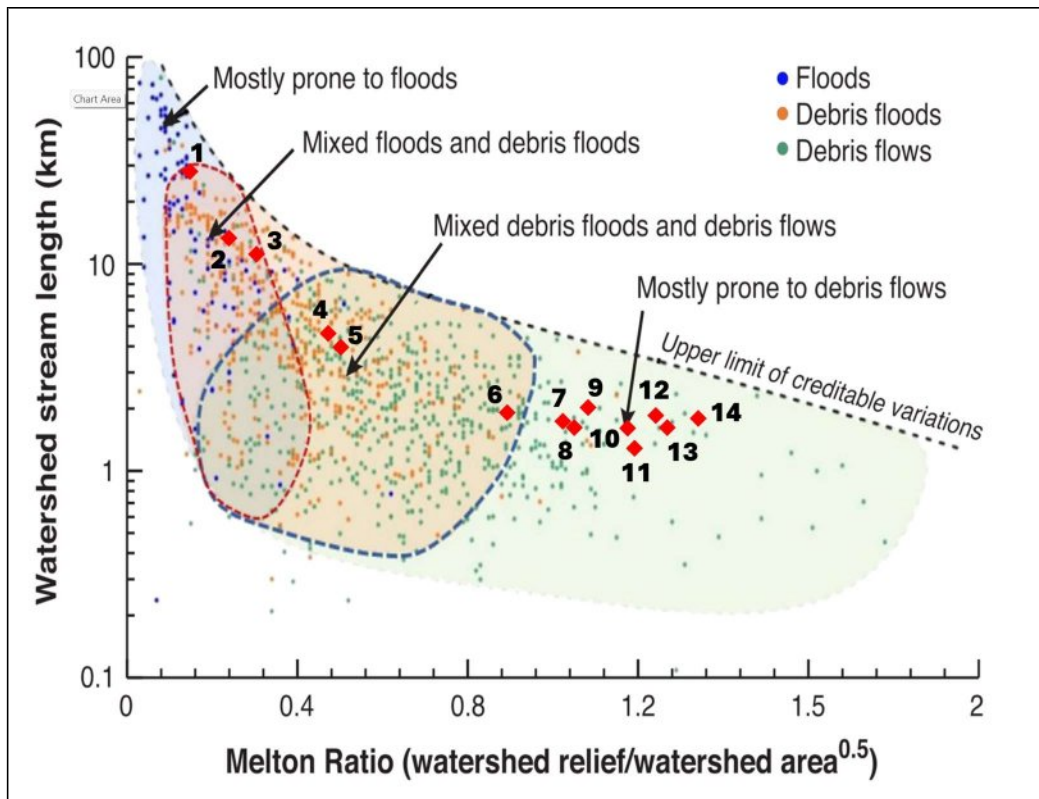
Church and Jakob (2020<sup>28</sup>) use a different metric to differentiate between hydrogeomorphic processes; they plotted the Melton ratio versus stream length for a large dataset of watersheds across BC and Alberta (Figure 6). Due to greater relief along shorter streams, the Melton ratios in steep face unit streams have higher Melton ratios; these are shaded in green in Table 6. All of the small face unit streams plot in the “*Mostly prone to debris flows*” zone. The slightly larger to mid-sized watersheds, shaded orange in Table 6, have lower Melton ratios and plot in the “*Mixed floods and debris floods*” or “*Mixed debris floods and debris flows*” zones. Lemon Creek has a long, gentle gradient stream that plots in the “*Mixed floods and debris floods*” and very close to the “*Mostly prone to floods*” zone. None of the creeks in the Fire plot in the “*Mostly prone to floods*” zone as the physiography of the region is typically mountainous with steep slopes.

**Figure 6:** Creeks within the Fire plotted on a figure of the steep creek processes as a function of the Melton ratio and stream length, from Church and Jakob (2020). The numbers refer to the watersheds in Table 6.

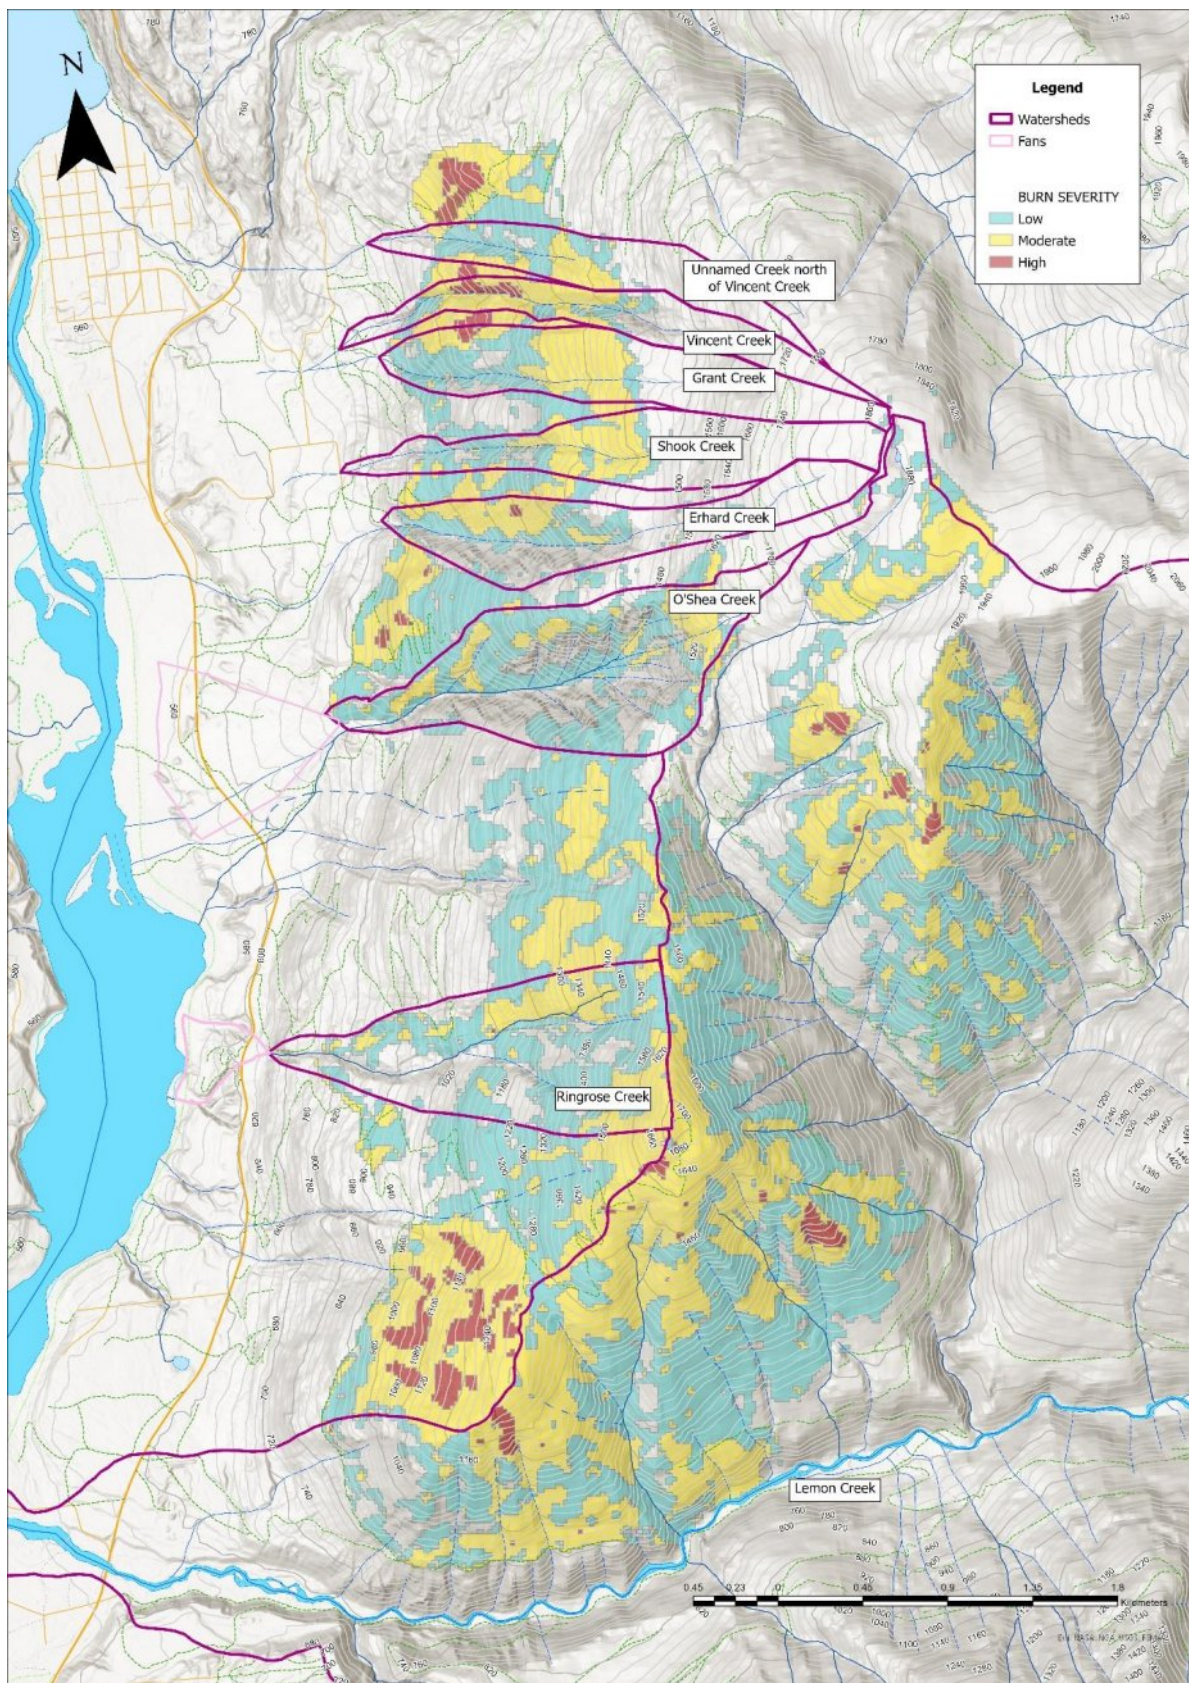
Figure 1 Soil burn severity map of the Ponderosa FSR fire showing estimated classes derived from Sentinel-2 imagery and some limited field work (prefire: July 7, 2024 post-fire: August 11, 2024). Further work may alter the estimated burn severity classes.
