## **RDCK FLOODPLAIN AND STEEP CREEK STUDY**

# **Eagle Creek**

FINAL March 31, 2020

Prepared by BGC Engineering Inc. for: Regional District of Central Kootenay

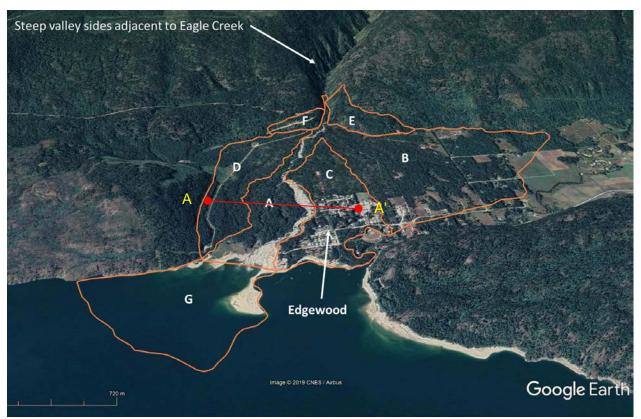
Figure 3-4. Oblique view of the Eagle Creek fan-delta looking west. Edgewood is located on the mid to distal end of the fan-delta. Areas A through G refer to geomorphic surfaces described in text. Photo: Google Earth (2019). The cross-section A-A' related to Figure 3-3.

There are seven distinct geomorphic surfaces on the fan-delta (annotated in Figure 3-4 and shown on Drawing 06):

The second active fan-delta surface (Surface B in Figure 3-4) is defined as the portion of the fandelta extending from the fan-delta apex towards the northeast, approximately paralleling the Worthington Creek Forest Service Road. Boyer (1988) reported that a historical channel survey in 1903 showed Eagle Creek flowing northeast from the fan-delta apex, across this portion of the fan-delta, and entering Inonoaklin Creek north of Edgewood. Between 1903 and 1907, the main channel was re-routed into its present configuration. A historical map from 1912 shows a similar configuration for a secondary channel of Eagle Creek (Figure 3-7).

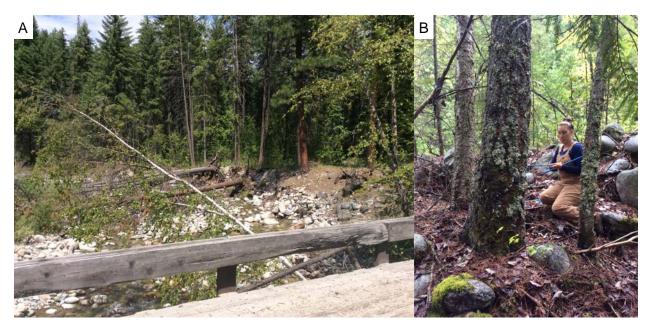
Figure 3-7. Photos of Eagle Creek Dike (EGL-FP-01) near fan-delta apex. A) Looking upstream (north) from Worthington Creek Forest Service Road Bridge at EGL-FP-01 (Photo by BGC July 23, 2019). B) looking south at material of EGL-FP-01 approximately 120 m upstream of the bridge, note the rounded clasts of the dike behind field staff (Photo by BGC July 23, 2019).

Almost directly upstream of the bridge on the left bank is a two-tiered, dike delineated in Drawings 02A, 02B as EGL-FP-01. Photos of EGL-FP-01 are shown in Figure 3-5. This dike was built in the mid 1900's, though there are conflicting accounts of the construction date; BC Hydro claims it was built in the 1970s while Edgewood residents say it was built in the 1940s. The dike does not appear to be maintained as recent floods have deposited sand over the first tier and vegetation is growing out of it. The dike appears to have been constructed out of smooth, rounded river rock. The Government of British Columbia's (2020) list of dikes by river/watercourse states "no local authority" as Owner/Administrator of EGL-FP-01, rendering it an orphan dike, i.e., a flood protection structure which is not maintained by a diking authority<sup>4</sup>. Attributes of EGL-FP-01 from the BC Flood Protection Works Database are listed in Table 3-4.

- BC Hydro installed flood protection measures (berm) in the 1980s at the base of the large bank slope below the town site. The berm is constructed of rip rap and shown in Drawings 02A, 02B. It was repaired in 2007.
- Eagle Creek Dike (EGL-FP-01) (Figure 3-7 and Drawings 02A, 02B) was constructed near the fan-delta apex upstream of the Worthington Creek Forest Service Road bridge in the 1940s or 1970s (residential recollections and reports differ). Photos of Eagle Creek Dike (EGL-FP-01) are shown in Figure 3-7 and Drawings 02A, 02B shows its location. Eagle Creek Dike (EGL-FP-01) was built using in channel material (i.e., rounded channel clasts). The design and intention for this structure is uncertain, but it was likely constructed to prevent avulsions to the northern and central portions of Eagle Creek fan-delta.

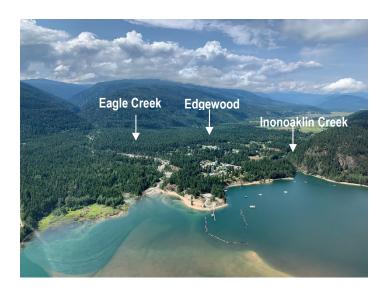
### Photo 1.

Eagle Creek fan – delta looking northwest with the community of Edgewood and channel outlet at Lower Arrow Lake. Inonoaklin Creek is flowing into Lower Arrow Lake from the right. Photo: BGC, July 6, 2019.

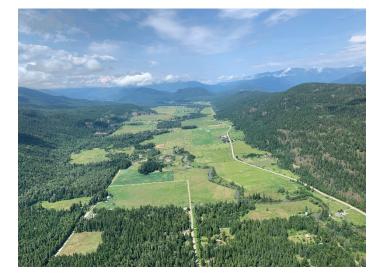
## Photo 3.

Overview from helicopter, looking north at the northern margin of the Eagle Creek alluvial fan and the Inonoaklin Creek floodplain. Photo: BGC, July 6, 2019.

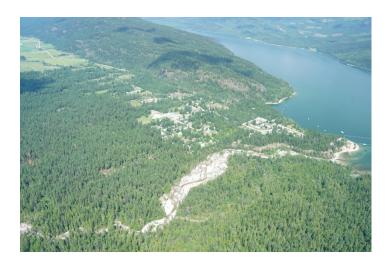
#### Photo 4.

Eagle Creek alluvial fan, looking northeast at with the aggraded reach of the channel, and the outlet at Lower Arrow Lake. Photo: BGC, July 6, 2019.

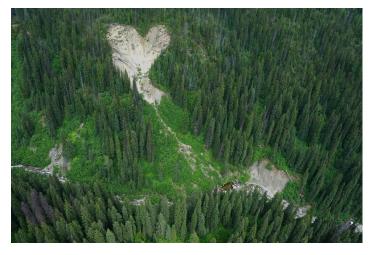
## Photo 6.

Looking north at a recent landslide in presumably fluvioglacial or till sediment in the central watershed approximately 8 km upstream of the fan apex and 1000 masl. Photo: BGC, July 6, 2019.

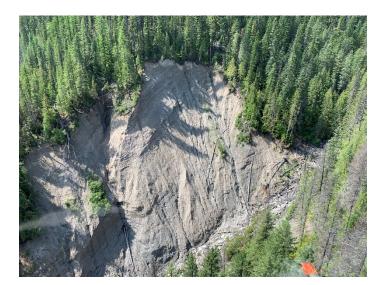
### Photo 7.

Photo from helicopter overflight looking northwest at a recent landslide in the central watershed approximately 8 km upstream of the fan apex, and El. 1000 m. Stratification in the upper escarpment suggests fluvioglacial sediments, possibly overlying till. Photo: BGC, July 6, 2019.

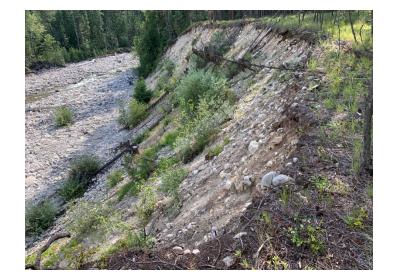
#### Photo 8.

Standing at top of approximately 15 m high left bank looking upstream (northwest). The bank is comprised of a 0.3 m thick soil horizon overlying fluvial gravel and cobbles in a sandy matrix. The bank is presumably a paleo - river terrace. Photo: BGC, July 23, 2019.

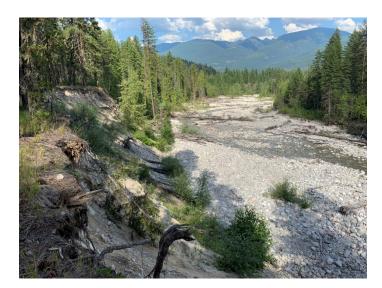
#### Photo 9.

Standing at top of approximately 15 m high bank looking downstream (southeast) at the aggraded reach of Eagle Creek in the alluvial fan. The active floodplain is approximately 30 m wide at this location, and the bank is presumably a paleo – river terrace. Photo: BGC, July 23, 2019.

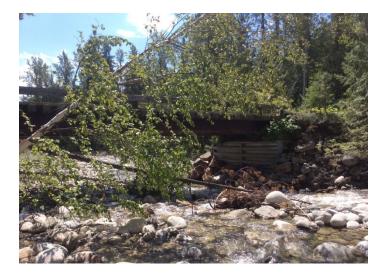
#### Photo 10.

The Forest Service Road bridge near the fan apex partially obstructed by a half-fallen birch tree. Bridge is constructed of steel beams and railway ties and supported by timber retaining walls on either side of bridge. Looking upstream (northwest). Cross Section EGL-01 was taken under the bridge. Photo: BGC, July 23, 2019.

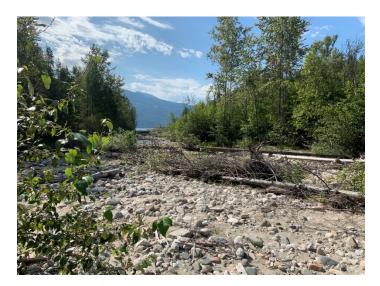
### Photo 12.

Standing on a gravel bar to the right (west) of the Eagle Creek channel approximately 500 m upstream of the outlet to Lower Arrow Lake. Looking at aggraded reach of channel with cobble and gravel bars. The active (unvegetated) floodplain width is approximately 65 m. Photo: BGC, July 23, 2019.

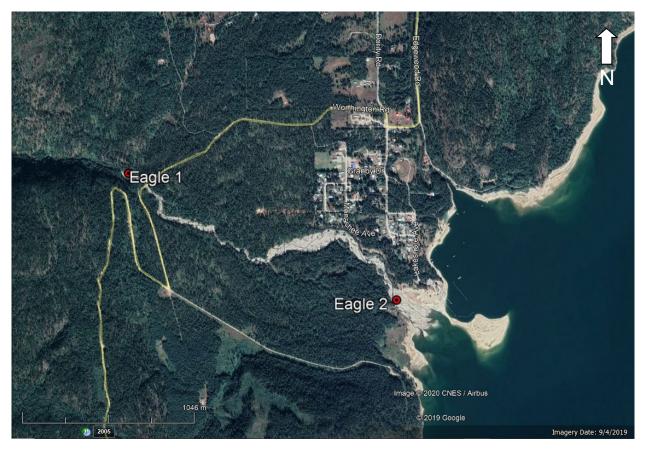
Figure C-1. Wolman sampling locations along Eagle Creek. Google Earth image of September 4, 2019.

## Table C-1. Wolman sampling locations.

Site Name	Eagle 1	Eagle 2
Location	Downstream of fan apex	Confluence with Lower Arrow Lake
Longitude	118° 9'52.22"W	118° 8'30.67"W
Latitude	49°46'50.16"N	49°46'25.29"N
Number of stones measured	98	138

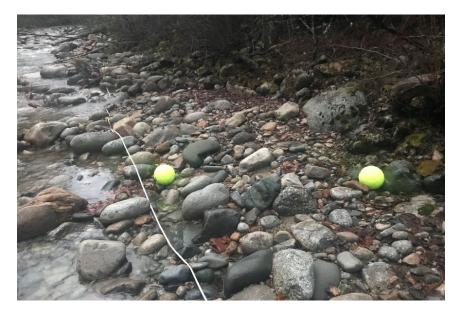
Figure C-2. Photograph taken of Wolman sampling location Eagle 1. BGC photograph of November 18, 2019.
