Funding Water Infrastructure for the Long Term

Regional District of Central Kootenay

Ymir

April 11, 2018

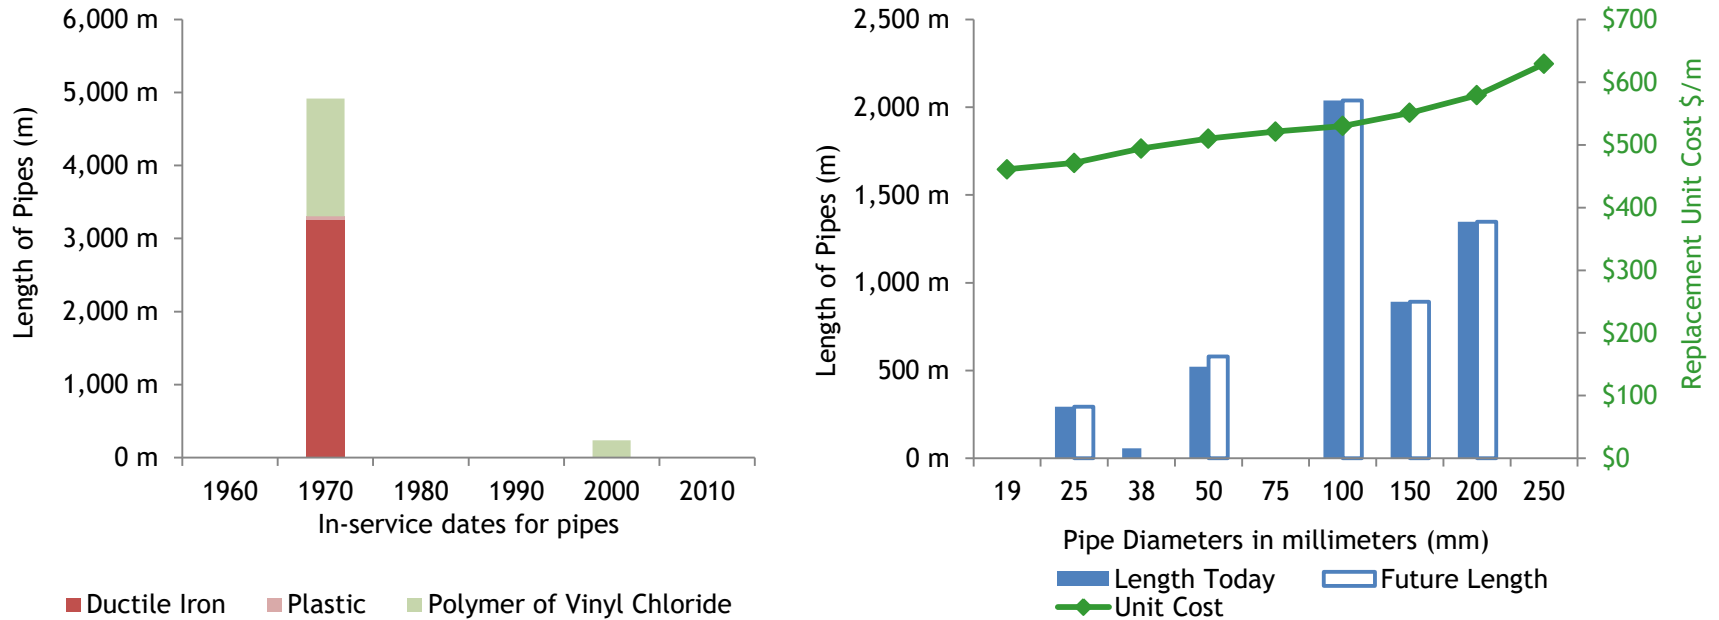
Figure 2: Ymir Pipe Distribution Network (Length, Material, Diameter)

Approximately 5.2 Kms of pipes made of ductile iron and PVC plastic ranging in diameter from 25mm to 200mm was installed in Ymir circa 1979.

Note: due to minimal availability of records, some in-service dates may be estimated by decade from old maps.

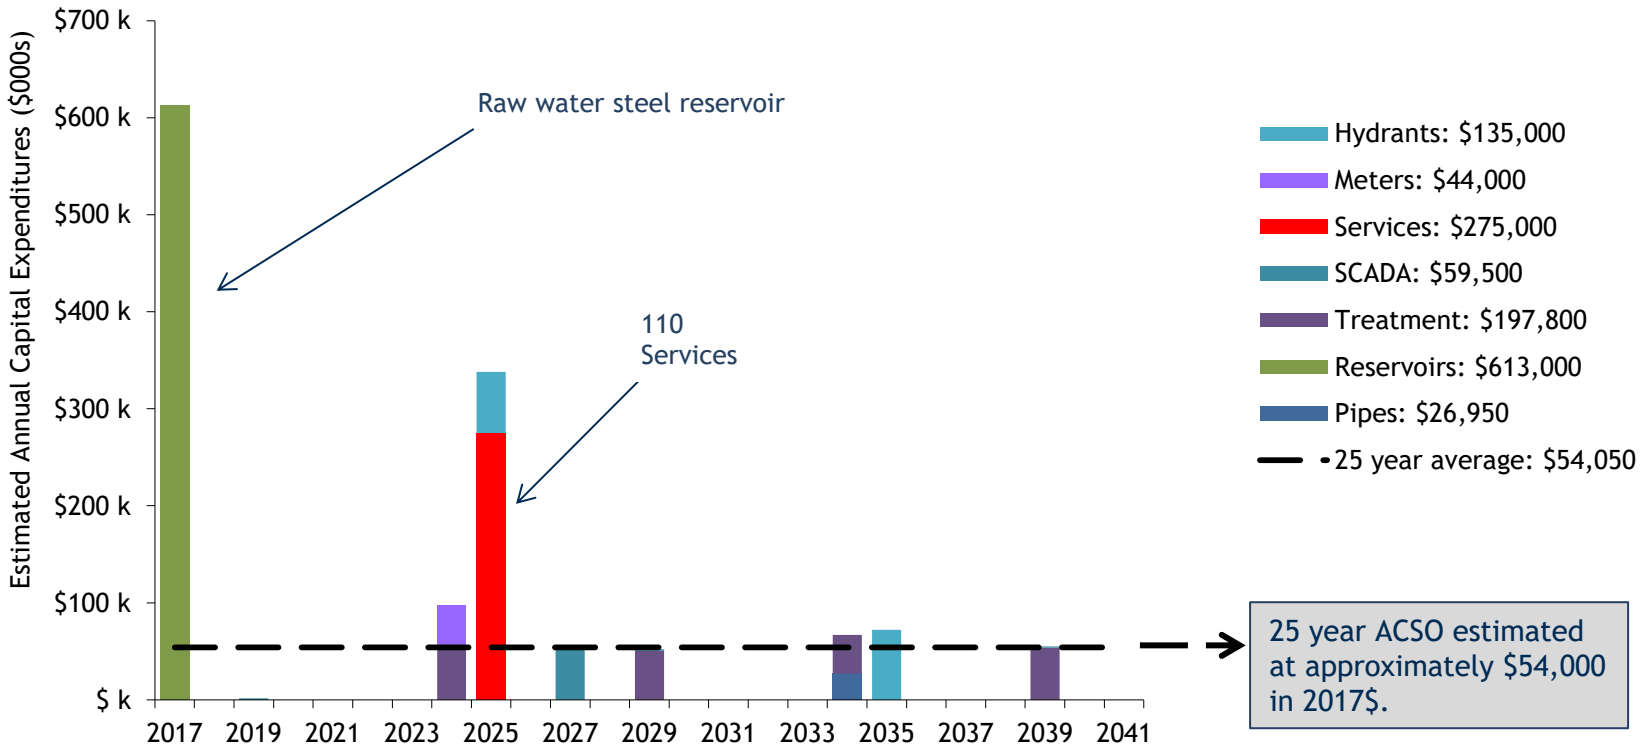
Figure 5: Ymir 25 Year Asset Replacement Schedule

This chart summarizes the Asset Replacement Schedule (ARS) 25 year period projection of asset replacement. The average cost over the 25 year period, also termed the Annual Cost of Sustainable Ownership (ACSO) is shown by the dash line.

Figures are in 2017\$ and not adjusted for inflation.

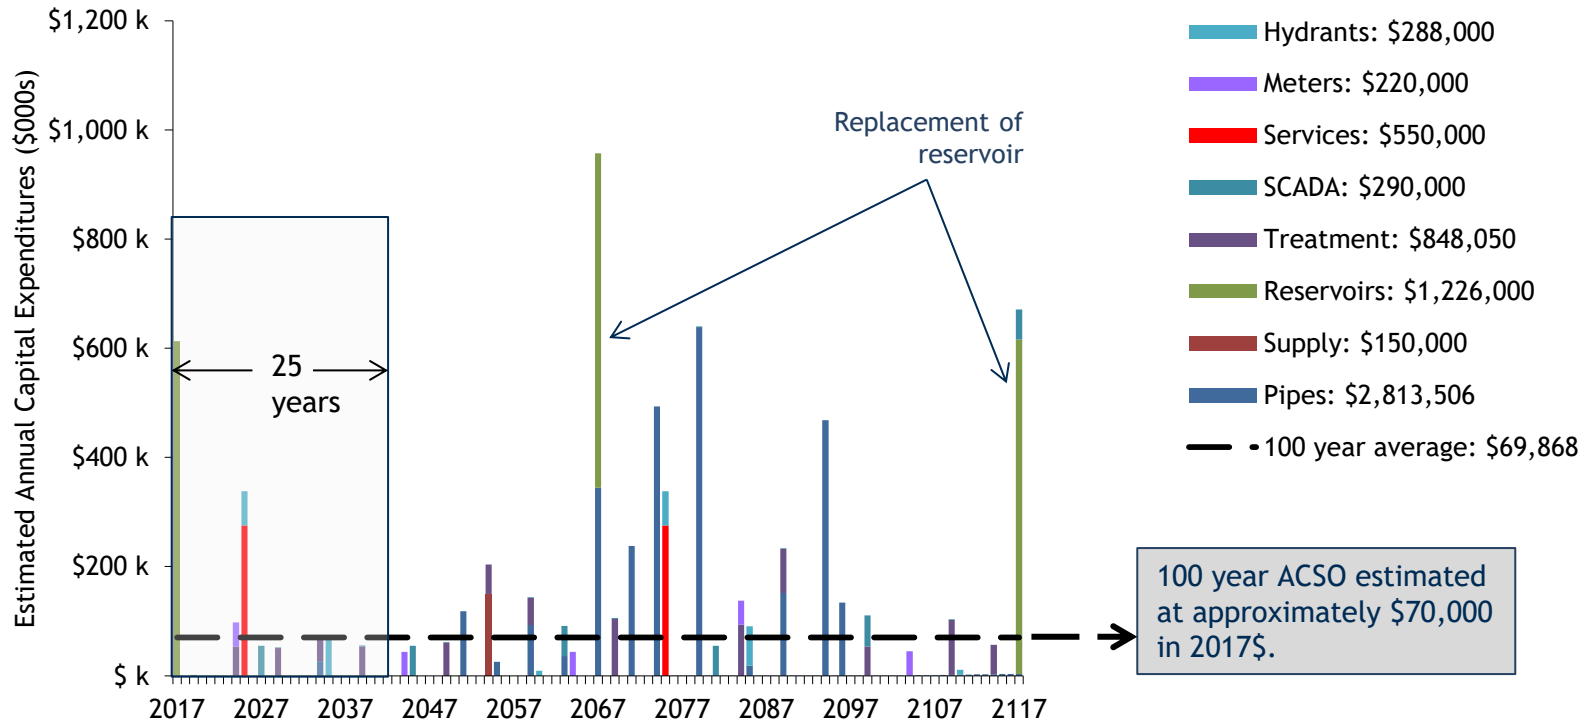
Figure 6: Ymir 100 Year Asset Replacement Schedule

This chart summarizes the Asset Replacement Schedule (ARS) 100 year period projection of asset replacement. The average cost over the 100 year period, also termed the Annual Cost of Sustainable Ownership (ACSO) is shown by the dash line.

Figures are in 2017\$ and not adjusted for inflation.

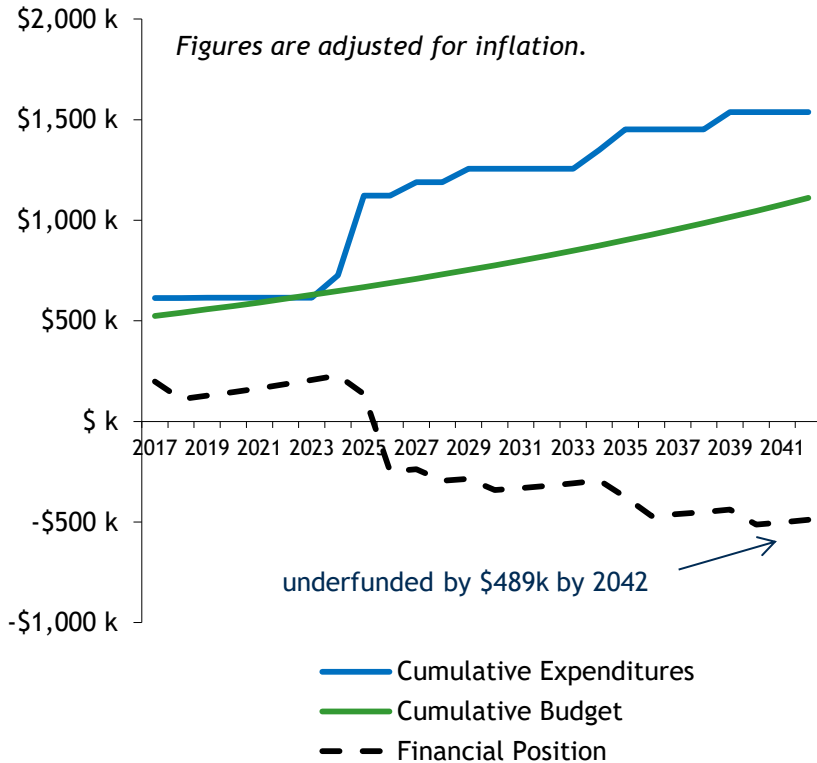
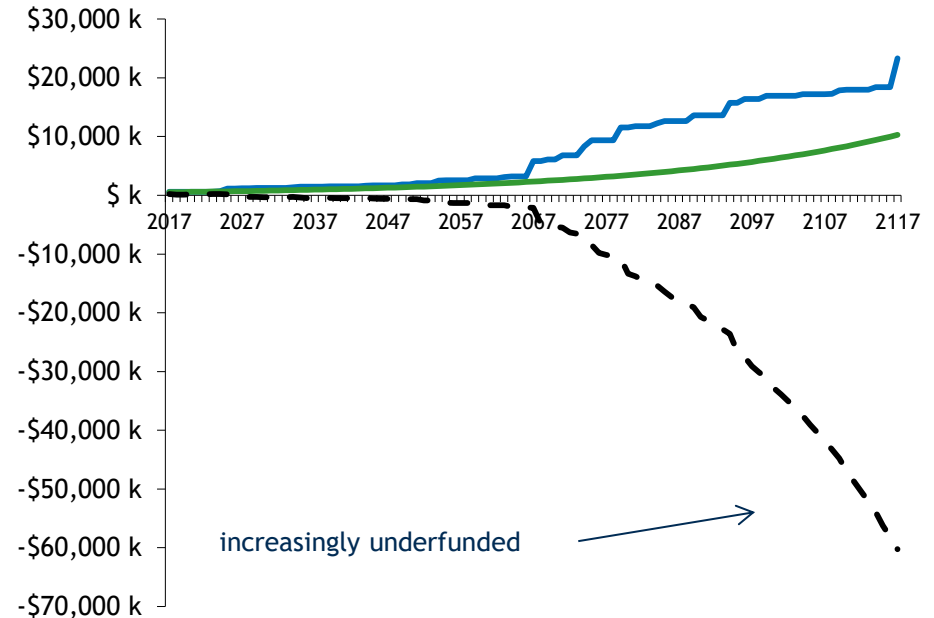
Figure 8: Ymir 25 Year and 100 Year Financial Position

This chart compares the expenditures and allocated funds from figure 7. The blue line shows the cumulative expenditures, inflation adjusted, projected over the next 25 years in the asset schedule. The green line shows the cumulative funds allocated towards these projects.

The dash line is the difference between what is projected to be spent and available funds. When this line is above 0, it represents a surplus of funds typically held in an asset reserve fund; when below zero, the dash line represents a shortfall and implies the need for additional funding, or the works need to be delayed or canceled.

3. Make necessary adjustments to rates and fees to bolster the annual contribution for asset replacement (ACFAR) with an aim to have ACFAR meet ACSO and to build up a reserve fund in advance of large future expenditures. The financial position on page 20 can be a guide in determining reserve fund target level; and,
